AIRTIGHTNESS OF BUILDINGS — TOWARDS HIGHER PERFORMANCE

Interim Report D6 — Seminars and Developer Feedback

Dr David Johnston, Centre for the Built Environment, Leeds Metropolitan University

Reference Number: CI 61/6/16 (BD2429)

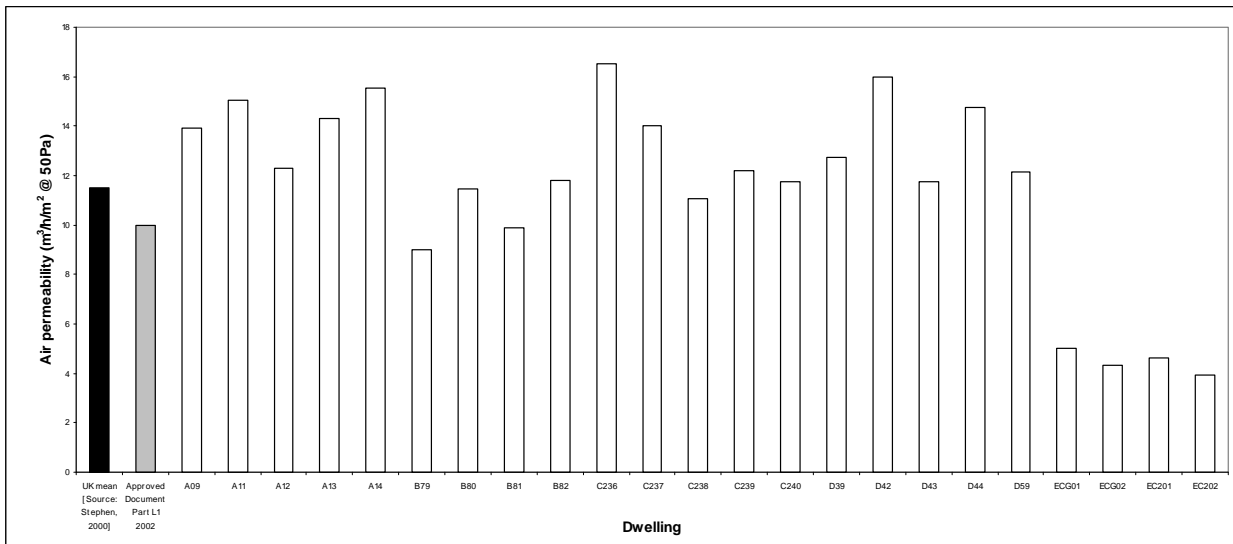
Figure 1 Mean air permeability of the tested dwellings.

- 19 Figure 1 illustrates the air permeability of the 23 tested dwellings compared to the UK mean¹ and the recommended maximum level set in the 2002 edition of the Building Regulations Approved Document Part L1 of $10 \text{ m}^3/(\text{h.m}^2) @ 50\text{Pa}$ (ODPM, 2001). The data show that a relatively wide range of airtightness was measured for the 23 tested dwellings. The air permeability of the dwellings ranged from 4.0 to $16.5 \text{ m}^3/(\text{h.m}^2) @ 50\text{Pa}$, with a mean of $11.1 \text{ m}^3/(\text{h.m}^2)$ and standard deviation of $3.9 \text{ m}^3/(\text{h.m}^2)$. Although the range of air permeability that was measured within the tested dwellings is consistent with some recent measurements undertaken by Grigg (2004),² the mean for the dwellings tested in this project is higher (11.1 as opposed to Grigg's $9.2 \text{ m}^3/(\text{h.m}^2) @ 50\text{Pa}$). This is probably a result of the larger proportion of apartments³ (36%) that were included in the sample tested by Grigg (2004) compared with our sample (24%).

- 20 Only eight of the 23 dwellings (35%) had an air permeability that was lower than or equal to the UK mean of $11.5 \text{ m}^3/(\text{h.m}^2)$. The mean of all 23 results ($11.5 \text{ m}^3/(\text{h.m}^2) @ 50\text{Pa}$) suggests that these dwellings are as airtight as the average for the UK stock as a whole ($11.5 \text{ m}^3/(\text{h.m}^2) @ 50\text{Pa}$).

- 21 One of the most important results to be obtained from Figure 1 is that only six of the tested dwellings (four flats and two houses) (26%) had air leakage values that were lower than the maximum specified level of $10 \text{ m}^3/(\text{h.m}^2) @ 50\text{Pa}$ set in the 2002 edition of the Approved Document Part L1 (ODPM, 2001). Of the 19 houses tested only two achieved a level below the value given in ADL1, However, given the small sample size and the range of values measured, no claims of statistical significance can be made. All five developers were using Robust Details (see DEFRA, 2001) as the basis of the application for regulatory approval. Given this, only one of the developers (developer E) has managed to satisfy the air leakage criterion with all of their dwellings that have been tested. The other four developers were unable to achieve the airtightness target in the majority of cases. The reasons for this could be due to a lack of on site quality control relating to the construction of Robust Details, poor communication, poor inherent construction design relating to airtightness, a lack understanding of how Robust Details work or possibly even that the Robust Details themselves may be difficult to achieve in practice, impractical or insufficiently tolerant of site variability - so called 'buildability'. We understand that the impact of Robust Details on whole dwelling air leakage was not subjected to empirical testing when the current catalogue was compiled. This report suggests that empirical testing would be needed as part of a process of developing a catalogue of details capable of reliably delivering an air leakage target.

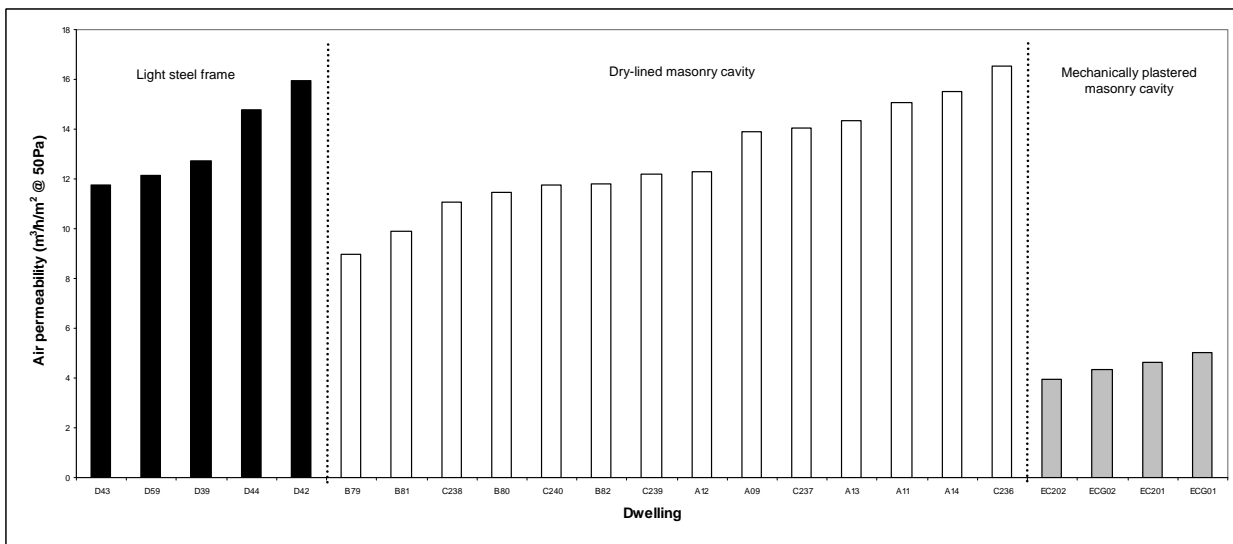
Figure 2 Mean air permeability of the tested dwellings by construction type.

- 22 The small sample size of this survey precludes absolute certainty when comparing data either by developer or by construction type. However, ignoring the issue of sample size, the data do show a difference in the air permeability between the different types of construction method covered in this survey (see Figure 2 and Table 3). The tightest dwellings were those of mechanically plastered masonry cavity construction (developer E). These dwellings are on average a factor 3 more airtight than those that were built using dry-lined masonry cavity construction. The reasons for this are likely to be two-fold. First of all, wet plastered masonry dwellings tend to be intrinsically more airtight than comparable dry-lined masonry or steel frame construction (Olivier, 1999). Secondly, as previously mentioned, apartments tend to be more airtight than comparable dwellings of different built form. The least airtight dwellings were those constructed using light steel frame (developer D). These dwellings were only marginally leakier than the dry-lined masonry cavity dwellings (mean air permeability of 13.5 as opposed to $12.6 \text{ m}^3/(\text{h.m}^2) @ 50\text{Pa}$) constructed by developers A, B and C. It is not certain whether the poor performance of the light steel framed dwellings is attributable to an intrinsic problem with the airtightness of steel framed construction, the quality of workmanship, or a combination of the two. However, large gaps were observed between a number of the components in dwellings D42 and D44, such as flooring panels and floor/wall junctions. Assuming that the air barrier within these dwellings is formed by the plasterboard dry-lining, such gaps between components would enable free passage of air to the outside. This suggests that the poor air leakage of these dwellings may therefore be attributable to factors such as poor tolerances of

components, quality of workmanship, site supervision and training, or unfamiliarity with the construction technique.

- 23 The data also show that there appears to be a difference in performance between the three developers that are building using dry-lined masonry cavity construction (developers A, B and C). The tightest dwellings were those constructed by developer B (mean air permeability of $10.5 \text{ m}^3/(\text{h.m}^2) @ 50\text{Pa}$), whilst the leakiest dwellings were those constructed by developer A (mean air permeability of $14.2 \text{ m}^3/(\text{h.m}^2) @ 50\text{Pa}$). Despite these results, no significant differences in the quality of the workmanship were observed between the dwellings constructed by developers A, B and C. Therefore, we believe that workmanship alone is unlikely to have caused the difference in performance that has been observed between these three developers. It is more likely that the difference in performance is due to a combination of design, and site quality control processes as well as workmanship.
