AIRTIGHTNESS OF BUILDINGS — TOWARDS HIGHER PERFORMANCE

Interim Report D8 — Site Assessments and Test Results

Dr David Johnston, Centre for the Built Environment, Leeds Metropolitan University

Reference Number: CI 61/6/16 (BD2429)

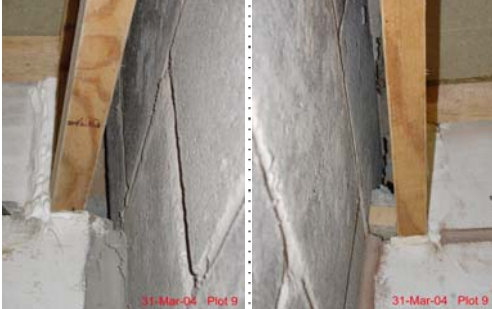
<p>Gaps through to cavity observed at a number of instances where joists are in close proximity to walls.</p>

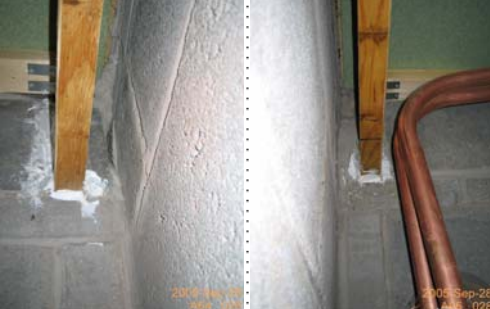
<p>No corresponding gaps observed at these junctions, although mastic is rarely applied to these less accessible areas.</p>
Threshold

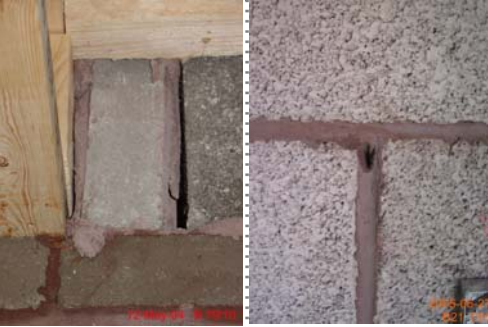
<p>Gaps observed in blockwork and unfilled perpend which often remain unsealed, hidden in floor voids and behind the 'dot and dab' dry-lining.</p>

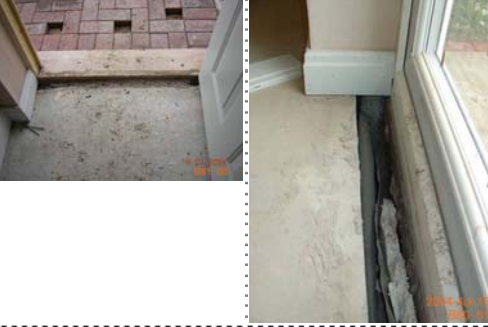
<p>Threshold not sealed until after dry-lining, creating potential air paths from behind the dry-lining into the cavity.</p>

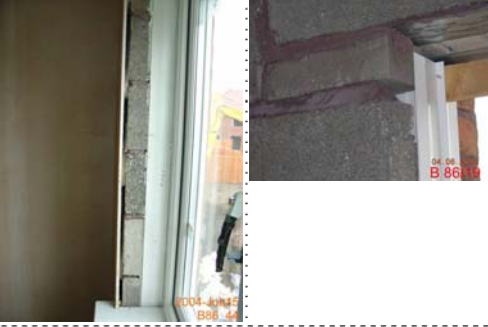
<p>Potential leakage paths from behind the dry-lining and jamb liners into the cavity, with jamb/head junctions often relying on mineral wool as the plugging material.</p>

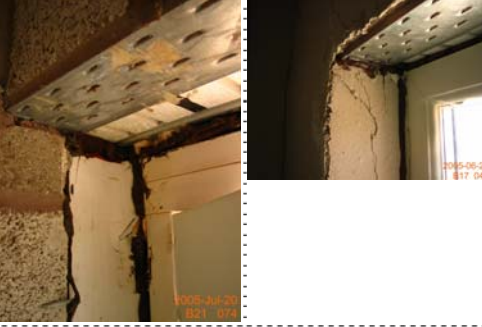
<p>All gaps around closers sealed with mineral wool and mastic, expanding foam and mastic, or fully parged (B17).</p>

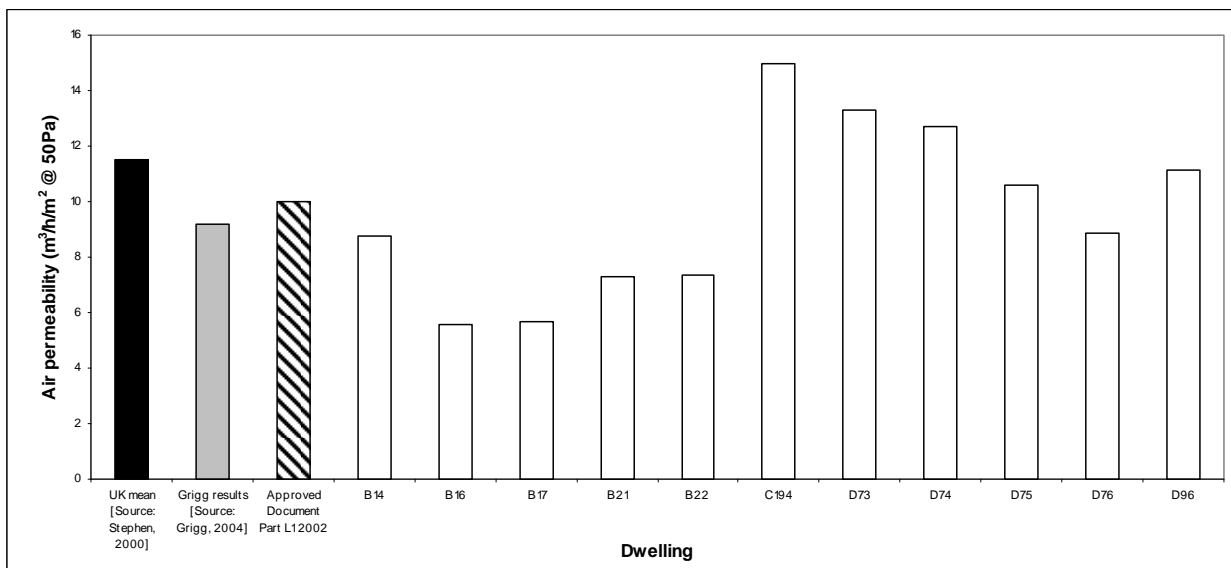
Figure 1 Mean air permeability of the tested dwellings.

36 Figure 1 illustrates the air permeability of the 11 tested dwellings compared with the UK mean,¹ the recommended maximum level set in the 2002 edition of the Building Regulations Approved Document Part L1 of 10 m³/(h.m²) @ 50Pa (ODPM, 2001) and some recent measurement

- 37 Perhaps of most importance is that only six of the 11 dwellings tested to date have achieved air leakage values that are lower than the maximum specified level of 10 m³/(h.m²) @ 50Pa set in the 2002 edition of the Approved Document Part L1 (ODPM, 2001). As in Phase 1 of the project, all of the dwellings that have been tested to date were using Part L Robust Details (see DEFRA, 2001) as the basis of the application for regulatory approval. In addition to this, each developer also received detailed and targeted feedback from the Leeds Met research team on any potential areas or issues that may have an influence on the eventual airtightness performance of the selected dwellings.

- 38 The data also show that the tightest dwellings tested were those constructed by developer B. All of the dwellings constructed by this developer achieved air leakage values less than the target of 10 m³/(h.m²) @ 50Pa that is specified within ADL1 2002. The leakiest dwelling tested to date was constructed by developer C, which was built as per their standard Phase 1 construction. Only one of the five dwellings constructed by developer D achieved an air leakage rate of less than 10 m³/(h.m²) @ 50Pa.

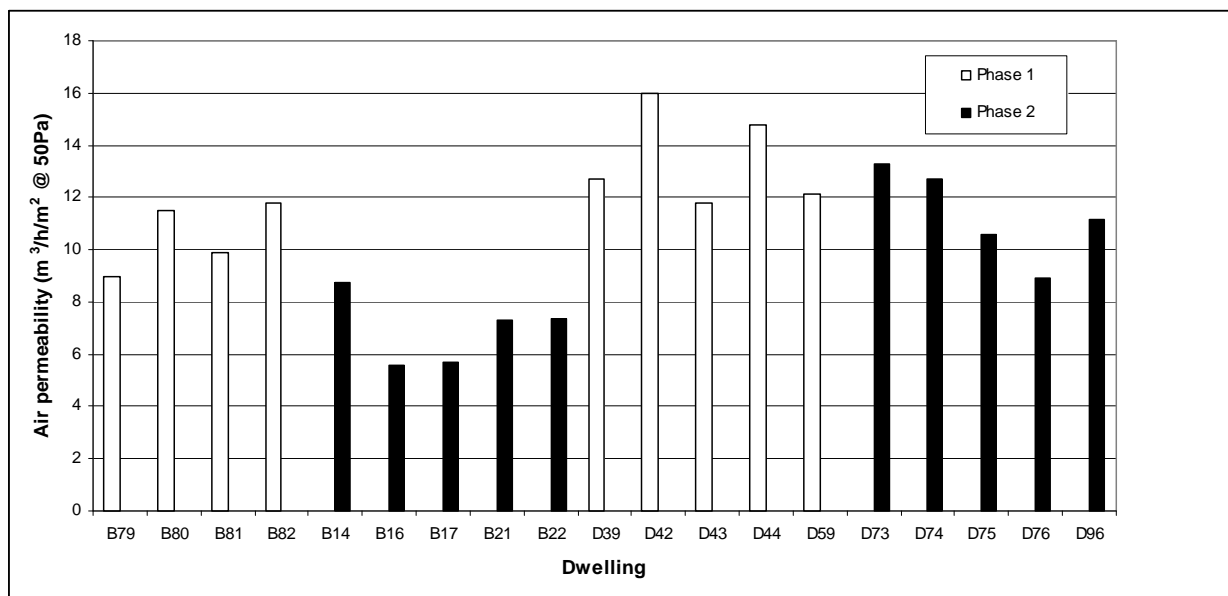
Figure 2 Mean air permeability of the tested Phase 1 and Phase 3 dwellings.

- 39 The air permeability of the 11 tested dwellings has also been compared against the air permeability results that were achieved during Phase 1 of the project. The results of this are shown in Figure 2.

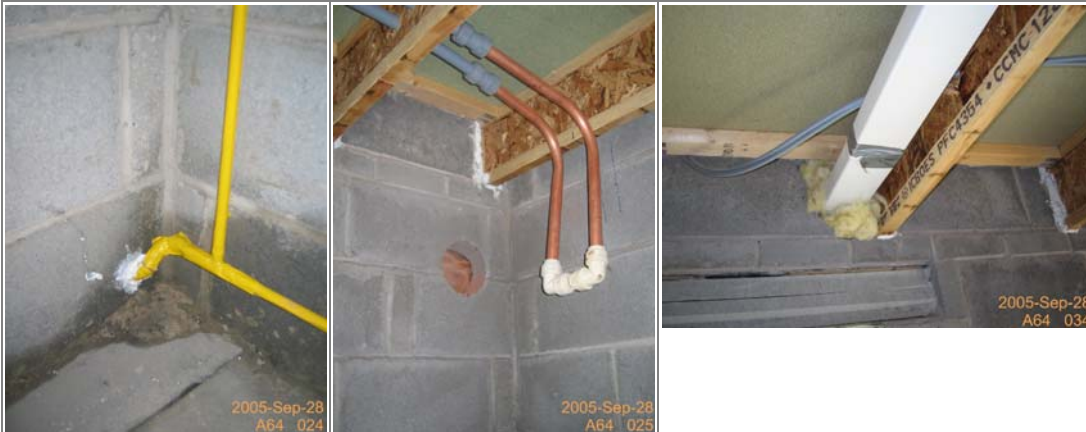
Service Penetrations – Intermediate Floor

Although air will not escape directly to outside the building envelope through these penetrations, they allow air to move more freely throughout the dwelling generating 'hidden' leakage paths. Some penetrations through the intermediate floor are larger than necessary and will take more time and effort to seal; if penetrations through the cylinder cupboard floor are to be sealed effectively this will require doing so before the tank is positioned and access is restricted.

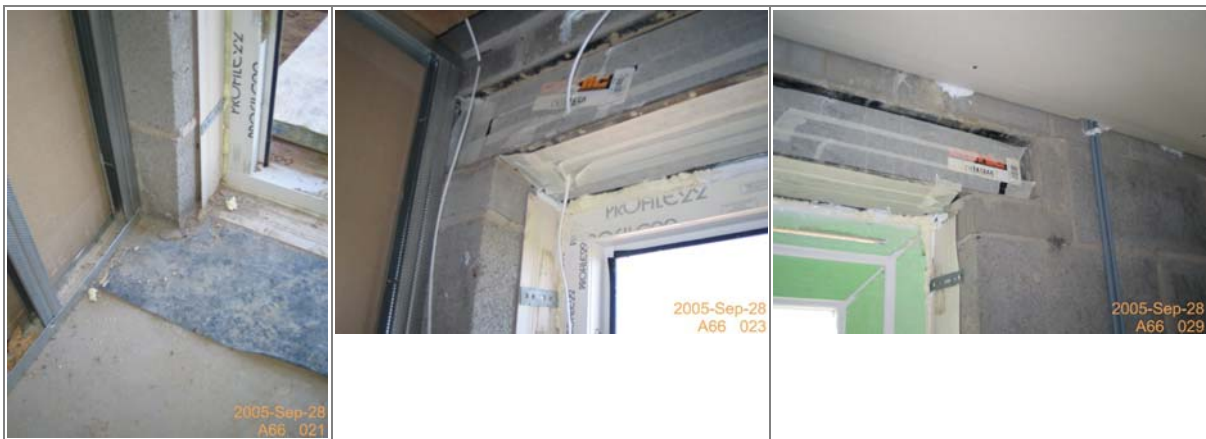
Service Penetrations – External Walls

Small penetrations for cables have been sealed around using mastic. The hole for the boiler flue is not excessively large and will be filled with expanding foam where it penetrates the blockwork once the boiler is installed. The mineral wool surrounding the cables to the electrical consumer unit is to be compacted and sealed using expanding foam prior to dry-lining.

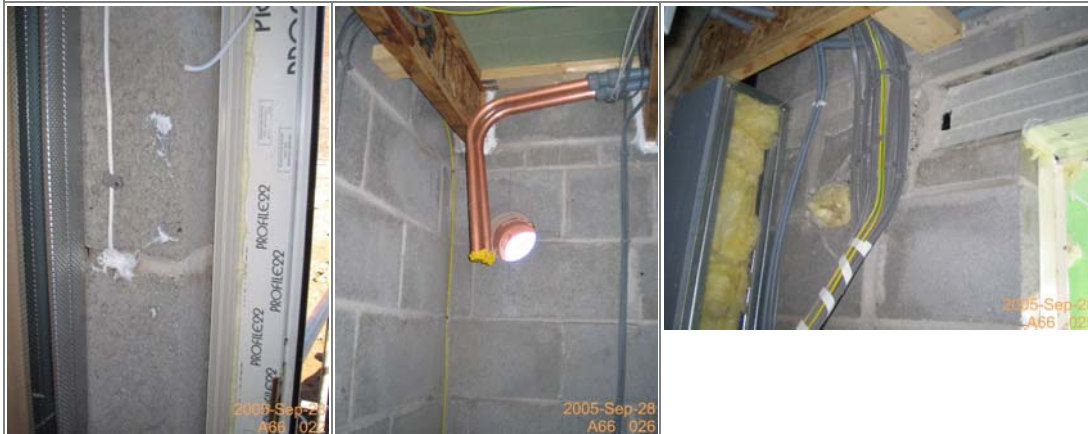
Cylinder Cupboard

Penetrations beneath the cylinder cupboard floor link various voids and may help create hidden leakage paths. As mentioned previously, penetrations through the cylinder cupboard floor will require sealing around prior to the tank being positioned.

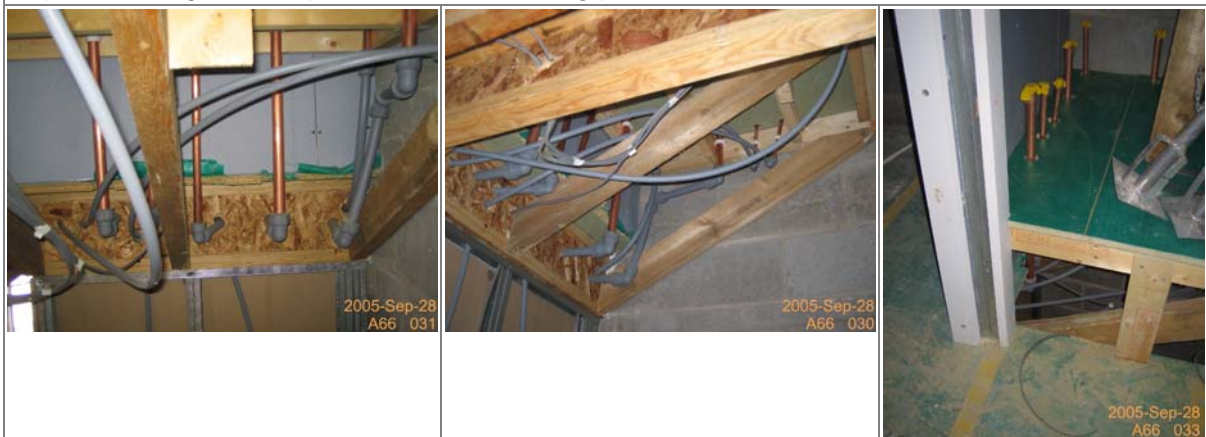
Loft-space junction

Some possible air leakage paths may remain after dry lining. Holes in the top of the steel studwork will allow air to move between the void in the partitioning and the loft. Gaps around the edges of the first floor ceiling and gaps at the ends of the wall plate may both allow air from behind the plasterboard on the walls to move into the loft, if continuous ribbons of plasterboard adhesive are not used at this junction.

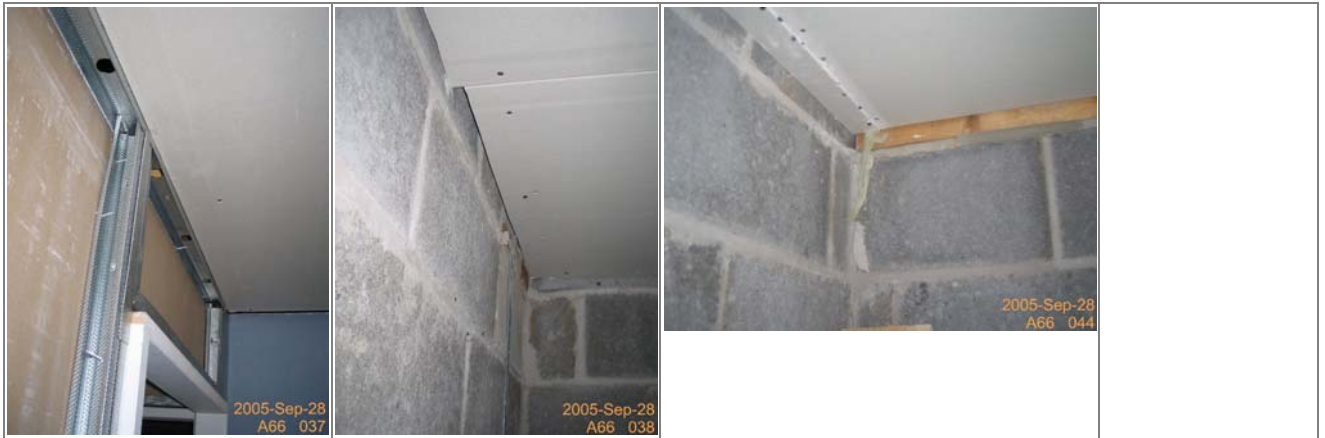
Shower

As mentioned in A65, the shower is an area where air moving through the steel studwork may be a major source of air leakage, as air entering the void under the shower tray (from around the panel, from the intermediate floor and through adjacent studwork voids) may move relatively freely into the loft-space.

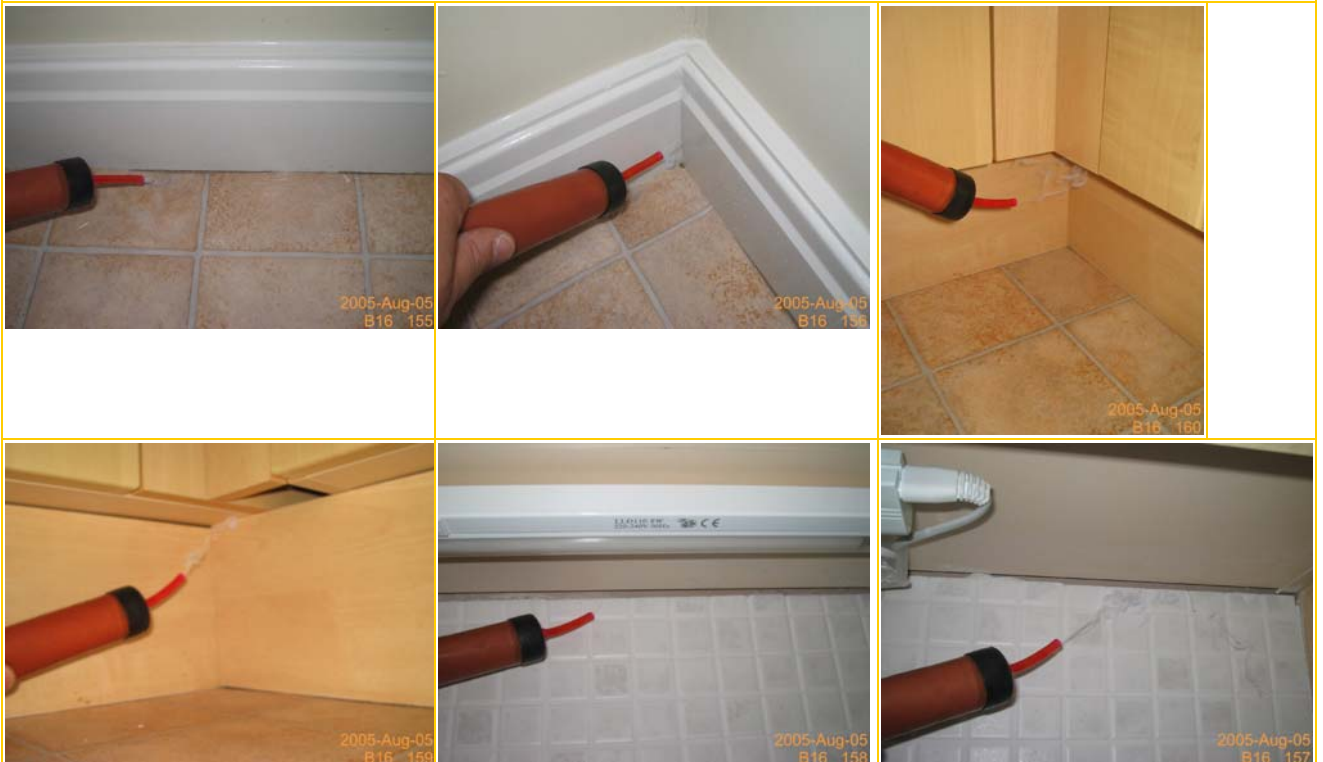
Utility room

- Air movement around both sides of the threshold and bottom of the back door, and through the keyhole.
- Leakage detected around the boiler.
- As in the kitchen, air movement was observed around the base of the units, over the unit back under the sink and through service penetrations.

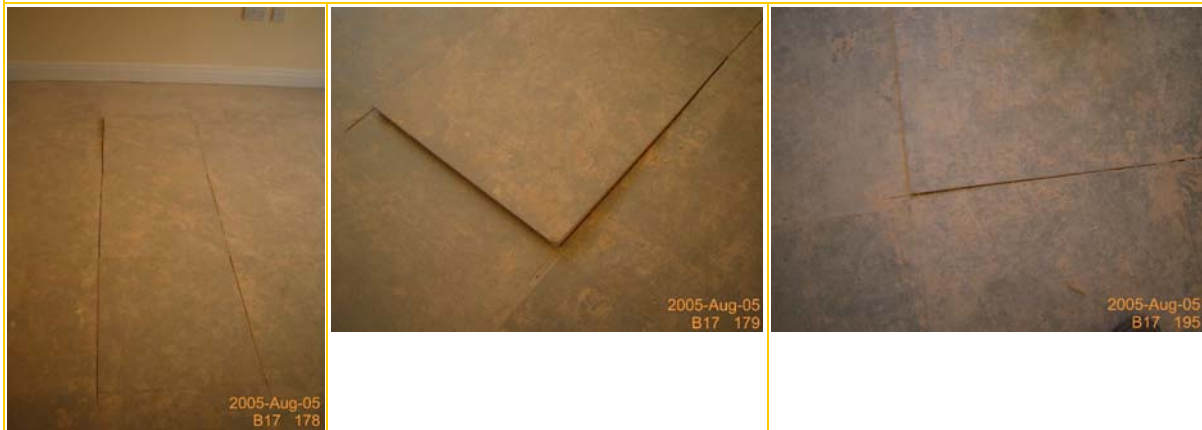
Intermediate floor/wall junction

Some gaps were observed around the intermediate floor perimeter, enabling movement of air into the floor and wall voids. Behind the bath, where no skirting board is applied and the wall/floor junction is not finished-off, any air movement around the bath panel will be able to travel directly into these voids.

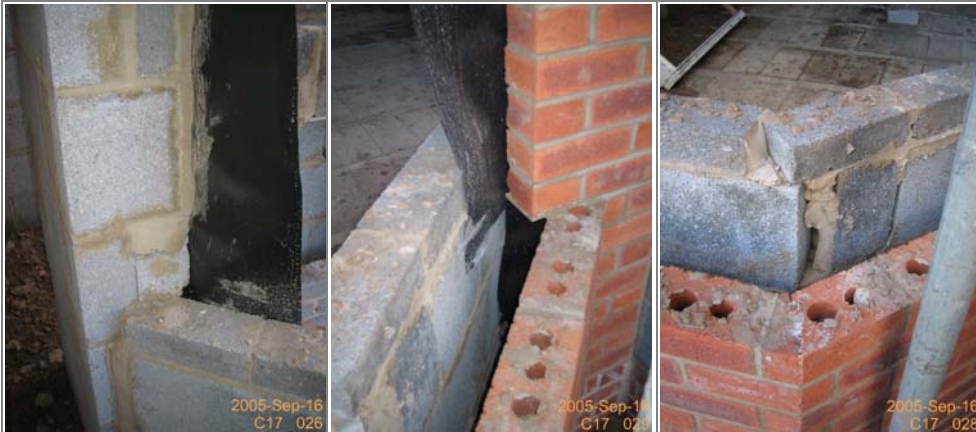
Built-in joists

A mixture of good and bad examples. In some cases the joints around the joists have been completely filled with mortar which will assist in airtightness and the potential problem areas where joists are fitted closely parallel to walls have been well constructed. However, in some cases there are gaps around and between joists large enough to make the external brickwork visible, these may prove difficult to seal with mastic and could contribute to the leakiness of the dwelling.

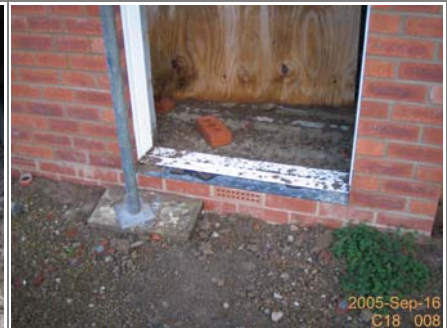
**Openings**

At door, window and patio door heads only small gaps exist which should easily be sealed with a suitable sealant.

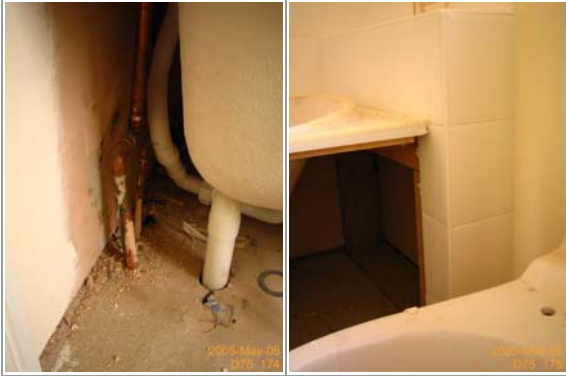
Shower

The problems noted for the bath are increased here as there is no facing on the partition walls beneath the shower tray. Air movement from underneath the tray, via the partition wall, to the loft space can be expected.
