EVALUATING THE IMPACT OF AN ENHANCED ENERGY PERFORMANCE STANDARD ON LOAD-BEARING MASONRY DOMESTIC CONSTRUCTION

Partners in Innovation CI 39/3/663 - BD2324

Interim report number 6 – Airtightness monitoring, qualitative design and construction assessments.

Dominic Miles-Shenton, Centre for the Built Environment, Leeds Metropolitan University

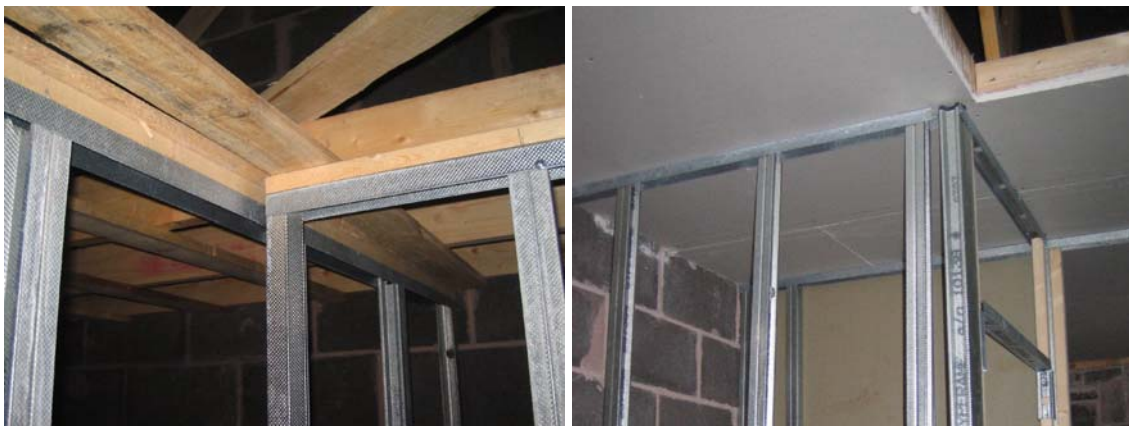
- 13 The improved test results achieved by Bryant were partly due to the decision to return to constructing full top floor ceilings prior to installation of the internal partitioning. This was the technique used on the first dwellings constructed at Stamford Brook in February 2005, which gave mean air permeability measurements of 2.04 and 3.32 m³/(h.m²) @ 50 Pa. Returning to the original build sequence produced results of 4.0 and 3.7 m³/(h.m²) @ 50 Pa in two 2½ storey dwellings tested by Bryant staff during August/September 2006. Two further results below the target of 5 m³/(h.m²) @ 50 Pa five weeks later for an apartment and a 2 storey terraced dwelling gave the developer confidence that no further design/sequencing changes were required and to concentrate on quality of workmanship. Figure 4 illustrates the two different methods with Redrow continuing to adopt a partitioning first approach and Bryant installing ceilings first; nevertheless this is not the only sequencing issue exhibited here as in both cases there would have been benefits in applying the parging layer to the external and separating walls prior to erection of the metal studwork.

Figure 4. The potential for air leakage directly into the loft via top floor partition walls in Redrow plot R111 compared to Bryant plot B116 with a full ceiling installed before the partitioning.

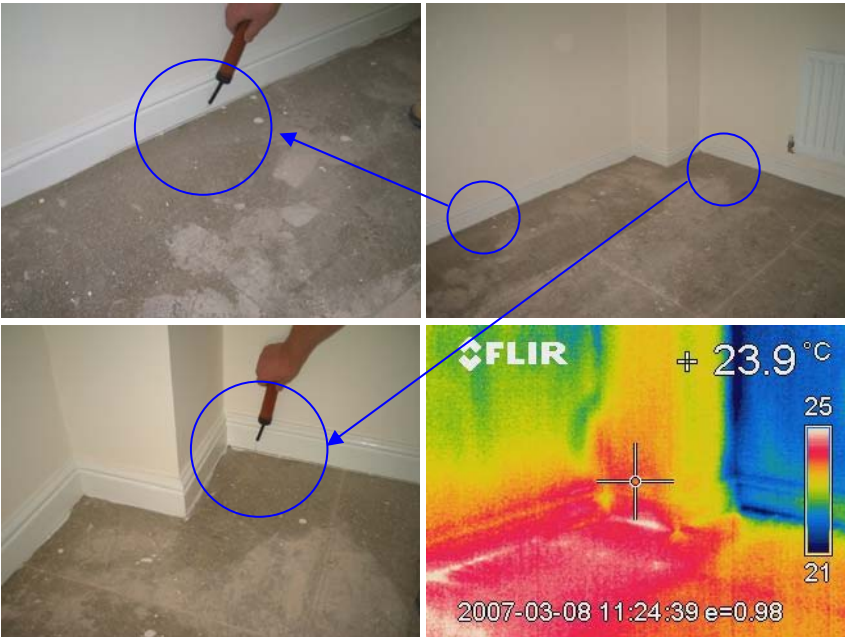
- 23 An example from plot R117 further illustrates how using both techniques for leakage detection can provide further insight as to the complexity of air movement within dwellings. Figure 9 shows the corner of a 1st floor bedroom at the wall/floor junctions of an internal and an external wall. Under dwelling pressurisation smoke can be seen entering gaps under the skirting boards on both walls indicating points of air leakage. However, under dwelling depressurisation thermal imaging shows warmer air emerging from gaps beneath the skirting board on the internal wall, yet on the external wall the air entering through a similar gap is cooler. This implies that there are two separate leakage paths being observed rather than the more straightforward direct air leakage paths observed in the figure 7. The warmer air emerging from the internal wall in this example has been heated up by central heating pipework running through the floor void in close proximity to the wall, an effect which was only possible to observe in this dwelling as it had been left relatively undisturbed for 2 days prior to the pressurisation test with the heating turned on. Without knowledge of the construction process and the routing of the pipework the image would have been difficult to interpret.

Figure 9. Example of complex leakage paths observed in plot R117.

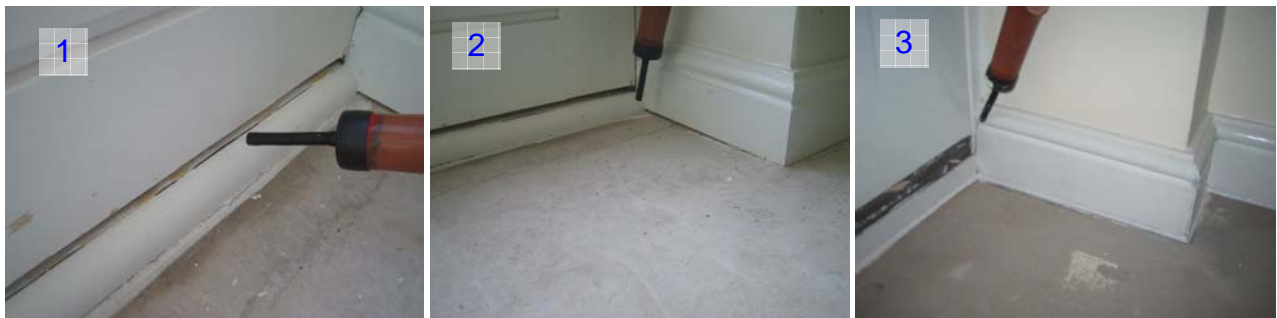
- 31 Leakage detection at front door thresholds was not possible due to the placement of the blower door for the duration of all the pressurisation tests apart from the re-test of plot B121 (Appendix 14). For all the other tests too much turbulent air movement was present around the front door thresholds for detection using either smoke puffers or IR imaging. Hence leakage detection at thresholds was primarily performed at the rear doors. Out of the nine plots included in this study, five had traditional single-leaf rear doors and six had double-leaf patio doors. Air leakage occurred around the thresholds in all of them to varying degrees of severity. Detection of air movement under the threshold was a routine occurrence usually through gaps in the sealant, often caused by misapplication, adhesive failure due to inadequate surface preparation or an incorrect choice of sealant (figure 11). In the majority of cases infiltration was also observed around the skirting board at the reveals. Even where sealant had been successfully applied to the skirting/floor junction, as in plot B120, air movement was still detectable between skirting and back door frame.

Figure 11. Air leakage at the patio door threshold in plot R110 (1 & 2) and at the threshold reveals of single leaf back door in plot B120 (3)

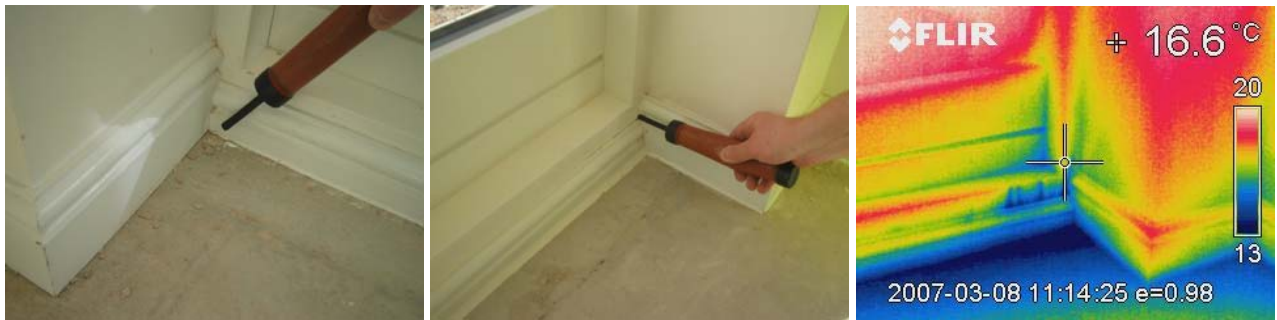
- 32 The gallery windows in plots R116 and R117 also displayed air leakage at the junctions with the ground floor, much the same as was observed at the thresholds with the window frame sited directly on top of the floor slab. The thermal image in figure 12 shows distinctly cooler air entering the dwelling at this junction under dwelling depressurisation, indicating a direct leakage path.

Figure 12. Air leakage at the gallery window “thresholds” in plots R116 and R117, the thermal image showing infiltration in plot R117 at this detail

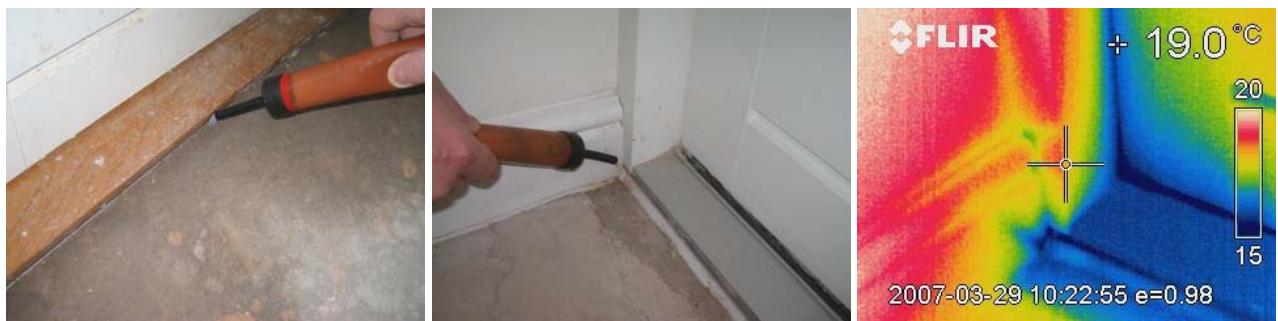
- 33 Air leakage was observed around the ground floor patio doors in all plots where this detail existed, to varying extents of severity (figure 13). As was observed with both the thresholds and the gallery windows, the most common points of leakage were at the junctions of the skirting boards with both the frame and floor, and also under the sills where the sealant had been often been inadequately applied or had subsequently failed.

Figure 13. Direct air leakage at patio doors thresholds in various plots.

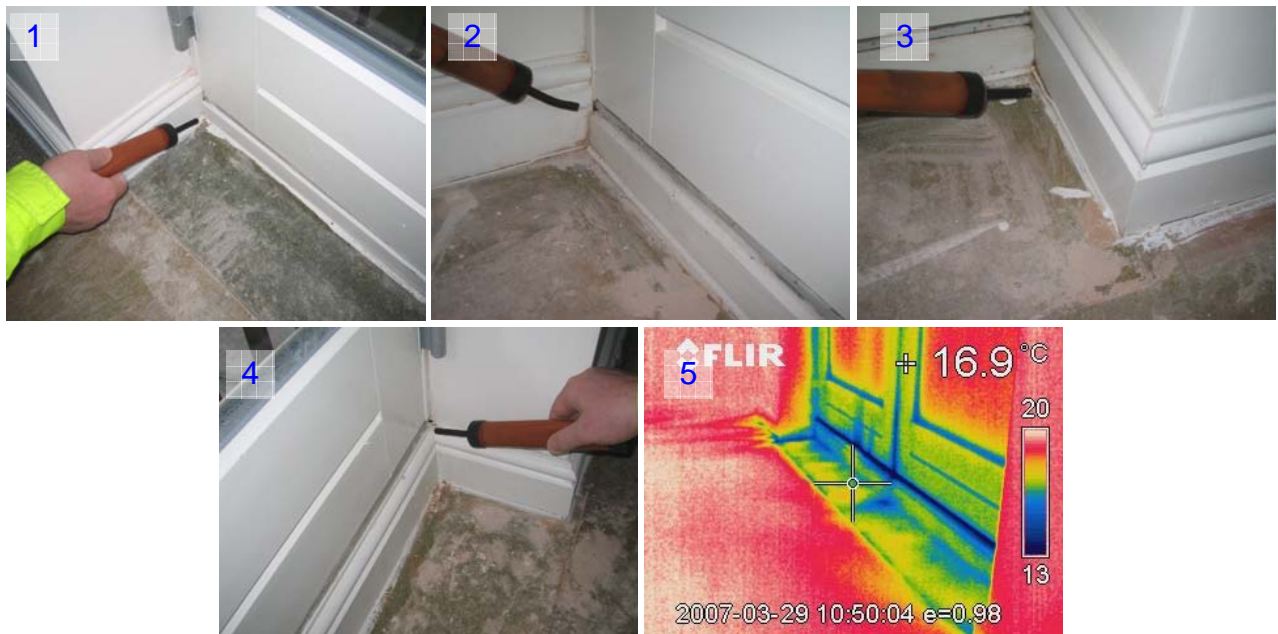
- 34 Similarly significant air leakage was observed where patio doors had been installed on the 1st and 2nd floors (figure 14). Leakage was detected to similar degrees of severity regardless of whether the patio doors were installed where the joists ran parallel or perpendicular to the external wall.

Figure 14. Infiltration at patio doors installed on intermediate floors in plot R110 with joists running parallel to the external wall (1, 2 & 3) and plot R111 with joists running perpendicular to the external wall (4 & 5).

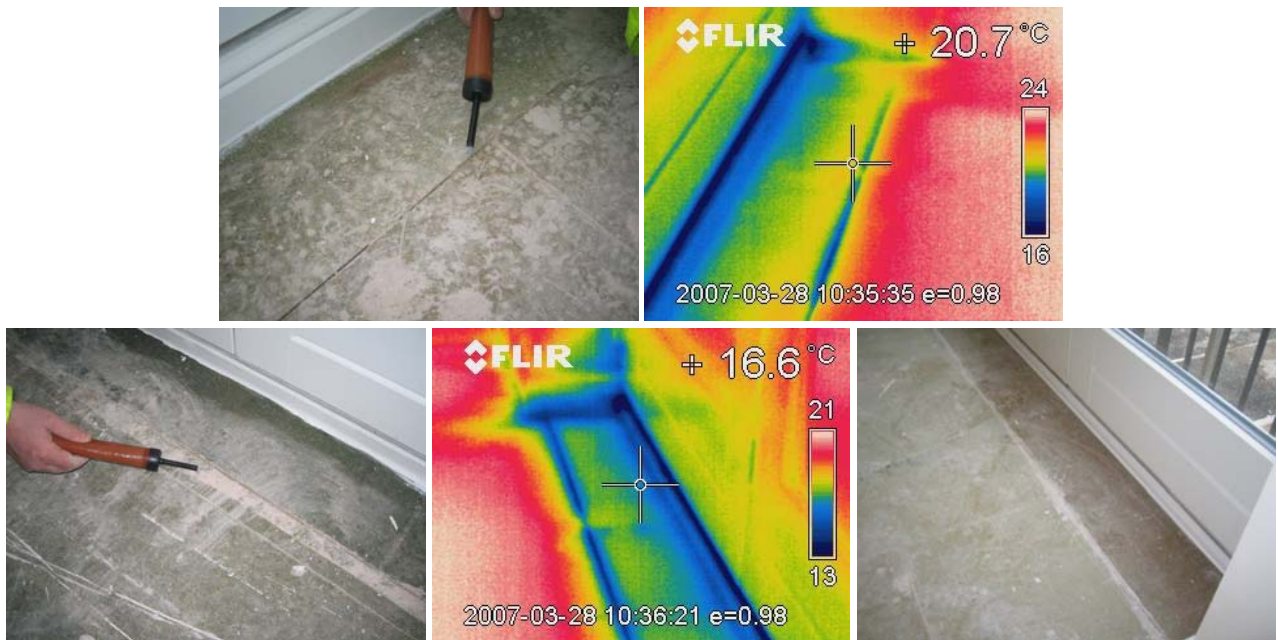
- 35 Significant air leakage was also observed at the floor junctions directly in front of these intermediate floor patio doors in both plots R110 and R111, although this was noticeably reduced in plot B120 where additional attempts had been made to seal the junction between the flooring panels (figure 15). Further discussion of this detail is contained in paragraphs 83 to 85 below.

Figure 15. Smoke detection and IR images of air movement through gaps between flooring panels directly in front of the intermediate floor balconies in plots R110, and the additional sealing applied in plot B120.

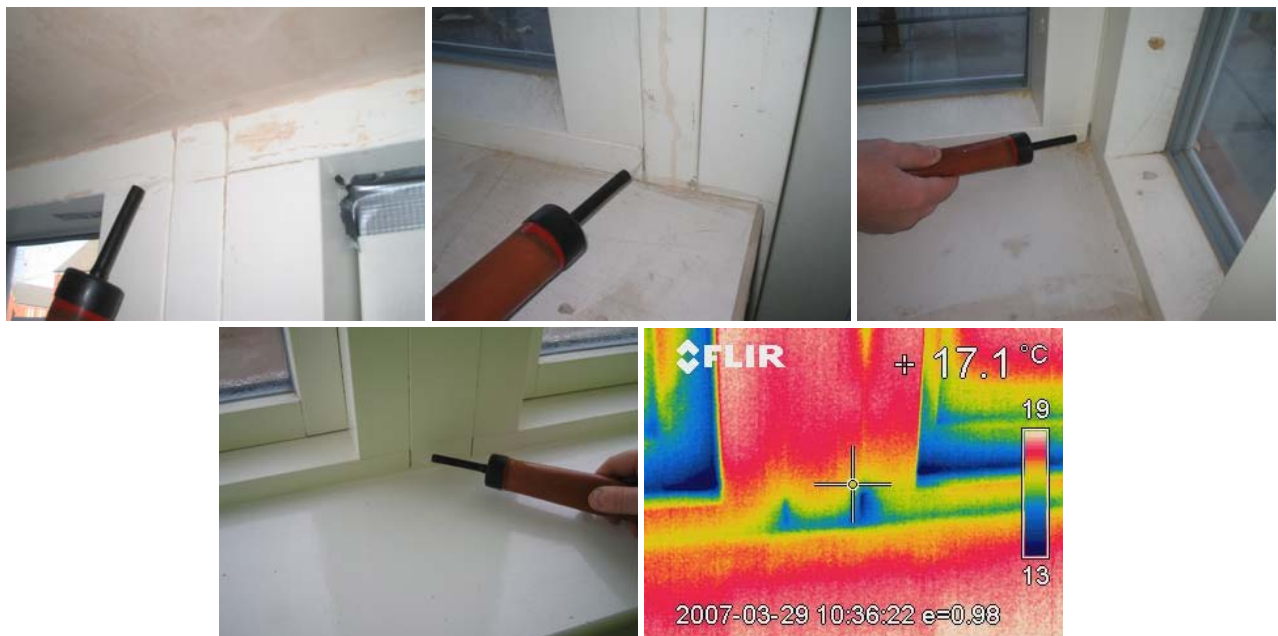
- 36 Direct leakage paths were observed at the bay windows in all the plots where these were present (plots B116, B117 and R111). A number of these paths are expected to be sealed to some degree (depending upon the quality of the sealant application) at the internal surface by the subsequent application of the decorators' caulking during snagging, however there were also leakage paths through gaps between individual elements of the bay windows, and at the sills, which may still remain upon dwelling completion (Figure 16).

Figure 16. Air leakage through gaps at bay windows in plots B116 and R111

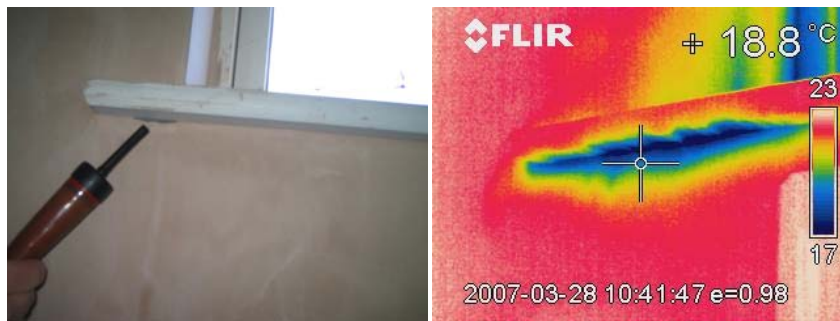
- 37 Additional leakage paths were detected around other windows, through some small holes around the edges of the frames but mainly at or around the window sills. Figure 17 illustrates typical leakage points around window sills which may get sealed internally upon decoration/snagging but

Air leakage through visible gaps beneath window sills

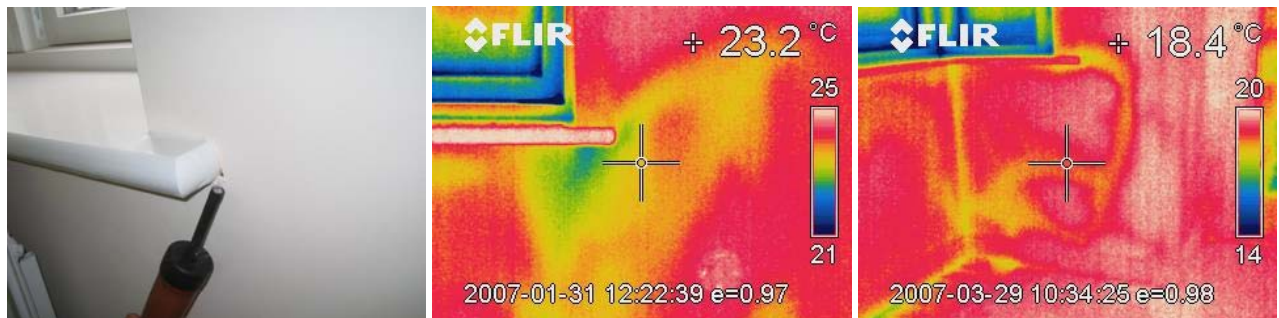
At visible gaps around a sill board

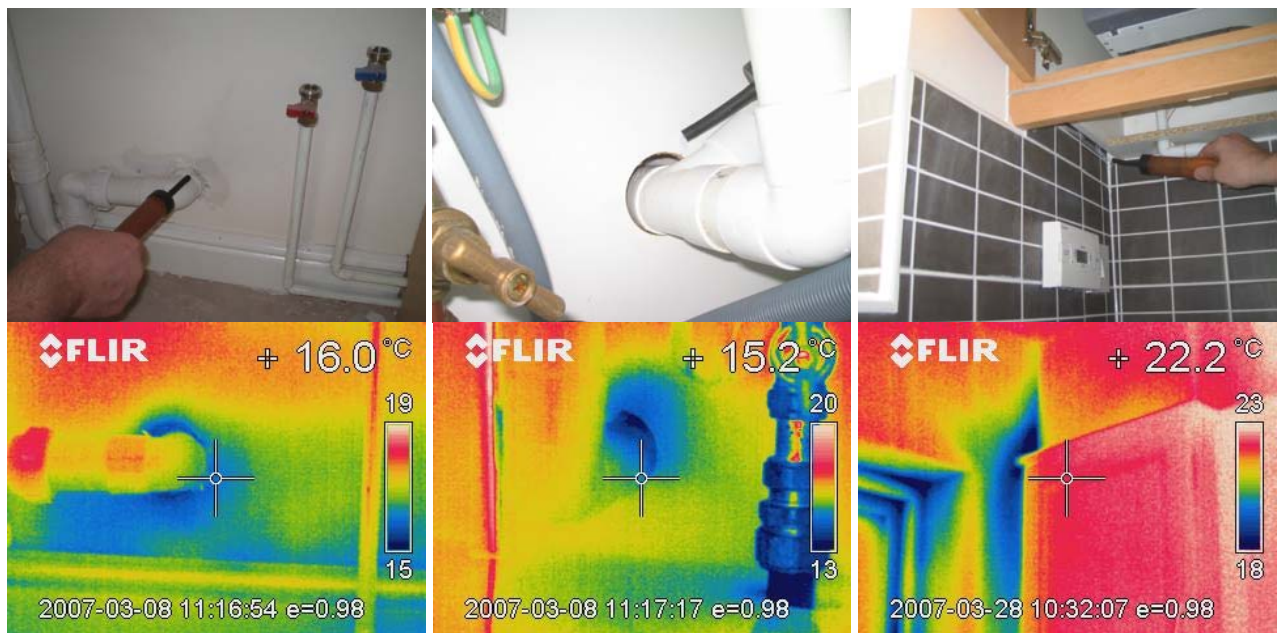
- 38 Where penetrations were made through the walls after the dwelling had already been dry-lined there appeared to be problems sealing around them. This was common around waste pipes and boiler flues where suitably sized holes are core-drilled through the plasterboard and external walls then only sealed externally for weatherproofing and internally for aesthetics, not at the less accessible parged blockwork layer which provides the air barrier. The result is that air can move easily between the cavity and the void behind the plasterboard. This is compounded when the penetration also passes through the backs of kitchen units making sealing at the blockwork virtually impossible, thus requiring a different approach either to sealing products or to the build sequence. Figure 18 illustrates direct air leakage at these penetrations; for a washing machine and kitchen sink waste pipe in plot R117 where air movement is through visible gaps, and around a boxed-in boiler flue in plot R110 where the penetration is hidden from view and the thermal image reveals the extent to which the cooler external air is drawn into the void behind the plasterboard due to the lack of effective sealing at the blockwork layer.

Figure 18. Infiltration in plot R117 around the waste pipes for the washing machine and kitchen sink, and around the boiler in plot R110.

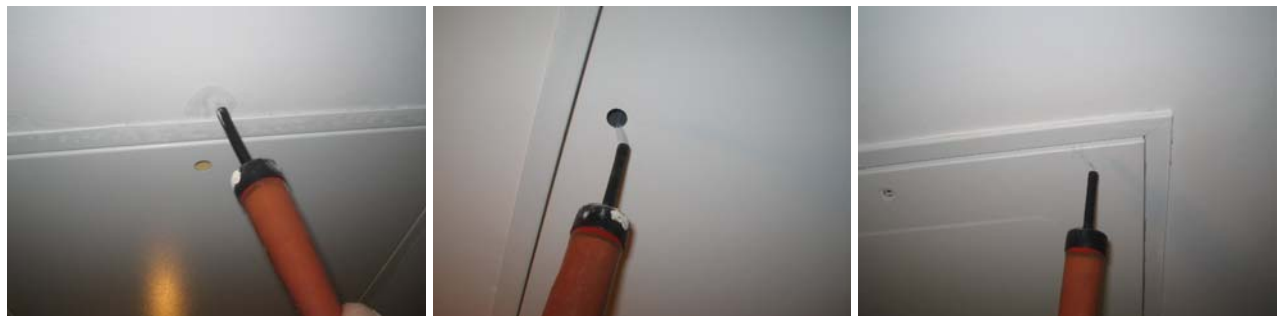
39 Direct air leakage through and around the loft hatch was detected in each of the 9 properties included in this study (figure 19). This was observed around the loft hatch surround where the junction with the ceiling was either unsealed or shrinkage cracks had developed, through the open hole for the loft hatch key in 2½ and 3 storey dwellings, and between the door and the hatch where the compressible seals were often not continuous and rarely compressed along all 4 edges.

Around the loft hatch surround in plot B120

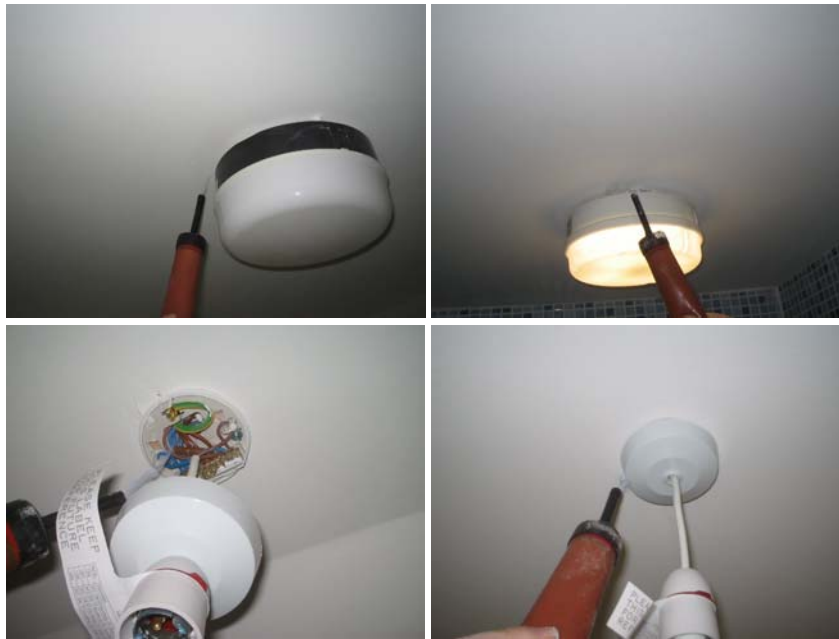
40 In all the properties tested there was some air leakage directly around electrical penetrations into the loft. This occurred around the wiring for ceiling mounted lights, light switches and smoke alarms. Figure 20 shows the light fittings fitted in en-suites and bathrooms which invariably allowed some air leakage, and leakage through the central rose fixings where the penetration for the wiring had not been sealed or the sealant had been displaced by manipulation of the wiring. As the

Figure 20. Air leakage into the loft around the 2nd floor bathroom lights in plots R110 and B119, and at standard ceiling-mounted fixings for lights in top floor bedrooms in plots B121 and B119.

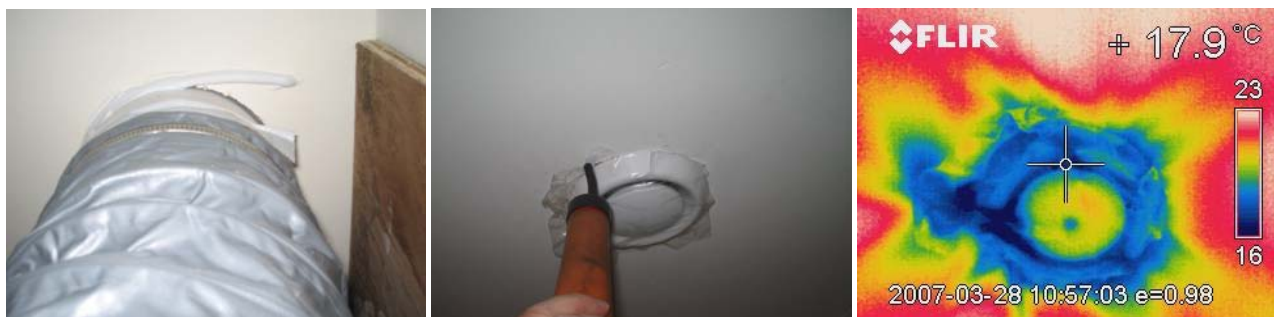
- 41 Ventilation penetrations into the loft were a common source of direct air leakage for both developers. Sealing around the ductwork for the MEV systems was the duty of the system installers which appeared not to have been performed thoroughly enough particularly where the penetrations were less accessible in the gap between the ducting and wall. The extract vents were generally not sealed to the ceiling leaving air movement possible at their interface with the ceiling which could be observed even when the vents themselves had been temporarily sealed (figure 21).

Figure 21. Ventilation ducts in B119 and vent in R110

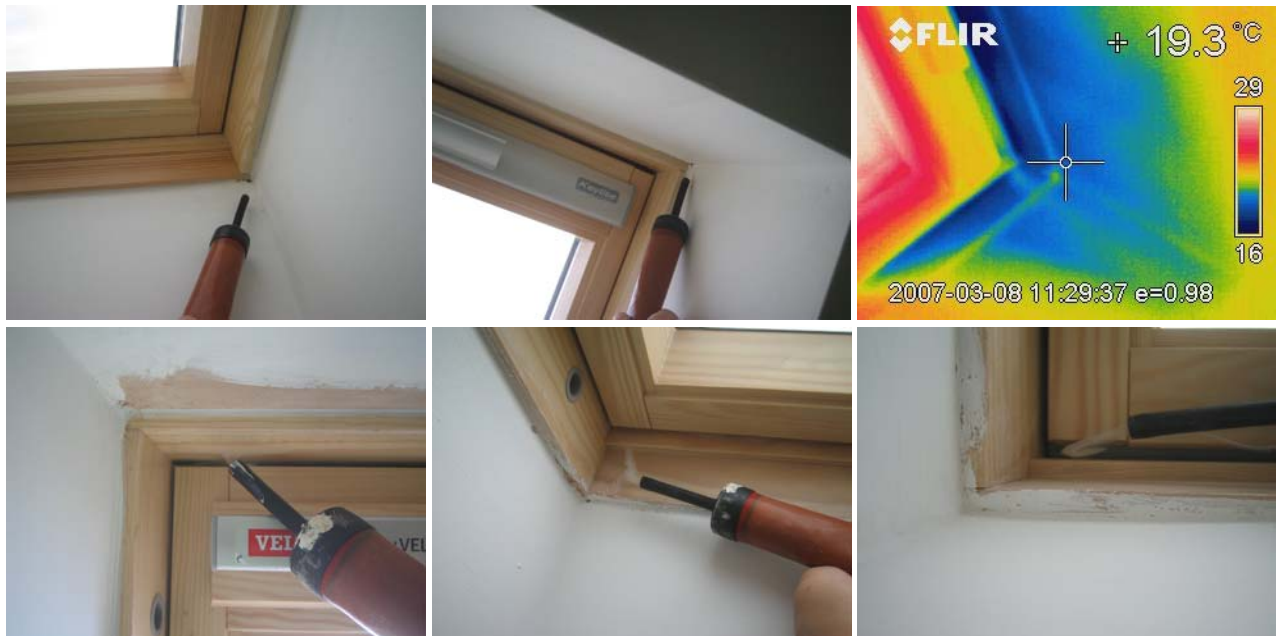
Figure 22. Air leakage at the rooflights, around the frames in plots R116 and R117 and between the rooflights and frames in plots B120 and B121.

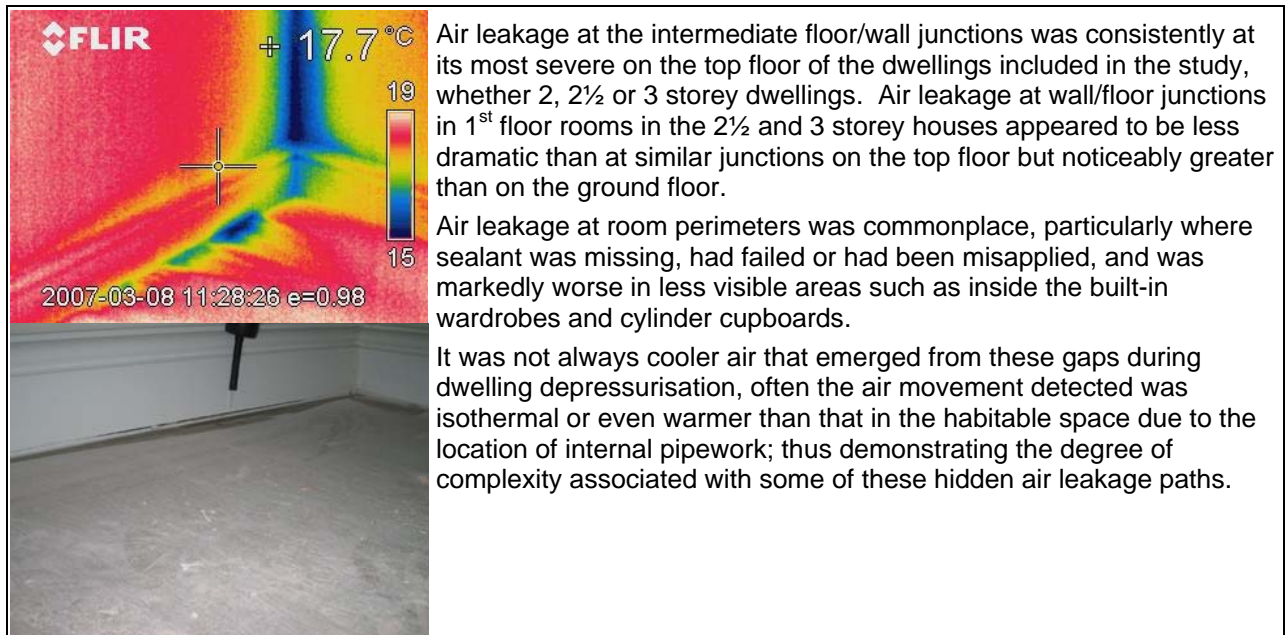
Figure 28. Air leakage at intermediate floor perimeters.

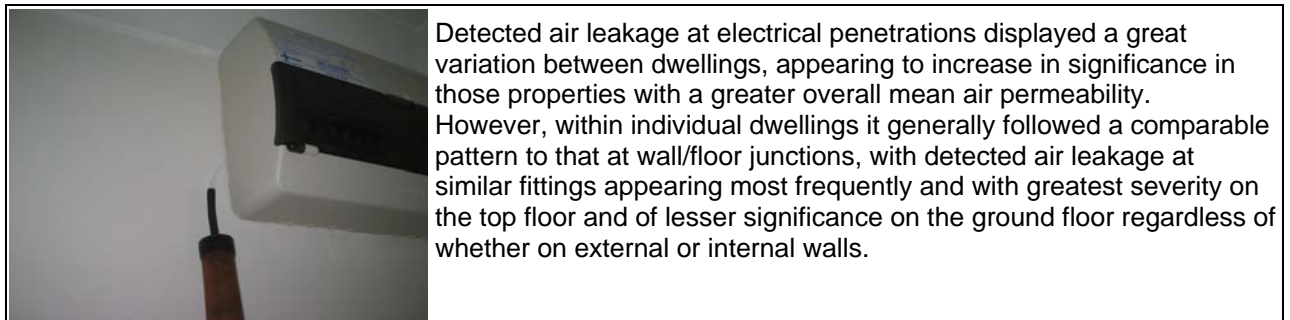
Figure 29. Air leakage detected around the electrical penetrations.

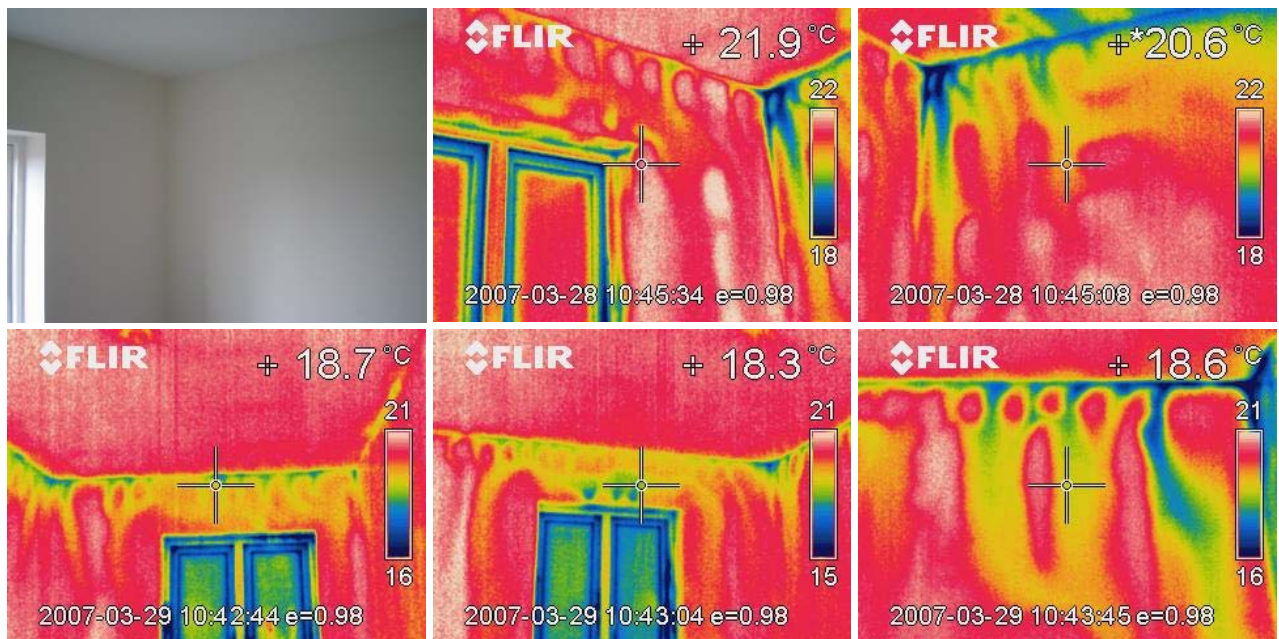
Figure 32. In plot R110 cooler air being drawn in behind the dry-lining along the eaves junction and the adjacent separating wall. In plot 111 the cooler air can be seen being drawn down around 2 windows at the gable walls and along the loft boundary at the party wall.

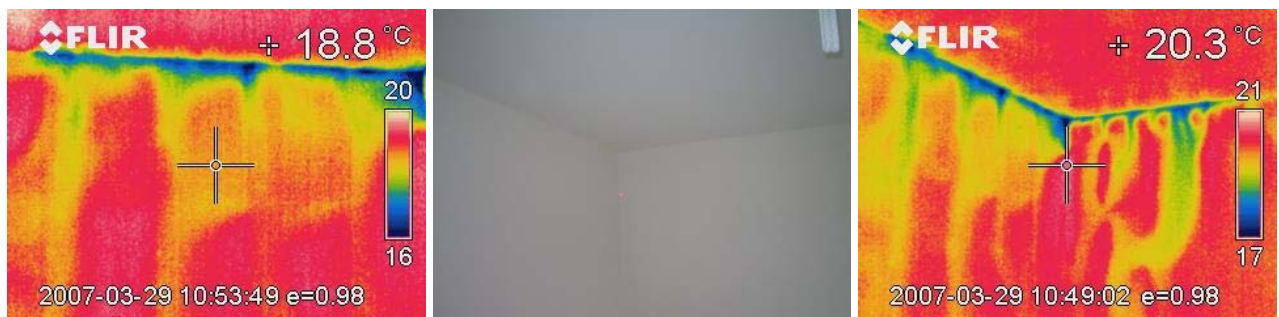
Figure 33. Infiltration at the tops of partition walls in plot 111 on either side of the 2nd floor bathroom, the pattern of the studwork is visible and contrasts with the airflow around the plasterboard dabs on an adjacent external wall.

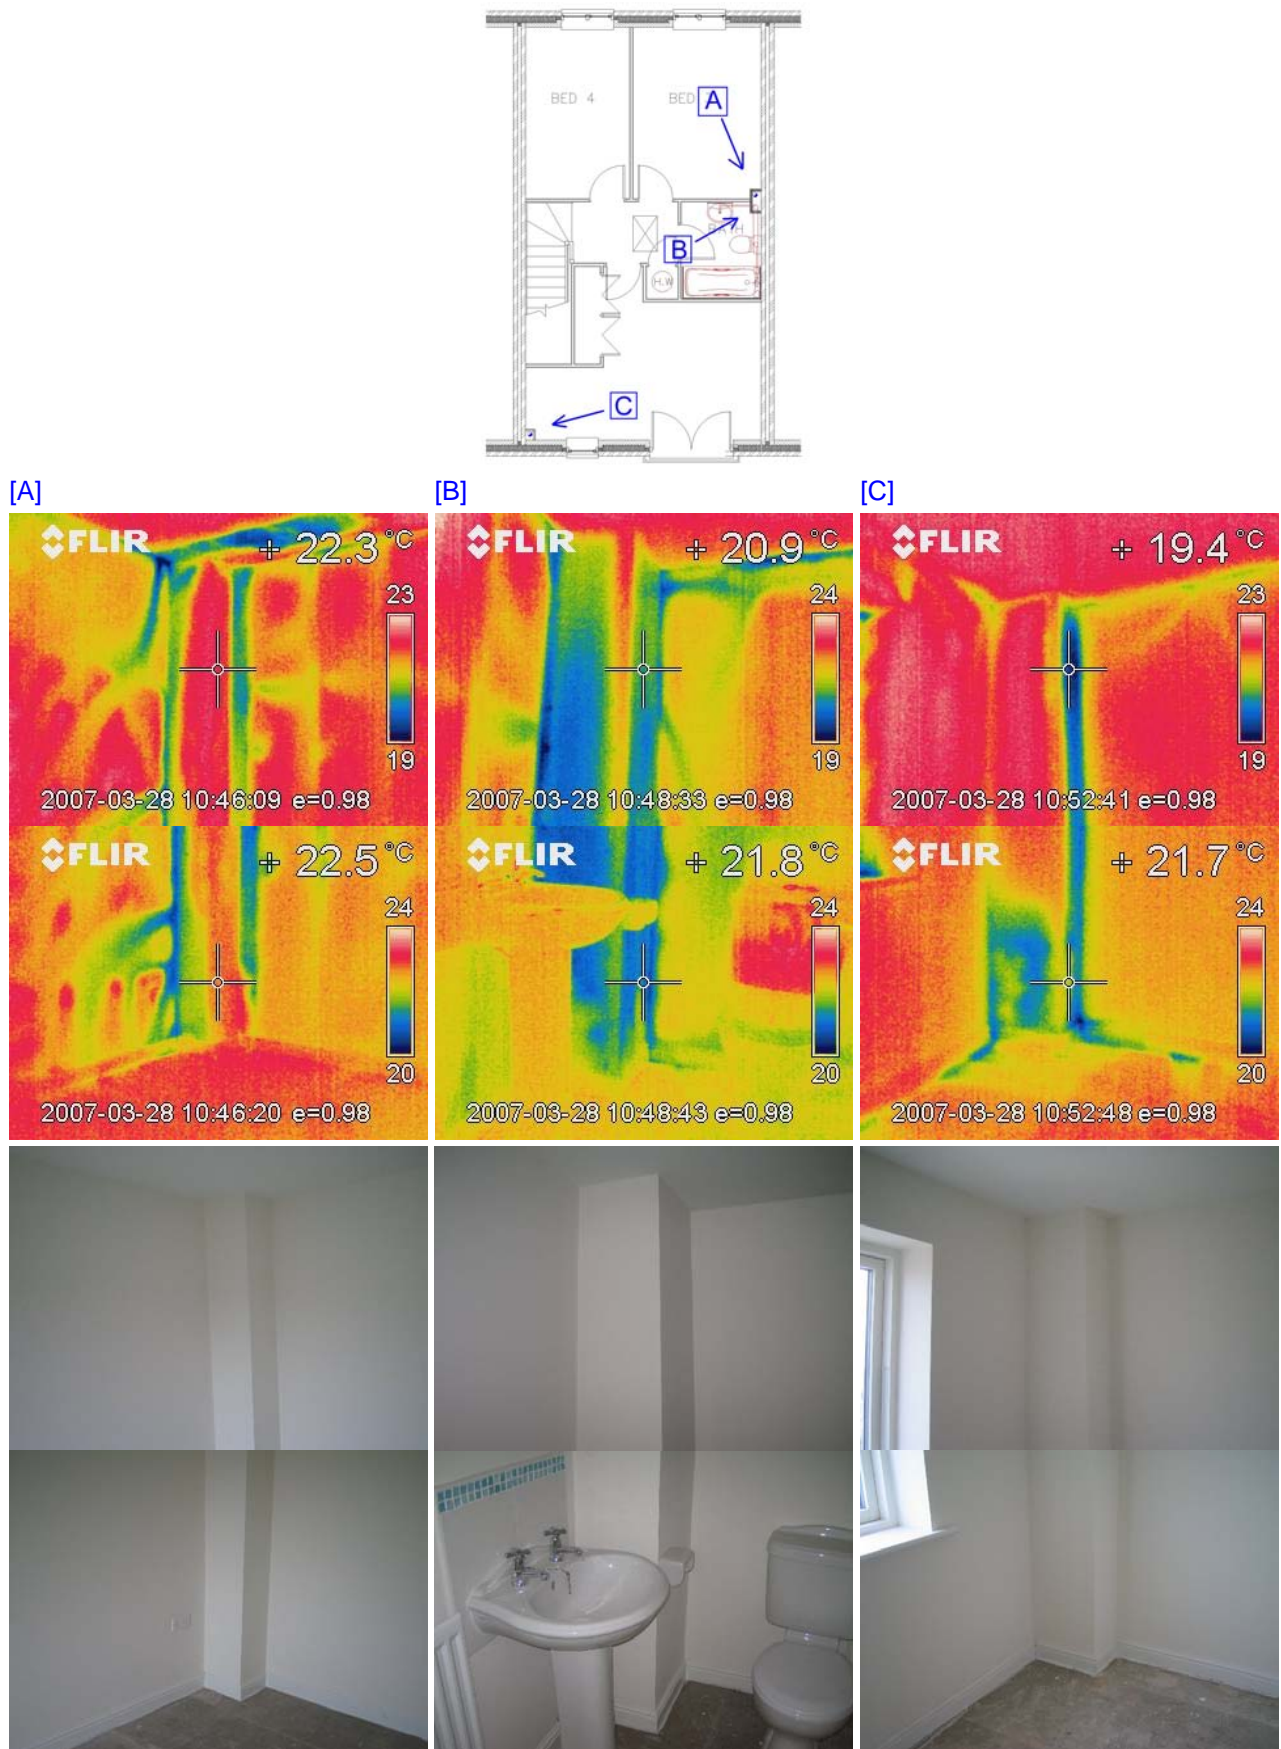
Figure 34. 2nd floor service voids in plot R110 with thermal images taken during dwelling depressurisation showing infiltration from the roof space.

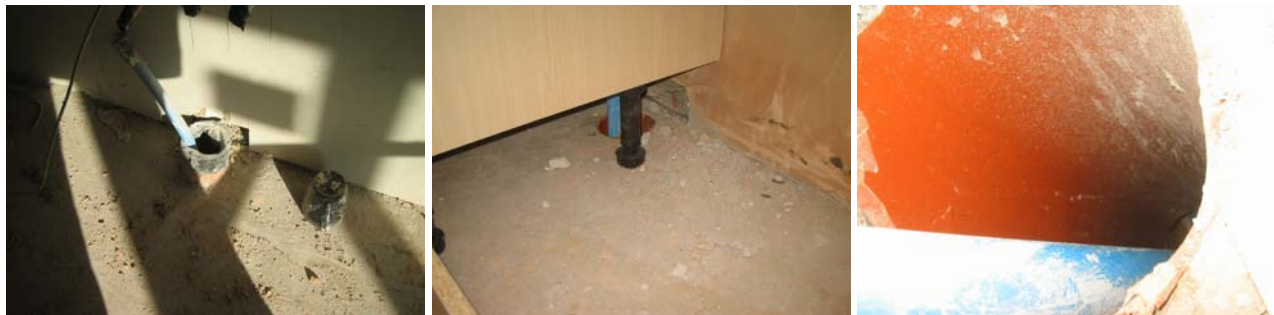
Figure 35. Mains water supply pipe in the kitchen of plot R116.

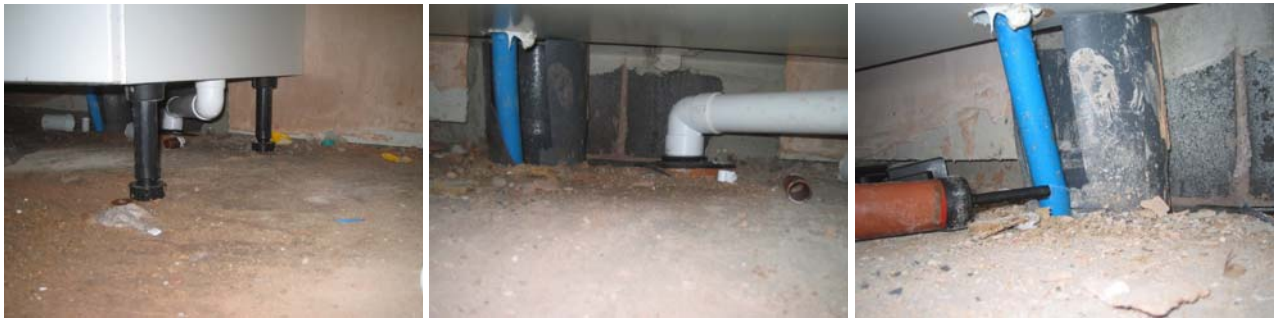
Figure 37. Utility room water supply and waste pipes in plot B119

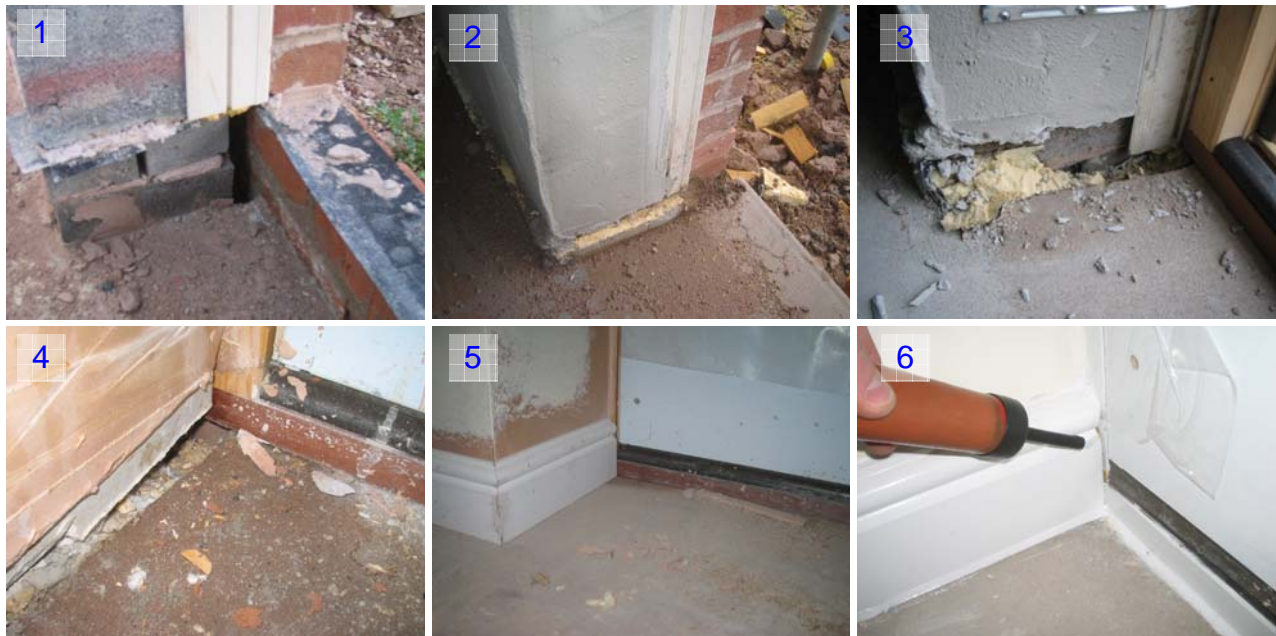
Figure 39. The build sequence of the threshold for Bryant, leaving the potential for air transfer between the cavity and the void behind the skirting.

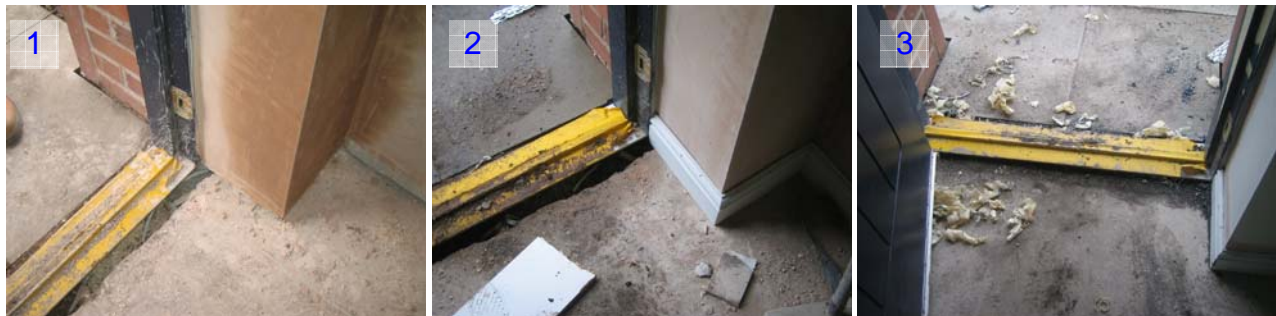
Figure 40. The front door threshold in plot R117.

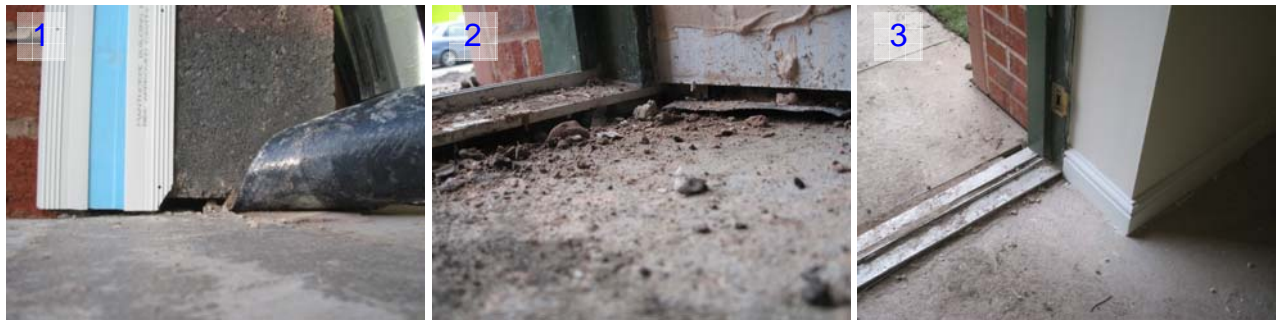
Figure 41. The front door threshold in plot R111.

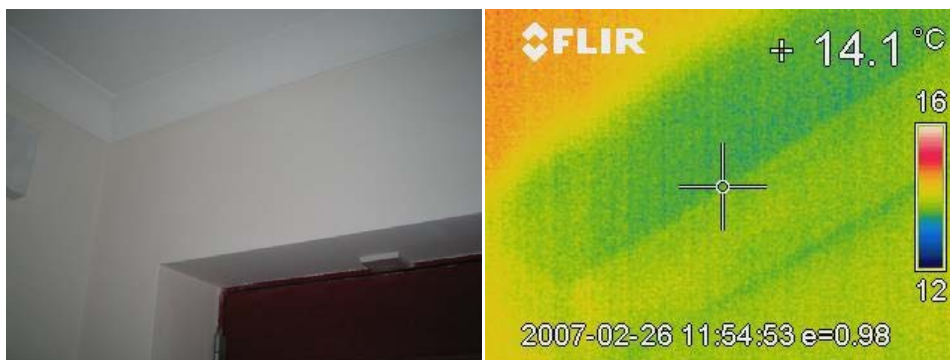
Figure 45. Stratification of temperature in the intermediate floor void directly above the recessed door detail (plot R110 - no induced pressure differential).

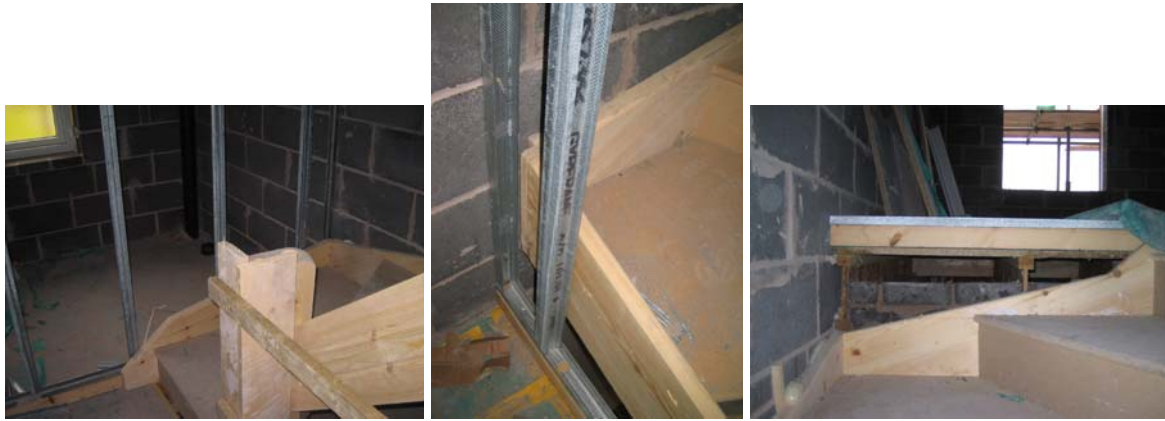
Figure 48. The staircase between the 1st and 2nd floors in plot R110, installed before the parging coat had been applied to the party wall.

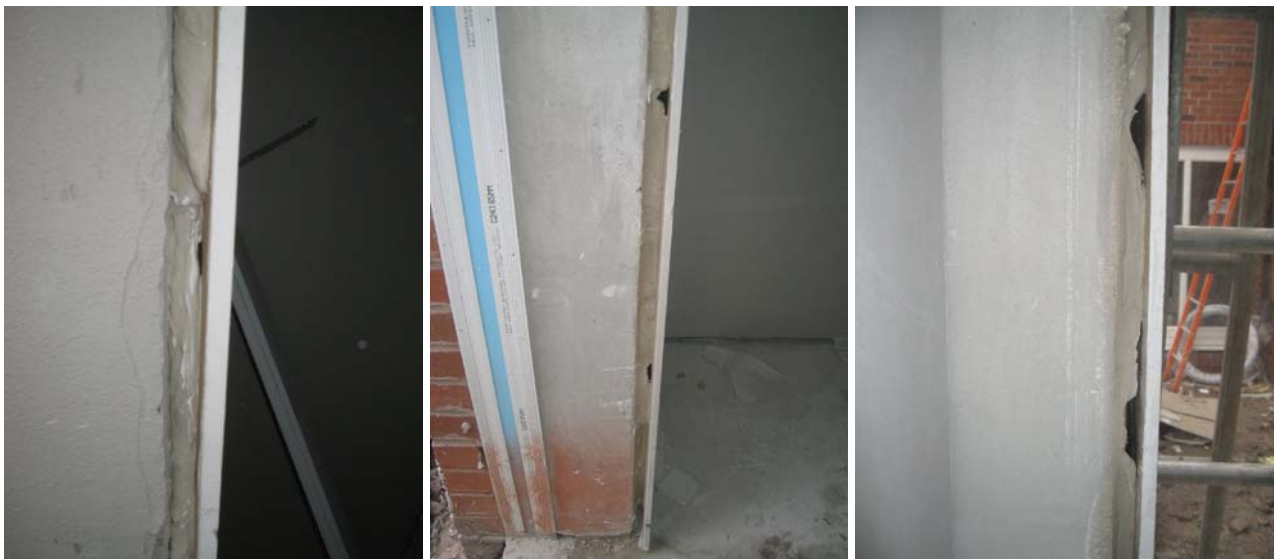
Figure 51. Photographs of plot R116, at the front door, back door and patio door; the gaps in the plasterboard adhesive ribbons are illustrative of the good, typical and poor examples observed.

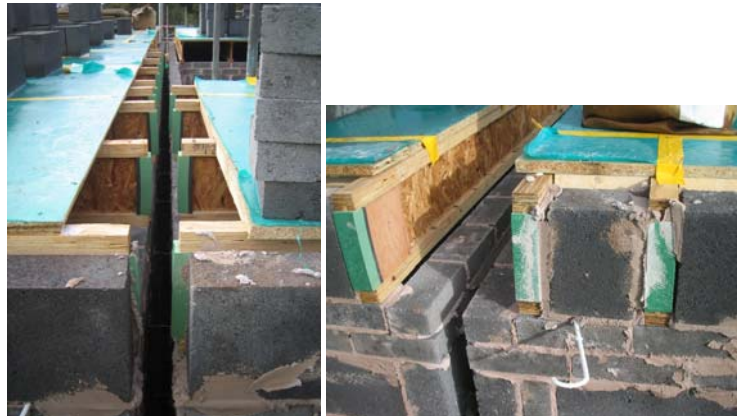
Figure 52. Difficulties of gaining access to construct well sealed blockwork in intermediate floor space.

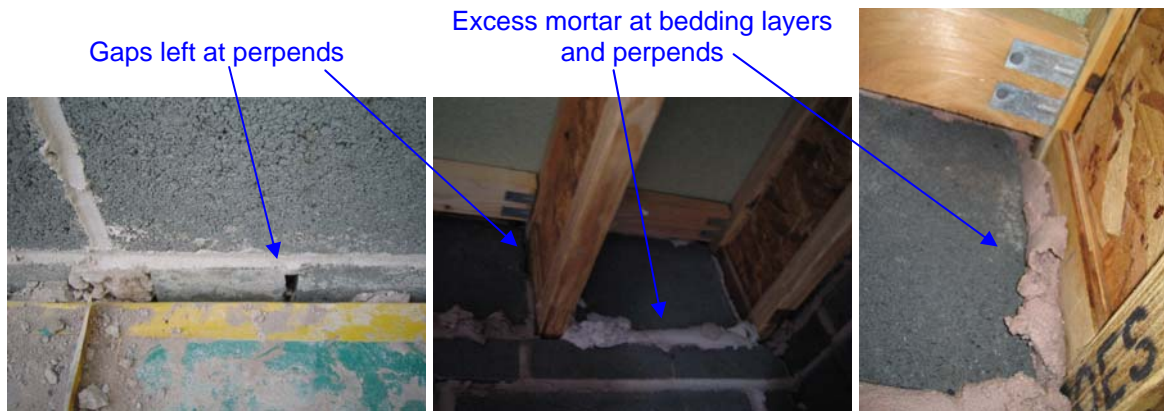
Figure 54. Gaps at perpend and excessive mortar around built-in joists creating difficulties for sealing.

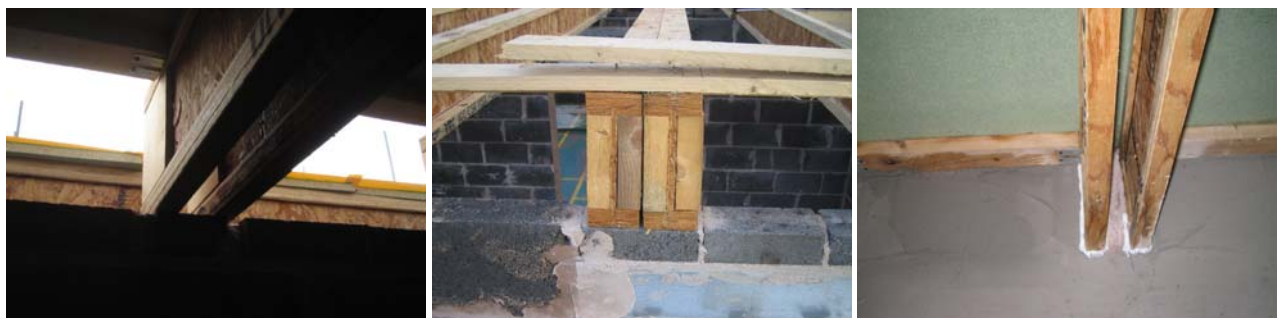
Figure 58. Double I-beams in plot B120 with a small gap between, giving limited access to gap between the joists.

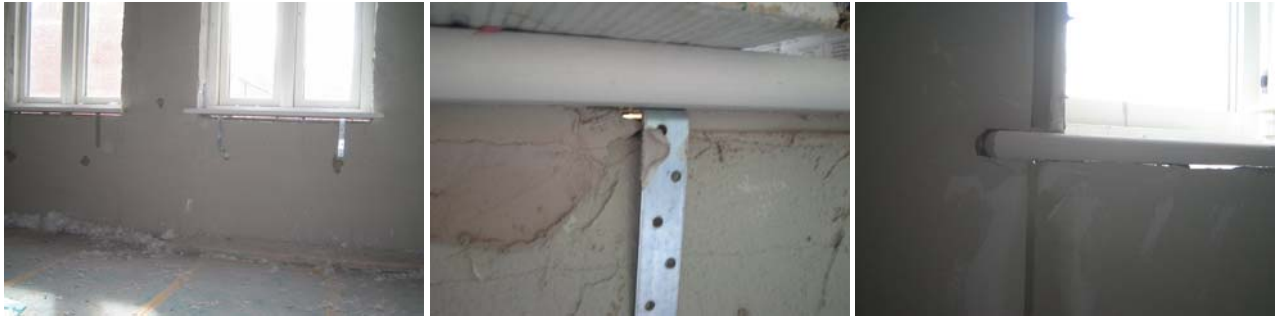
Figure 61. Daylight visible through gaps beneath the window sills in plot B121; after sill board installation, after patching and after dry-lining.

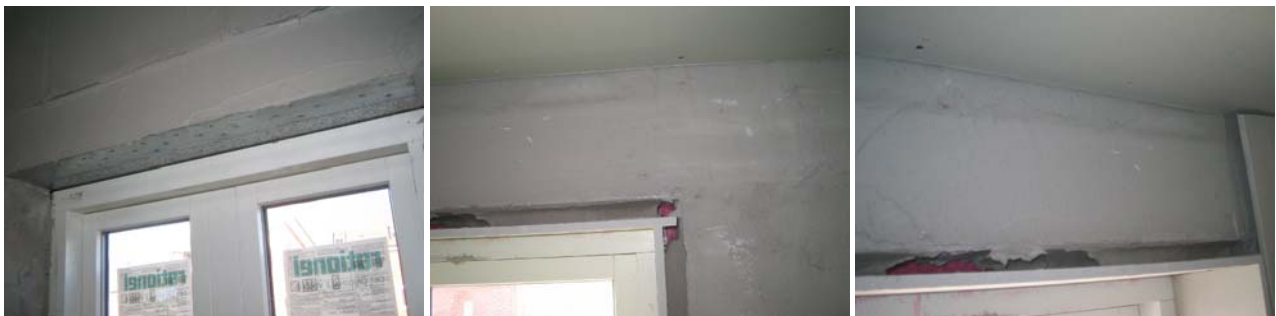
Figure 62. Window heads with no parging to the underside of the lintel and with large spaces left between adhesive dabs bonding the head liner.
