EVALUATING THE IMPACT OF AN ENHANCED ENERGY PERFORMANCE STANDARD ON LOAD-BEARING MASONRY DOMESTIC CONSTRUCTION

Partners in Innovation CI 39/3/663 - BD2324

Interim report number 6 – Airtightness monitoring, qualitative design and construction assessments.

Dominic Miles-Shenton, Centre for the Built Environment, Leeds Metropolitan University

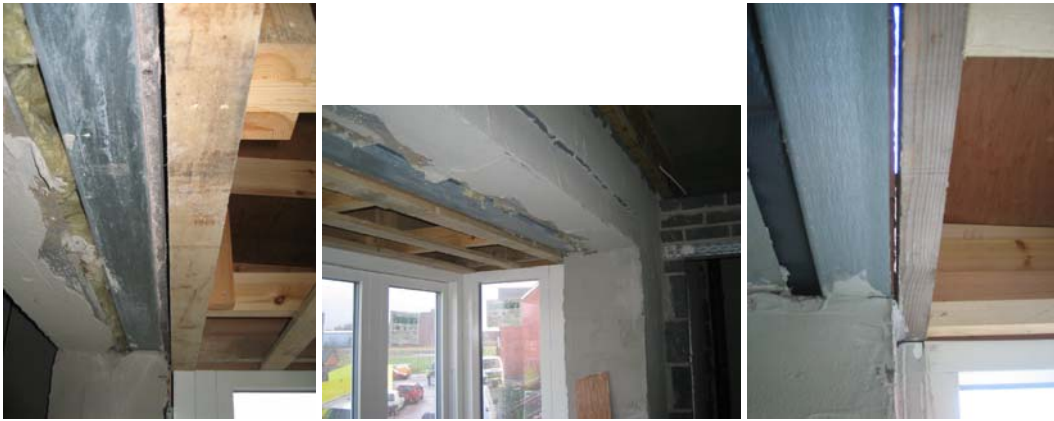
Figure 63. Incomplete parging of the lintel over bay window openings and leakage routes to the outside via the flat bay roof void.

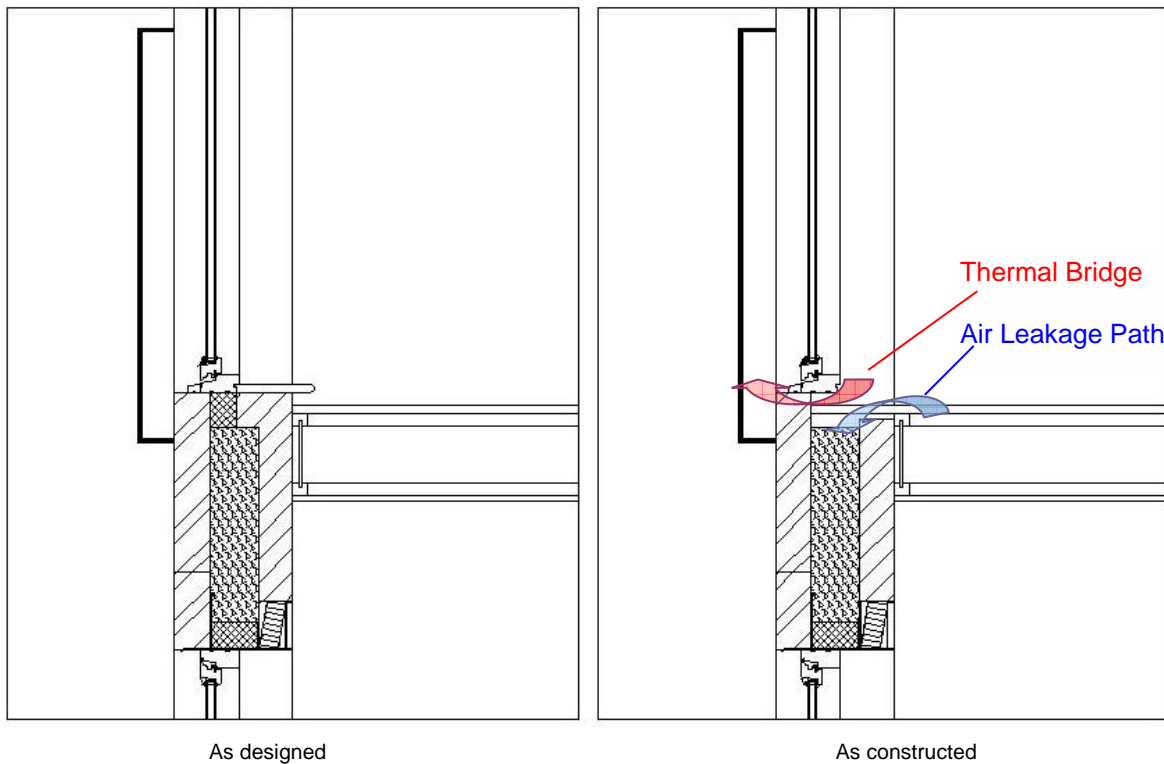
Figure 64. Intermediate floor balcony detail as designed and as observed.

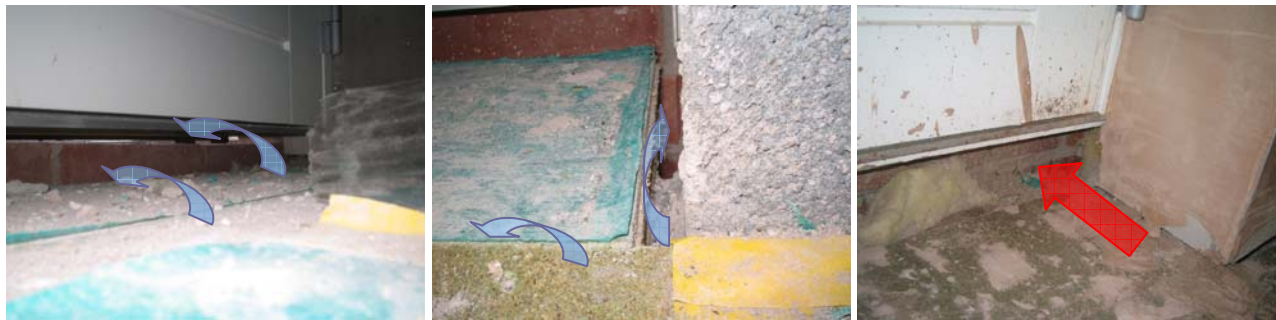
Floor deck to be continued over the external wall block work and cavity – air movement into the cavity and floor void.

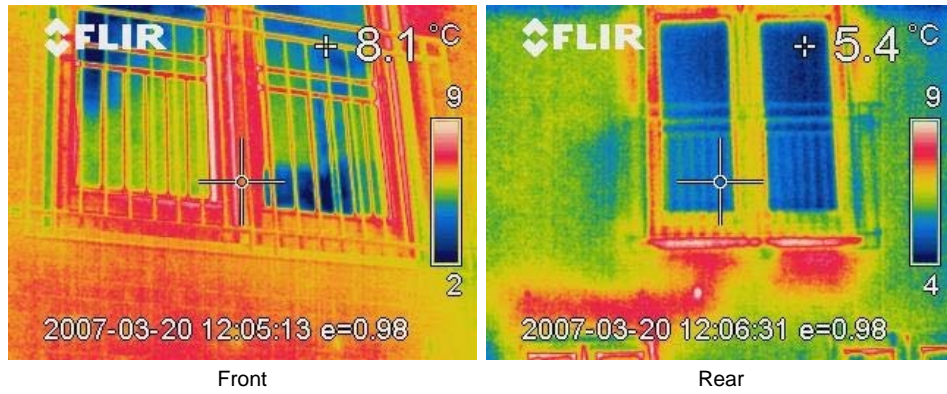
Figure 68. Plot R110 on 20th March 2007, with no air leakage or thermal bridge observable beneath the 1st floor balcony at the front (windward) of the dwelling, but still detected at the rear (leeward) of the property.

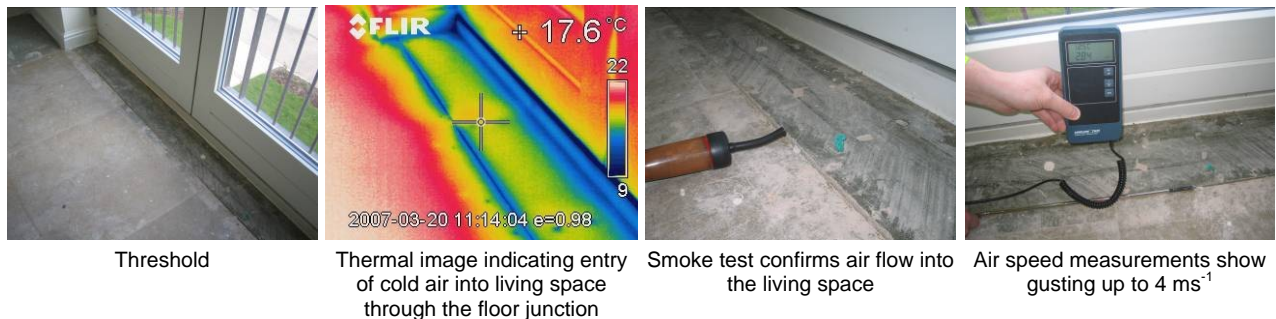
Figure 69. At the front of plot R110, air entering the living space from the floor void directly in front of the balcony doors.

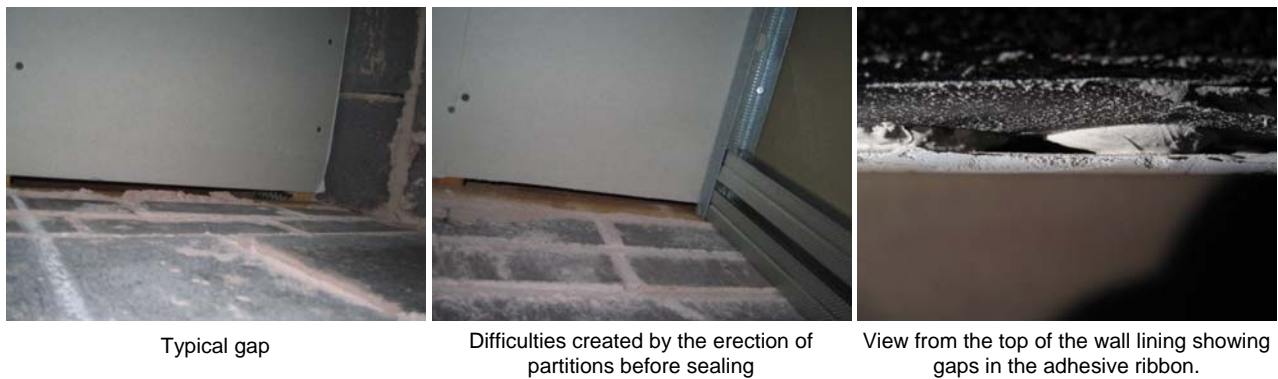
Figure 74. Gaps around the edge of ceiling boards which were not adequately sealed when the parging coat and wall dry-lining were applied.

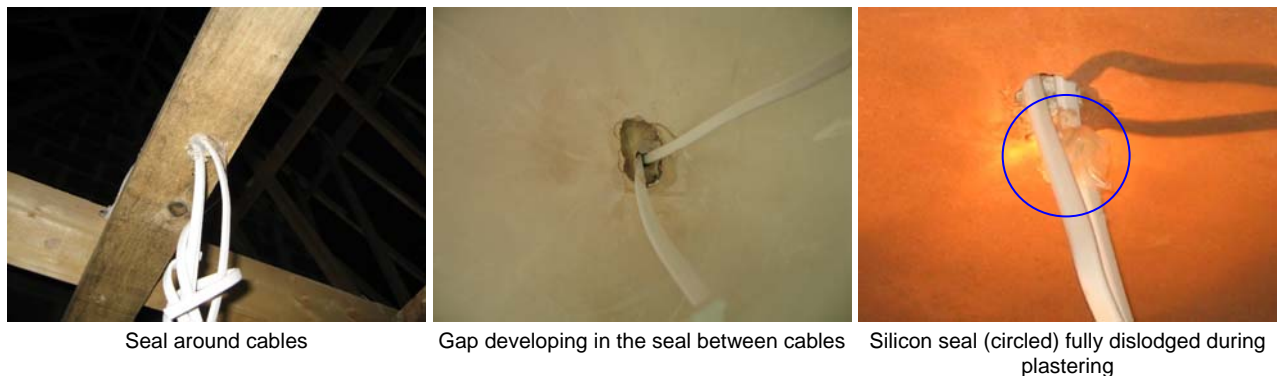
Figure 77. Dislodging of seals at electrical service penetrations.

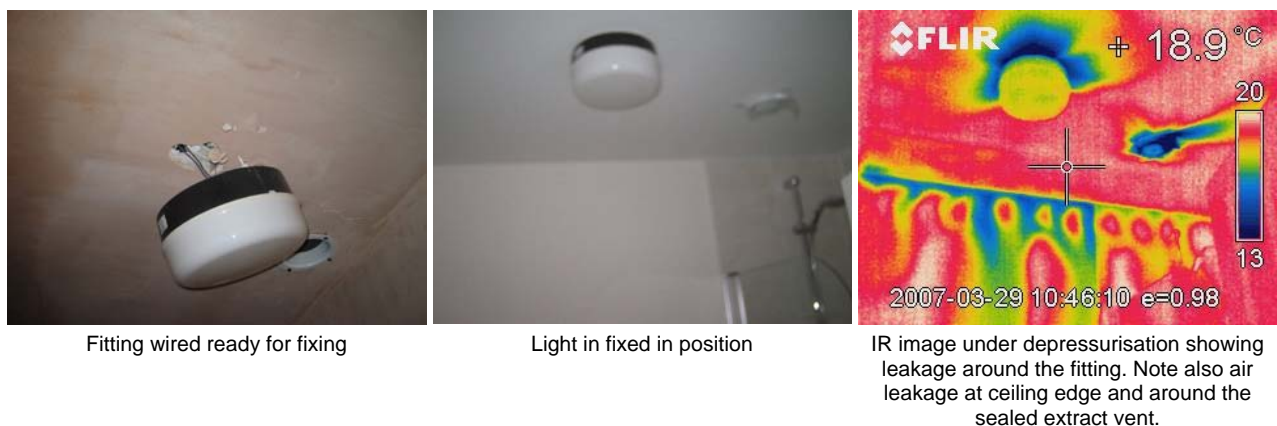
Figure 78. Air leakage around the ceiling light fitting in the 2nd floor bathroom of plot R111

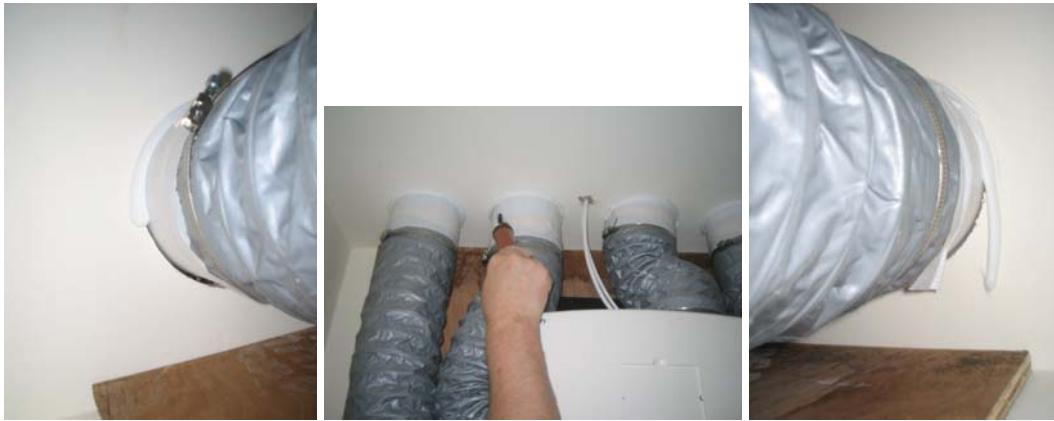
Figure 79. Gaps in the sealant and air leakage around the MEV ducting in plot B119.

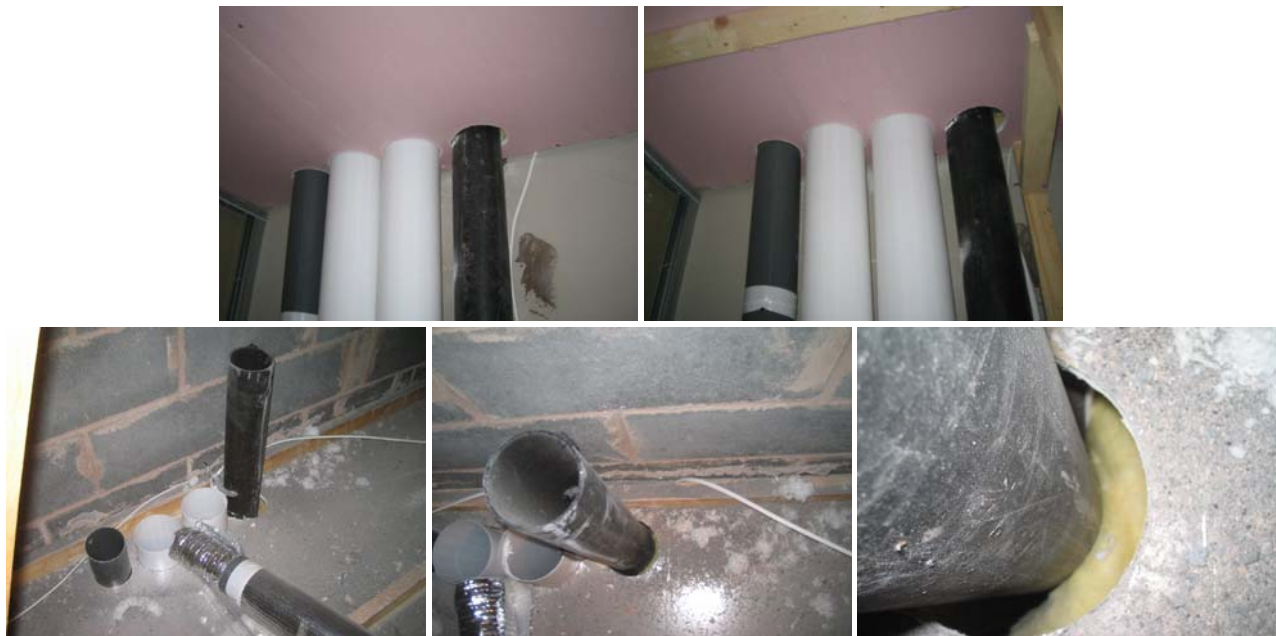
Figure 80. Penetrations through the ceiling inside the service void in the rear en-suite bathroom in plot B119.

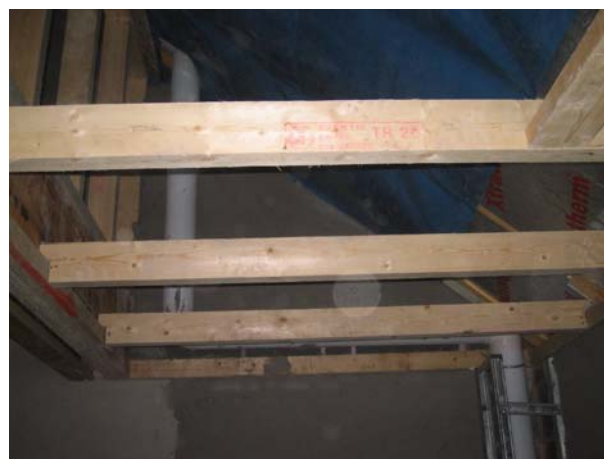
Figure 87. The service void in the 1st floor bedroom in plot R117 entering the void between the eaves and 2nd floor knee wall, and gap at the junction with the 1st floor.

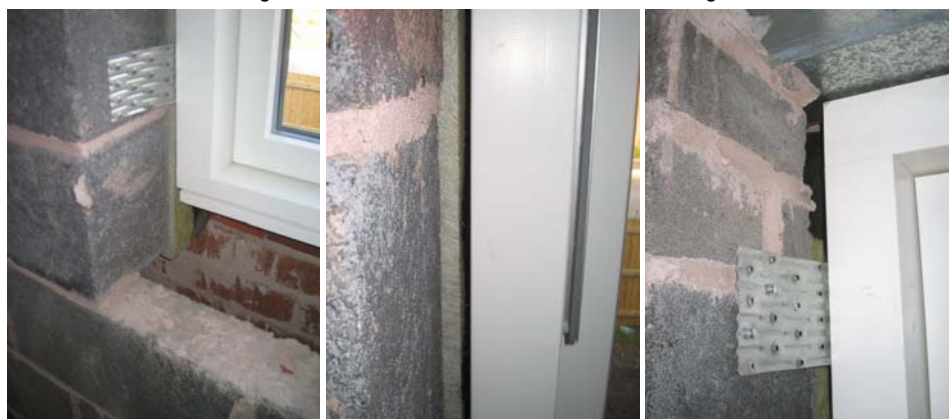
Figure 98. Incorrect window formers found in plot B121 and acoustic cavity barrier used instead of the proprietary formers in plot B117.

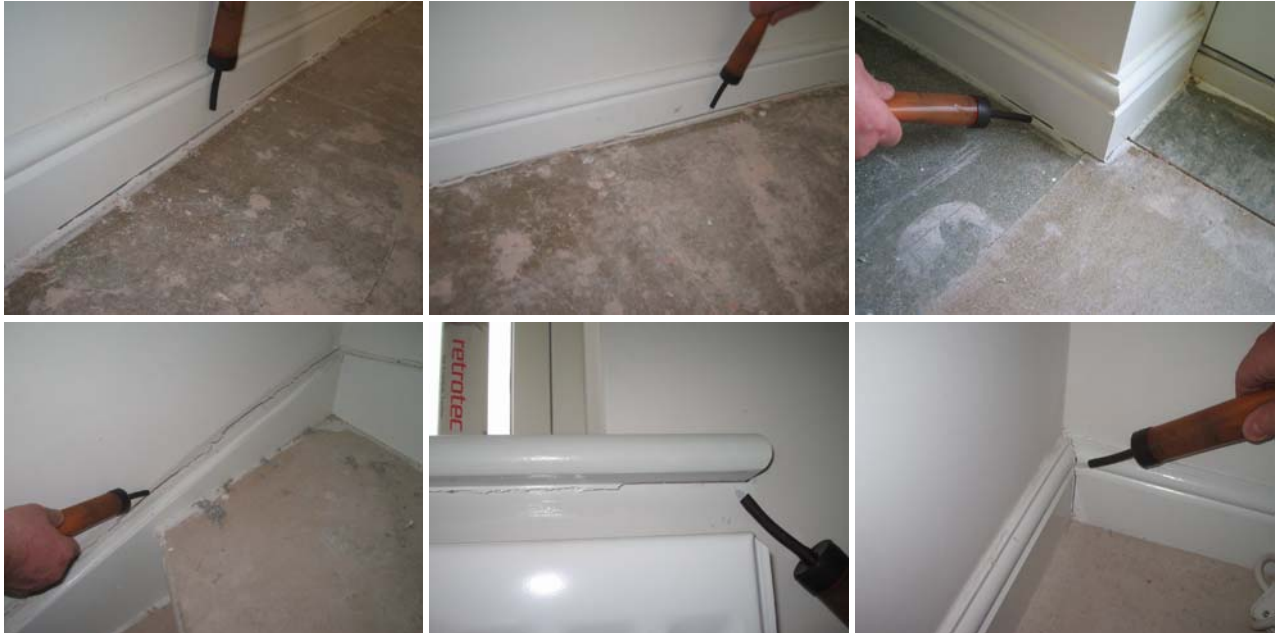
Figure 99. Air leakage detected during the re-test of plot R110, through failed secondary sealing and shrinkage cracks following the co-heating test.

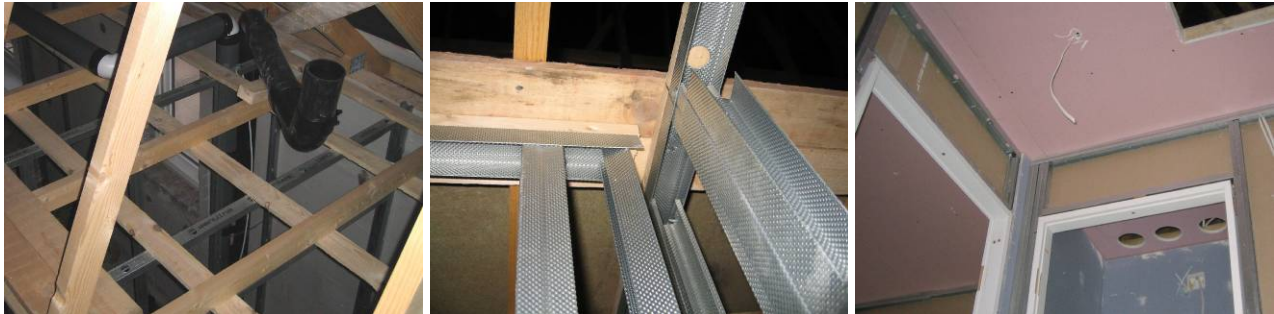
Figure 102. Open gaps in the partition head studwork in Redrow area 3; the gaps covered by timber head plates in plot R111 but with gaps still remaining at partition junctions; a full ceiling in plot B119 erected prior to the partitioning with easily sealable gaps around penetrations.

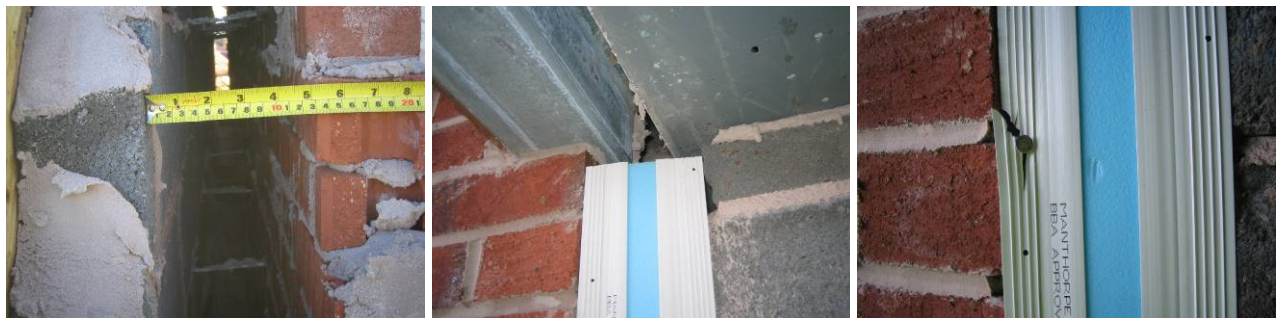
Figure 105. Variations in cavity width in plot R110 from 10% narrower than specified, to 10% larger where the originally specified cavity closers had to be replaced.

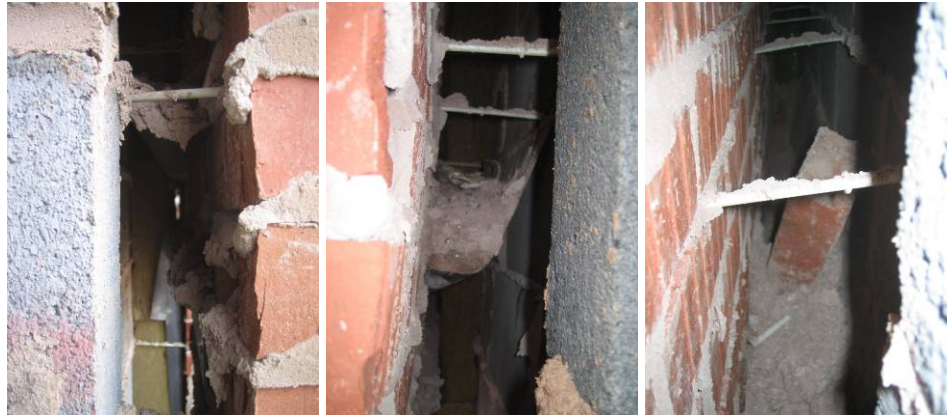
Mortar snots affecting the placing of the vertical cavity barrier in plot B116.

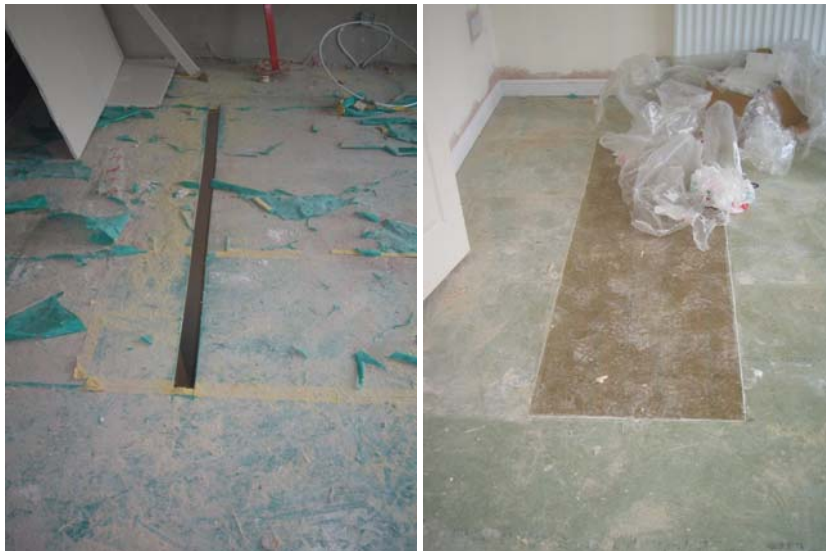
Figure 109. Holes cut and then repaired in a first floor in order to pass plasterboards to upper floors.
