Project Title: Temple Avenue Project Part 1

Temple Avenue field trial – Evaluation of design & construction process and measurement of fabric performance of new build dwellings

May - 2010

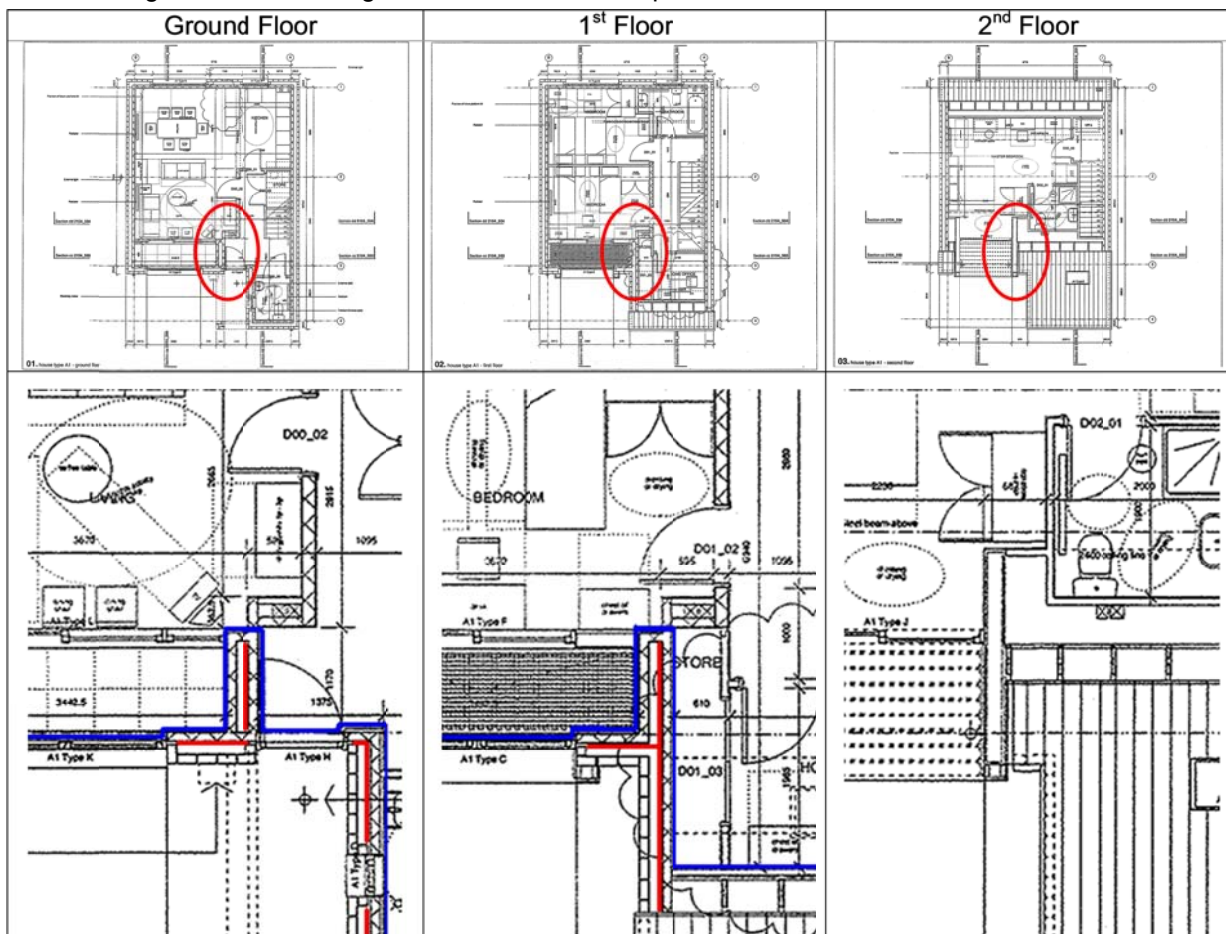
- 9 Some design issues were resolved on site following discussions between the site and design staff. Thermal bypasses arise where the air barrier and insulation layer have become separated. The potential thermal bypass in the A1 (masonry) prototype, in the area ringed in Figure 1, linked the void beneath the ground floor to the roof void; it was resolved by fully filling the void with insulation and a membrane used to ensure that the top of the void was closed off before it linked to either the roof void or the intermediate floor void. This solution was agreed between the architect and site manager after discussing a number of different options.

Figure 1 Potential thermal bypass in the A1 prototype (from the architects' drawing 2154_100).

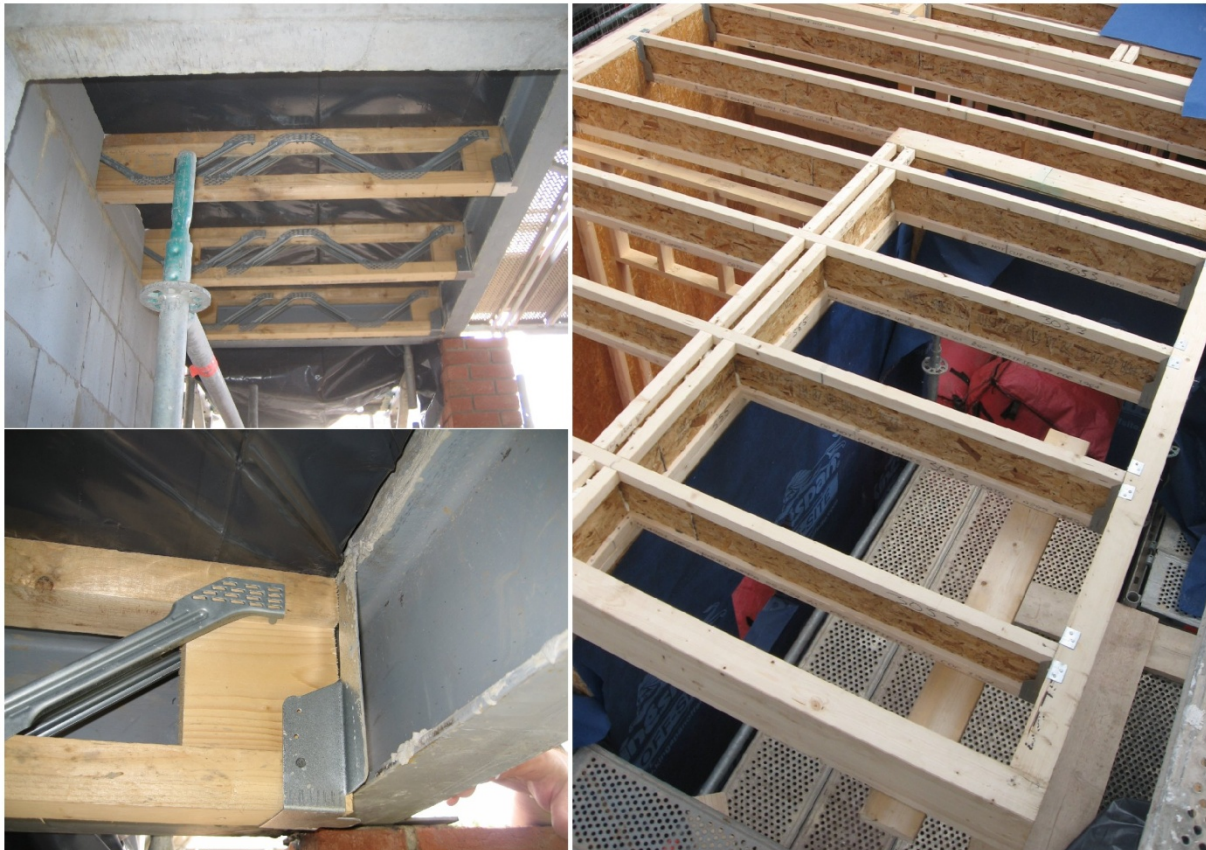
- 10 Other problem details required a lot more involvement and some of the issues were not fully appreciated until the details were part constructed. An example of a problematic detail was the canopy above the front door on both dwellings illustrated in Figure 2.

- b) A2 (SIPs) prototype – The drawings again appeared to position the air barrier and VCL the wrong way around and a problem along the downstairs WC side of the canopy, this resulted in an uninsulated void with a potential thermal bridge. Without any mineral wool on site the void was filled with expanding foam; this had the additional benefit of increasing the airtightness of the joint between the insulated floor above the canopy and the intermediate floor above the ground floor toilet. A piece of polyethylene DPM over the canopy, with silicone sealant around the edges, before covering over with the flooring board was chosen to provide the link between the air barrier at the wall and that in the canopy. The VCL was stapled to the underside of the canopy after it was filled with insulation and boarded. A decision was made on site to lay a double bed of sealant on top of the beams around the perimeter of the canopy, and then lay the membrane on this, before placing the floorboards over the membrane. This solution should prove to be airtight, but by leaving the edges uncut, so that they can be folded and taped around the edges, provides robustness to the solution.

Figure 2 Front canopies in the A1 and A2 prototypes during construction.

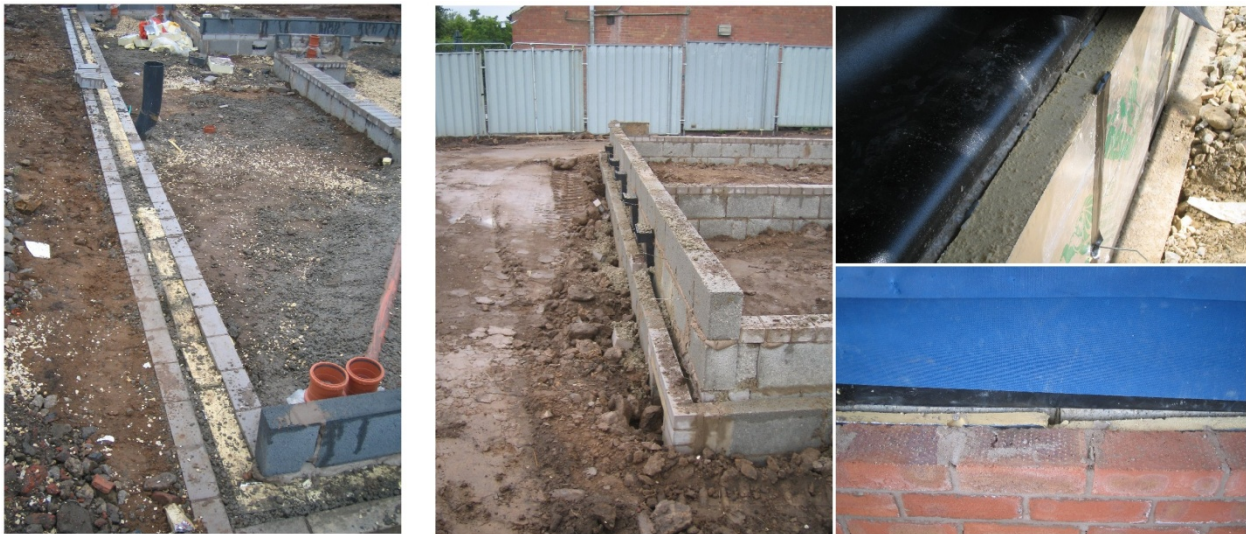
- 16 The slab perimeter insulation below floor level in both prototype dwellings presented some difficulties (Figure 3). In both dwellings there were issues relating to fitting insulation around the underfloor vents at the front and rear of the properties, with gaps remaining around the vents and the vents displacing insulation. In the A1 prototype, the partial fill insulation was subject to mortar build-up and damage resulted in additional discontinuities of the insulation layer and gaps between the inner leaf and insulation boards. In the A2 prototype, the full fill rigid board insulation allowed air gaps between the insulation and inner leaf, all the joints were taped but some gaps between insulation boards remained, and often the insulation was trimmed short of the top of the slab creating a thermal bridge through the floor slab directly underneath the sole plate.

Figure 3 Perimeter insulation below floor level in the masonry prototype, and at various stages on the SIPs prototype.

- b) The insulation between the slab perimeter blockwork and dpm was a 10mm thick expanded polystyrene expansion strip rather than the 20mm rigid PU foam specified was laid prior to the wall panels being erected. As the bottom of the 20mm internal insulation did not extend right down to the slab level (in some cases there were a 20 to 30mm gaps) there was a discontinuity in insulation around most of the slab perimeter to varying extents. This was exacerbated by gaps between the full-fill perimeter insulation boards and at the top of the slab perimeter insulation in the external wall cavity as shown in Figure 3.

- 67 The continuation of the 20mm internal insulation lining of the external walls down to the base of the floor slab to provide slab perimeter insulation is not buildable due to sequencing issues. The use of 10mm expanded polystyrene expansion strip at the slab perimeter as a suitable substitute needs to be fully assessed, particularly at the front and rear elevations where the underfloor vents replace the full fill insulation boards in the cavity below floor level. Increasing the height of the full fill insulation boards to above the top of the sole plate could mitigate any thermal bridging at this junction, or alternatively review the floor construction process to enable the 20mm perimeter insulation to be successfully installed.

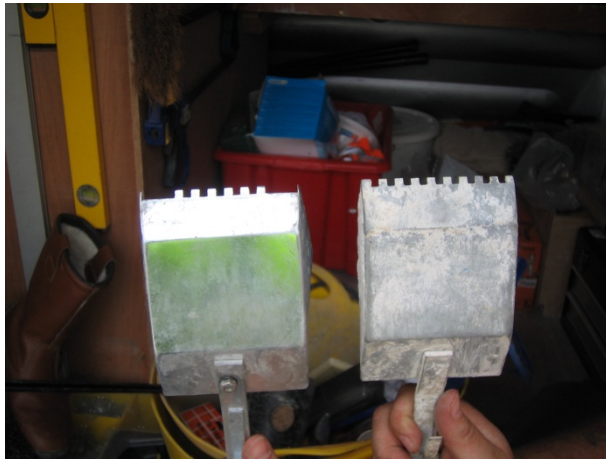
- 18 The mortar scoop was adapted to provide mortar at the edges of perpend and bedding layers (Figure 4) after comments that the joints didn't look full because there was no excess mortar at the edges that required striking off. Additional work was created in removing the excess mortar with an abrasive tool prior to both applying the wall insulation externally and the parge layer internally. Using the abrasive plate, rather than just striking off, removed the powdery surface layer which had caused a problem with tape adhesion to un-parged blockwork; instead it left a dusty residue on the blockwork which presented new adhesion problems.

Figure 4 The adapted mortar scoop, on the left, with the 2 outer teeth removed from each side.

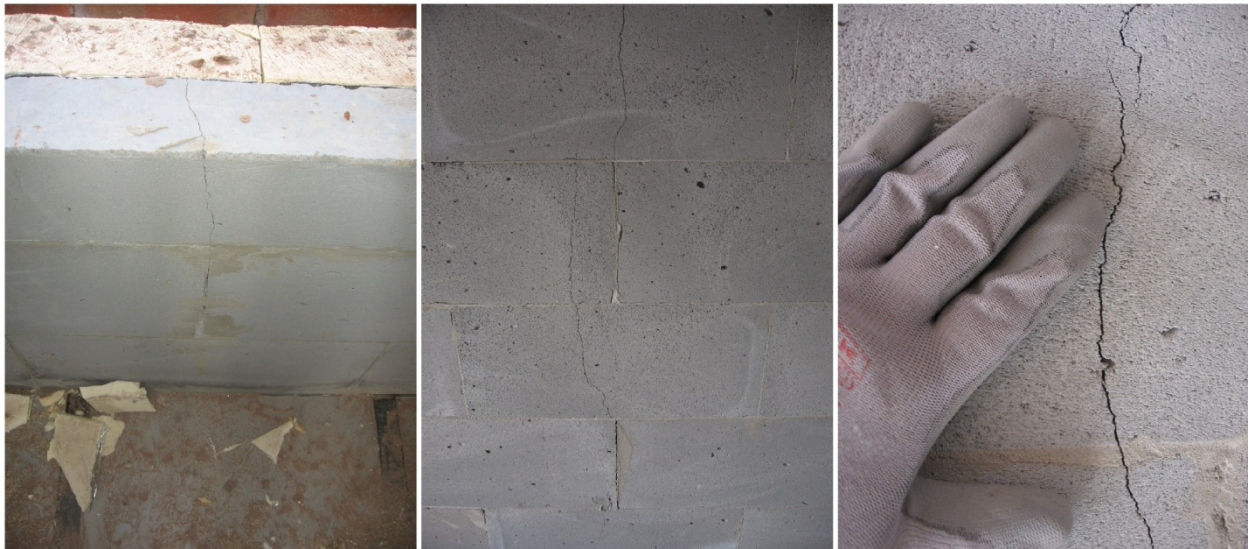
- 21 Concerns were raised in September 2009 when numerous cracks began to appear in the thin joint blockwork (Figure 5). These cracks were generally at/near the centre of walls, at/near the centre of sills, under padstones and at the internal angles of corners. When the block manufacturer was approached over the cracking in the blockwork this response was received from the Development Manager of the block manufacturer:

“None of these cracks showed displacement to the block face, and are typical of drying shrinkage associated with cementitious materials. Although it is not possible to give a complete guarantee against drying shrinkage, we had instructed our Recommended Contractor to include bed joint reinforcement in alternate courses, and this has contributed to controlling the drying shrinkage in this instance.

This type of cracking is not of a structural concern. However, we were also asked to consider the affect on air tightness through the construction: As far as the fine cracking is concerned, the effect will be negligible. For the slightly wider cracks, we would have advised raking out and applying a suitable sealant prior to dry lining. However, on this occasion we understand the walls are to be parged before finishing, in which case no further action need be taken.”

Figure 5 Cracking of the blocks in the masonry prototype.

- 72 The cracking that appeared in the blockwork is a concern with relation to the airtightness. The pre-parging pressure test revealed air leakage through most of these cracks, if new cracks were to appear post-parging, or existing ones expand, it is possible that new air leakage paths will be created that will be obscured by the dry lining so are not repairable without considerable cost.

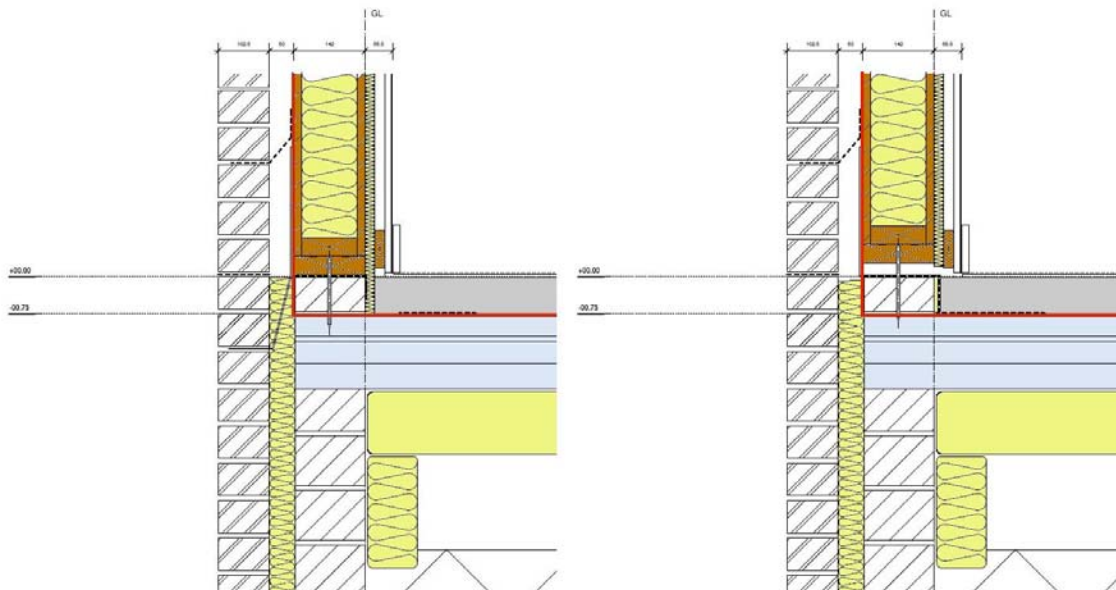
- a) The SIPs system manufacturer’s BBA certificate indicates that there should be an injectable grout between the sole plate and slab where spacers/shims are required to level the soleplate, the designs showed no gap between the sole plate and slab so no such grout appeared on the design. The main contractors were responsible for grouting the gap between the sole plate and floor and received details of the recommended material from the SIPs system manufacturer. This gap varied from 0 to >30mm in places. The grouting was delayed until after 20mm internal insulation had been installed, making job much more difficult to perform successfully.

Figure 6 Adapted from drawing 2154_820, a comparison between the as-designed (left) and as-constructed (right) sole plate detail.

- 75 In these days of laser levels it should be possible for the contractors to fix the sole plated perfectly level, unfortunately variations of up to 30mm in the slab were observed which had to be made up with plastic spacers and an injectable grout. This process was made much more difficult because it was delayed until after the 20mm insulation had been fitted internally.
- 76 The breather membrane on the outside of the wall panels was returned into the heads, jambs and sills at openings and was not trimmed back prior to window and door installation. What resulted

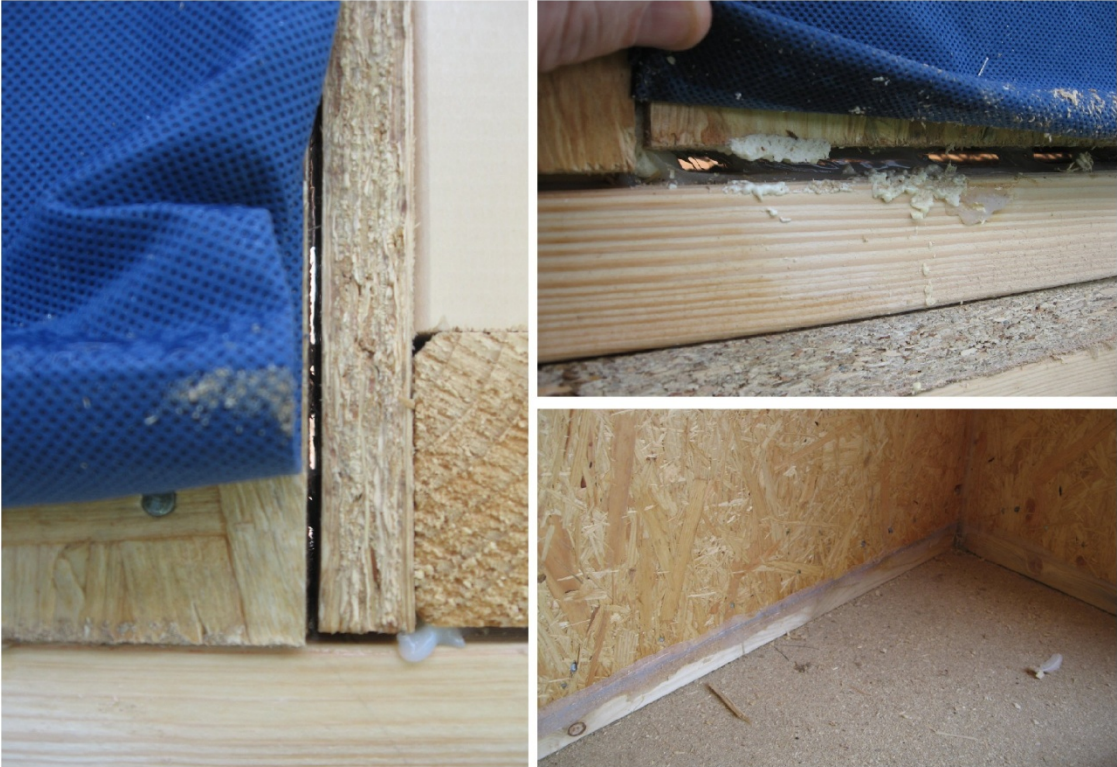
- 27 The SIPs panel erectors were aware of gaps between and around the wall panels which had been observed by the Leeds Met researchers (Figure 7), and indeed other, similar ones which had not been remarked upon. This was regarded as normal by them and part of their standard process was to inspect for these gaps and make them good with mastic, adhesive and foam, as they deemed appropriate, as construction progressed and before they were covered over with the breather membrane externally or with subsequent construction and/or insulation internally. Whether these gaps were completely filled or just sealed at the surface was not determined, and questions remain about the longevity of such repairs.

Figure 7 Gaps observed between SIPs panels during construction were sealed using a silicone mastic as construction progressed.

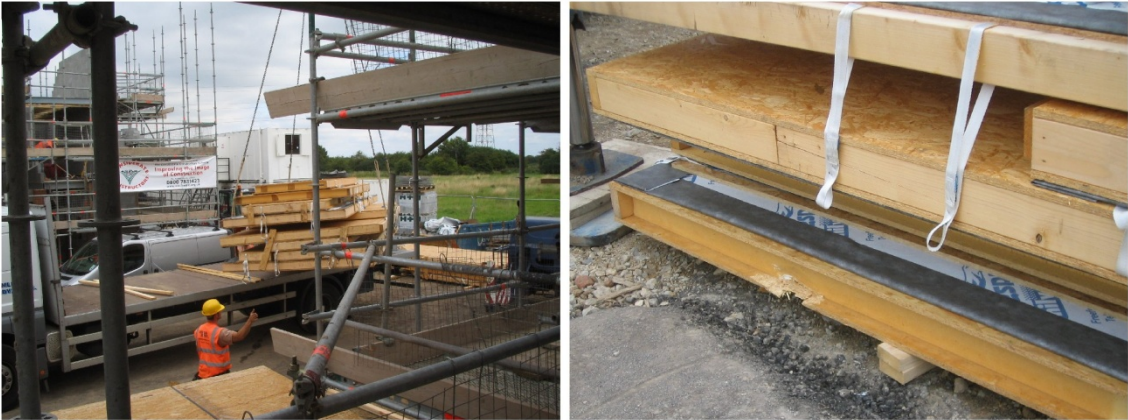
- 28 In their apparent haste to unload a lorry the contractors were observed lifting all the panels at once, rather than just in discrete packages, a few at a time (Figure 8). This resulted in damage to the panels where the lifting straps from the crane were positioned. The contractors again said they would be made good on site with OSB cut-offs, silicone and expanding foam where necessary.

Figure 8 Unloading of the SIPs panels and the resulting damaged panel.

- 77 A number of wall panels appeared to get damaged as they were unloaded from the delivery vehicle. The contractors installed these panels and then repaired the damaged OSB boards. If there was damage to the inside of the panels, as may well occur if these panels were present on site in larger scale production, clarification is needed on whether or how any repairs would be carried out.

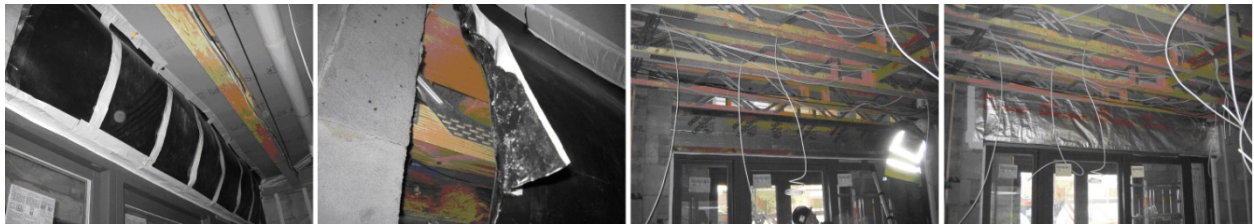
Although leakage detection revealed air leakage at all the above details, it should be stressed that the most concerning air leakage detected appeared to be through and around the air barrier membrane used throughout the sections of sloping ceiling. Inaccessible areas and awkward junctions were often areas where leakage appeared most severe, and the black gaffer tape used by the insulation fitters was already coming away from the membrane in several places. The physical act of performing the pressurisation tests appeared to be beyond the adhesive limits of this tape and was causing it to fail at pressure differentials of 50~60 Pascal.

Figure 9 The original membrane in the A1 prototype between the lounge and sunspace, shown failing during the pressure test, being removed and a replacement installed.

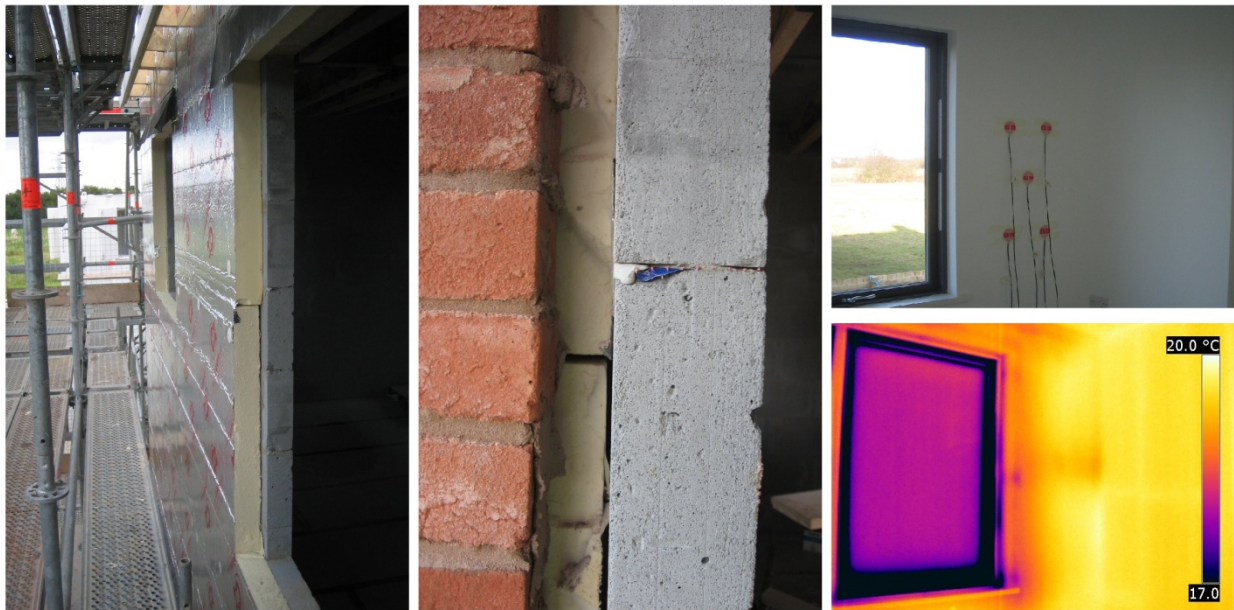
49 In the case of the wall on the north façade of the masonry prototype, there are some significant discrepancies in measured U-values. The worst measured heat flux densities were recorded on the windiest days suggesting some bypassing due to air movement arising from the edges of the boards by the window reveal, this was supported by photographs taken during the construction and thermal imaging (Figure 17). The measured U-values of 0.25 to 0.52 W/m²K on the North facing wall were drastically higher than the measured U-values on the gable wall of 0.19 to 0.28 W/m²K, a wall with no window openings, and all were higher than the design U-value of 0.17 W/m²K, listed in Table 2. In the SIPs prototype U-values between 0.18 and 0.27 W/m²K were measured on the gable wall, but lower values between 0.15 to 0.20 W/m²K on the North façade, where in both cases the design value was 0.15 W/m²K. These figures would suggest that rather than portraying an average U-value of the walls, the design U-values listed in Table 2 represent a 'best-case' or minimum U-value for these elements.

Figure 17 The masonry prototype 1st floor rear wall (North façade), showing gaps in the insulation, heat flux sensor placement, and thermal image captured during coheating.

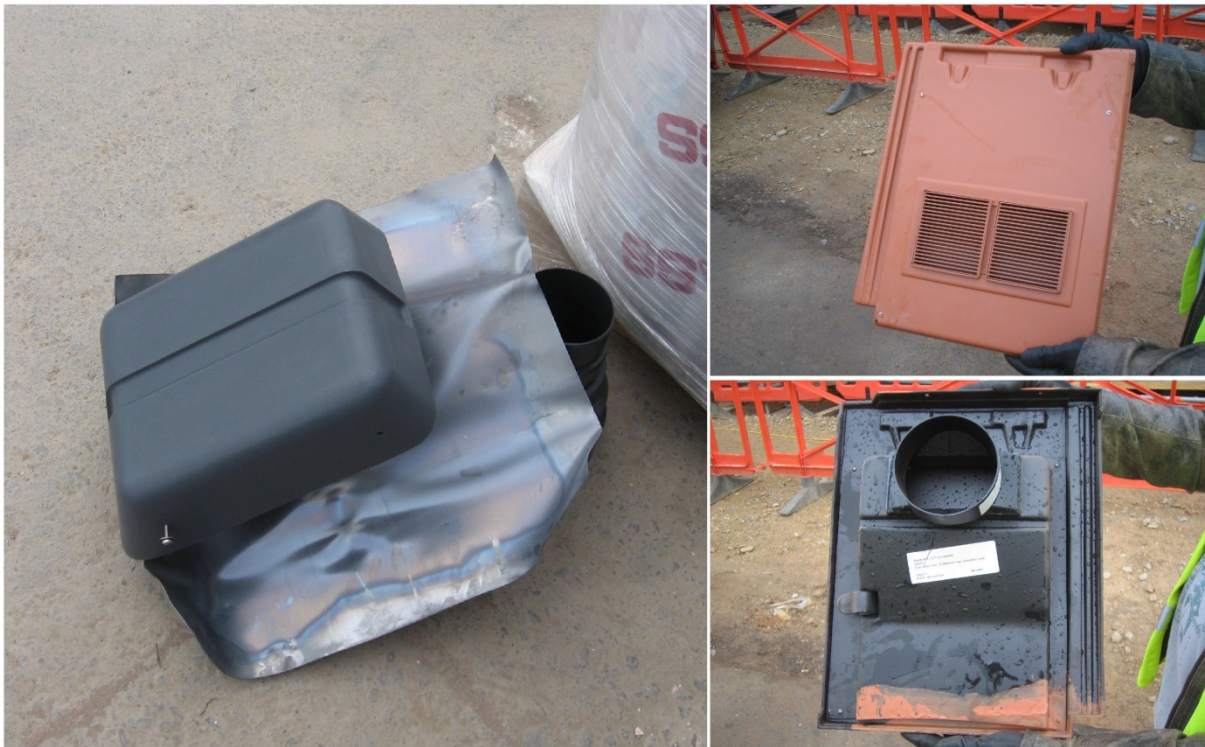
53 The MVHR Engineer deemed the concealed terminal roof tiles originally built into the roofs of the prototypes inadequate and insisted that terminal vents with a greater capacity were required (Figure 20). On the SIPs prototype the replacement terminal vent was installed in an alternative location on the opposite side of the roof due to accessibility and related safety issues, these safety issues also meant that the original vented roof tile was left in position but not connected.

Figure 20 The replacement “mushroom-type” terminal vent, complete with lead slate fixing, and the originally-fitted “concealed” vent tile removed from the masonry prototype.
