Project Title: Temple Avenue Project

Part 1: Temple Avenue field trial – Evaluation of design & construction process and measurement of fabric performance of new build dwellings

Part 2: Energy efficient renovation of an existing dwelling: Evaluation of design & construction and measurement of fabric performance

July - 2011

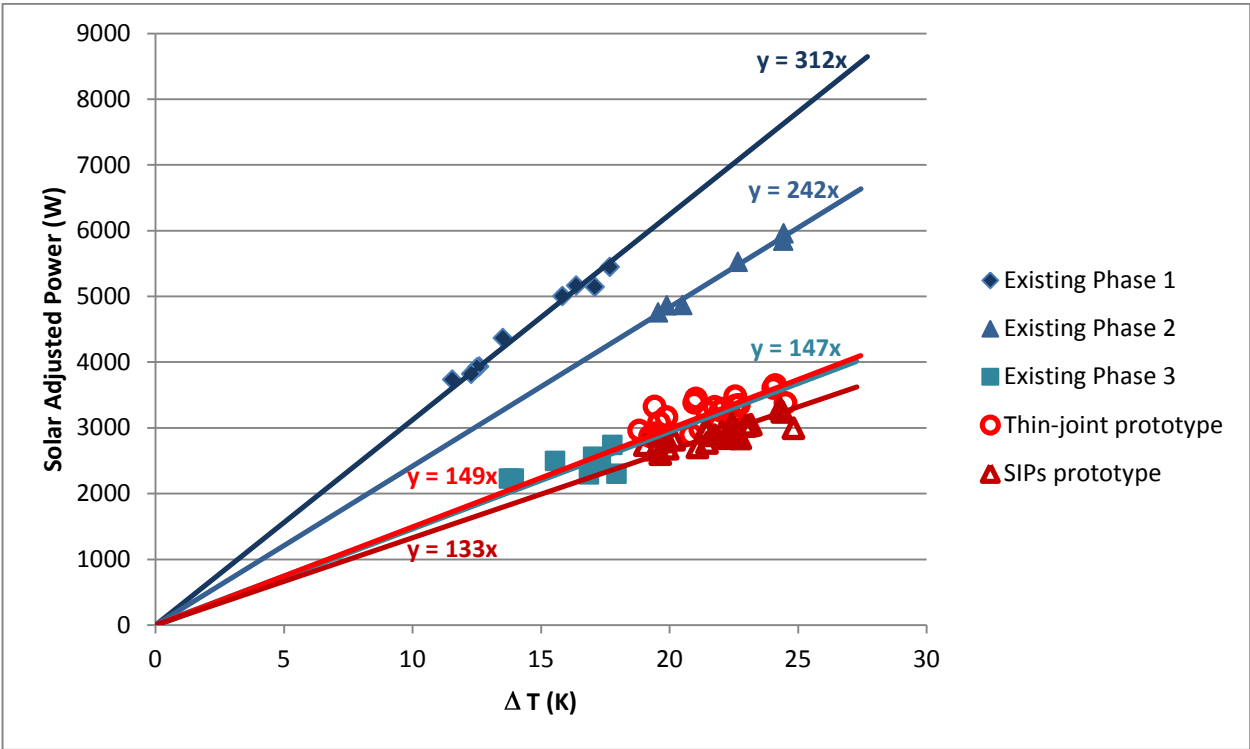
Figure 1 Coheating test results – measured heat loss coefficients..

- 40 What is immediately obvious from Figure 1 is the success of the refurbishment of the existing dwelling in reducing the fabric heat loss by over 50%, with improved systems performance and solar hot water this helps in almost achieving the design reduction in CO₂ emissions of 80%. The combined effect of the stage 1 and 2 renovations brings the heat loss coefficient to a level commensurate with the two prototype dwellings, which were also 3 bedroom family homes albeit larger. The SIPs prototype outperformed the thin-joint prototype by about 10%, possibly not much greater a difference than the potential for experimental error inherent within in the coheating test methodology.

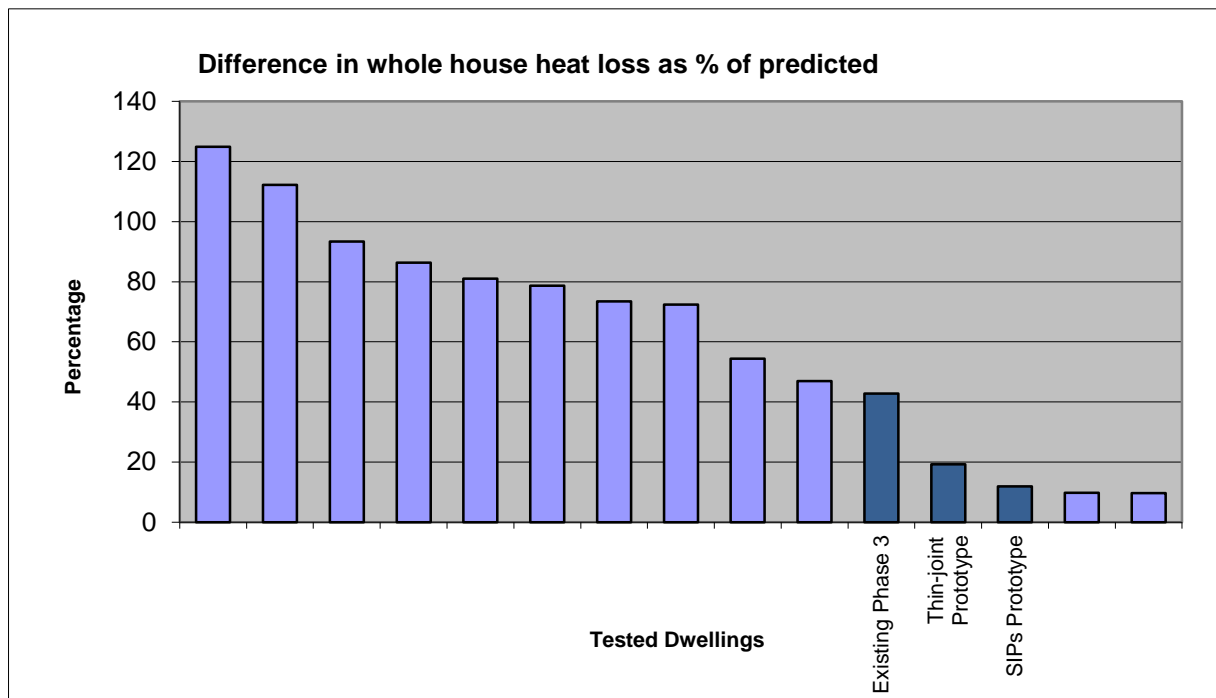
Figure 2 Variation between predicted and measured heat loss coefficients on dwellings tested by Leeds Met between December 2005 and March 2010 prior to interventions.

- 42 To put the Temple Avenue coheating test results into context Figure 2 compares the variation in measured heat loss over predicted performance of dwellings tested by the Leeds Met research team up to March 2010 prior to such interventions as retro-filling of party wall cavities. The SIPs prototype is on a par with the best performing timber framed dwellings, whilst the thin-joint prototype performs closer to the design values than any other masonry dwellings tested. The Phase 3 coheating test on the existing dwelling also displayed a lesser degree of underperformance of the building fabric than any of the mass-produced, speculative, new-build housing which was designed to Part L 2006 standards, or better, included in the dataset.

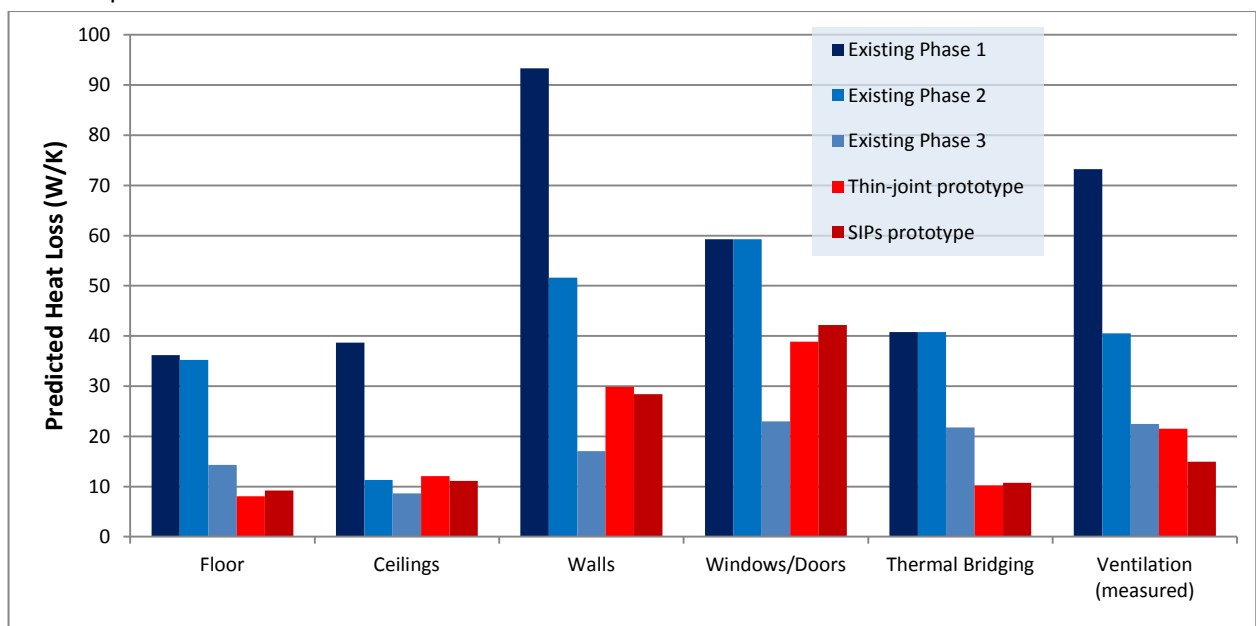
Figure 3 Predicted total heat loss through individual building elements.

- 46 The ventilation heat loss shown in Figure 3 is based on actual mean pressurisation test results rather than target air leakage rates. With lower levels of fabric heat loss the proportion of overall
