## Appendix C Thermographic survey

A thermographic survey of a sample of the houses in the York Energy Demonstration Project was carried out by EA Technology on 10th March 1993. The equipment used was an AGEMA 870. Because internal conditions in the houses could not be controlled, and because of the time available, this survey did not produce detailed numerical results. It did however provide a graphic illustration of a number of issues that are frequently raised when existing houses are thermally upgraded.

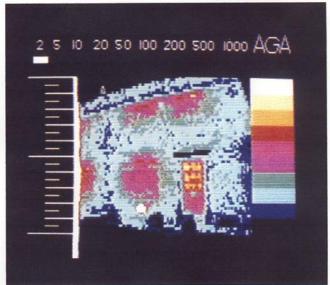
The first two pages of photographs were taken at Chapelfield A and B. The infra-red images of the front elevations of both properties show the large heat loss through the front doors. All doors used in the York Energy Demonstration Project were single skin tropical hardwood, with single glazed inserts. The U value of the opaque parts of these doors varies between 2 and 3 W/m²K, while the single glazed portion will have a U value of around 5.7 W/m²K. The doors installed in the 4 houses tended to warp, rendering the draught proofing largely ineffective. The single glazed inserts in doors show up as the warmest external elements in all infra-red images, and the opaque sections of the doors are significantly warmer than the adjacent double glazed windows. In heat loss terms, the letterbox on Chapelfield A appears to outperform the rest of the door.

Cold bridging around the front doors is masked by an external timber architrave, but examination of the images appears to show the effects of cold bridging around the windows. The resolution of the IR camera was not sufficient to show the heat losses at the edge of the glazing units.

Chapelfield B from front. IR photograph showing heat loss from windows and front door.

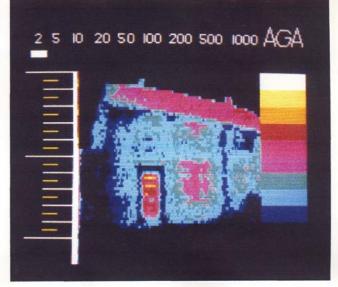
Chapelfield A IR from front. Note heat loss through uninsulated single glazed front door.

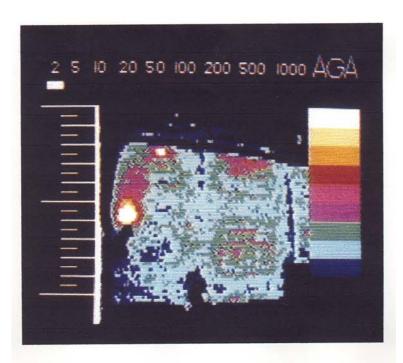
Chapelfield B IR photograph of back. Note image of multi-point heater flue.

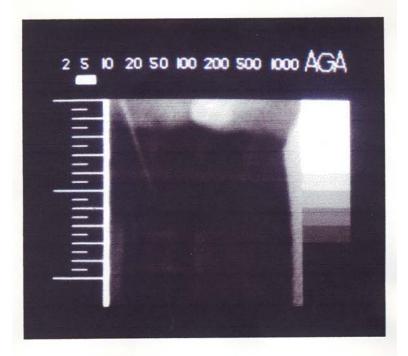
It was possible to gain access to Chapelfield B. One of the features of this house is the sloping section approximately 200 mm wide at the edge of the first floor ceiling. It was impossible to insulate this part of the roof, and the effects of this can clearly be seen in the infra-red photograph taken from the inside of the bathroom. In this image the ceiling below each rafter shows up as warmer than the surrounding ceiling because of the additional insulation provided by the timber rafter.

Chapelfield B IR taken from inside bathroom. Note cold bridging through sloping section of ceiling with rafters clearly outlined.

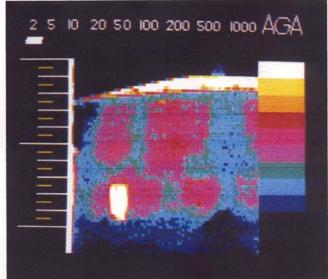
The third page of images was taken at the Bell Farm houses, and tells much the same story. The front door of Bell Farm A shows up as a major source of heat loss. The U value of the opaque parts of this door appears to be almost as high as that of the single glazed insert.

Bell Farm B IR from front. Note heat loss through uninsulated single glazed door.

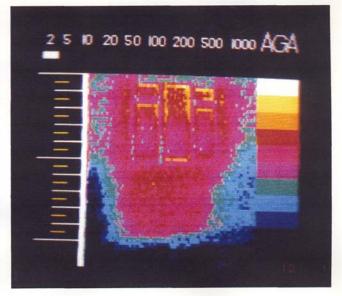
The infra-red images again suggest cold bridging around doors and windows (the doors in these houses are not surrounded by architraves as in the Chapelfield houses). The close-up of the ground floor rear window of Bell Farm A shows a significant area of additional heat loss below the window cill. This is not being caused by a radiator on the other side

of the wall, since this house has a ceiling mounted warm air heating system. Our only explanation is that the wall insulation is partly or completely missing at this point. This close-up shows the heat loss effects of the window frames, which appear significantly warmer than the glazing. The additional heat loss at the edge of the glazing units can just be seen at the bottom of the centre light of this window.

Bell Farm IR of rear window. Additional heat loss at edge of glazing units, and cold bridging through masonry around window is visible.
