# Low Carbon Housing Learning Zone

## BOUNDARY CLOSE

Boundary Close is a small development of 8 dwellings at Boundary Close in York that were designed by [Constructive Individuals](#) for York Housing Association. The Housing Association were keen to reduce the living costs for the prospective tenants and reduce the likelihood of fuel poverty.

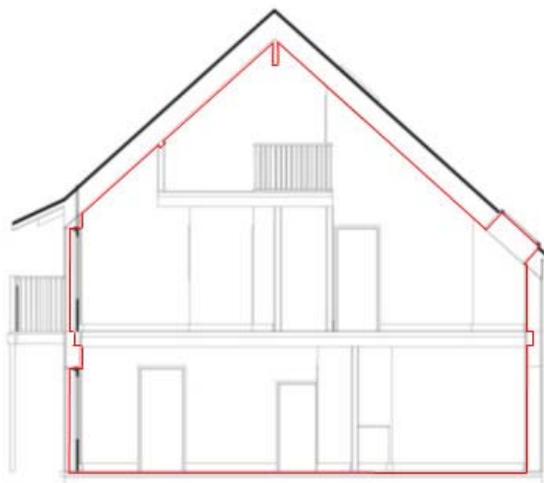
The location and continuity of the primary air barrier within the dwellings can be seen on the pen-on-section test shown below.

Pen-on-section test illustrating the location and continuity of the primary air barrier

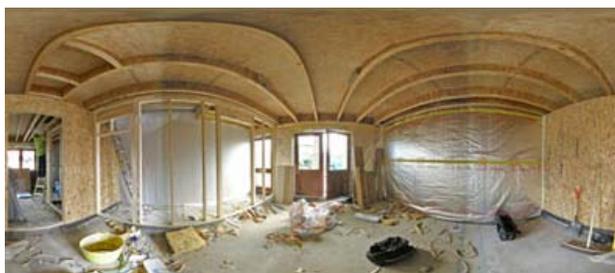
Air barrier incomplete

A virtual tour of one of the dwellings (Plot 1) illustrating the use of properly designated materials for taping and sealing of the air barrier and the considerable efforts that have been undertaken to maintain continuity of the air barrier, can be accessed by clicking on the image below.

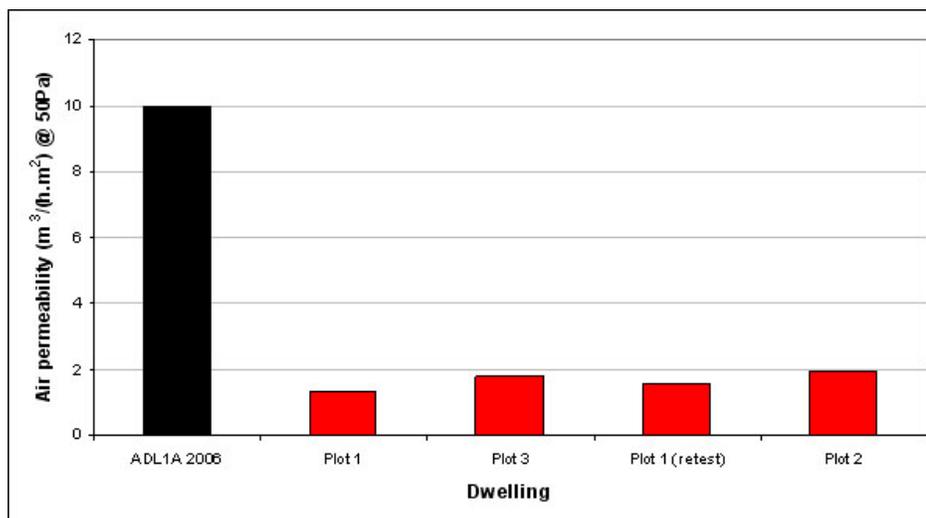
Air permeability of the tested dwellings

The calculated mean air permeability for the dwellings that were tested after the installation of the primary air barrier (Plots 1 and 3) was  $1.32$  and  $1.82 \text{ m}^3/(\text{h.m}^2) @ 50 \text{ Pa}$  respectively, indicating that the dwellings are extremely airtight by UK standards. These results were achieved despite that fact that these dwellings were far from being complete. Nevertheless, the figures do lie just outside the air permeability target of  $1 \text{ m}^3/(\text{h.m}^2) @ 50 \text{ Pa}$ . However, the air permeability results for both dwellings are significantly lower than Part L1A 2006 Building Regulations requirement of  $10 \text{ m}^3/(\text{h.m}^2) @ 50 \text{ Pa}$ .

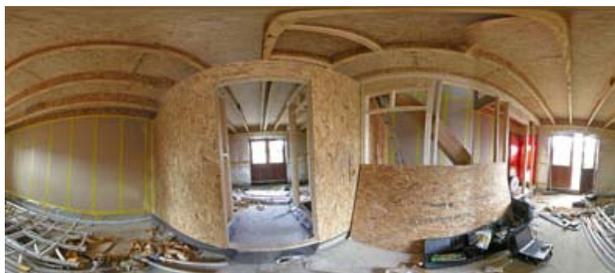
Air barrier complete

The main air leakage points within Plots 1 and 3 were identified using a handheld smoke puffer and were as follows:

- At the external wall junction with the ground floor and sub floor walls.
- Around the window and door seals.

These leakage points can be viewed on the following tour by clicking on the image below.

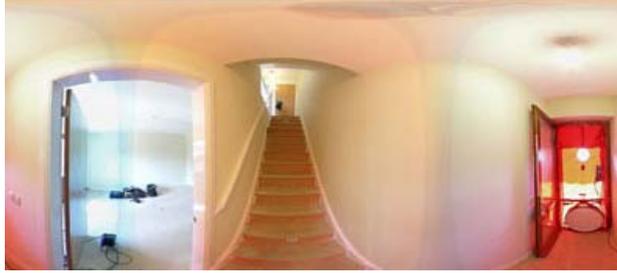
Pressure testing

The calculated mean air permeability for the dwellings that were tested once complete (Plots 1 and 2) was  $1.58$  and  $1.94 \text{ m}^3/(\text{h.m}^2) @ 50 \text{ Pa}$ . Although the figures obtained for these dwellings also lie just outside the air permeability target of  $1 \text{ m}^3/(\text{h.m}^2) @ 50 \text{ Pa}$ , they do indicate that these dwellings are still extremely tight by UK standards. Interestingly, the air permeability of Plot 1 has increased slightly by  $0.5 \text{ m}^3/(\text{h.m}^2) @ 50 \text{ Pa}$ . This increase is mainly felt to be attributable to additional leakage through the solar heat exchange unit, which was not installed when this dwelling was first tested in March 2008. Despite this, the air permeability results for both dwellings is still significantly lower than Part L1A 2006 Building Regulations requirement of  $10 \text{ m}^3/(\text{h.m}^2) @ 50 \text{ Pa}$ .

The main air leakage points identified within the tested dwellings were as follows:

- Around the window and door seals. A significant proportion of this leakage occurred at the corners of opening casements of the windows where the seal had merely been bent round the corner rather than being mitred. It is possible that this area of air leakage

could have been reduced if windows with mitred seals had been specified.

- Through the solar heat exchanger unit in the loft.

These air leakage points can be viewed by clicking on the image below.
