Air Leakage Test Results for St Nicholas Court (Fieldside Place) Development, York

Jez Wingfield, Centre for the Built Environment, Leeds Metropolitan University

Report prepared by		
Name: Jez Wingfield, David Johnston		
Organisation: Centre for the Built Environment. Leeds Metropolitan University. Brunswick Terrace. Leeds LS2 8BU		
Project manager:		
Signature		
Date: 29 April 2004

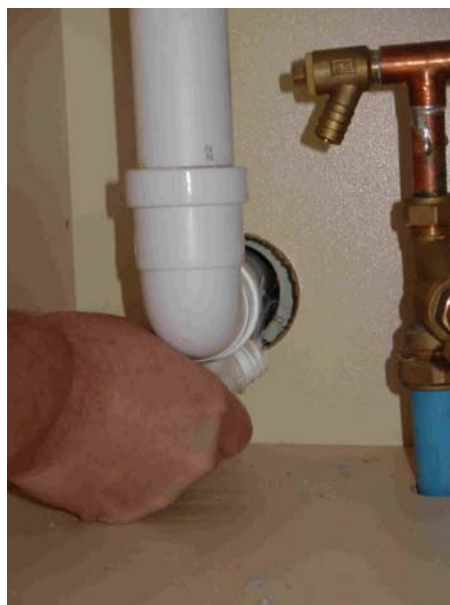
- a) Service penetrations in kitchen (except plot 4)

Figure 13 - Leak around Sink Outlet Pipe Penetration (Plot 16 kitchen)

- d) Lack of site supervision and quality control.
 - e) No apparent remedial action taken after first set of air leakage tests.
22. In general, there is poor attention to sealing of pipe penetrations. These should be sealed with the use of an appropriate expanding foam or sealant. There are also some significant leaks around door frames and windows (especially Velux) which should be rectified by adjustment, component replacement or sealing. The gap between skirting boards and floor should also be sealed with an appropriate sealant. A sealing strip should be used on the loft hatch and mechanical clips fitted that pull the hatch down onto the seals.

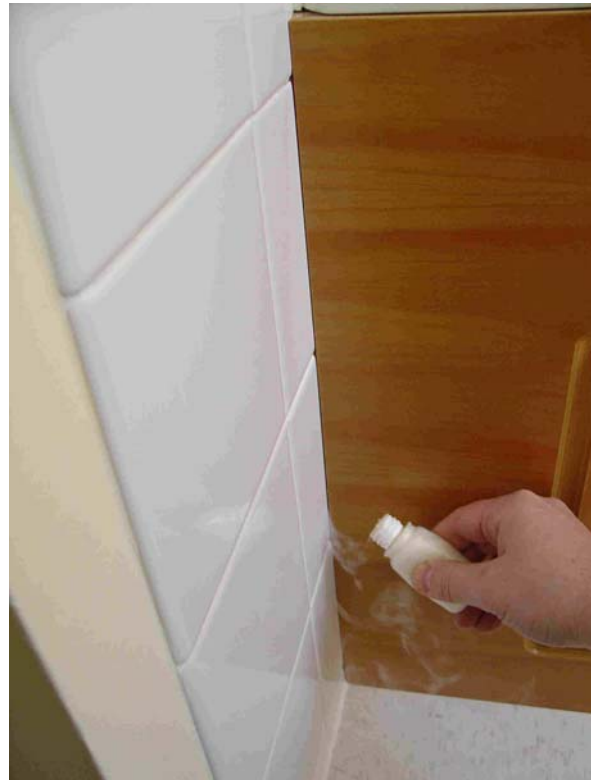
c) Service penetrations in bathroom and around bath panel

Figure 15 - Leak around Bath Panel (Plot 16)

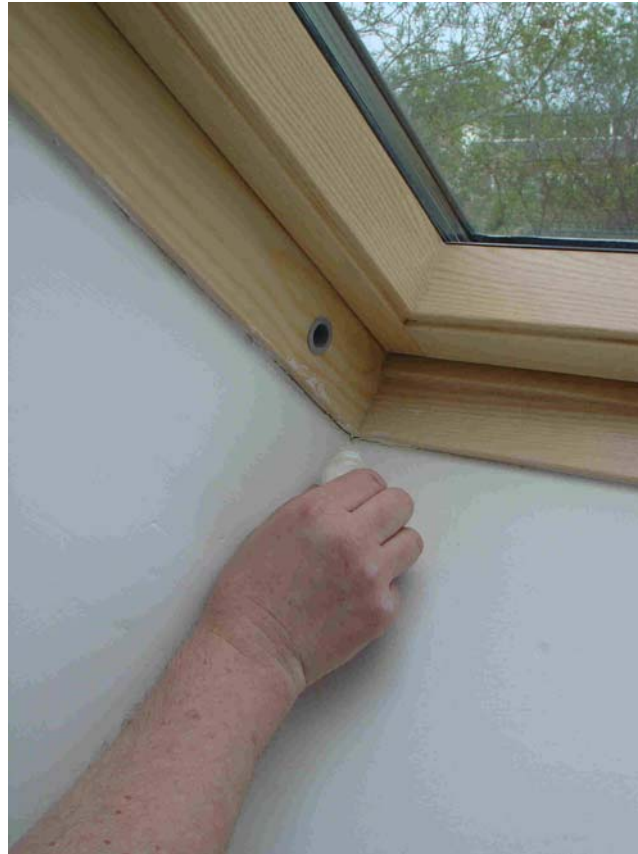
d) Joint between Velux window frame and wall

Figure 16 - Leak at Gap between Velux Frame and Wall (Plot 4)

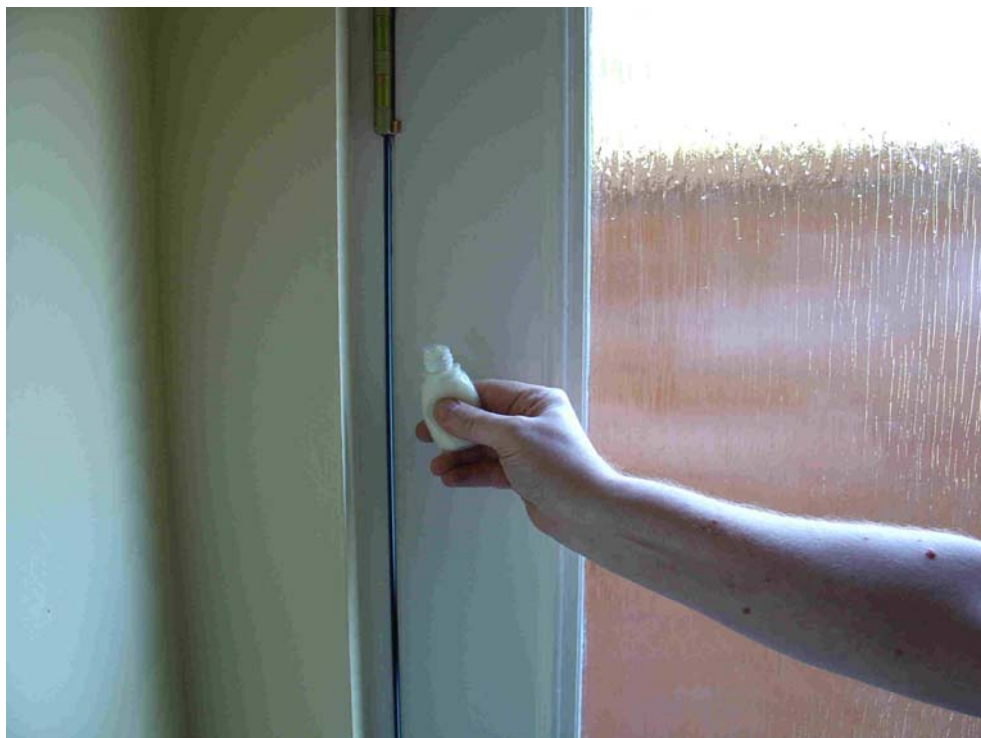
e) Gap between back door and door frame

Figure 17 - Leak around Back Door Frame with Smoke Shown Flowing Outside (Plot 16)

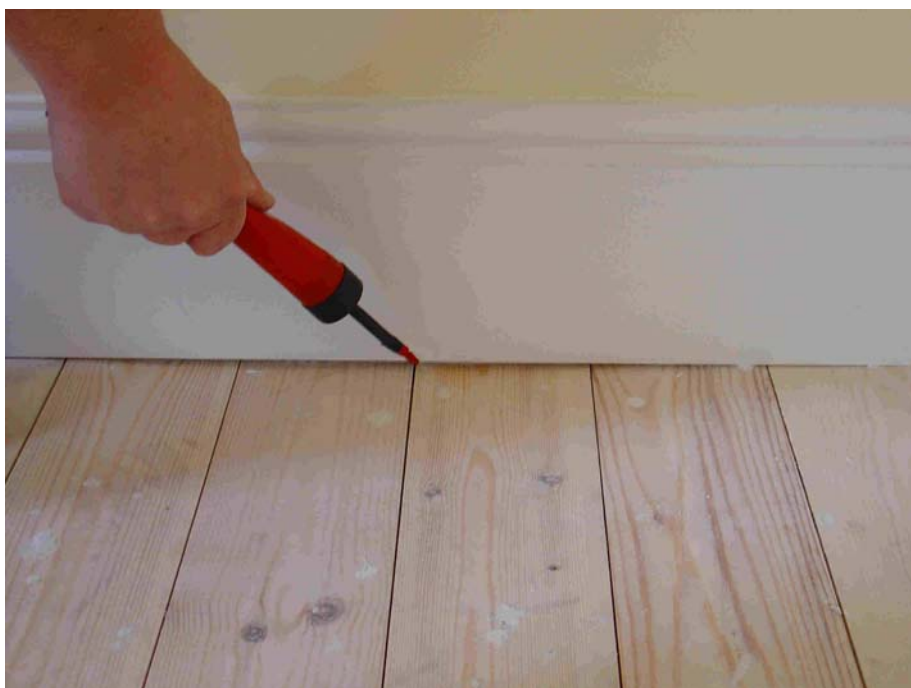
- g) Gap between skirting board and floor

Figure 19 - Leak at Gap between Skirting Board & Floor (Plot 4)

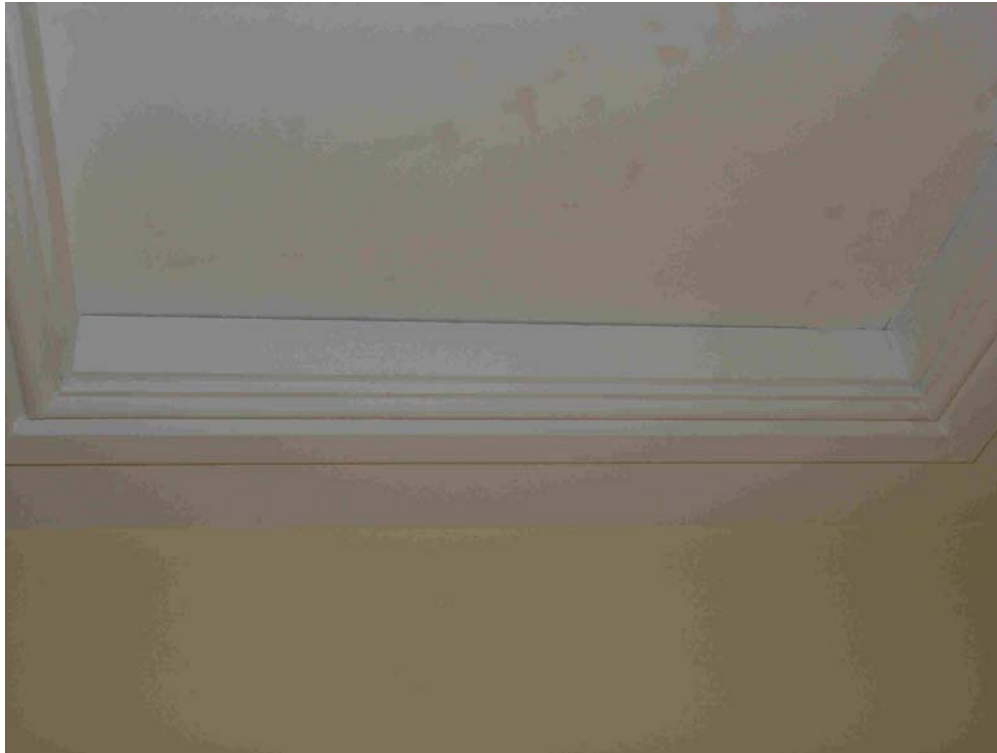
l) Around loft hatch

Figure 24 - Gap around Loft Hatch (Plot 16)

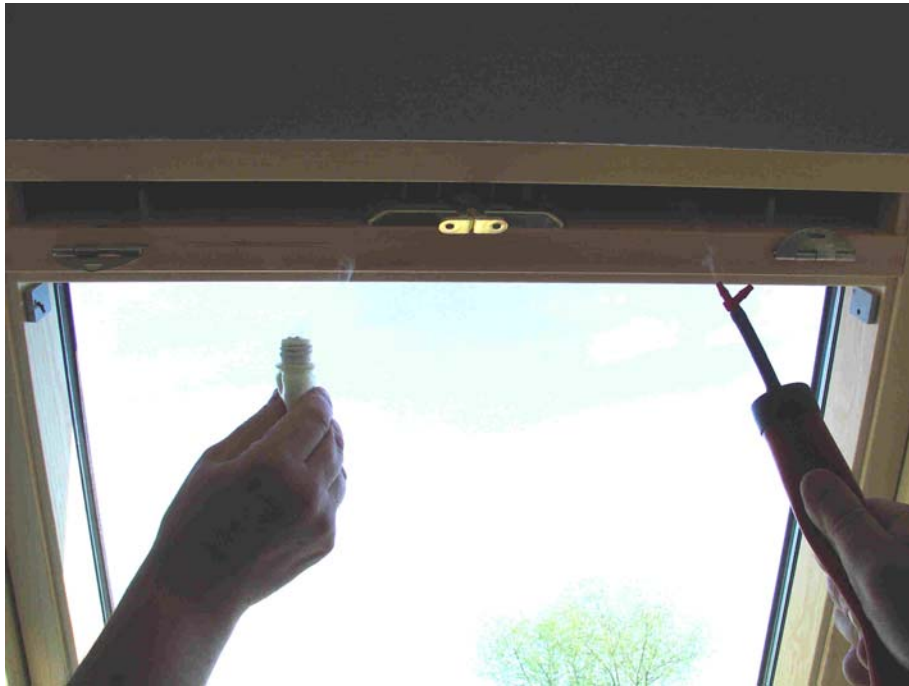
n) Missing trickle vent in Velux window in dwelling 17

Figure 26 - Leak through Missing Velux Trickle Vent/Handle (Plot 17)

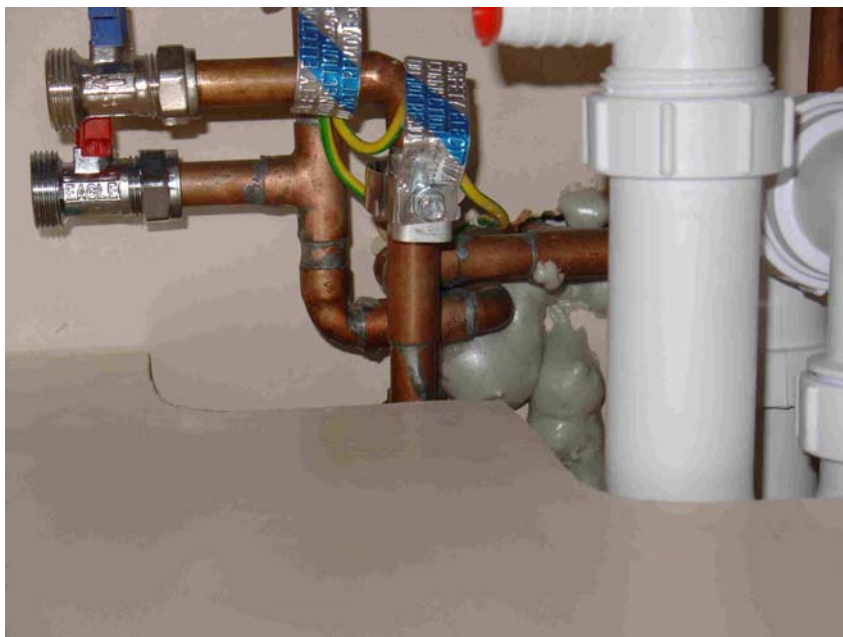
19. Many of the leakage paths had been identified in the previous test (Borland 2004) and have clearly not been remedied. Some attempts were visible in plot 4 (previously untested) to seal some of the problem areas. For example, expanding polyurethane foam had been used to seal around the service penetrations in the kitchen (Figure 28) and sealant had been used to seal the gap between skirting board and floor in the kitchen and downstairs toilet (Figure 29). These factors probably contributed to unit 4 having the lowest air permeability of the dwellings tested.

Figure 28 - Use of Expanding Foam to Seal Service Penetrations in Kitchen of Unit 4
