Final Report to Joseph Rowntree Housing Trust

Project Title: Temple Avenue Project Part 2

Energy efficient renovation of an existing dwelling: Evaluation of design & construction and measurement of fabric performance

March - 2011

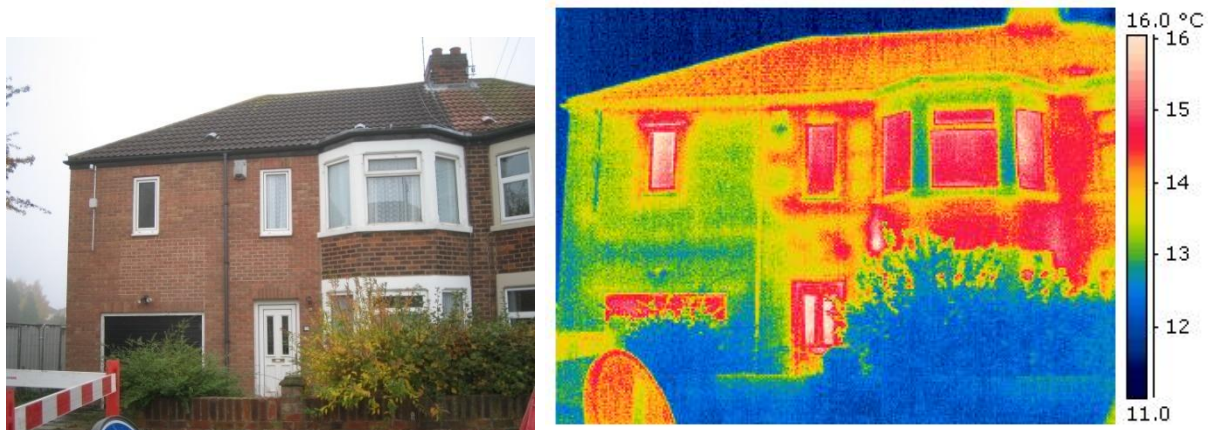
differing environmental conditions, it can clearly be seen that the process had had very little effect on the thermal conductivity of the wall, and had certainly not reduced it by the 73% assumed in the design calculations.

Figure 4 Front elevation during coheating test 1, 27-Oct-09, prior to cavity wall insulation installation.

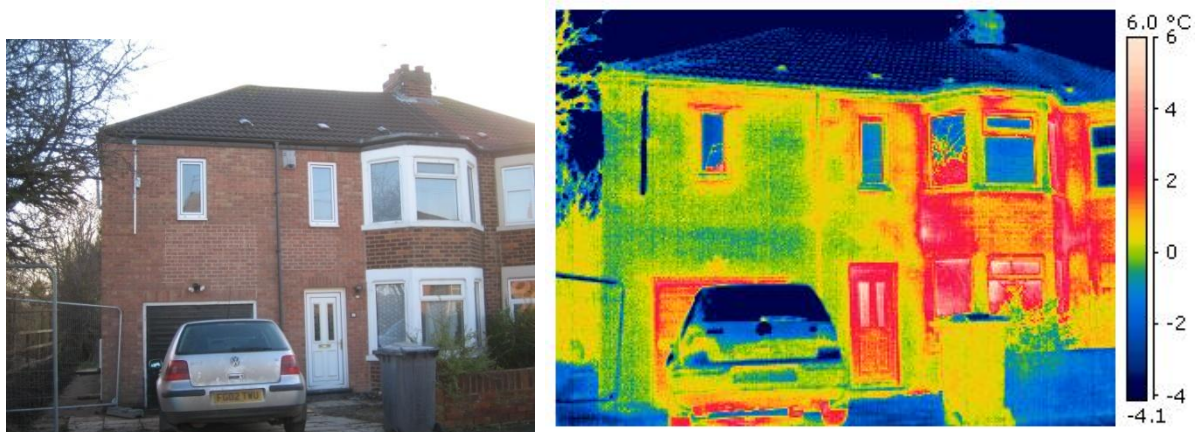
Figure 5 Front elevation during coheating test 2, 17-Dec-09, following cavity wall insulation installation.

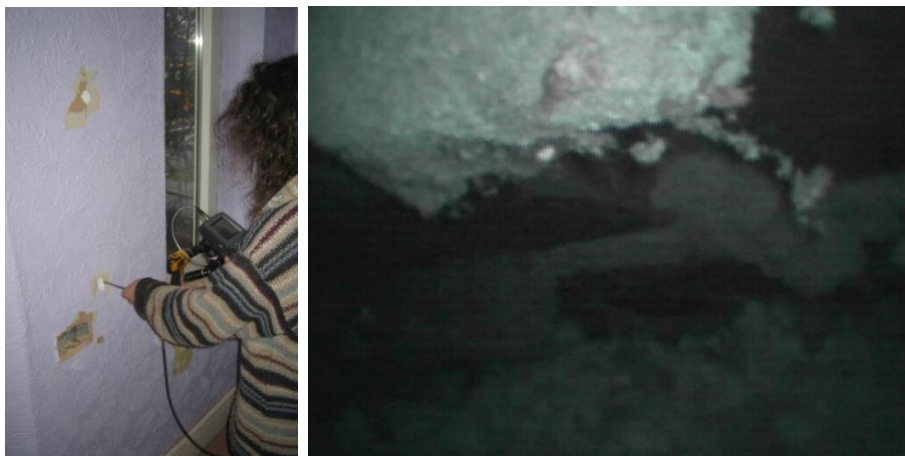
- 34 Boreoscope investigations, additional thermal imaging and heat flux measurements were performed by the research team to investigate why some of the CWI issues had arisen. In some areas highlighted by thermal imaging as potential causes for concern 10 mm inspection holes were drilled and a Hawkeye Pro Videoscope (manufactured by Gradient Lens Corporation), with 4-way tip articulation, inserted to view the inside of the cavity. Figure 7 shows a particularly poor example where the CWI did not spread through the cavity, instead just clustering around the injection hole. Additional boreoscope investigations of other areas of cavity wall showed a wide variation from very patchy fill to completely filled with insulation. One possible cause for the incomplete fill appeared to be the poor quality of the inner leaf brickwork and the amount of debris present in the cavity. The inner leaf brickwork displayed a number of instances of bricks crumbling and surfaces falling off around drill holes, possibly made worse because the installers drilled from inside the property so could not follow their normal practice of drilling through mortar joints rather than bricks/blocks where possible; this only added to the other debris in the cavity which ranged from bricks, mortar and other building waste to bird nests (Figure 8). The one area of wall where there was little variation in fill density and an apparent much more complete fill was the internal cavity wall between the garage/bedroom 3 and the hall/stairs/bedroom 1, where the original external brick outer leaf had been replaced by blockwork when the side extension had been erected.

Figure 7 Boreoscope investigation of the external wall showing insulation clustered around the injection hole, but not filling the cavity.

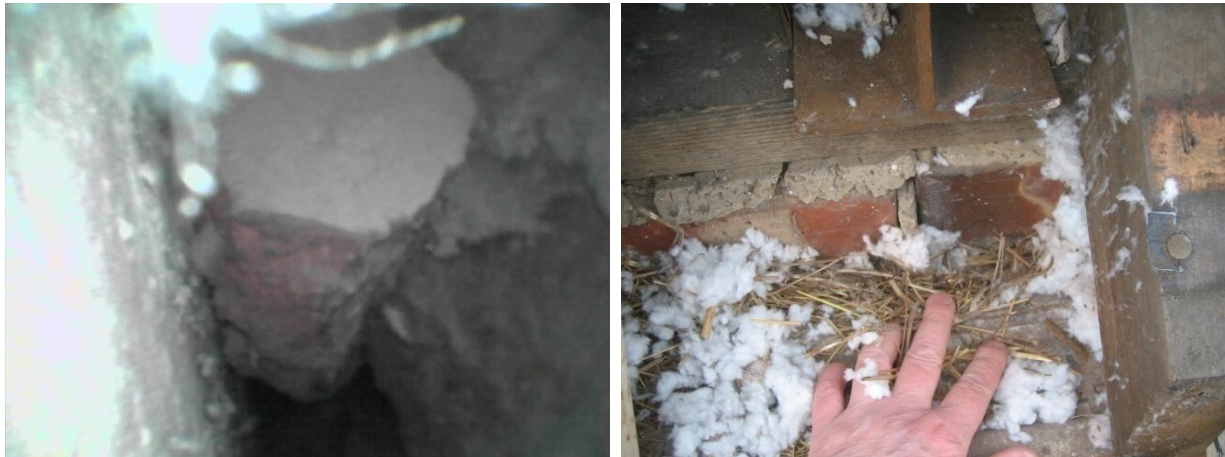
Figure 8 Debris in the cavity wall included masonry detritus and bird nests.

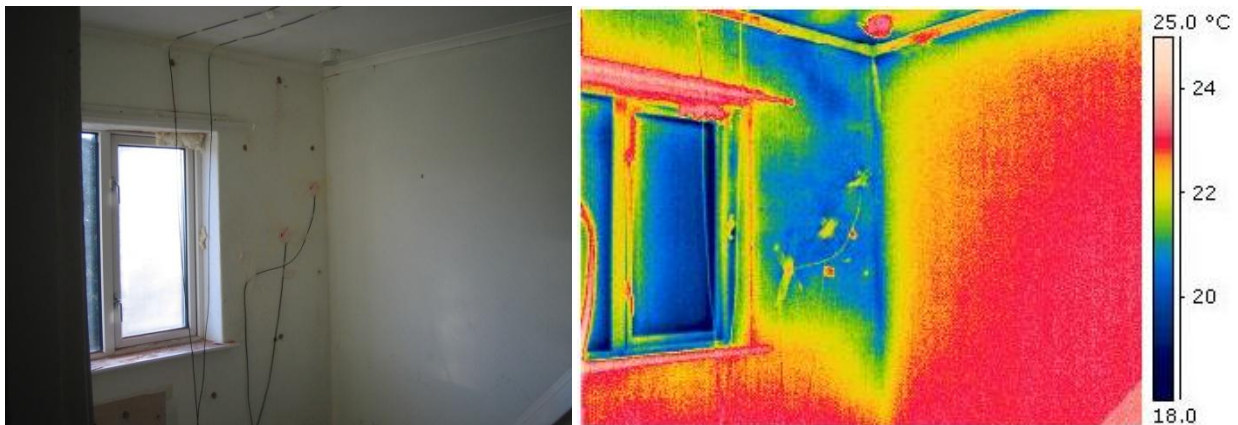
- 35 The incomplete fill of the CWI was not only due to the poor state of the cavities and the inadequate flow of the blown fibre through them. Thermal images captured using a FLiR ThermaCam B4 infrared imaging camera revealed a major cold spot at the 1st floor junction of the external and party wall at the rear of the property. Borescope investigations confirmed that there was no insulation at the sites shown in Figure 9 where heat flux sensors were placed even though there appeared to be adequate injection holes. Following conversations with the CWI installers it transpired that a vertical cavity brush had not been fitted at the party wall junction, allowing the CWI to fall sideways into the adjacent neighbour's wall cavity. An additional result of these conversations was that the CWI installers returned to the site in January 2010 to install the vertical brush and to drill additional holes and inject extra insulation at areas of poor fill identified through thermal imaging by the research team.

Figure 9 Heat flux sensors and thermal imaging of the external and party wall junction in bedroom 2.

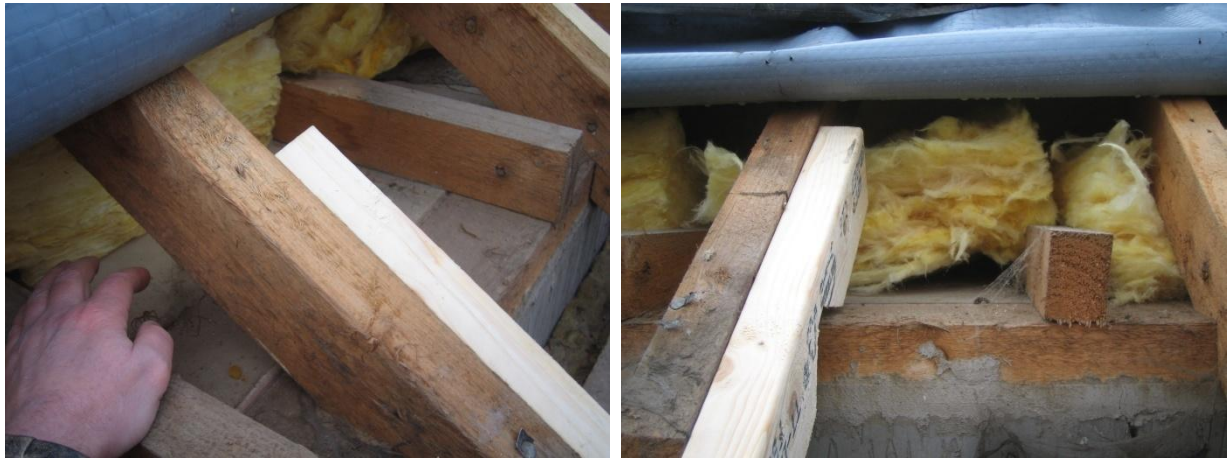
- 36 The partial boarding in the main loft was removed along with the majority of the old compressed loft insulation and debris; 400 mm of mineral wool quilt was laid and an insulated access hatch installed. The design suggested that 100 mm thickness of mineral wool quilt was to be laid between the joists and a 300 mm layer perpendicular to the joists for the best fill and fit, what appeared to have been installed was a double layer of 200 mm thickness. This provided additional air pockets in the insulation layer which will have degraded the performance. Of greater concern was that the insulation did not extend fully into the eaves and was some distance off meeting the cavity wall insulation to provide a continuous thermal barrier. The full extent of these gaps in the insulation layer was exposed when the roof tiles at the eaves were lifted during the stage 2 renovations (Figure 10) with gaps between the lower 200 mm of insulation and the wall cavity averaging around 300 mm and the upper 200 mm of insulation being inset by a further 300 mm. A loft ladder was also installed which was not fully compatible with the new increased depth of insulation, with the ladder mechanism disturbing the insulation to the hinged side on operation. The bay roof in bedroom 1 was also insulated during the stage 1 renovation work with 150 mm of mineral wool quilt laid between the roof joists.

Figure 10 Loft insulation not extending fully into the eaves and air spaces around the insulation.

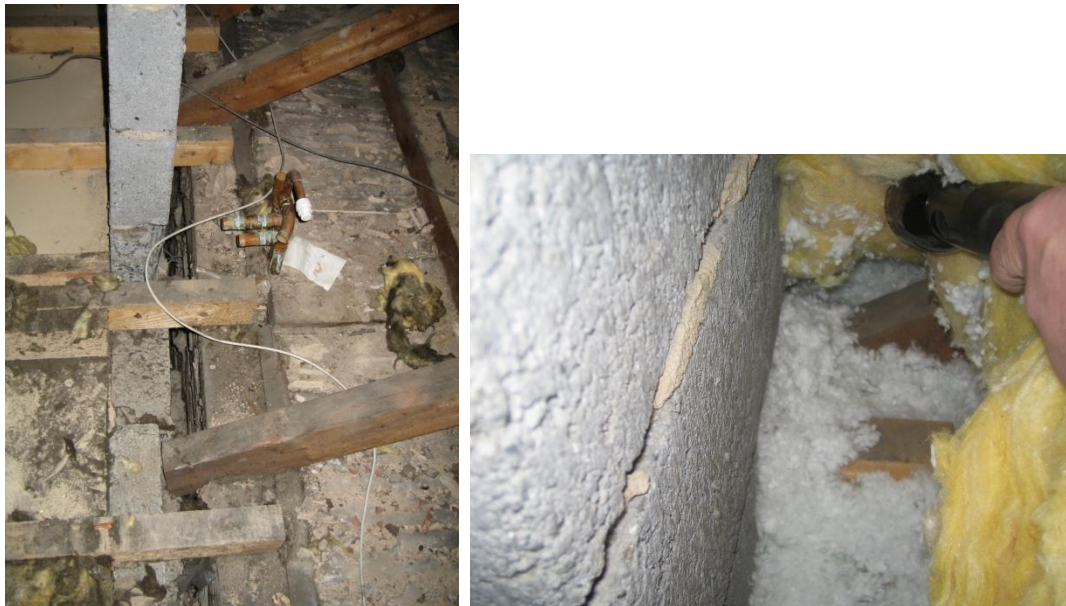
- 37 To reduce the effects of thermal bypassing in the cavity walls the gaps at the top of the cavities were intended to be closed by packing with cavity stop socks after the existing insulation had been removed and prior to the cavity fill and new loft insulation installed. With the site staff under pressure to get the house in a state where it was possible to perform the 2nd coheating test, this edge sealing of the top of the internal cavity wall was overlooked. Figure 11 shows the top of the cavity wall between the bathroom and bedroom 2 at the end of November 2009 with the old insulation removed and the following week with the cavity filled, new loft insulation laid, but no edge sealing along the top of the cavity.

Figure 11 The top of the internal cavity wall with the old insulation removed and with the cavity filled and new loft insulation laid.

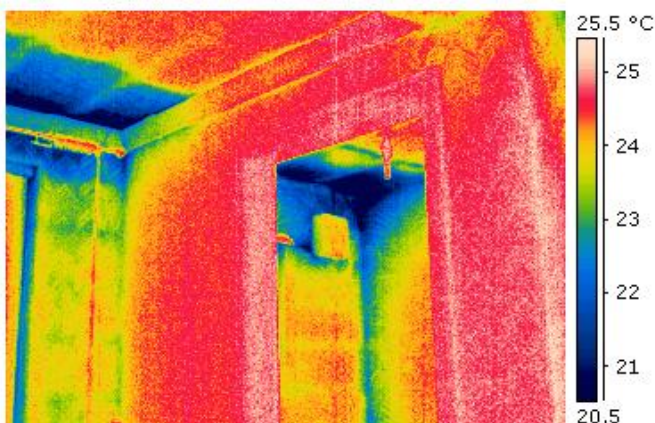
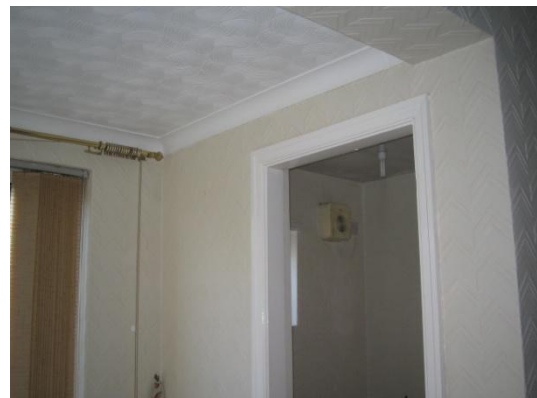
39 Both Figure 13 and Figure 14 show the effect of the movement of the insulation from ceiling level to rafter level at the ground floor rear extension. During the 1st coheating test thermal imaging highlighted a substantial cold area at the eaves where the mineral wool insulation did not extend fully into the junction to meet up with the wall insulation (Figure 13). The replacement phenolic foam at rafter level overcame this problem, with the thermal image (Figure 14) showing no such cold bridge at this junction.

Figure 13 Eaves at the rear extension during the 1st coheating test with the mineral wool insulation not fully filling right into the eaves.

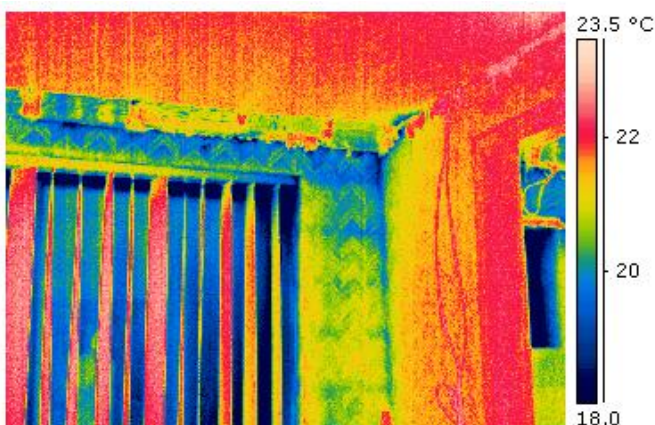
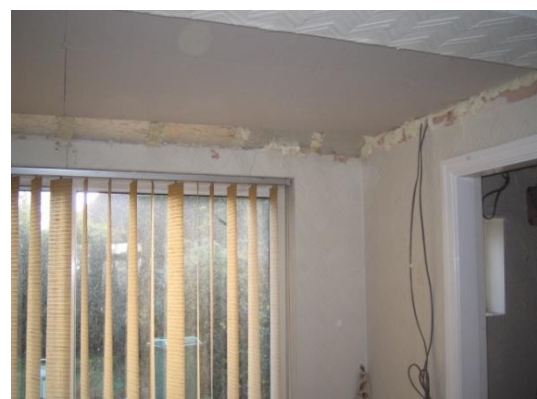
Figure 14 Eaves at the rear extension during the 2nd coheating test with the insulation and air barrier relocated to rafter level.

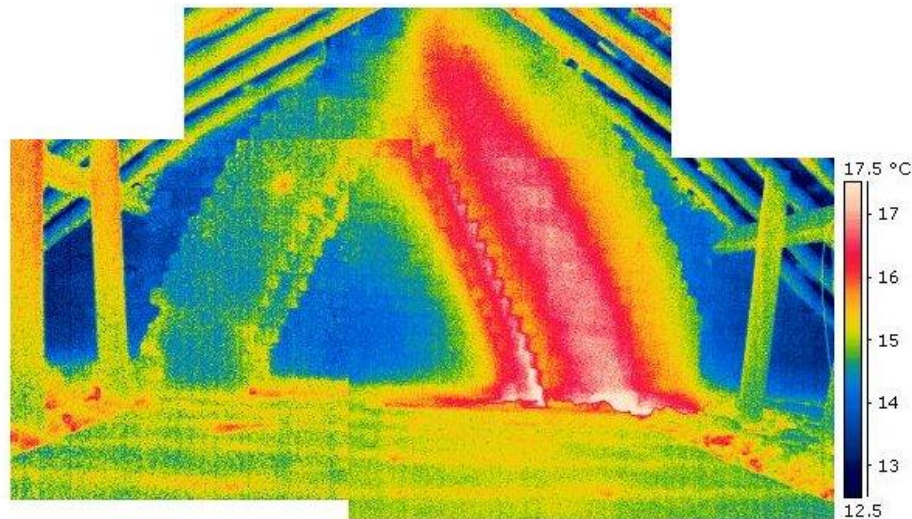
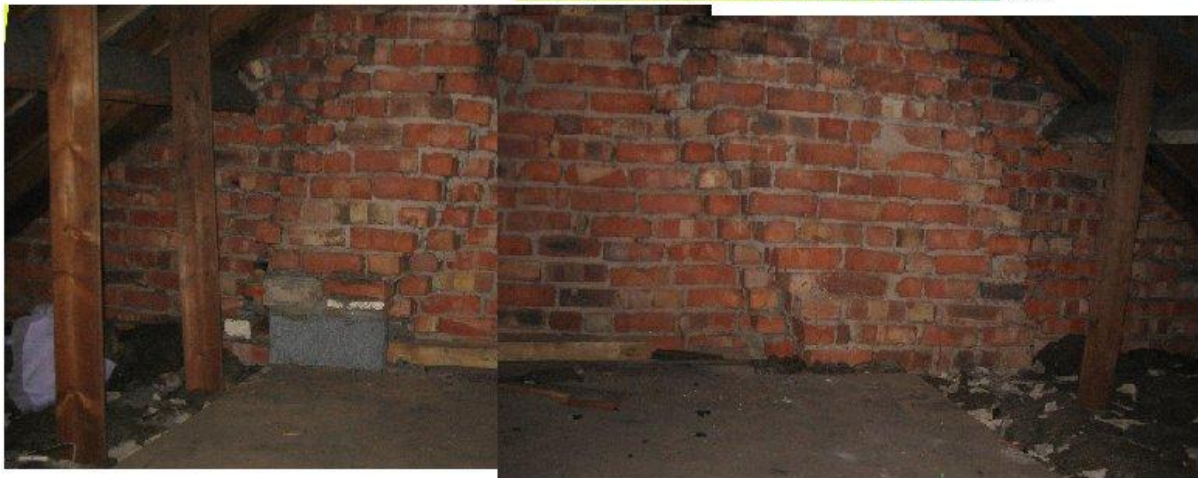
- 42 Thermal imaging of the loft during the 1st coheating test had showed a thermal bypass in operation via the front chimney stack (Figure 16). The rear chimney breast had been removed beneath the ceiling level so there was no upward movement of warm air as can clearly be deduced was occurring in the front stack. It was hoped that the sealing of the fireplace in the lounge would reduce this, but it was not possible to cap the chimney and fill the flue with insulation to eliminate the bypass without additional investigative work as the next door neighbour's chimney may also have been affected. The thermal images of the same detail during the second coheating test (Figure 17) revealed that the bypass was still in operation after the fireplace had been sealed and additional work was still required to stop this heat loss mechanism from operating.

Figure 16 The bypass via the open flue chimney during the 1st coheating test contrasting with the rear chimney which had been closed off at ceiling level.

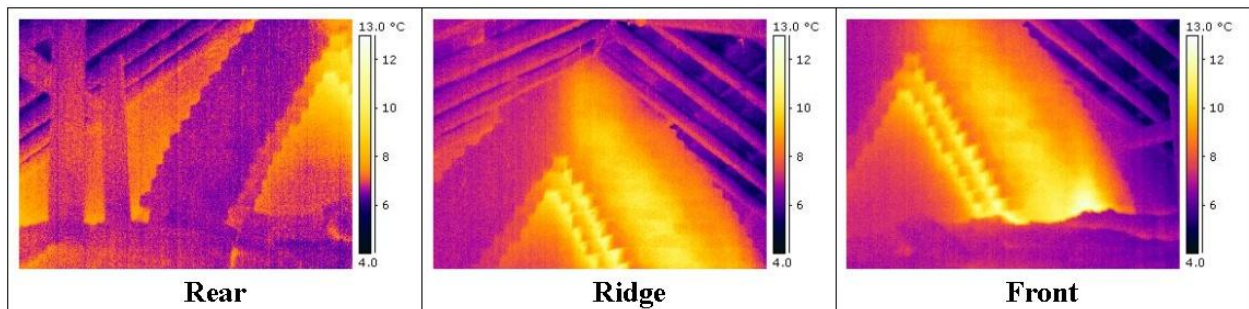
Figure 17 Thermal images of the chimney bypass during the 2nd coheating test.

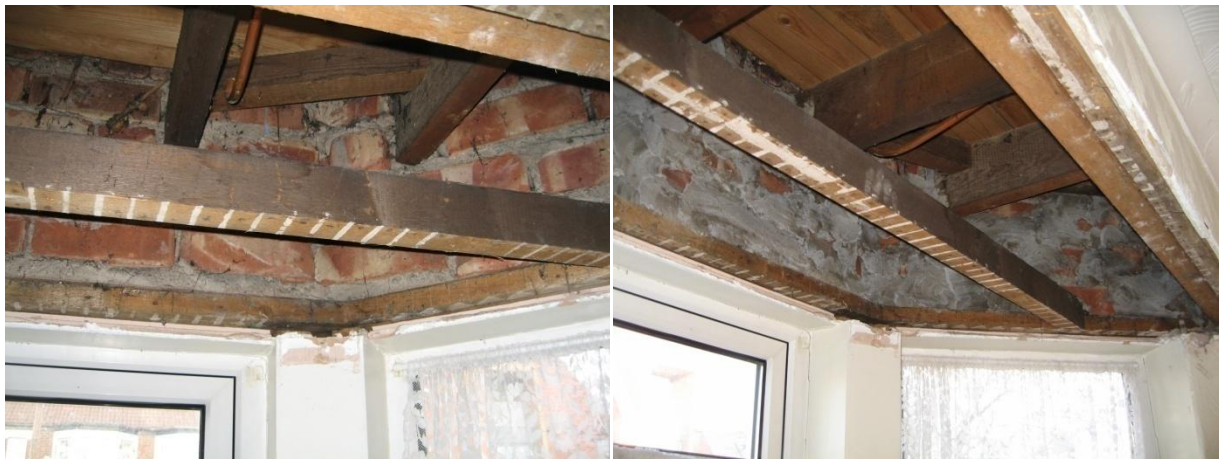
Figure 19 Void above the living room bay window re-pointed and sealed around the joists to reduce air leakage

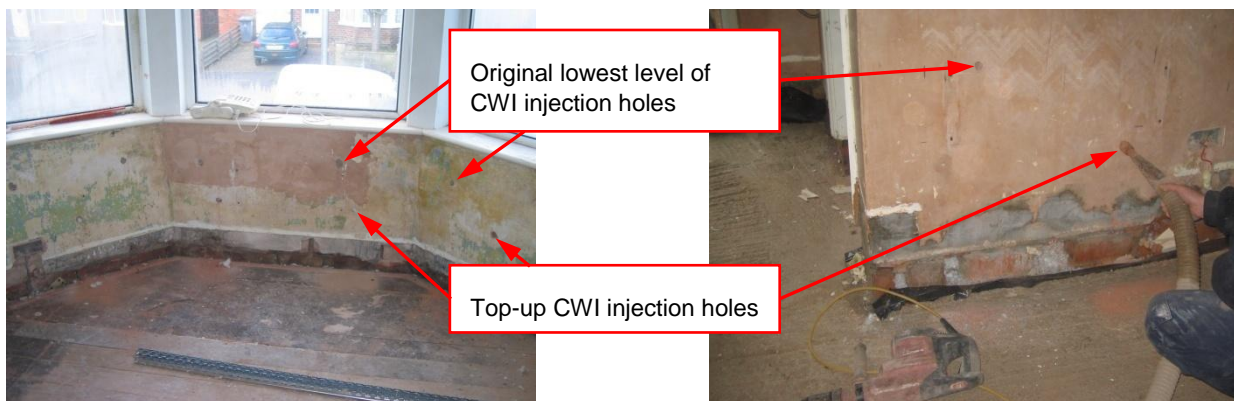
Figure 21 Top-up CWI at the ground floor bay and internal rear cavity wall.

- 46 Additional blown fibre cavity wall insulation was installed where thermal imaging and heat flux measurements taken during the 2nd coheating test had highlighted issues, many of which had been confirmed as areas of incomplete insulation fill by borescope investigations. A vertical brush was installed at the rear of the property at the party wall junction to resolve the issues observed at the external wall in bedroom 2 (Figure 9) and the CWI topped-up. Supplementary injection holes were drilled at the ground floor perimeter to enable insulation to be injected at a lower level than during the original cavity fill (Figure 21). However, with no coheating test being performed between the rectifying of the CWI issues and the application of the external wall insulation it was not possible to quantify the success of these remedial measures.

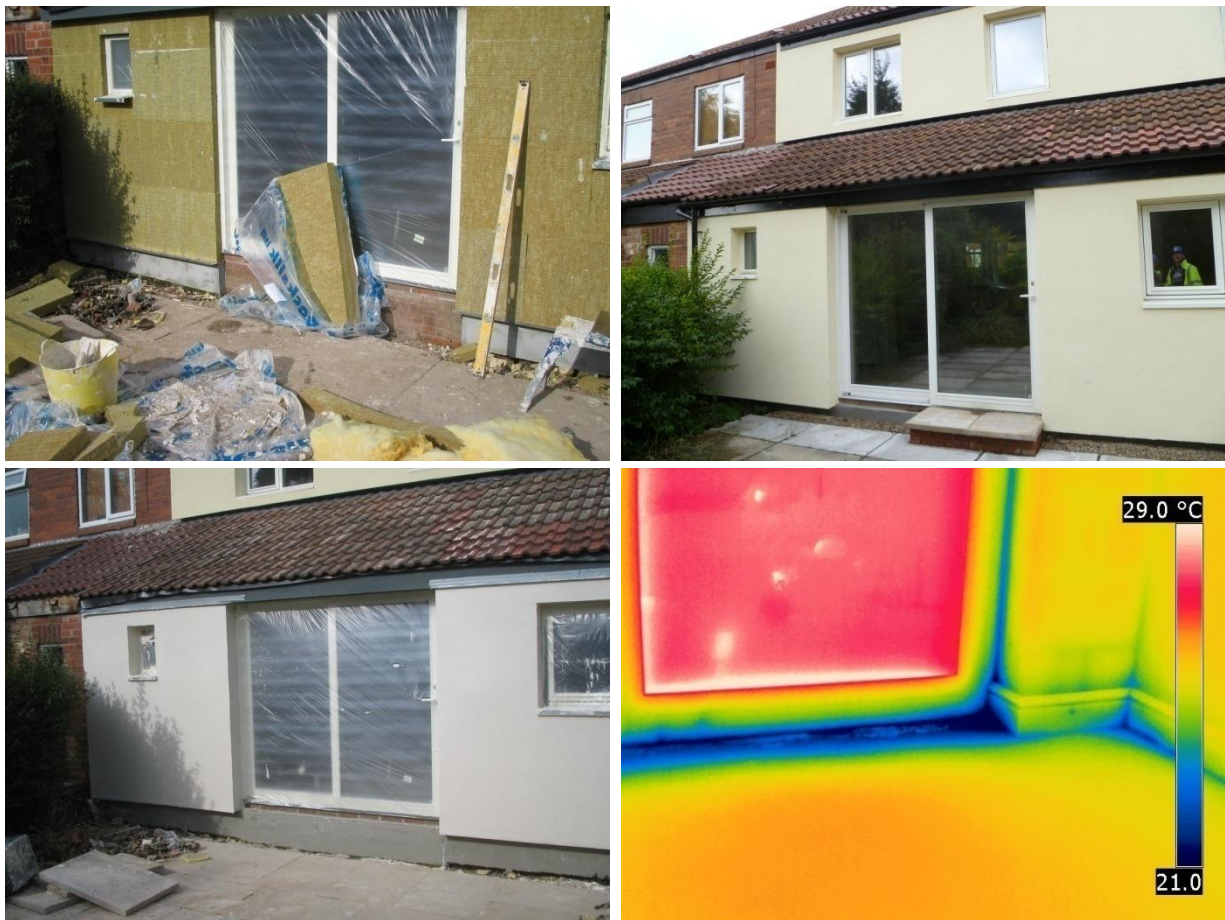
2006); if relevant detail drawings or thermal calculations had been prepared, they were not made available to the research team.

Figure 23 Patio door threshold during construction, on completion, and the external view and internal thermal image of the detail during the phase 3 coheating test.

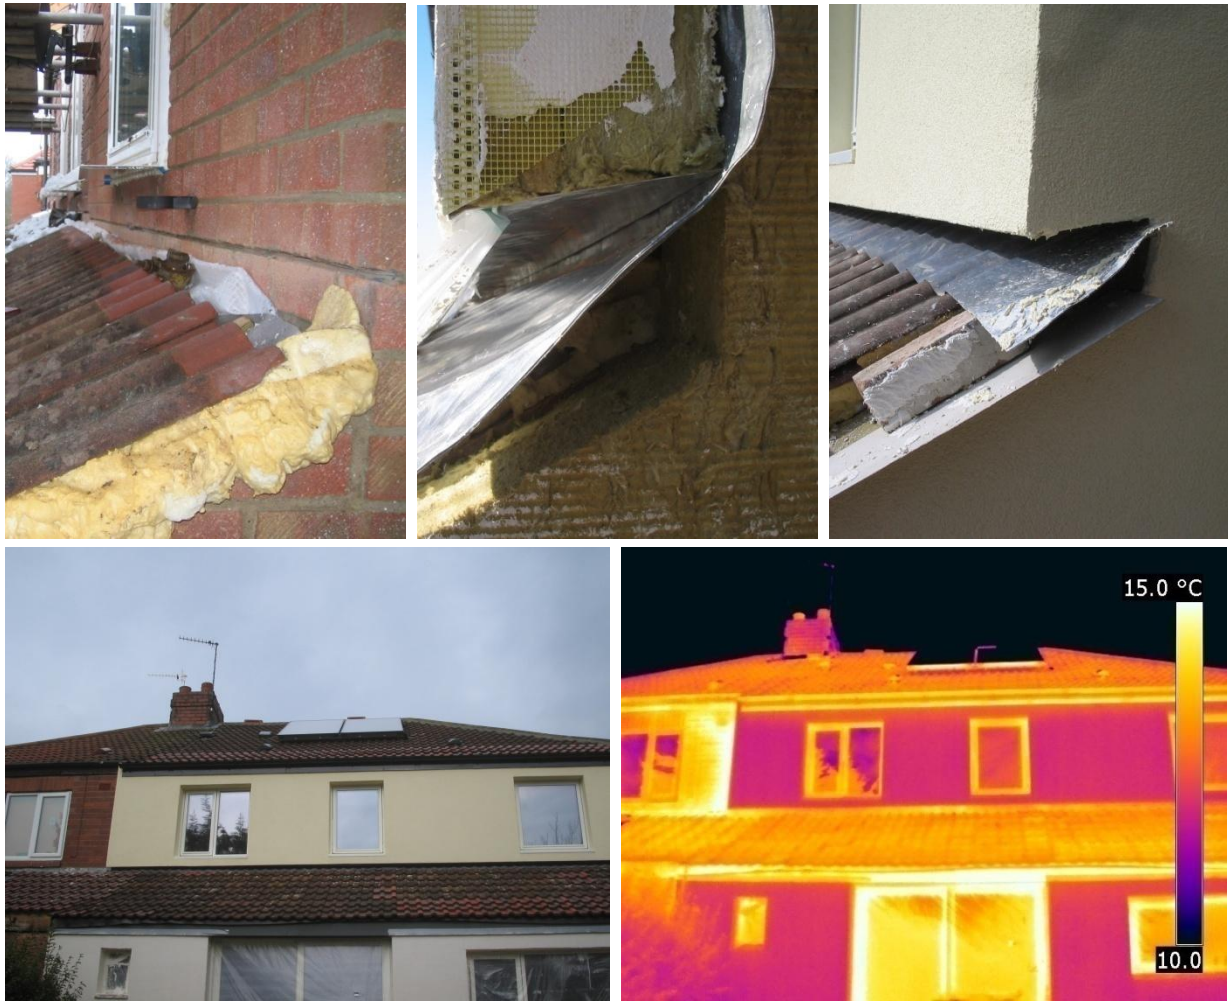
Figure 25 Junction of EWI with the rear extension roof at various stages of construction, and a thermal image of the completed detail captured during the 3rd coheating test.

temperatures between the two properties observed in the thermal images in both Figure 25 and Figure 27 will also be due to the lower emissivity of the newly rendered surface.

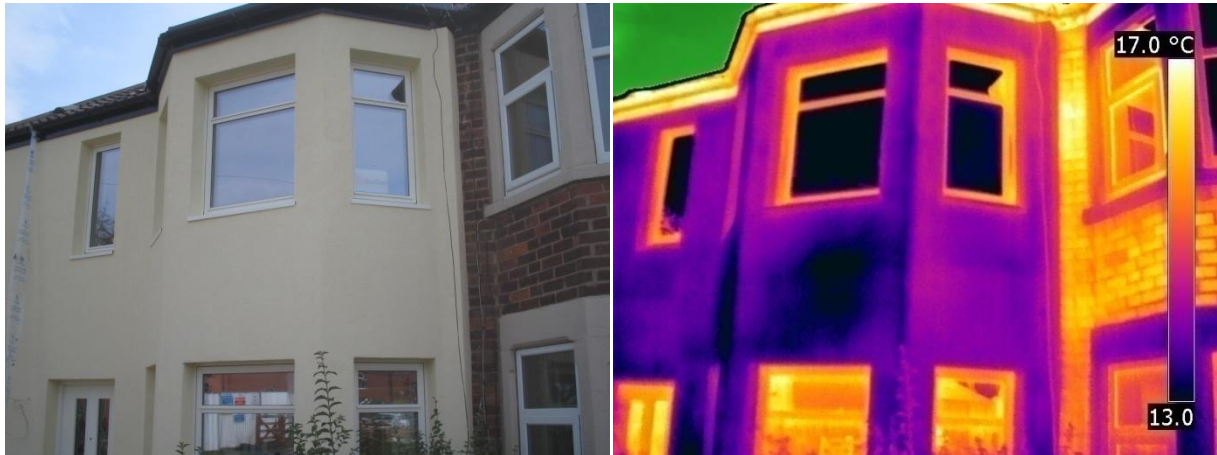
Figure 27 Finished party wall EWI detail and thermal image, front elevation.

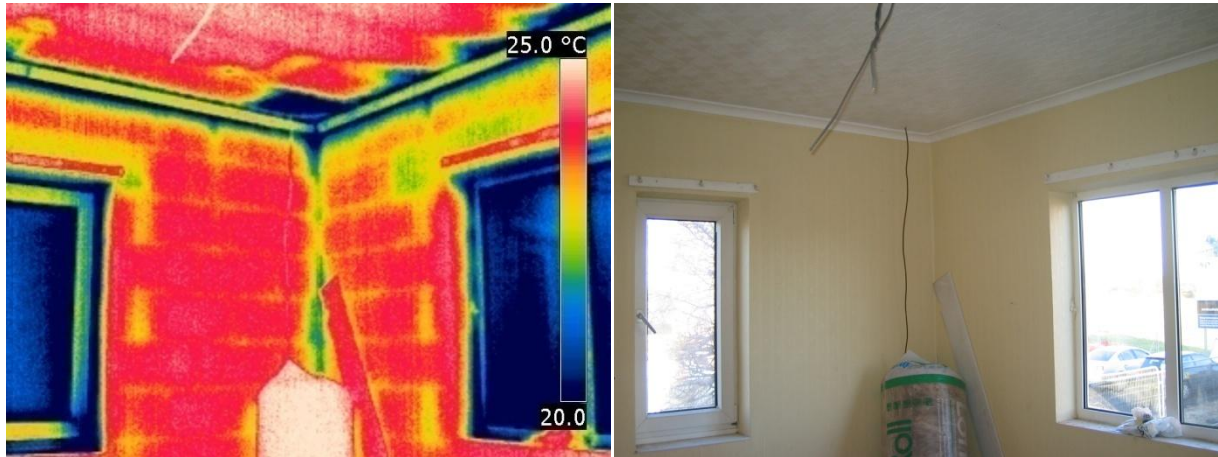
Figure 29 Bedroom 3 junction of front and side walls with the ceiling during the 2nd coheating test.

53 Figure 29 and Figure 30 also emphasize the difference in the thermal performance of the original windows and their replacements and the reduction in thermal bridging and/or air movement at the jambs, heads and sills resulting from the stage 2 renovations. The existing double glazed units were replaced with new argon-filled triple glazed timber windows throughout (U-value 0.83 W/m²K) and the external doors replaced with composite insulated doors (U-value 1.2 W/m²K). The kitchen to garage door was temporarily replaced. Placement of the windows in the external walls to more in line with the external wall insulation took place, but was limited by the weight of some of the replacement units. The replacement windows were planned to be fitted on brackets to extend them out into the insulation layer to optimise thermal performance, this was not always possible, with a number of windows fitted by screwing directly through the frames into the brickwork. This practical solution was decided upon by the window installer and site foreman and although the window placement was not optimal, it appeared acceptable as Figure 30 shows that there was no significant thermal bridging around the window frames. Similarly, with no formal design drawing, the insulation of the bay mullions appeared to rely on the vision and experience of the site foreman and no excessive thermal bridging observed during the final coheating test.

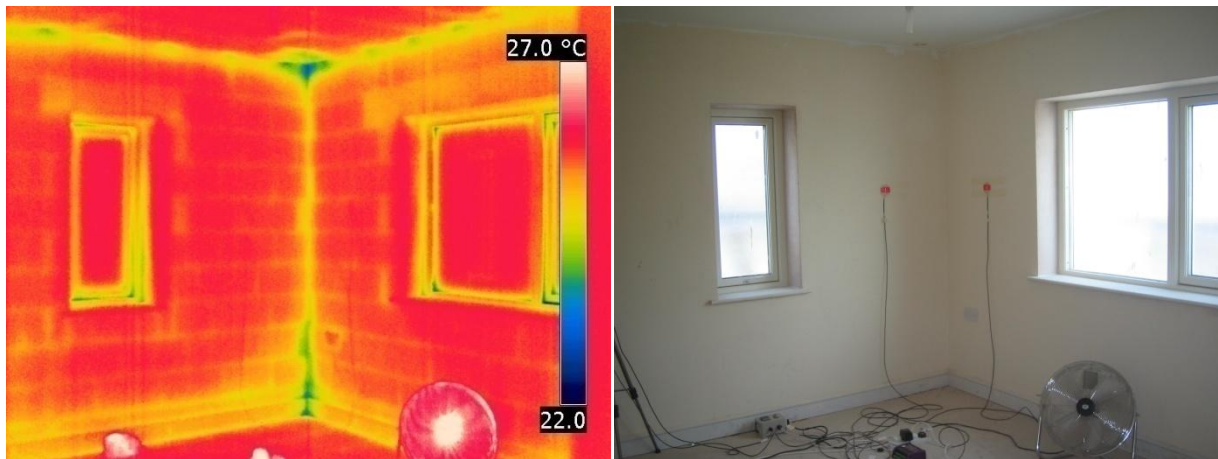
Figure 30 Bedroom 3 junction of front and side walls with the ceiling during the 3rd coheating test.

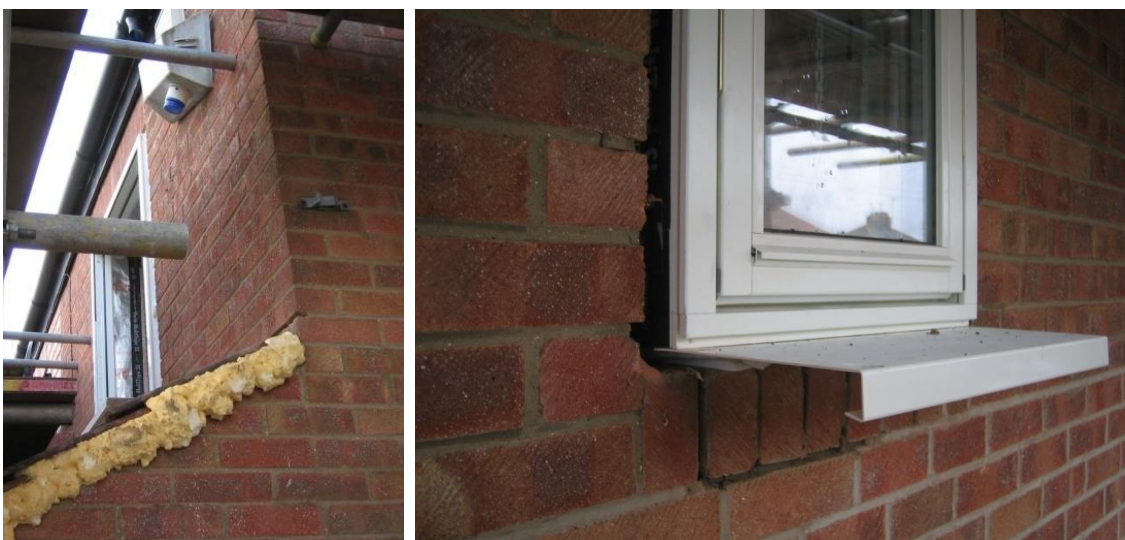
- 54 Without any specific detailed drawings to guide the window fitter, it was left to him and the site manager to agree a practical solution as how to best achieve an airtight fit whilst keeping thermal bridging to a minimum. Airtightness was assisted by using a vapour barrier taped to the window/door frames prior to installation which was then returned and taped into the reveals using suitable adhesive tapes (Figure 31). This method of minimising air leakage was adopted both where window and door frames were secured by brackets or by screwing through the frames directly into the brickwork. Thermally, the expected optimum position for the frames would have been fully in line with the EWI to minimise thermal bridging through the frame and opening. However, the compromise between thermal performance and structural stability resulted in a final overlap between the frames and EWI varying from 30 – 70 mm (Figure 32) and appearing to depend on the size (or weight) of the window, with smaller (lighter) windows being placed further out into the EWI than the larger (heavier) windows and doors. No thermal bridging calculations were made available to the research team regarding the window placement, so it is uncertain whether the decrease in thermal bridging was in line with the estimated reduction in γ -value from $0.15 \text{ W/m}^2\text{K}$ to $0.08 \text{ W/m}^2\text{K}$ used in the SAP calculations.

Figure 32 Rear and front elevation window frame positioning, showing potential for overlap with the EWI.

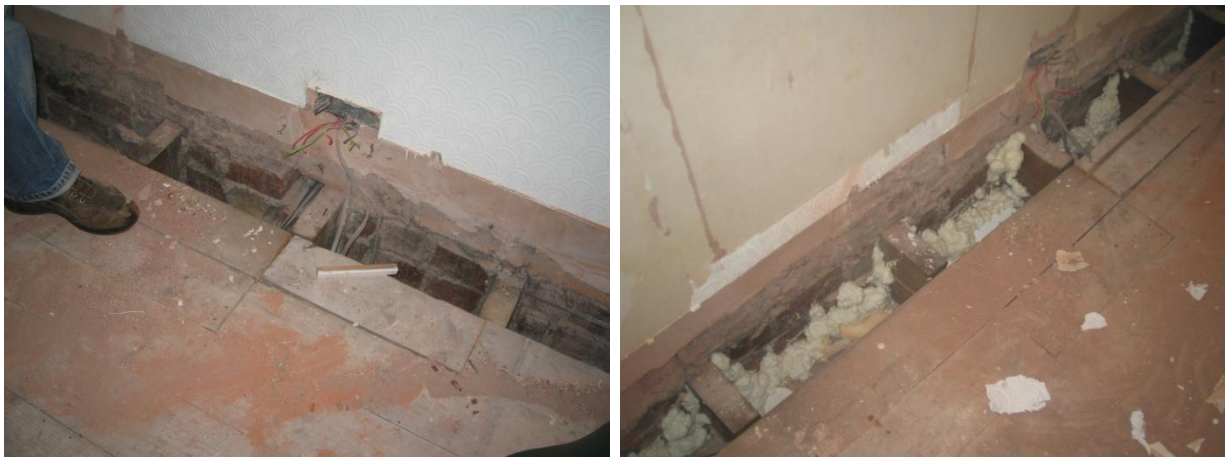
Figure 33 Rear wall of bedroom 2 before and after sealing work around the intermediate floor joists.

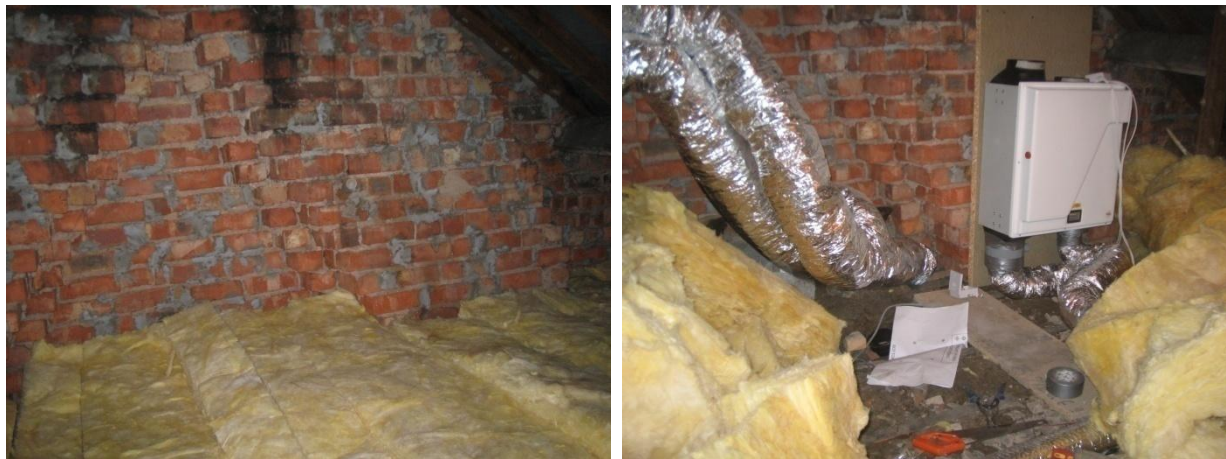
Figure 34 Loft insulation when laid (07-Dec-09) and after MVHR unit installation (02-Mar-10).

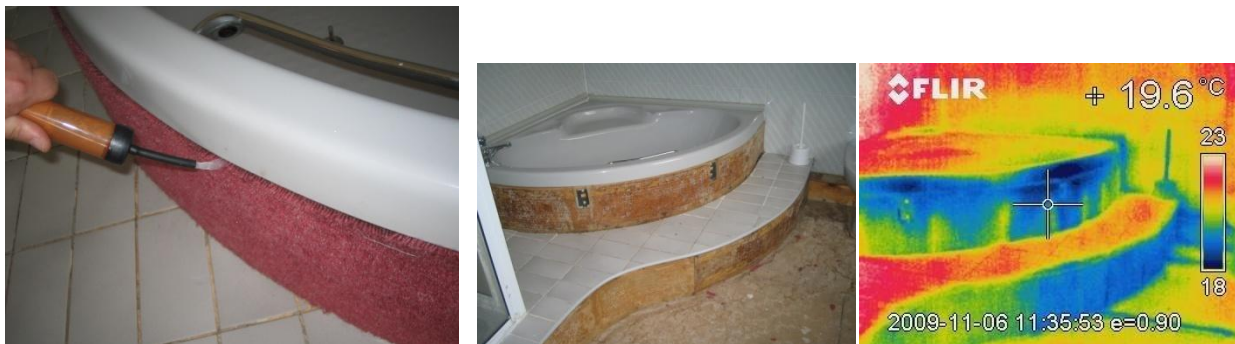
Figure 35 Air leakage around the bath in July 2009, using smoke detection under pressurisation, and cooler air being drawn in under depressurisation in November 2009.

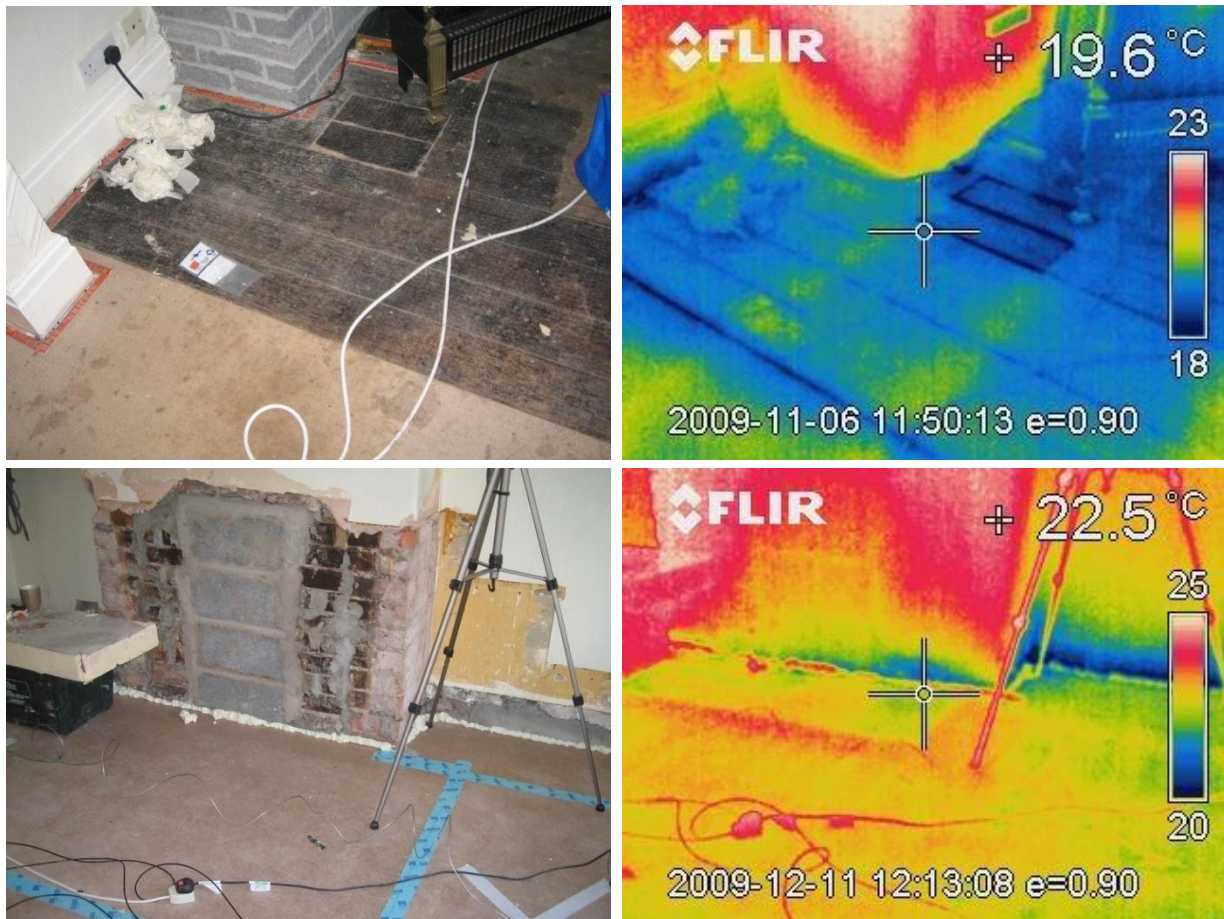
Figure 36 Infiltration, under depressurisation, through the original suspended timber ground floor following the 1st coheating test was addressed for the 2nd coheating test with a temporary floor covering.

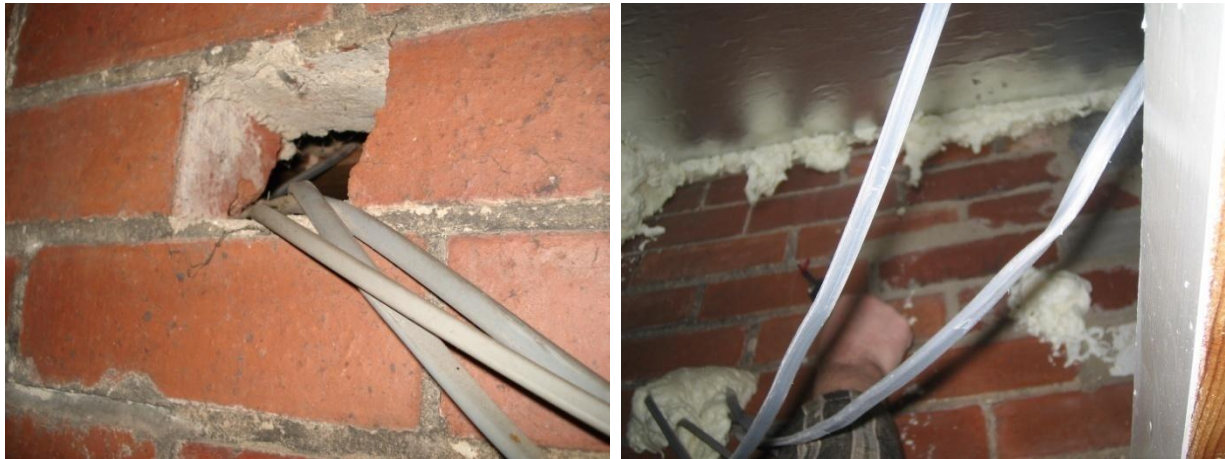
Figure 37 Gaps in the external wall in the rear extension loft space effectively became part of the air barrier and required sealing due to the movement of the air barrier from ceiling to rafter level in the rear ground floor extension.

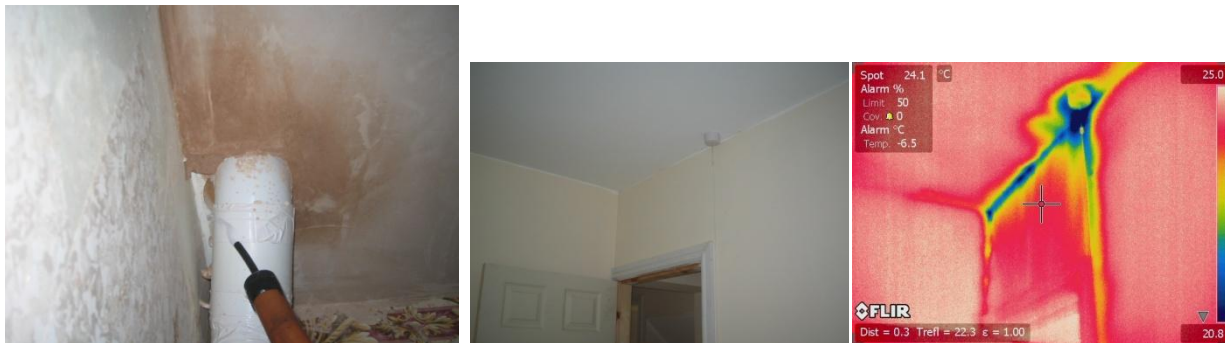
- 63 The partial boarding in the main loft and the old compressed loft insulation and debris were removed in late November 2009, and only some of the opportunities to address airtightness issues undertaken. With the boarding and old insulation removed, but prior to installation of the replacement insulation, it would have been possible to seal around penetrations through the ceiling from the loft space where access was difficult when performed from the first floor rooms, such as MVHR ducts and electrical penetrations positioned close to walls (Figure 38). The opportunity to seal along the tops of the old cavity external walls and internal partition walls was also not undertaken, this could have assisted in maintaining continuity of the air barrier by providing a link between internal wet plastered surfaces and helped to prevent indirect air leakage into the loft.

Figure 38 Air leakage into the loft which could have been sealed more effectively from inside the loft than from the 1st floor rooms.

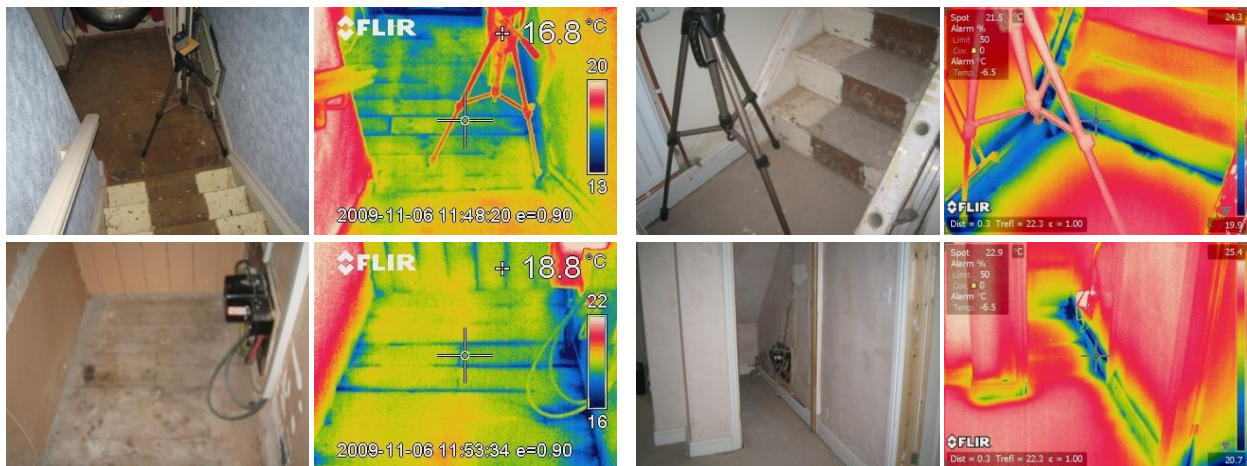
Figure 39 The hall and cupboard under the stairs, under depressurisation, showing the difference between the suspended timber ground floor and the replacement insulated solid concrete ground floor.

- Ground floor – Air leakage was eliminated through the ground floor after the entire ground floor had been replaced with an impermeable solid concrete floor.

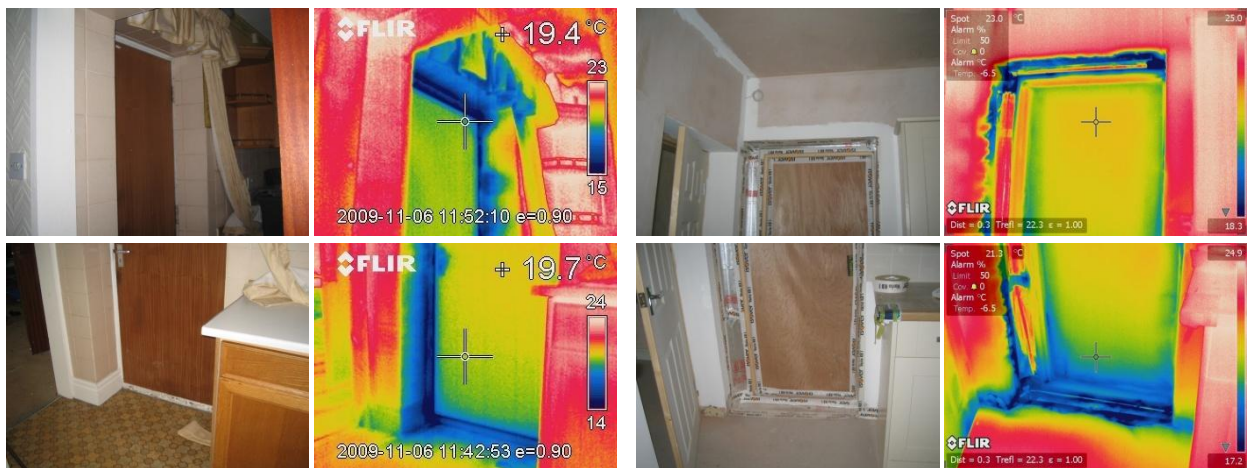
- 70 Whilst the replacement windows saw the anticipated reduction in airtightness realised, air leakage persisted at the external doors. Some air leakage was due to the back door not being fully sealed at the time of the final pressurisation tests, as an incorrect, outward-opening, door had been supplied. The site foreman was reluctant to expend too much effort in sealing around the door in the knowledge that it would be removed and replaced shortly after the testing schedule had been completed. The door would then be fully sealed and an improvement in airtightness expected. The front door and patio door threshold detailing was also not fully completed externally (Figure 24 and Figure 23), this may have provided a further improvement on completion, although this benefit may only be limited as the air leakage from the dwelling around these openings appeared to be into the existing wall cavity. The door between the kitchen and garage was only a temporary replacement and as such had not been draught-stripped or sealed at the sill as no floor covering had been applied in the kitchen. The temporary sealing did not adhere fully to the unfinished floor surface and would also expect to improve on full completion. With all the door detailing complete the dwelling may achieve the necessary reduction in mean air permeability to meet the target figure of $5 \text{ m}^3/(\text{h}\cdot\text{m}^2) @ 50\text{Pa}$.

Figure 40 Infiltration around the door between the kitchen and the garage at the November 2009 and March 2010 pressurisation tests.

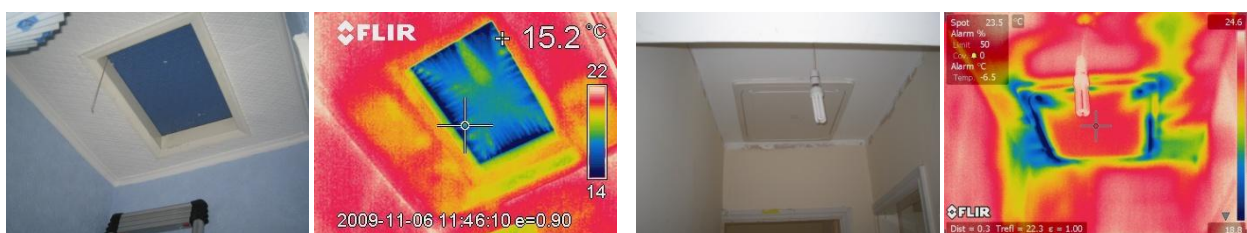
Figure 41 The original lofthatch into the main loft and the replacement, both under dwelling depressurisation.

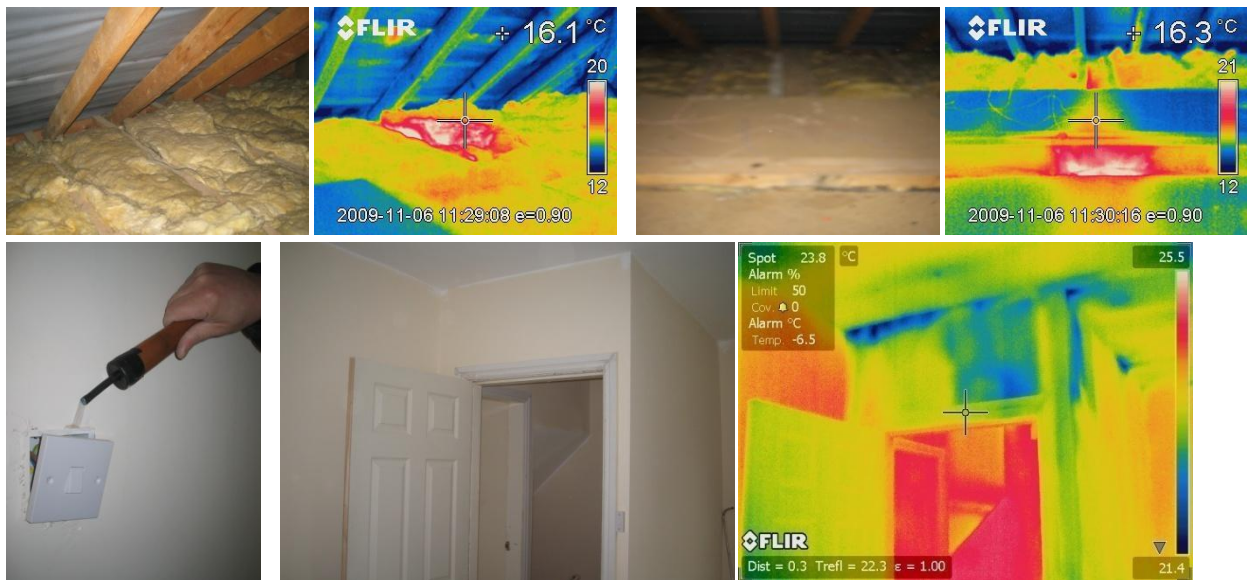
Figure 42 Hot air escaping through the partition wall heads into the loft in the 2nd pressurisation test in November 2009 under dwelling pressurisation. And in March 2010, air leakage into the 1st floor partition wall voids; via an electrical pattrass under dwelling pressurisation and from the roof space under depressurisation.

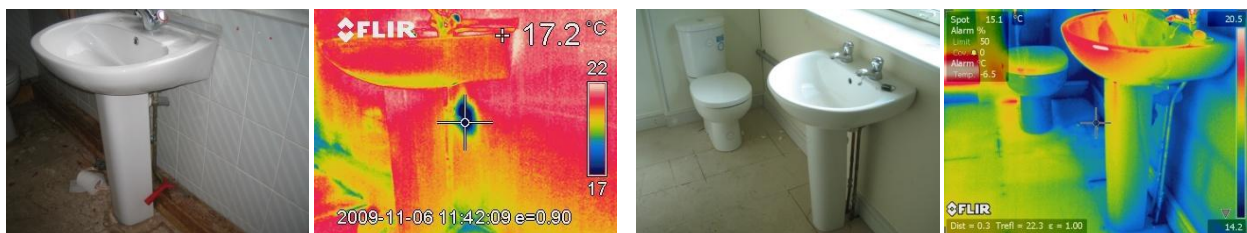
Figure 43 Air leakage at the bathroom hand basin waste pipe in November 2009, and the equivalent detail in March 2010, under dwelling depressurisation.
