Final Report to Joseph Rowntree Housing Trust

Project Title: Temple Avenue Project Part 2

Energy efficient renovation of an existing dwelling: Evaluation of design & construction and measurement of fabric performance

March - 2011

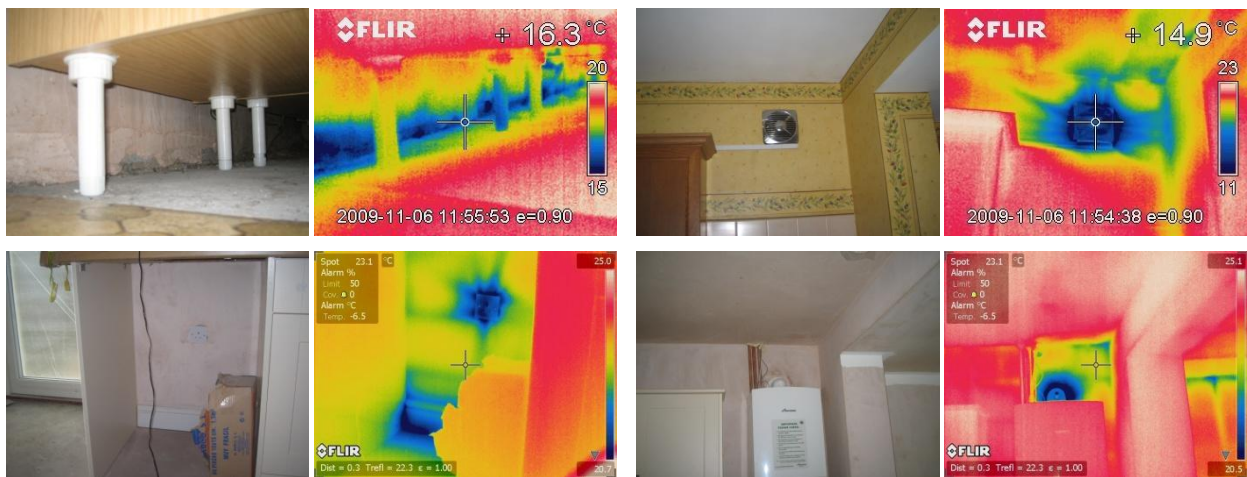
Figure 44 Air leakage under the kitchen units and around the extract vent in November 2009 (top), and at the same locations in March 2010, both under dwelling depressurisation, with the new boiler flue situated where the extractor fan had been positioned previously.

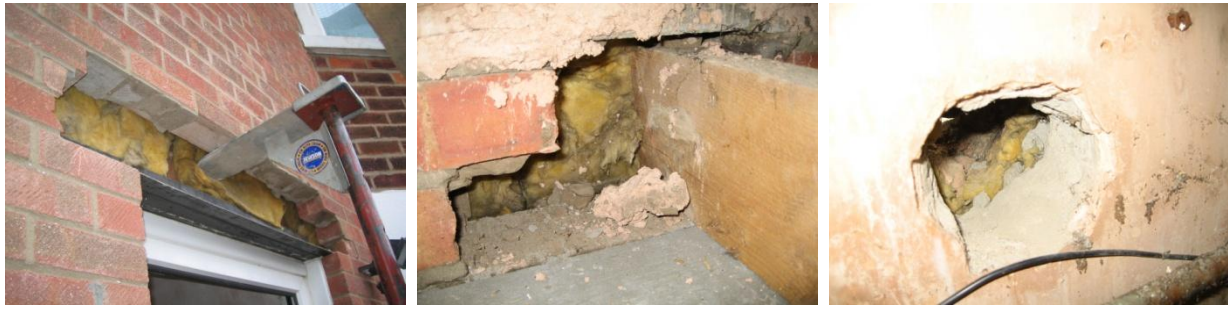
Figure 52 Cavity insulation at the front door, gable wall, and rear extensions wall was revealed during renovations works and shown to be thicker than originally estimated (photographs taken during relocation of the front door lintel, installation of the new extension floor and removal of the existing kitchen service penetrations).

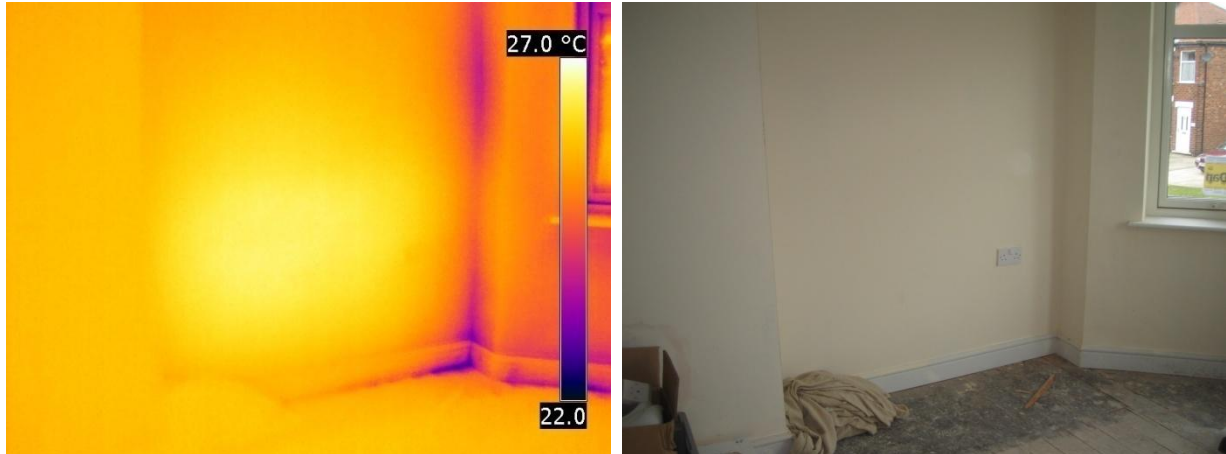
Figure 57 Party wall in bedroom 1 during the Phase 3 coheating test.

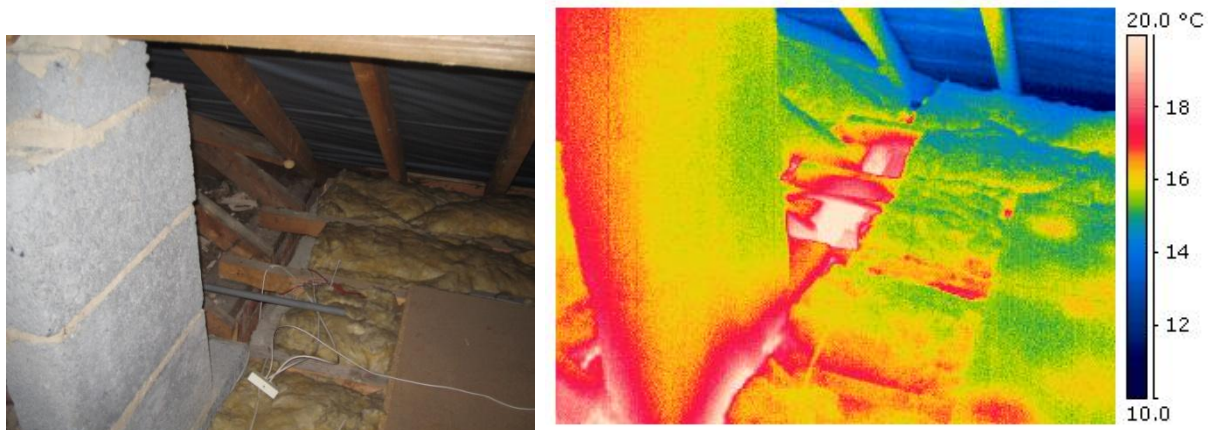
Figure 62 Heat escaping into the loft through the top of the internal cavity wall between bedrooms 1 and 2, prior to filling the cavity with blown fibre insulation.
