Condensation Risk – Impact of Improvements to Part L and Robust Details on Part C

Project Reference Number: CI 71/6/1 BD2414

Interim report number 7: Final report on project fieldwork

Malcolm Bell, Melanie Smith & Dominic Miles-Shenton
Buildings and Sustainability Research Group
Leeds Metropolitan University

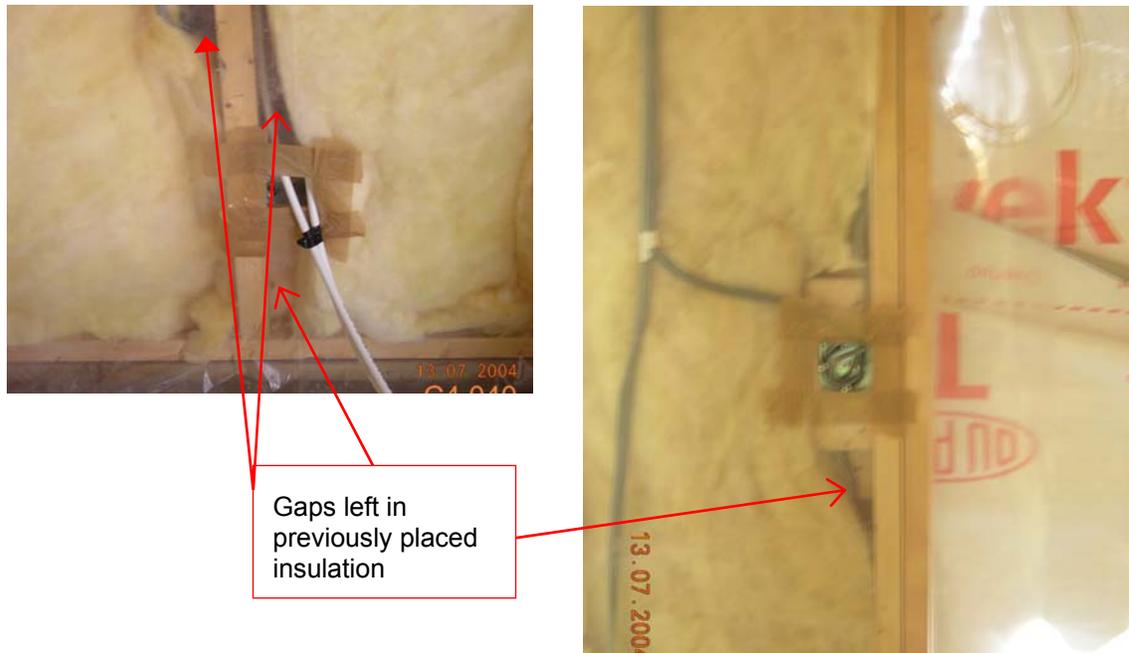
43. Creating defect free construction requires not only the provision of detailed design information to the operatives who are to carry out certain operations but also a more general awareness of the requirements among others who may have an impact on the work in question. This is of particular relevance in the case of one trade following another, for example services installers following joiners. Figure 3.03 shows how the work of an electrician resulted in gaps in the insulation despite the initial efforts of the joiner to ensure a good fit.

Figure 3.03 Insulation laid by one trade is moved by a following trade to create gaps.

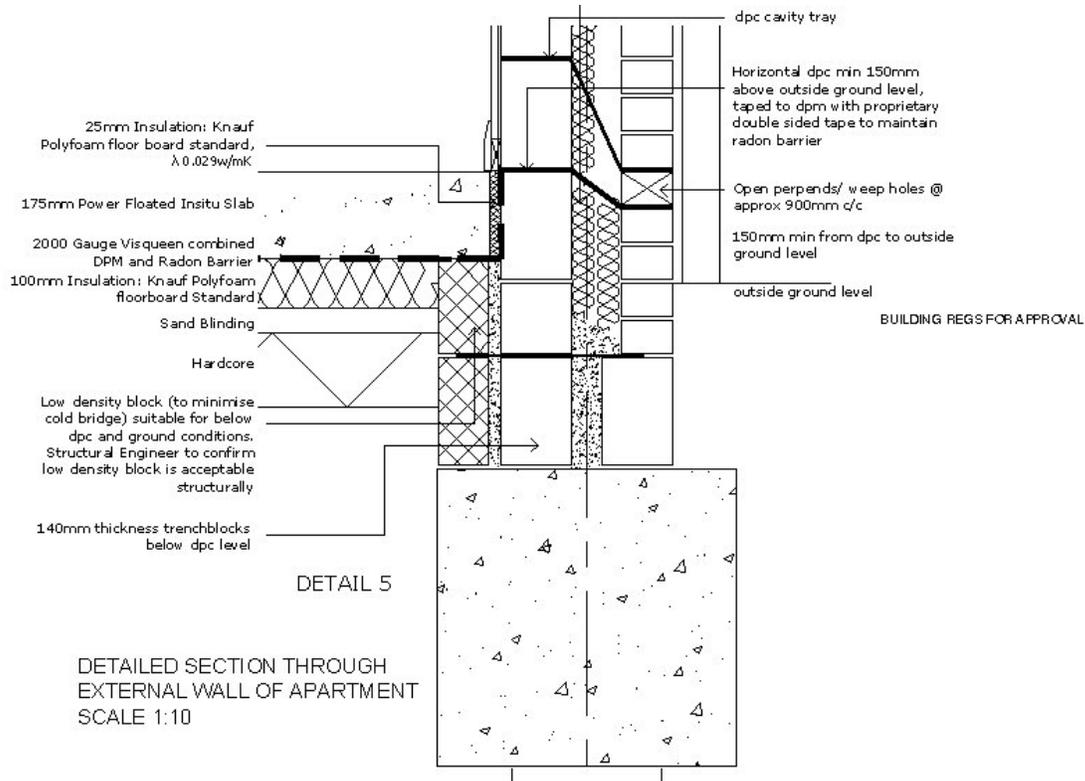
Figure 3.07 Ground floor slab detail – partial fill masonry site.

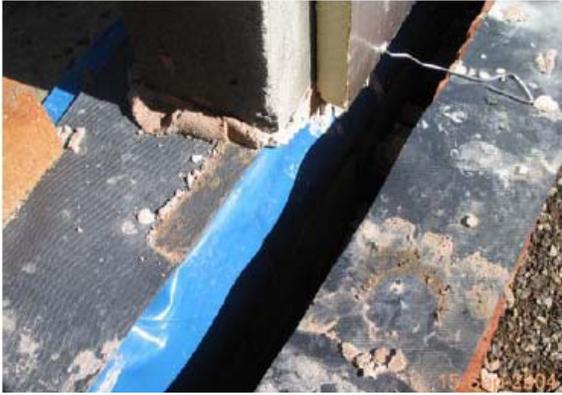
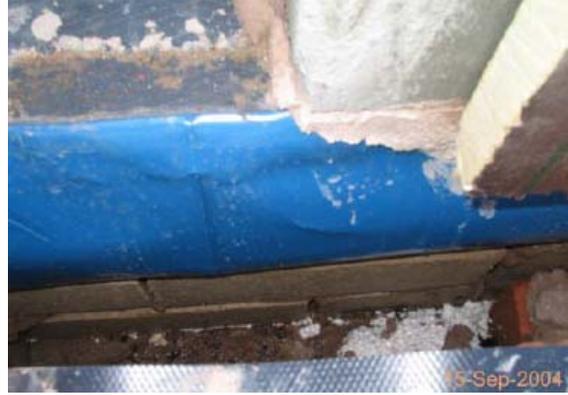
Figures 3.08 and 3.09 Partial-fill masonry construction, slab edge detail.

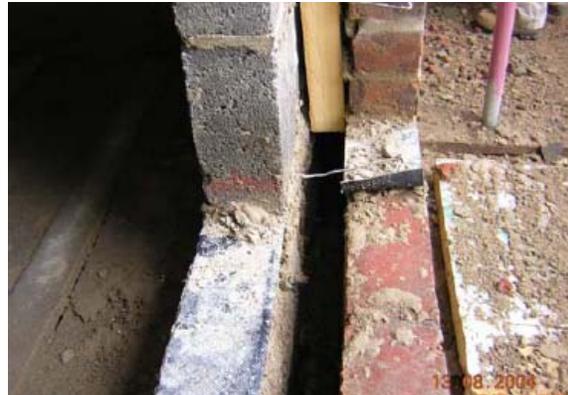
Figure 3.11 Perimeter insulation missing below dpc in masonry construction.

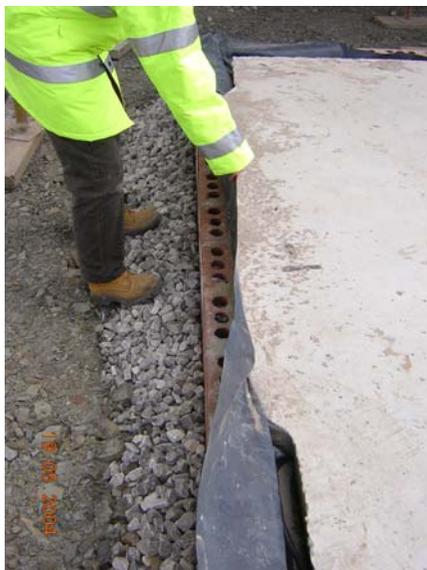
Figure 3.12 Omission of edge insulation at patio door reveal – and RD 8.06.

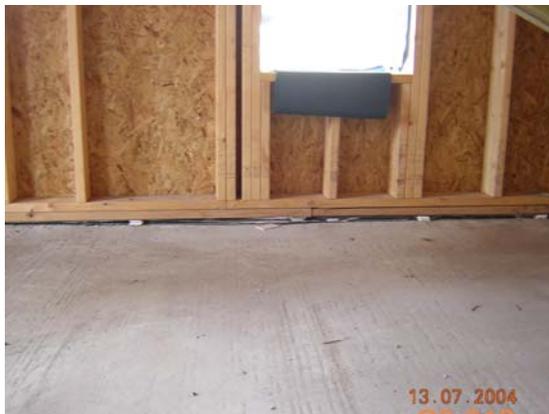
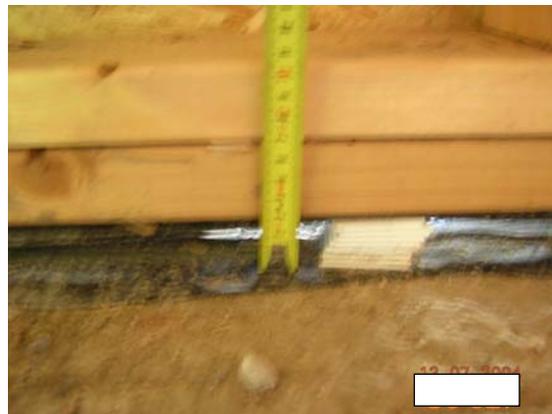
Figures 3.14 and 3.15 Plastic spacers used to level timber frame.

49. The significance of such gaps lies in the potential created for reduced airtightness and thermal performance both of which will tend to result in local cooling of the floor slab and the space behind the skirting board with increased risk of surface and interstitial condensation. Figure 3.16 shows a sketch of the detail, as constructed, with edge insulation missing. Carlsson et al (1980) show clearly how this problem can be overcome through the use of a gasket between the slab and the sole plate of the wall.

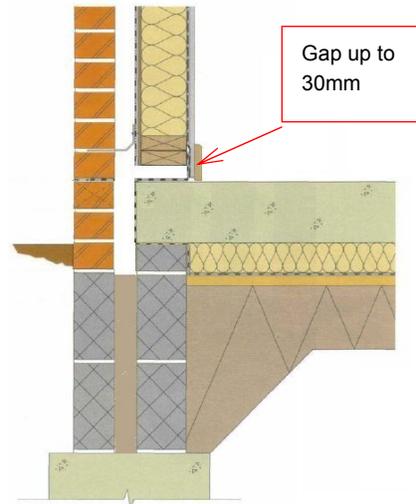
Figure 3.16 Timber frame on in-situ RC suspended slab - as constructed¹. (this figure is intended to stress the modified from

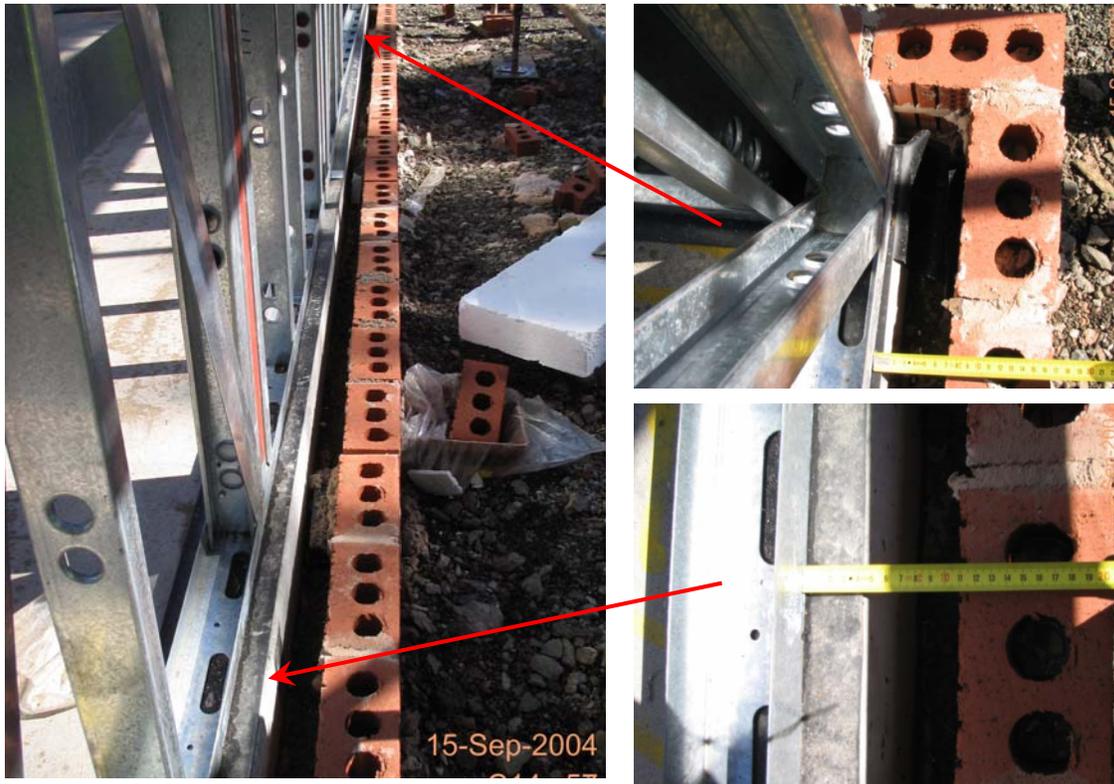
Figure 3.18 Slab not square in steel frame construction.

51. Whatever the cause of the misalignment (setting out of the base or manufacturing errors in the steel frame) its effect was to make it very difficult to maintain continuity in the external insulation. The practical response to this problem was two-fold; either the wall insulation was stopped at dpc level and a separate piece of insulation placed in the

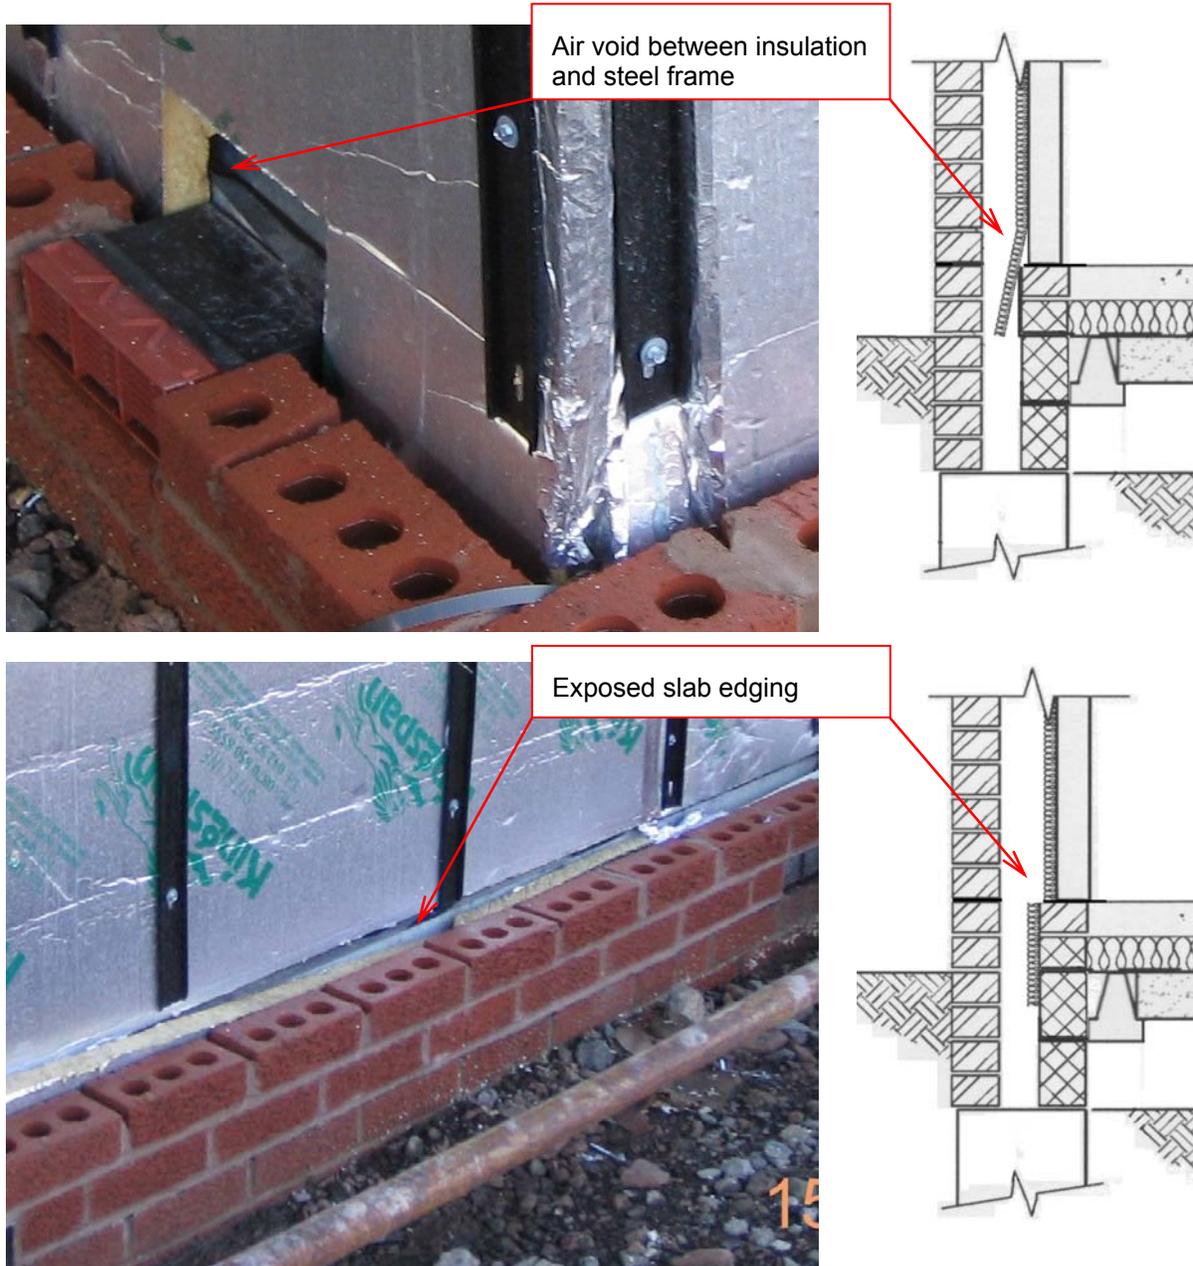
cavity, leaving gaps in insulation, or the wall insulation was bent over the protruding slab leaving an air space around the base of the steel frame. The sketches in figures 3.19 and 3.20 illustrate this together with examples of site observations. Although the resulting gaps appear to be small, they have implications for the effectiveness of the insulation around the junction and airtightness. The integrity of the insulation layer is of particular importance in warm steel frame construction since it has an additional function as the prime air and vapour control layer.

Figure 3.19 and 3.20 Placement of cavity wall insulation, above and below slab, in steel frame construction with misalignments of steel frame and slab.

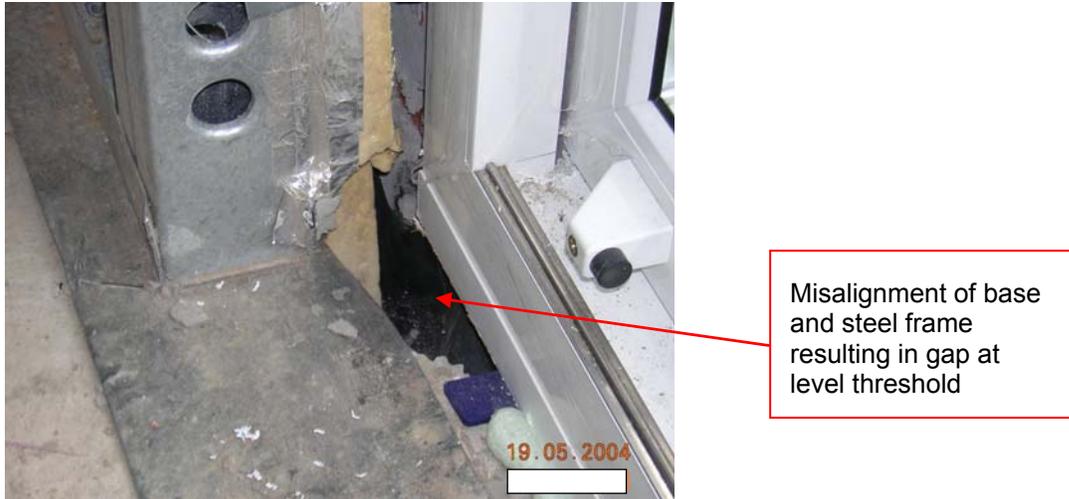
as an integral part of the base prior to frame erection. If there are minor setting out errors in casting the base (or minor changes to the frame in manufacture) the threshold does not line up with the door opening in the frame resulting in holes in the floor at the threshold as illustrated in figure 3.21. Although this could be rectified when the steel frame and its insulation was erected, it is often left until a much later time when satisfactory remedial work is more difficult to carry out. We did not observe cases where it was rectified. We have highlighted this as a problem in steel frame construction, but it was observed also in other forms. As with other similar defects its significance lies in the potential for small areas that could be susceptible to surface and interstitial condensation.

Figure 3.21 Gap at level threshold.

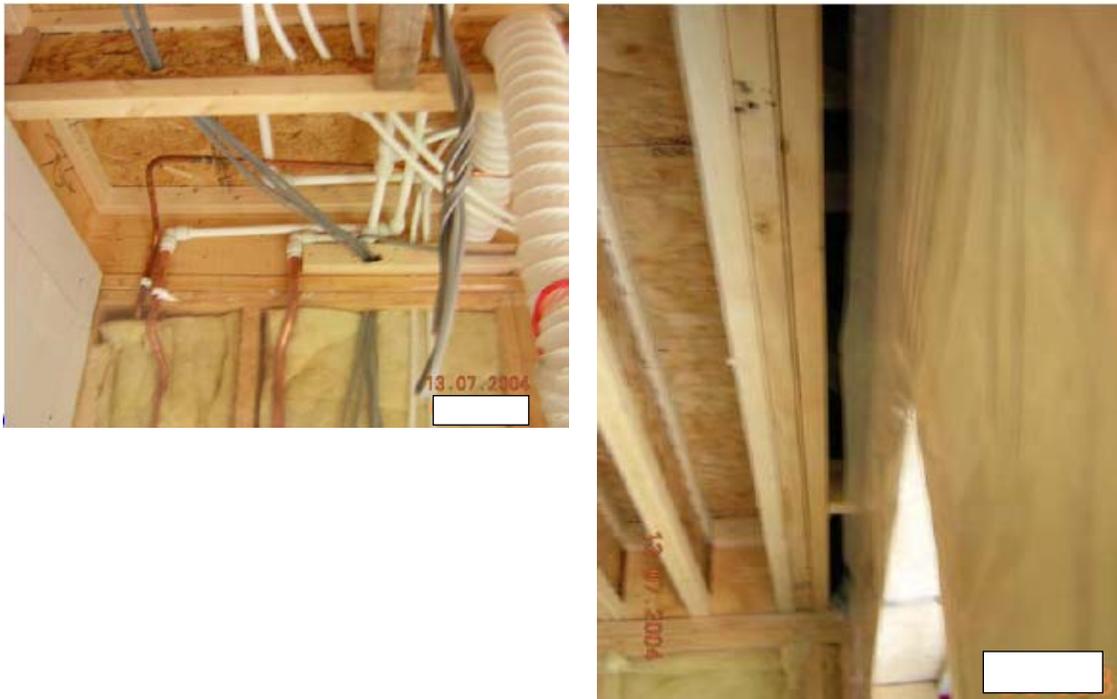
55. Despite the perimeter insulation shown in design drawings, site observations revealed little evidence that it was actually placed. Figure 3.25 shows external walls with wall insulation and vapour control layers in place but no perimeter insulation at intermediate floor level. Although it is possible that insulation would be placed at a later date, this was considered unlikely as it would have required a second visit by the insulation gang. In any case the proliferation of services runs (figure 3.25) would make placement difficult as would the narrow space between the multiple joist and the wall. On some sites there seems to have been an assumption that the timber I-beam floor cassettes would have perimeter insulation fitted at the factory. In one case the site team had an opportunity to check this assumption through a hole in the perimeter space, which was cut for a gas pipe. As shown in figure 3.26 no insulation was evident. Evidence from another timber frame site where access to the floor edge¹ was available provided another example of an uninsulated void (see figure 3.27). The lack of perimeter insulation would seem to be a general problem since in none of the timber frame sites visited was the placement of perimeter insulation observed.

Figure 3.25 High concentration of services and close proximity of I-beam to external wall reduce both access and the likelihood of effective insulation at intermediate floor perimeter.

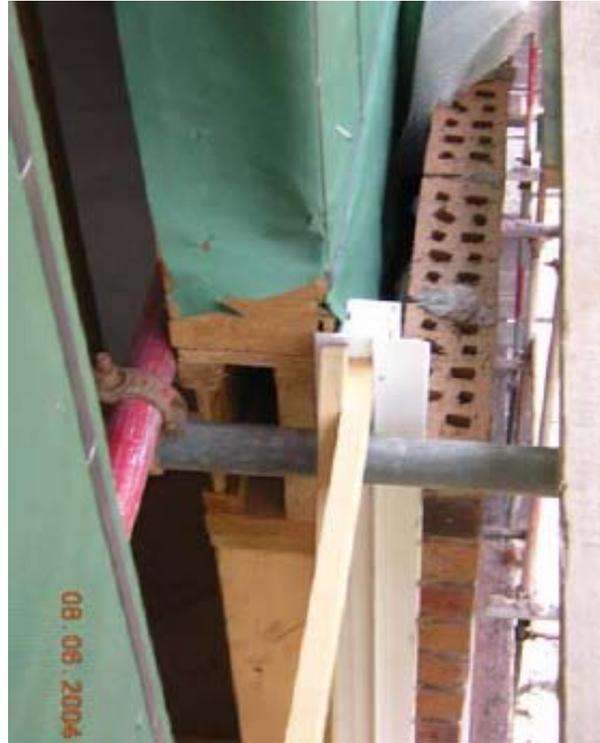
Figure 3.27 Uninsulated edge beam to timber frame intermediate floor.

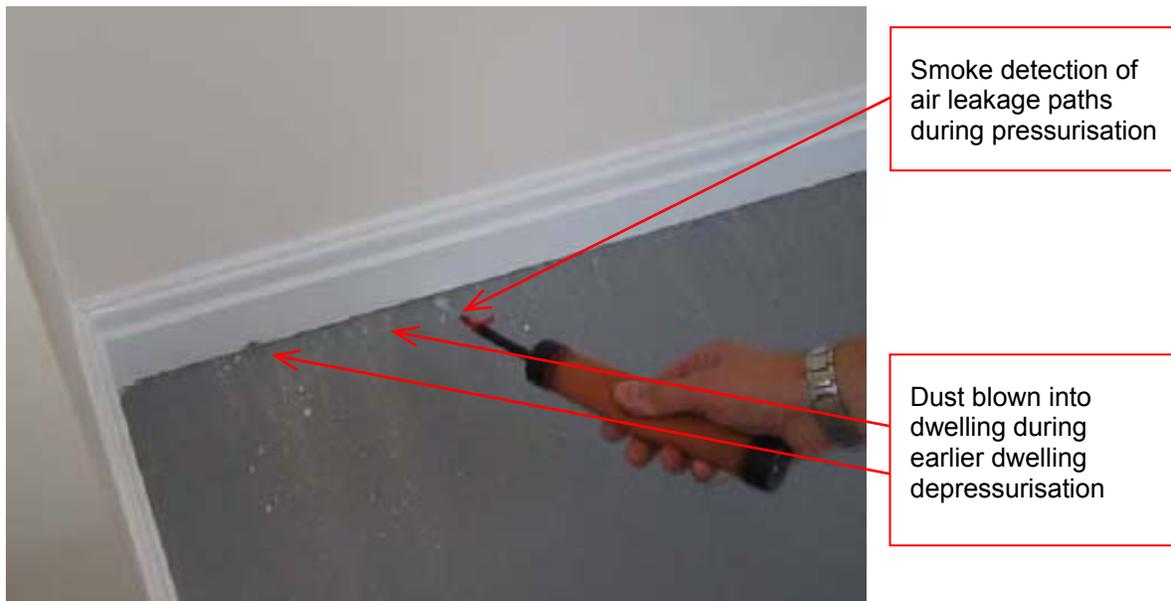
Figure 3.29 Air leakage through intermediate floor junction (Johnston et al, 2004).

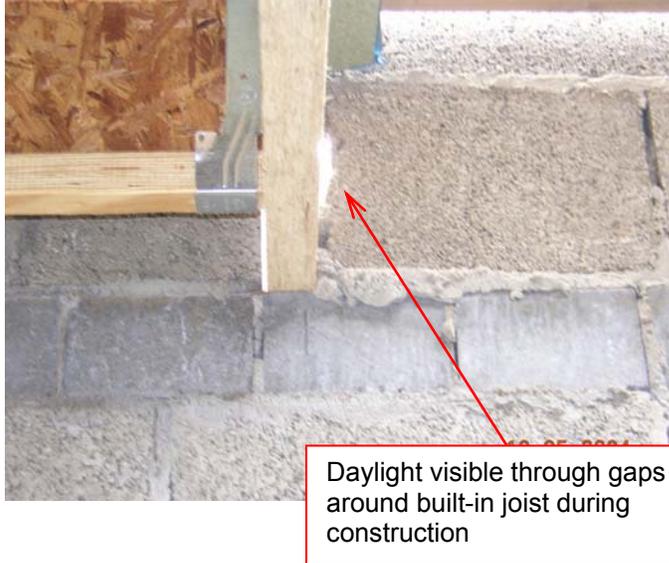
an illustration of the difficulties of insulating across the joist ends. In figure 3.31 the joist ends protrude into the partially filled cavity but instead of trimming the joists to a tight fit the insulation has been cut back, not only reducing the insulation thickness but also leaving room for air flow which bypasses the insulation. This is, perhaps, something of a curio in this project and the problem is not particularly severe but it is conceivable that in extreme cases, even greater thicknesses of insulation could be removed.

Figure 3.30 Built-in joists in masonry external walls¹.

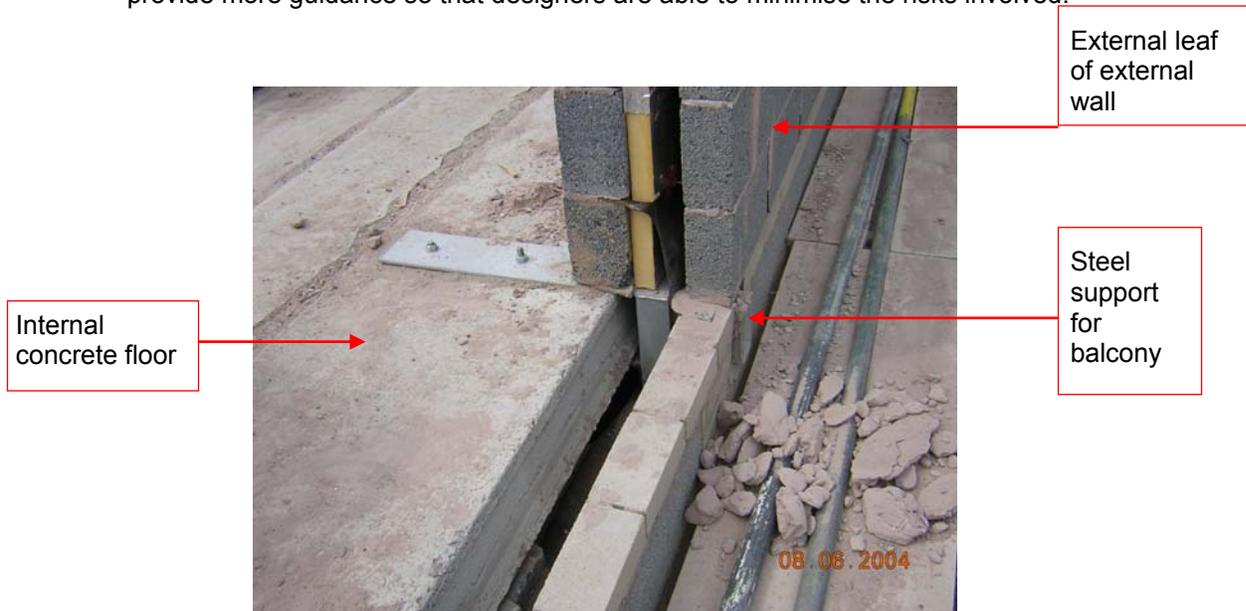
Figure 3.33 Balcony support through partial-fill masonry construction.

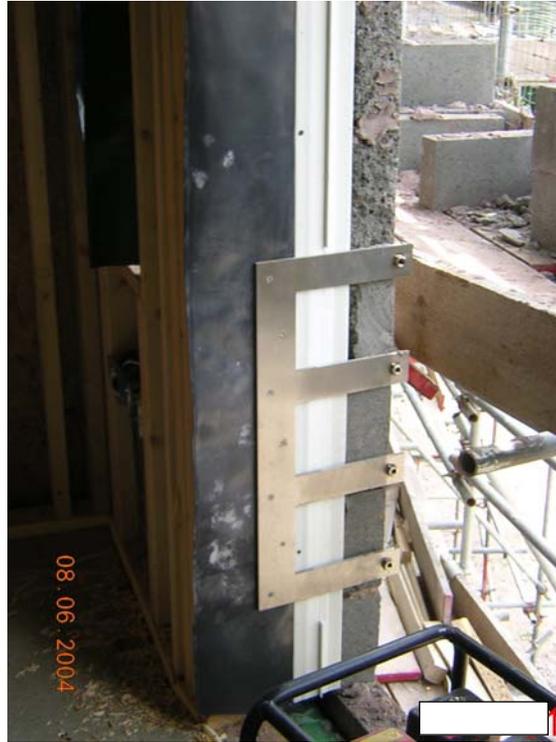
Figure 3.34 Balcony support through timber-frame construction.

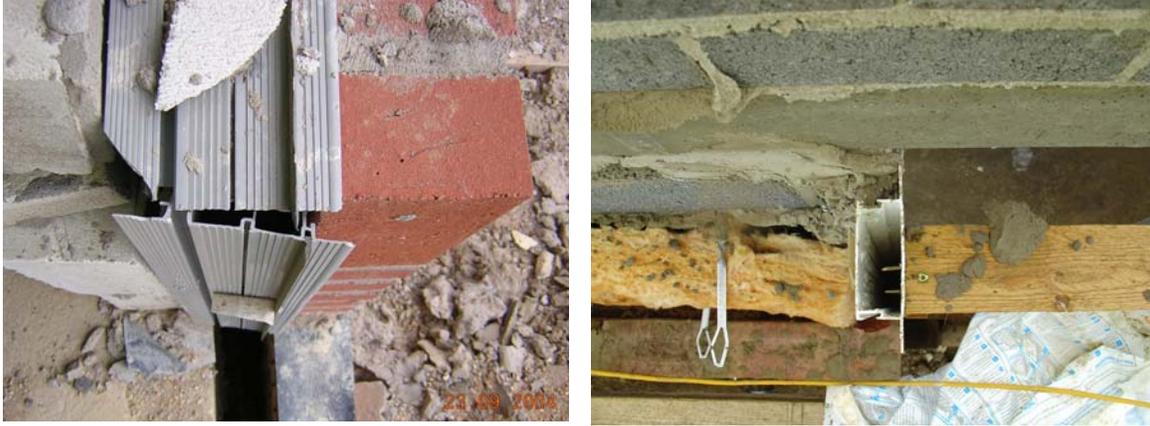
63. In the majority of cases where cavity masonry construction was adopted (both fully filled and partially filled) openings were designed using propriety cavity closers at sills and jambs. These usually consisted of plastic box section extrusions that fitted into the cavity to a depth of between 40 and 50 mm with fixing flanges overlapping the brick and block work reveals. Although on some sites the box sections were filled with a foam insulant, in the majority of sites sections were uninsulated. This is illustrated in figures 3.35 and 3.36.

Figures 3.35 and 3.36 Uninsulated closers.

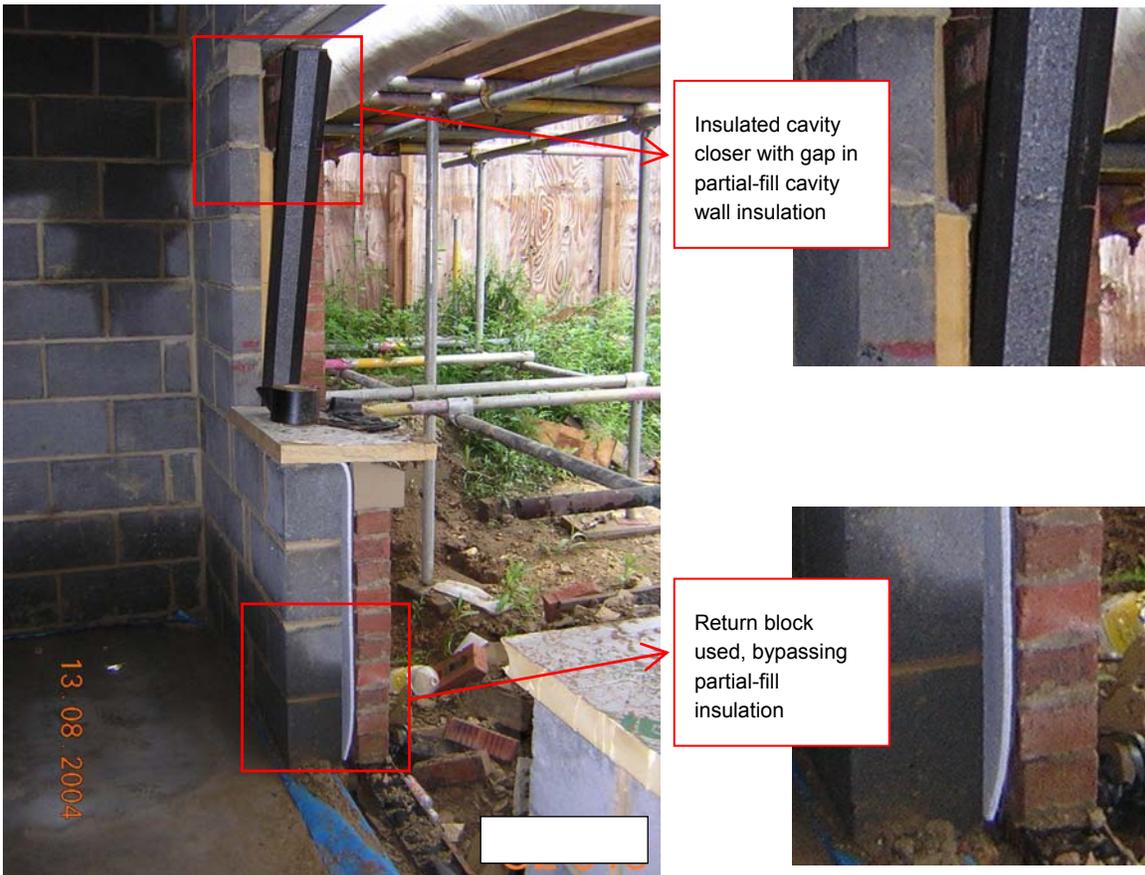
Figure 3.39 Inconsistencies in cavity closure detailing.

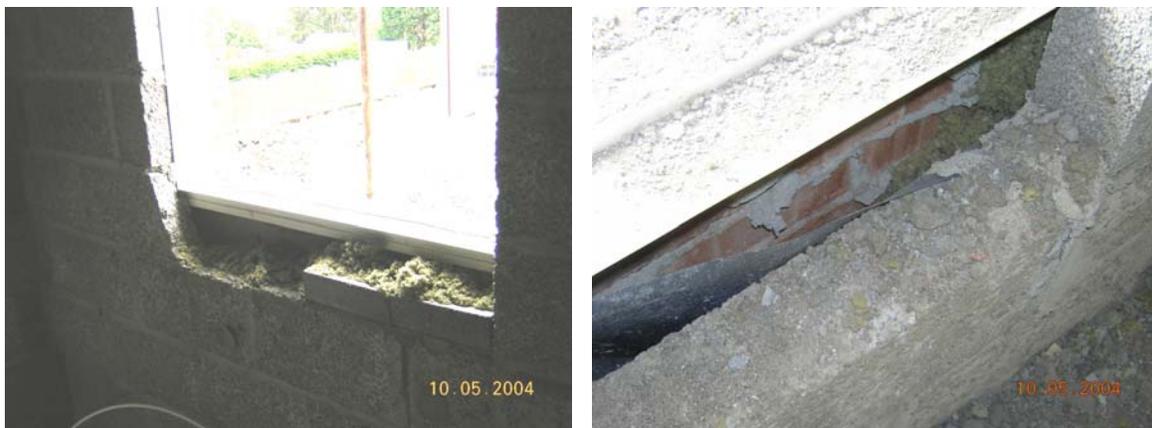
67. The problem of ensuring that full-fill cavities are completely filled with insulation and that partial-fill insulation bats are fitted with no gaps has been generally recognised for some years. The observations in the cases studies provide a number of examples of this problem, particularly around window openings. Figures 3.40 and 3.41 show a fully filled cavity in which the filling work has been completed before the internal blockwork had been completed to sill level. This appeared to be a reasonably common occurrence and although it was not possible to ascertain whether insulation bats were placed in the cavity as blockwork was built up to the sill, it is likely that, at least in some cases, the additional insulation would be missed out. This would lead to increased thermal bridging and, depending on the thermal properties of the internal blockwork, increased risk of surface condensation problems.

Figures 3.40 and 3.41 Blown fibre, full-fill cavity wall insulation at incomplete sills

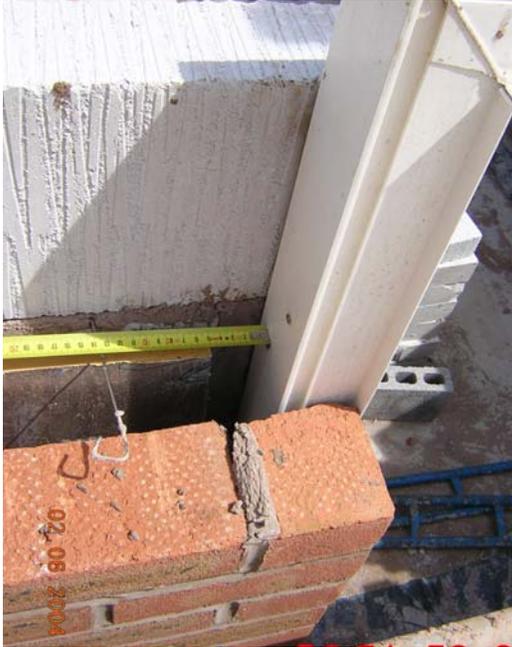
68. A similar problem was observed in a number of cases involving partial fill. Figures 3.42 and 3.43 illustrate a window jamb arrangement in which a gap of some 50mm between the cavity closure and the partial-fill cavity insulation was observed. A similar problem was shown in Figure 3.39. In other cases partial fill was loosely fitted and combined with other problems, such as mortar build up on cavity trays, to reduce thermal performance and increase not only condensation risk but also other moisture problems (see figure 3.44). Over all, this type of problem was recorded in 5 out of the 12 masonry cavity sites visited and, since we did not have access to open construction at window and door reveals on all sites, the number of observations may be an underestimate of the frequency of occurrence.

Figure 3.42 Gap observed between cavity closer and partial-fill cavity wall insulation.

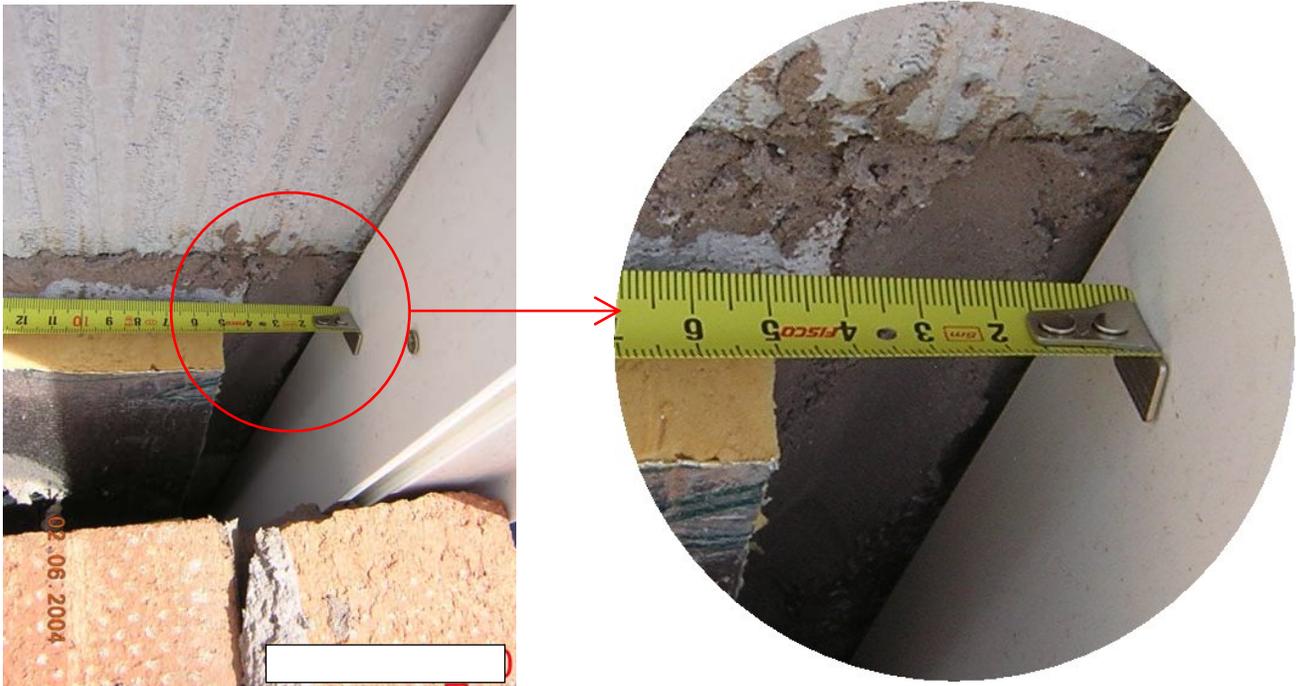
Figure 3.43 Up to 50mm of uninsulated area around jambs and reveals, causing potential thermal bridging problems.

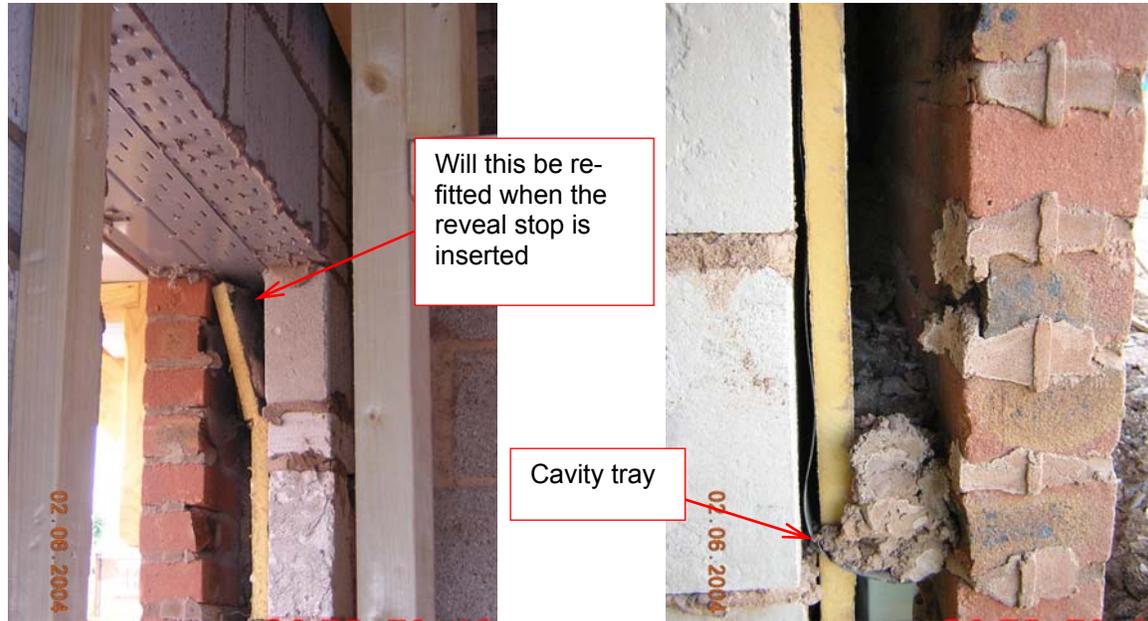
Figure 3.44 Partial-fill cavity insulation – gaps and mortar build-up on cavity tray.

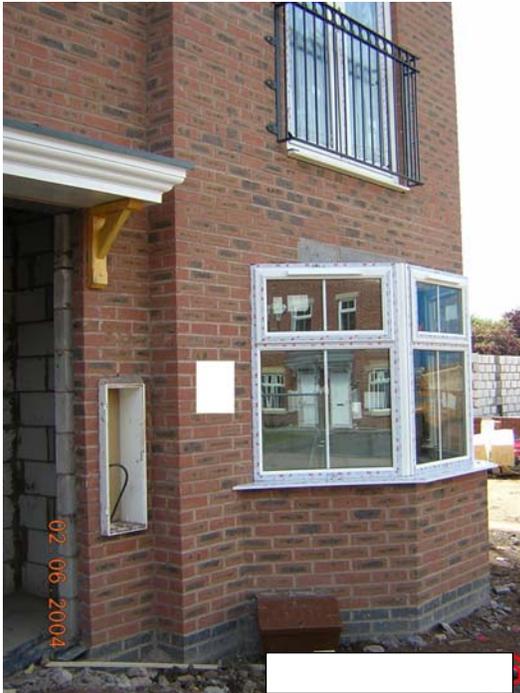
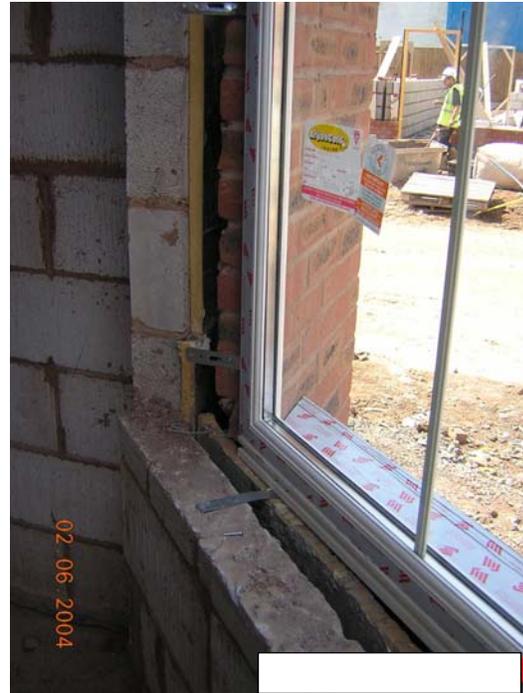
Figures 3.48 and 3.49 No overlap of insulation layer at a bay window.

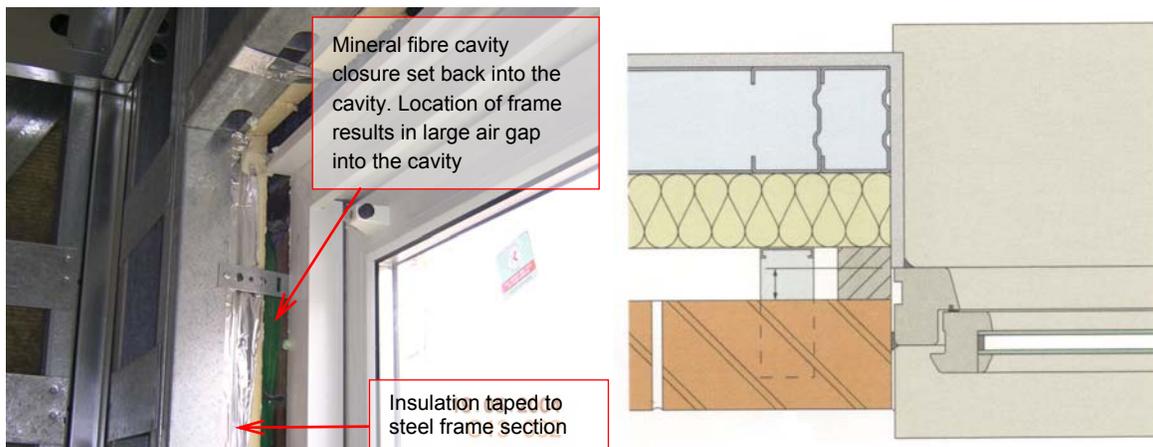
72. Problems of window location and insulation at cavity closures were observed also in steel frame construction. Figure 3.50 shows a door frame set forward of the external insulation layer by about 40mm. Although the insulation is fully taped, as recommended by RD 7.06, the fact that the cavity closure has been pushed well back in to the cavity creates a discontinuity of insulation. This, together with the location of the frame significantly reduces the resistance path from inside to outside. In addition, unless an air/vapour control layer is introduced in the jamb the detail will reduce overall airtightness.

Figure 3.50 Door opening in steel frame construction (as constructed) compared with robust detail 7.06.

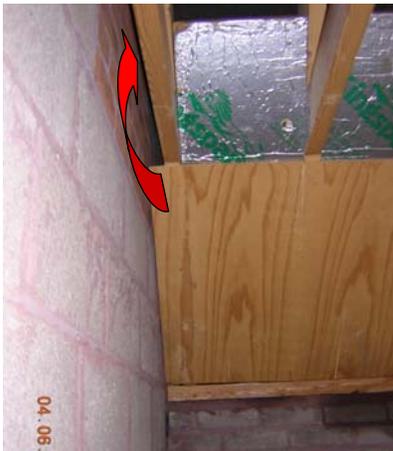
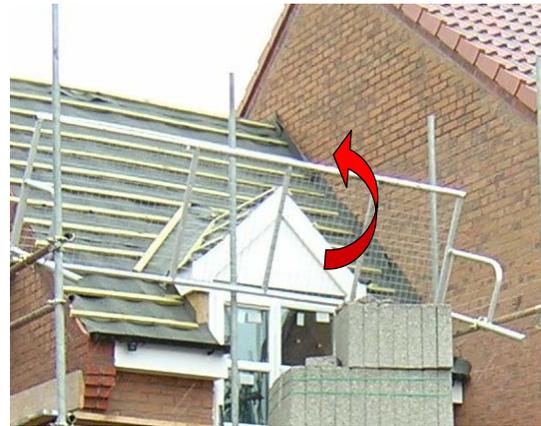
Figure 3.53 Gap in insulation adjacent to gable wall and structural thermal bridge (arrows).

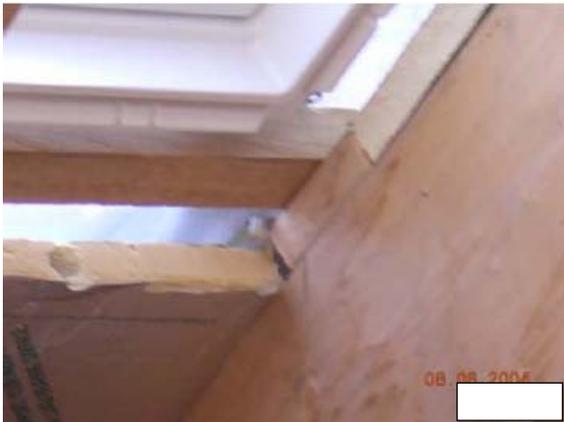
82. Although, as with other site observations, it is hard to know for certain if defects will be identified and rectified by site quality control, the observations made during visits suggested that the insertion of small strips of insulation and the accurate cutting of boards around rooflight openings was not always done with the level of care required. Figure 3.62 shows a typical gap in external insulation and figure 3.63 shows a framing board at the “sill” of the rooflight, which, when investigated proved to have no insulation in the space behind nor evidence of an air/vapour barrier. This would certainly give rise to airtightness problems and poor thermal performance, both of which may lead to increased condensation risk. A number of observations of the space available for lining insulation to the sides of rooflight openings suggested that achieving the required resistance ($R \geq 0.34 \text{ m}^2\text{K/W}$) would be difficult especially if decorative linings were also to be applied. As a general observation missing insulation (particularly when small strips are required) around roof lights was a common occurrence on most sites.

Figure 3.62 Gaps in external insulation around

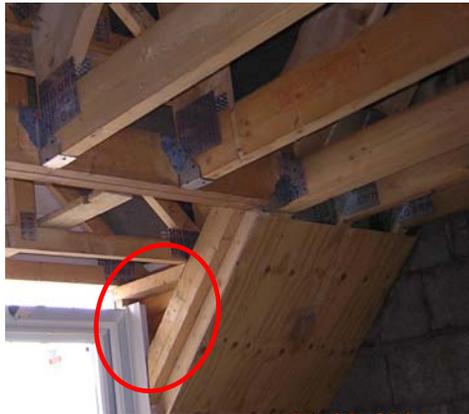
Figure 3.64 Small triangle of external wall difficult to fill with insulation.

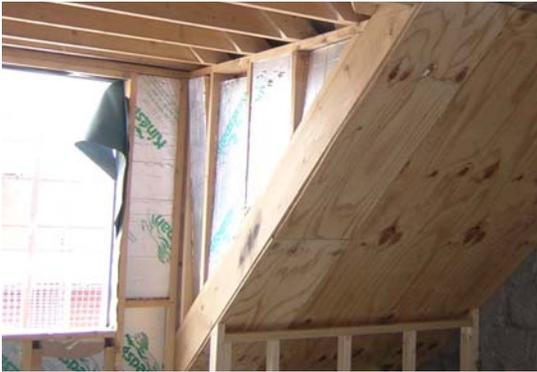
84. As in other cases the main problems related to the fitting of the insulation board. Figures 3.65 and 3.66 illustrate typical fitting problems with gaps around boards and missing insulation in small sections, sections that can be very small indeed requiring considerable attention to detail (see figure 3.64). The missing insulation in the corner section (figure 3.66) is of particular concern since this is one of the most exposed areas of the external envelope.

Figure 3.65 Irregular fitting of 35mm insulation boards.

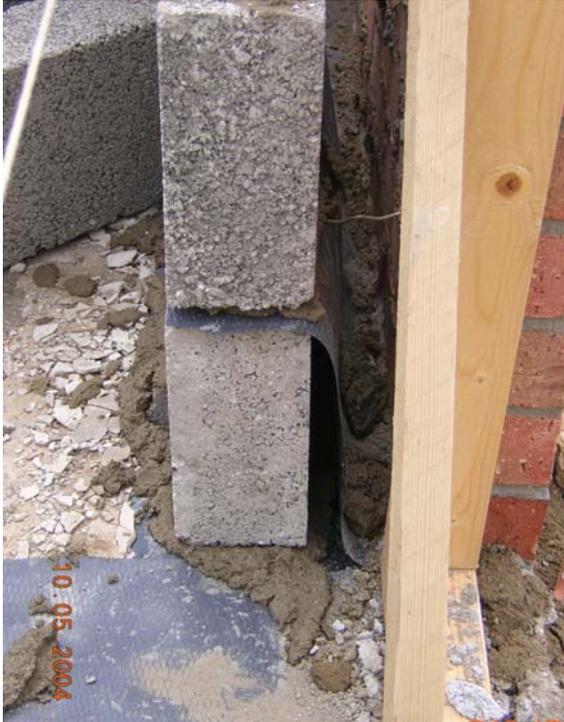
Figure 3.68 Injected insulation unlikely behind cavity tray. Mortar droppings will impair performance.

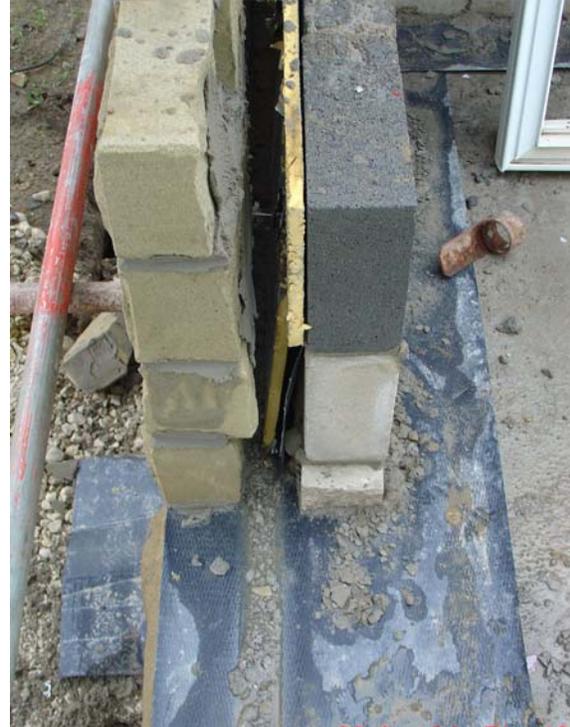
Figure 3.69 Partial fill insulation displaced by cavity tray resulting in gaps around insulation.

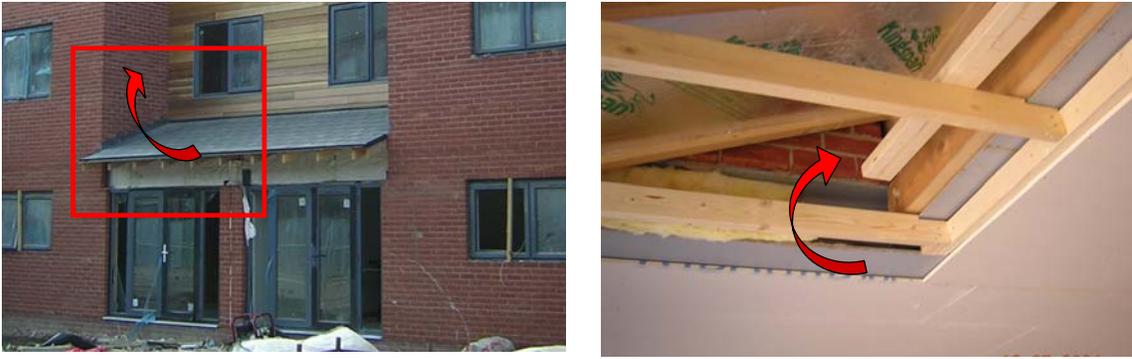
90. Figure 3.72 shows a different arrangement where the thermal bridge is, perhaps less obvious. In this case the ground floor “projection” fits between two flanking walls. However the flanking walls do not extend to the foundations but, in order to create a large unobstructed space below, they are supported by steel sections within the first floor void. The internal view of the construction in figure 3.73 shows the steel beam with some insulation between the flanges and the sloping roof with insulation at rafter level. Although this may seem like a reasonable detail, due to the fact that there is no insulation below and around the steel (as opposed to between the flanges) considerable heat loss would be expected into the brickwork above resulting in a relatively low surface temperature of the flange and increased condensation risk. Since steel has a very low thermal resistance the insulation between the flanges has almost no effect on heat flow or the surface temperature of the lower flange.

Figures 3.72 and 3.73 Thermal bridging through structural steel in first floor space.

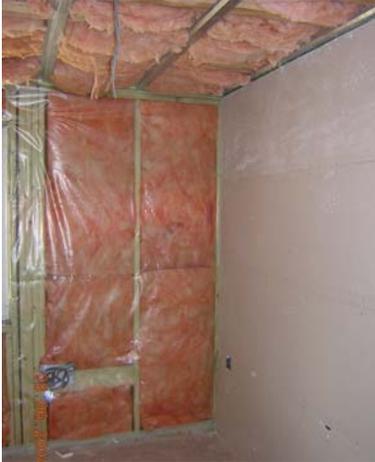
92. Thermal bridging in timber frame walls is often allowed for by specifying an appropriate timber fraction in the calculation of U values¹. However the timber fractions used in the calculations often underestimate the amount of timber present (Bell and Overend 2001). Similarly, the impacts of the concentrations of timber that occur around openings and at areas of point loading in the structure have not been extensively analysed from the point of view of thermal and moisture performance. The highest concentration of timber (studs or head/sole plates) shown in any of the details in section 6 (timber frame) of the Robust Details document, is a doubling of the relevant timber section. This can be seen in figure 3.74, showing the double stud at a door or window jamb (RD 6.10). In practice, timber concentrations at openings and other areas where structural strengthening is provided (not all of which are structurally efficient) can be much higher than shown in the Robust Details document. Figures 3.75 and 3.76 show examples of timber concentrations ranging from 6 studs adjacent to and below a window opening to a corner arrangement that includes 11 studs supporting the double I-beams above.

Figure 3.75 High timber concentration at window jamb.

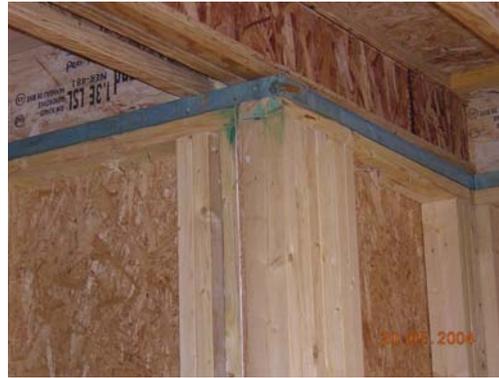
Figure 3.76 High timber concentration at corner post.

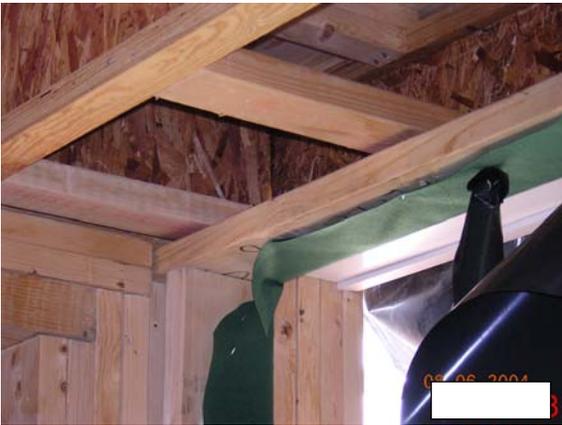
93. Other examples include difficulties at corners in general and at other junctions. Figures 3.77 and 3.78 show a particular instance where timber detailing has ignored the thermal performance of the junction. The sketch (figure 3.78) not only indicates the amount of timber but also the small gap in the framing that would require assiduous attention to detail on site if it were to be filled. The existence of such small strips where insulation is omitted is something that was observed time and time again, figures 3.79 and 3.80 are typical examples. The impact of such air gaps may be considerable since the resistance of the cavity is about three times less than that of an equivalent section of timber and many times less than that provided by insulation.

Figure 3.77 High timber concentration at opening to balcony.

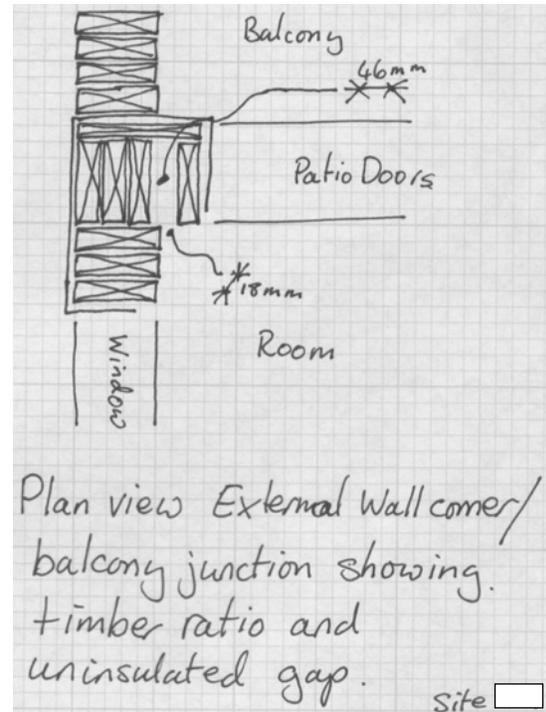
Figure 3.78 High timber concentration at opening to balcony.
