Condensation Risk – Impact of Improvements to Part L and Robust Details on Part C

Project Reference Number: CI 71/6/1 BD2414

Interim report number 7: Final report on project fieldwork

Malcolm Bell, Melanie Smith & Dominic Miles-Shenton
Buildings and Sustainability Research Group
Leeds Metropolitan University

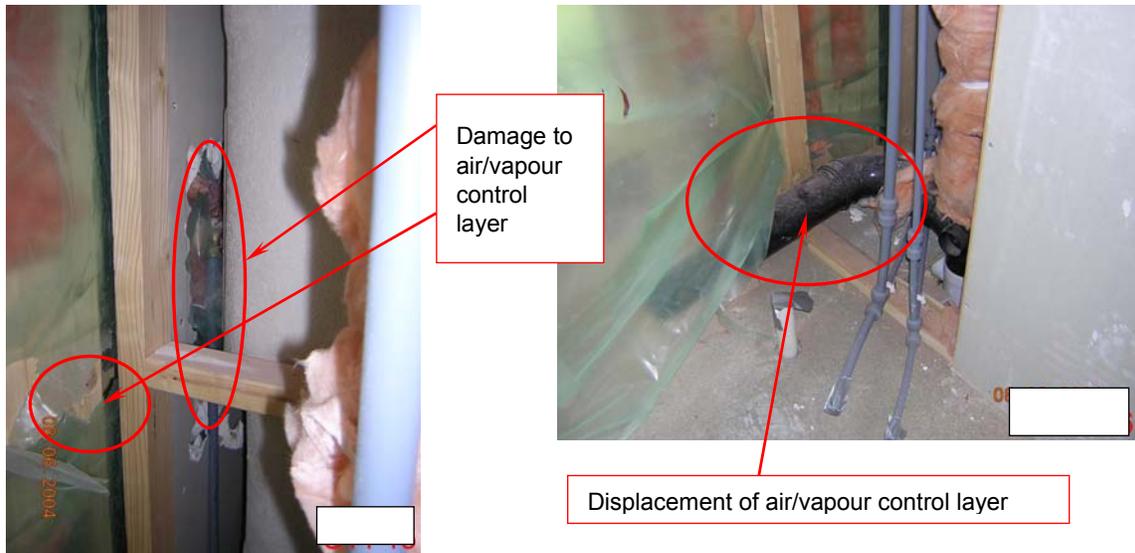
96. Areas where continuity of the air/vapour control layer is particularly vulnerable are behind baths, shower trays and kitchen units and in services voids. Figure 3.81 illustrates the construction of a services duct in a bathroom (timber frame dwelling) showing damage to the air/vapour control layer and internal lining to the services duct.

Figure 3.81 Damage to and displacement of the air/vapour control layer.

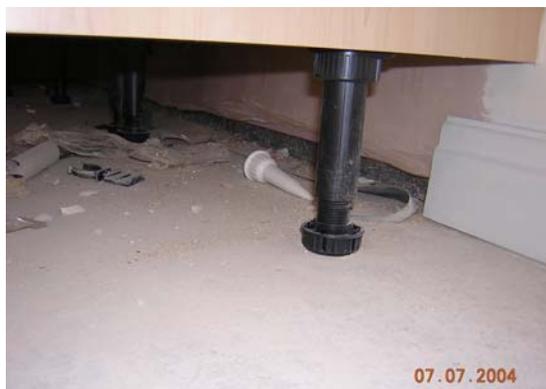
Figure 3.82 Plasterboard finish stopped short of the floor under kitchen fittings.

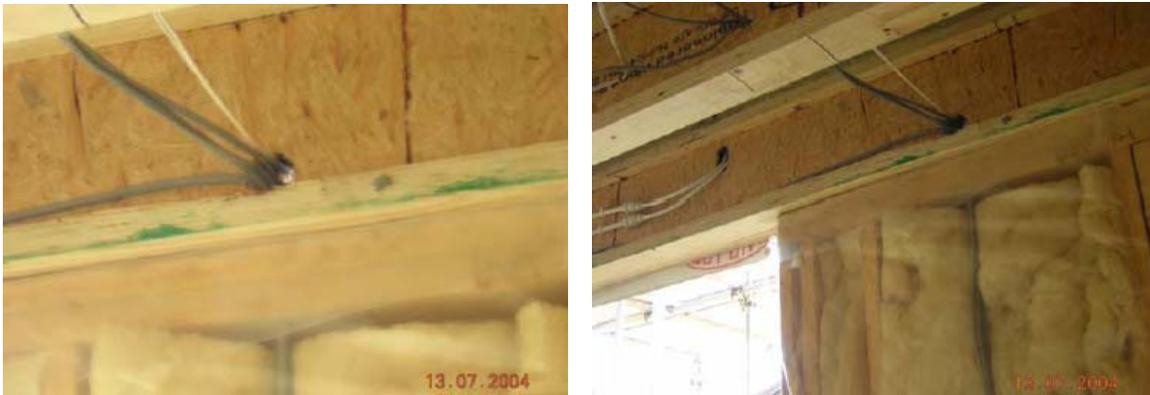
Figures 3.85 and 3.86 Holes in floor perimeter for electrical services.

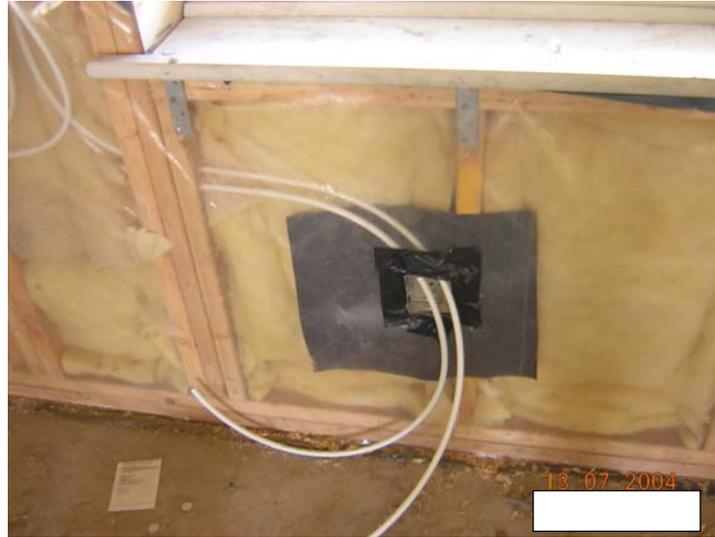
Figure 3.87 Air/vapour control layers not lapped to DPC¹.

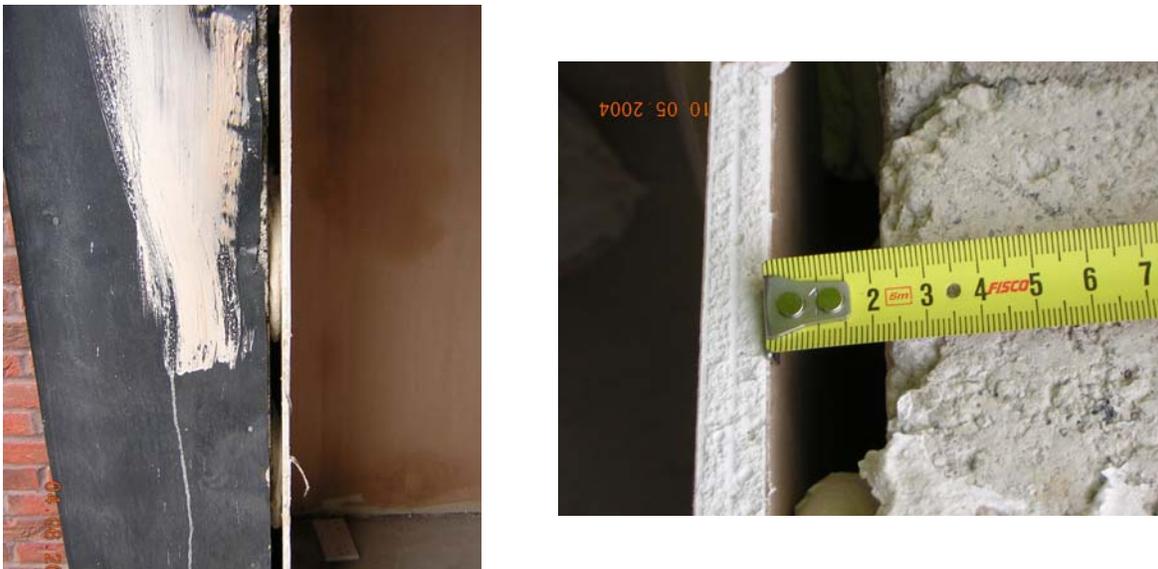
Figure 3.91 Lack of continuity of plaster adhesive to plasterboard lining.

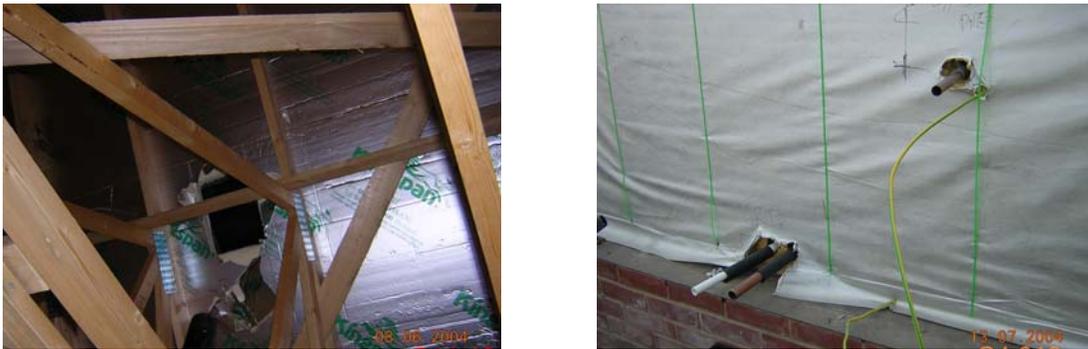
Figure 3.93 Service penetrations through the insulation and air/vapour layers in roofs and walls.

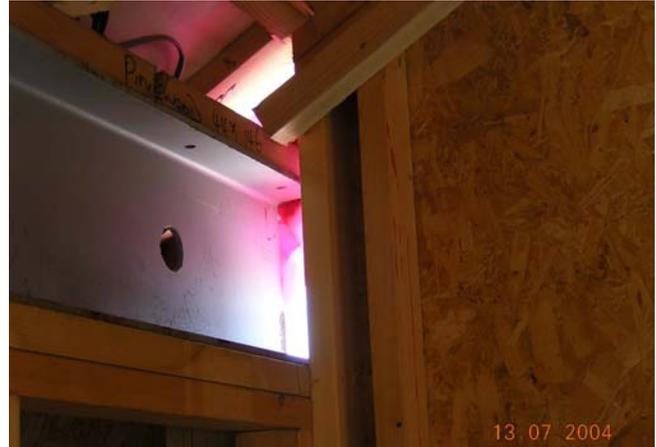
Figure 3.95 Penetration of timber frame wall by steelwork.

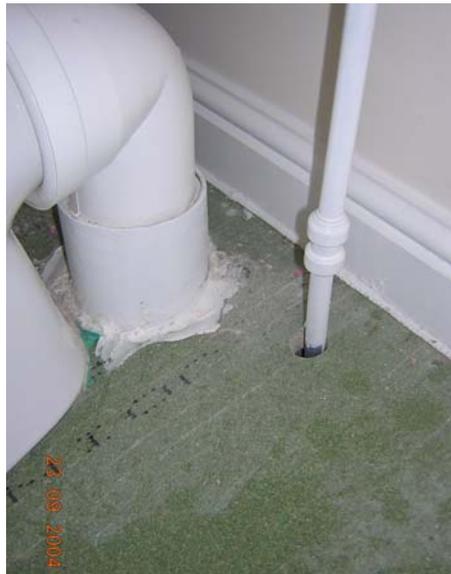
Figure 3.97 Sealing around soil pipe – water pipe yet to be sealed?
