Elm Tree Mews Field Trial – Evaluation and Monitoring of Dwellings Performance

Final Technical Report

January 2011

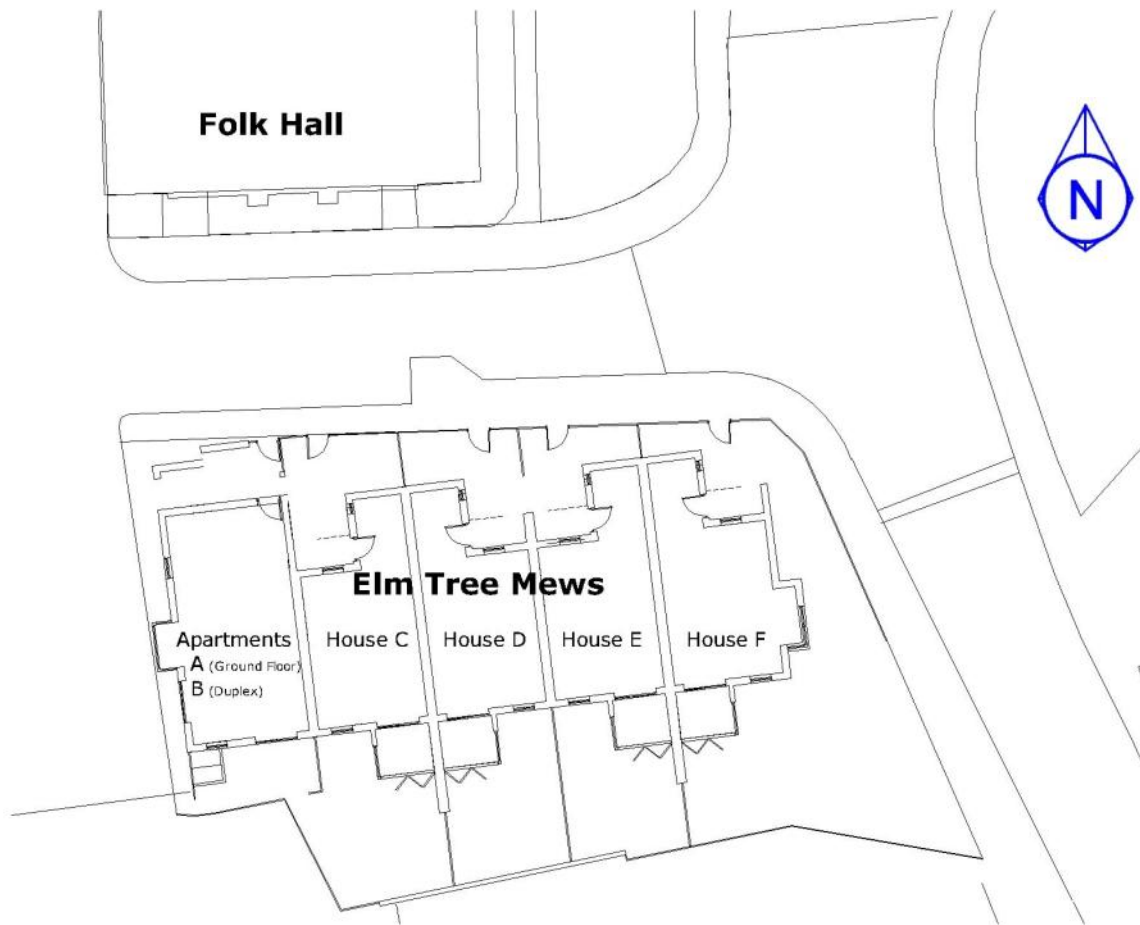
Figure 6 – Site Plan for Elm Tree Mews

- 25 A site plan of the Elm Tree Mews development is shown in Figure 6. The shows the location of Elm Tree Mews relative to the Folk Hall, as well as the position and codes for the six dwellings. The adjacent road to the east of the development is Haxby Road which leads to the centre of York.

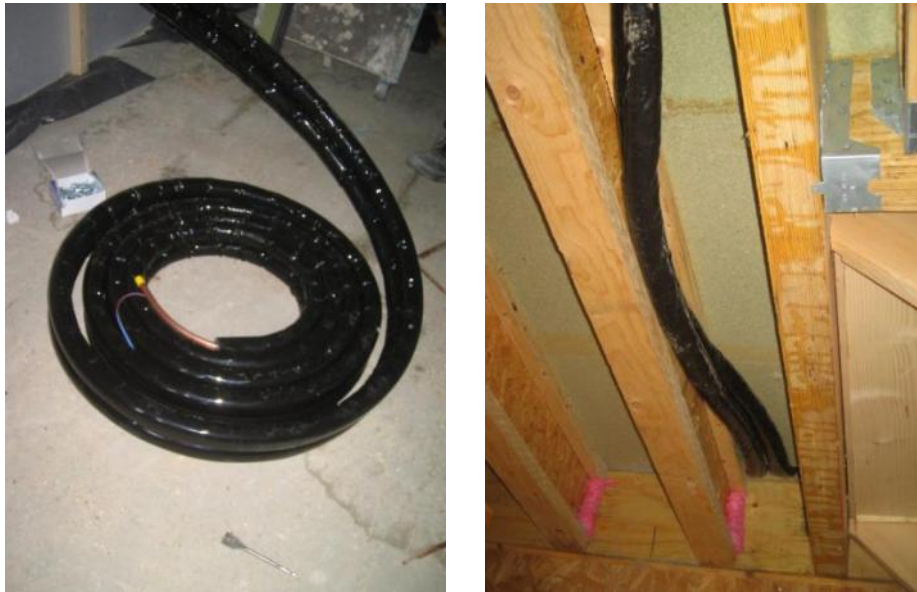
Figure 14 – Solar System Pipework

49 In the light of the more detailed monitoring data, further investigations were carried out by the solar subcontractor using a more rigorous approach to diagnosis involving re-pressurising the system and using the external filling pump to monitor flow of the solar heat exchange fluid bypassing the solar pump. It is now known that there was a flow restriction in the solar circuit. This diagnosis correlates well with the observed low system pressures and pump cycling behaviour. Based on the meter reading data, a similar problem could exist in the solar system in House A and perhaps to a lesser extent in any of the other four dwellings. The pipework used to link the solar panels with the cylinder was 15mm malleable copper that had been pre-insulated with foam insulation (see Figure 14). Where this pipework had been bent to take it around corners then there is the possibility that any potential kinks may be disguised by the layer of insulation, and this was subsequently found to be the case.

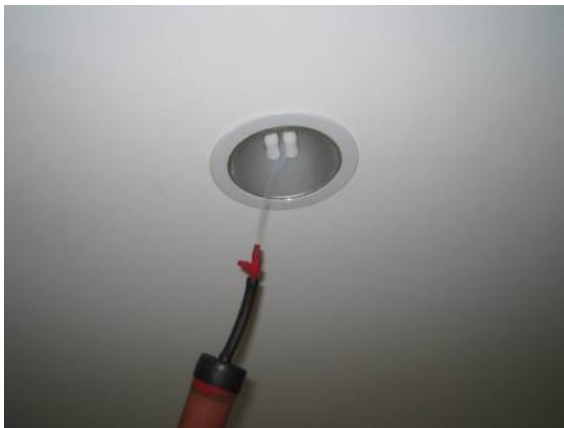
Figure 16 – Leakage via Recessed Light

61 Identification of air leakage paths was carried out for all 6 dwellings using thermal imaging under depressurisation conditions (when the inside-outside temperature difference was sufficiently large) and using smoke detection during pressurisation conditions. The observed leakage paths were found to be common across all six dwellings and included the following:

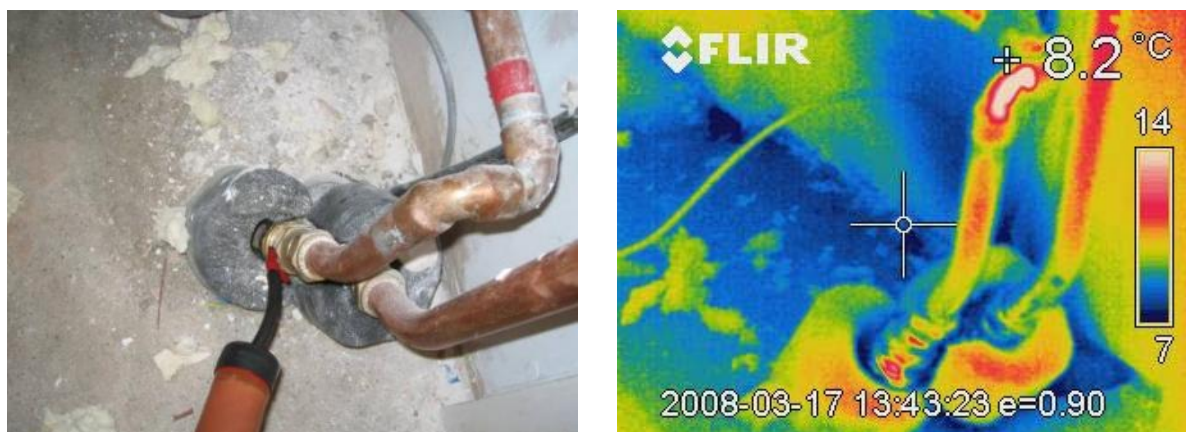
Figure 23 – Leakage at Heat Main Floor Penetration using Smoke and Thermal Imaging

c) **Ground Floor Slab Penetrations** – There was air leakage through the ground floor slab in situations where penetrations through the floor slab had not been effectively sealed, such as for pipework and drains. The example in Figure 23 shows leakage via the heat main penetrations, in particular between the insulation and pipe, and in Figure 24 air leakage can be seen around the boxed in pipework and soil pipe in the toilet on the ground floor.

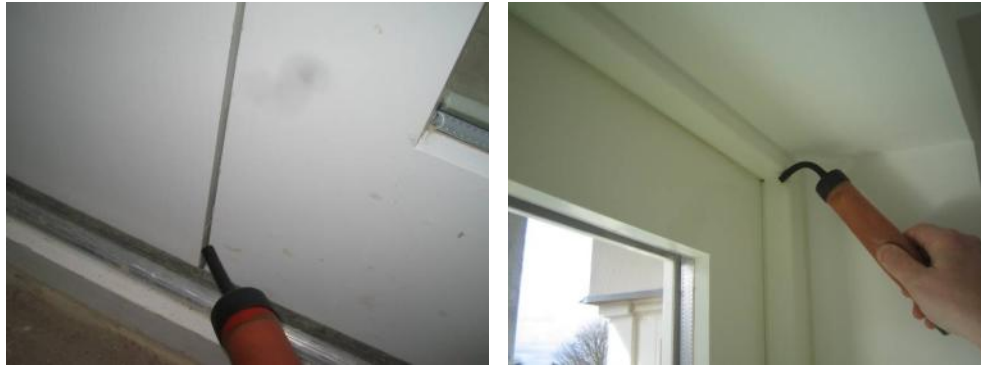
- e) **Window and Door Frames and Seals** – There was some leakage at the seals of both windows and doors, in particular where window seals met at frame corners and at the top and bottom of the seals between double patio doors (see Figure 28).

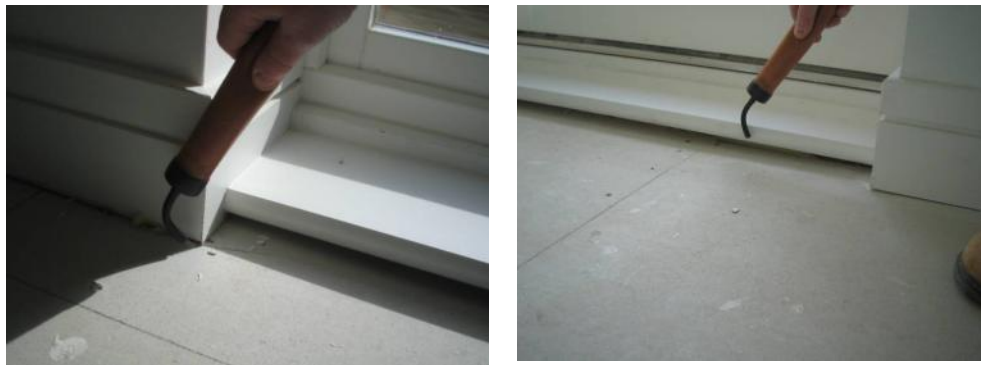
- f) **Door Thresholds and Full Height Window Sills** – Air leakage was observed at the thresholds of the patio doors and the sills of full height windows, and in particular at the corner of the threshold at the junction with the skirting board (Figure 29).

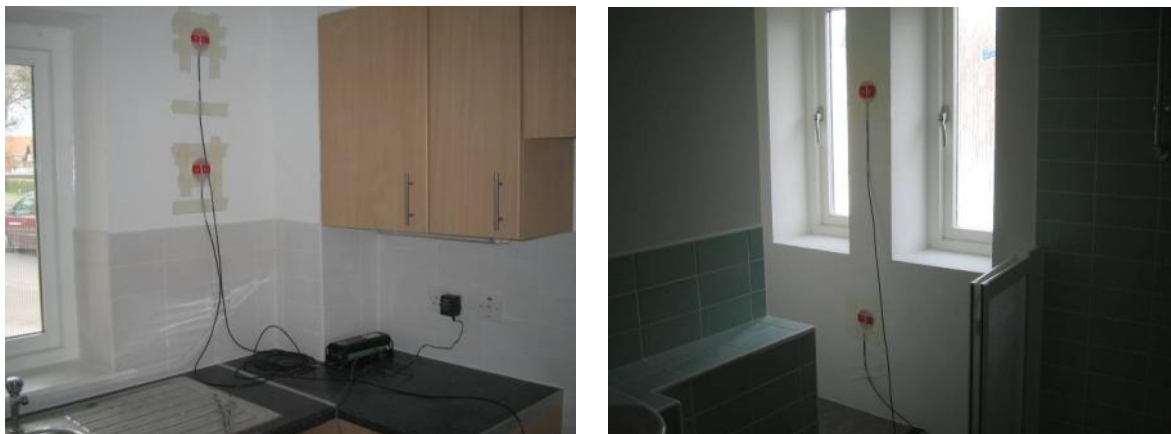
- 65 Heat flux measurements were taken at various wall locations (external wall and party wall) in the end terrace during the period of the coheating test. Four Hukseflux HFP01 sensors were used and these were attached to the wall using masking tape and a thin layer of thermally conductive paste (Dow Corning 340) between the sensor and wall (locations shown in Figure 31). The sensors were always located on internal surfaces and, in the case of external wall panels, always on north facing walls to minimise solar heating effects.

Figure 31 – Heat Flux Sensors on North Facing Wall of Kitchen and Top Floor Bathroom

- 66 Heat flux measurements for sensors placed on the north facing wall of the ground floor kitchen (at a location with 100% insulation in the wall panel) and top floor bathroom (at a location with 100% timber in the wall panel) for a period of 1 week and with the flux recorded at 10 minute intervals are given in Table 20. Also given are U-values calculated from the heat flux and mean internal-external temperature difference. It can be seen that in all cases the measured U-values are higher than the nominal design U-value of 0.18 W/m²K. In the case of the bathroom wall with 100% timber in the panel at the sensor location, the measured U-value is up to twice the nominal value. This indicates that, as expected, the proportion of timber in the wall panel will have a significant influence on the degree of heat loss. These data also indicate that the realised U-value for the external wall in the building as constructed is likely to be closer to 0.3 W/m²K and not the 0.18 W/m²K nominal design value. It is also interesting to note that the top sensors in each location show lower flux and lower U-values than the corresponding bottom sensors. This is thought to be due to stack air movement in the 38mm service void between the timber panel and plasterboard which will likely lead to higher void temperatures towards the top of the service void.

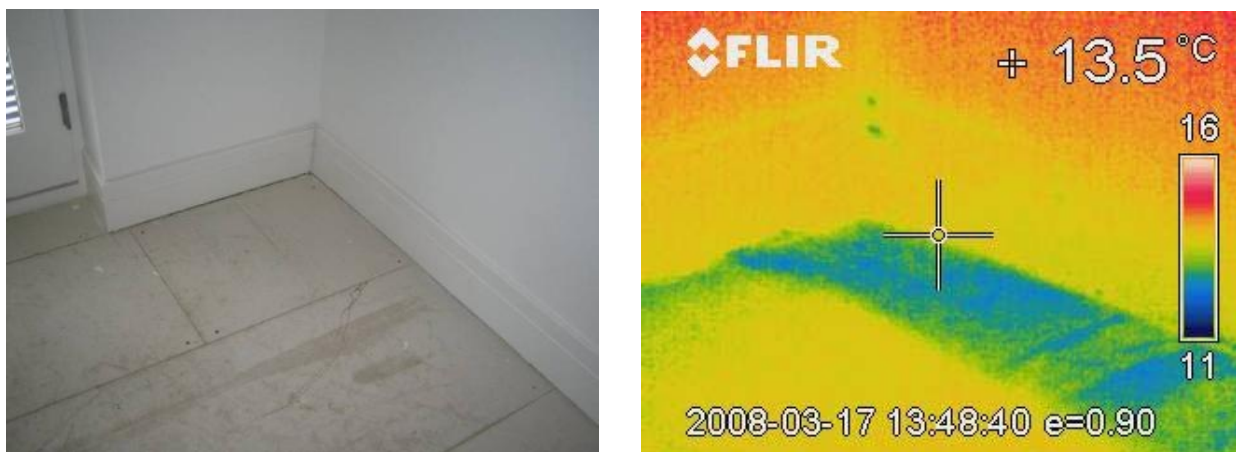
- 77 The images in Figure 41 show a cold zone at a junction in the ground floor screed above the underfloor heating pipes in House F. There is clearly an air leakage path either along the side of the partition wall or up through the floor below the partition.

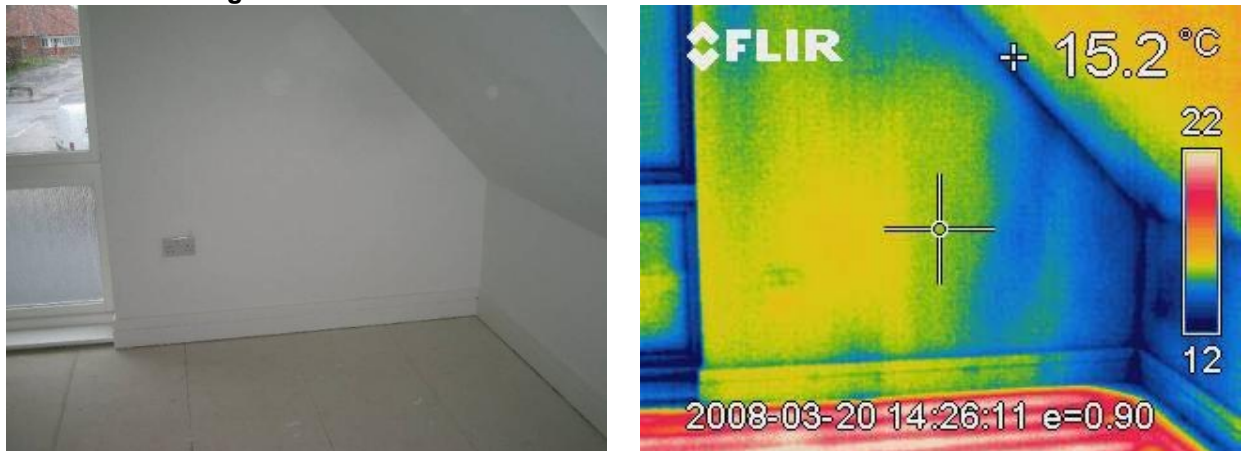
- 79 The external gable wall of the first floor bedroom of the duplex flat is illustrated in the images in Figure 44. The thermal image shows that there is a cold zone at the corner of the room where the

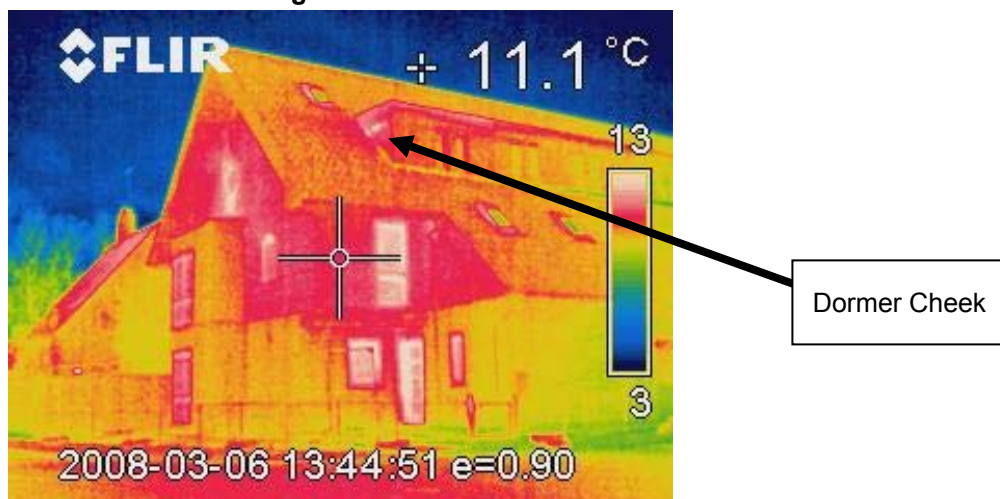
- 81 The heat loss from the dormer window cheek in the south facing dormer window of house F shown in Figure 46 appears to be higher than for other panels.

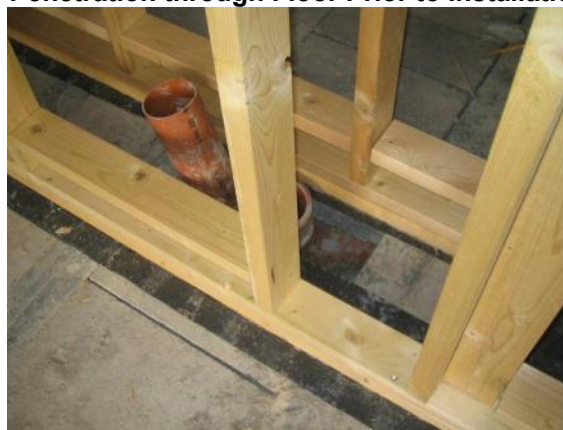
- 85 A series of site visits with photographic records were undertaken during the construction of Elm Tree Mews, with the first visit taking place on the 2nd March 2007 when the groundworks were under way.
- 86 The photograph in Figure 48 shows a typical soil pipe penetration through the beam and block floor at the stage prior to layer of the floor insulation and screed. It can be seen that there is a large gap between the pipe and floor block which would allow movement of air from under the floor into the dwelling if left unsealed. It was observed that these penetrations were indeed not sealed effectively as can be seen in Figure 49. This would give rise to the air infiltration paths that were observed by thermal imaging as shown in Figure 38.

Figure 48 – Soil Pipe Penetration through Floor Prior to Installation of Floor Insulation

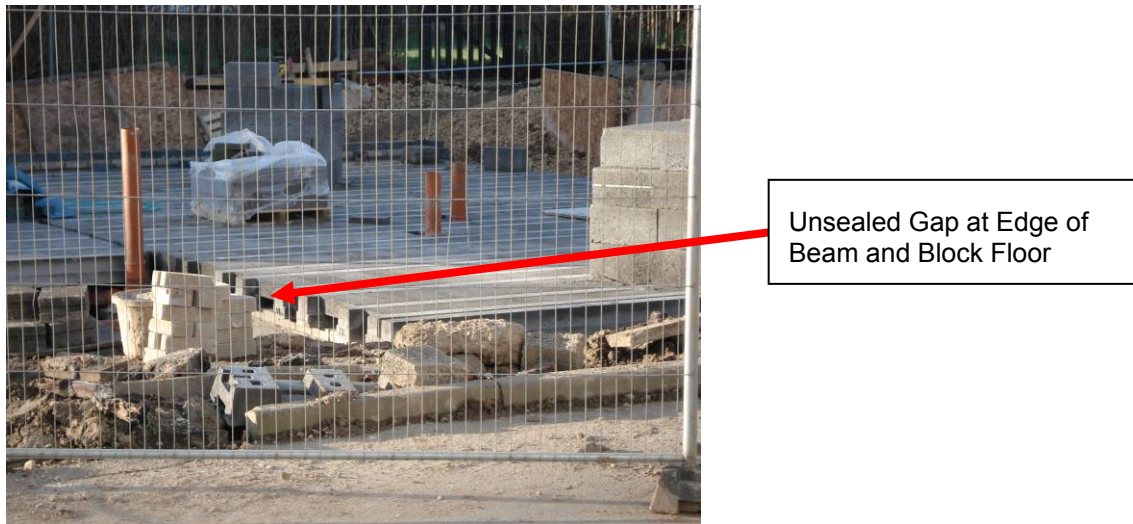
- 87 Observations were made of the construction of the party wall junction when the ground floor beam and block floor was being laid. Figure 50 shows the edge of the beam and block floors at the party wall between the ground floor flat and adjacent terrace. It can be seen that there are with gaps under the blocks which would allow air to move from the floor void into the party wall cavity. Conversations with the construction team confirm that there was no requirement in the construction specification to seal these gaps or to put any membrane or insulated sock at the bottom of the cavity. It is likely that air flow from the floor void into the party wall cavity at this point will be a major contributing factor to the party wall bypass at Elm Tree Mews as measured by the heat flux sensors (see paragraph 67).

Figure 50 – Construction of Beam and Block Floor showing Party Wall Junction

117 Observations made during the construction of the beam and block floor and party wall at Elm Tree Mews give some clues as to part of the possible mechanism of the party wall thermal bypass that has been identified during this study. The ventilated underfloor void is now known to link directly with the party wall. The connection between the party wall cavity and floor void is formed by the gaps in the construction of the beam and block floor (see Figure 50). This means that cold air can move from the ventilated floor void into the party wall cavity and, conversely, warmed air can move from the party wall cavity into the floor void. Such air movement would be induced by pressure differences between the two spaces. Air gaps in the cavity sock at the vertical edge of the party wall cavity (Figure 51) will also allow horizontal flow of air across the cavity. Measurements taken using a hot beam anemometer confirm that there is both vertical and horizontal air flow in the cavity at a rate of up to 0.5 m/s. A schematic of the proposed thermal bypass mechanism is shown in Figure 72. A photograph of the heat plume due to the thermal bypass is shown in Figure 73.

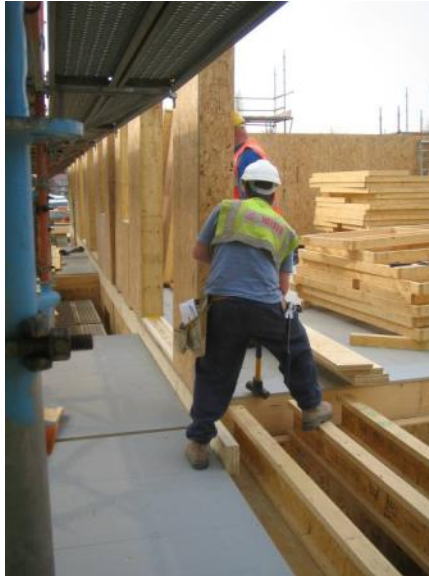
gaps between panel and flooring (Figure 52). Nor was a membrane used to wrap around the end of the intermediate floor. This indicates that there was no designed or constructed air barrier at these points and consequently the intermediate floor has the potential to be a major point of air leakage. It was also noted that edge section of the intermediate floor immediately above each panel did not seem to have been constructed with any insulation and would therefore potentially give rise to a significant thermal bridge. The drawing for this detail does show insulation at this point (Figure 53), so this suggests that the detail was not constructed as designed.

Figure 52 – Installation of First Floor Timber Frame Panels

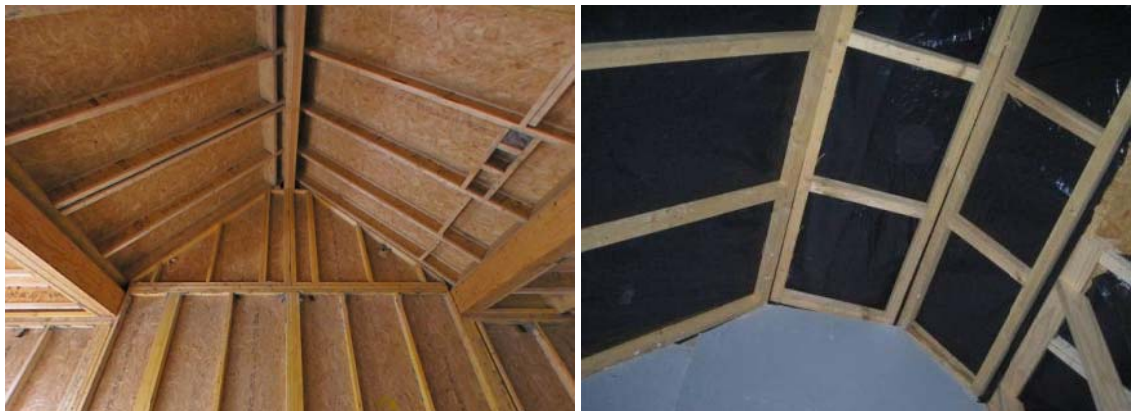
91 Inspection of the timber frame panel drawings showed that in some locations internal partition walls had been specified at locations which were in fact external and would have full 200mm external wall panels. The best example of this was for the cheeks of the dormer windows on the north facing roof. Several potential thermal bypass routes were also identified during the retrospective design assessment. This included a bypass created by the small ceiling void formed by boxing out the main ridge beam as shown in Figure 55. This created a separation of the air barrier and insulation layer at this point, thus forming a potential for thermal bypassing by allowing free movement of air through the insulation layer into the ceiling void (see Figure 56). The bypass can be observed in the thermal image shown in Figure 36.

Figure 55 – Construction of Ceiling and Roof Void

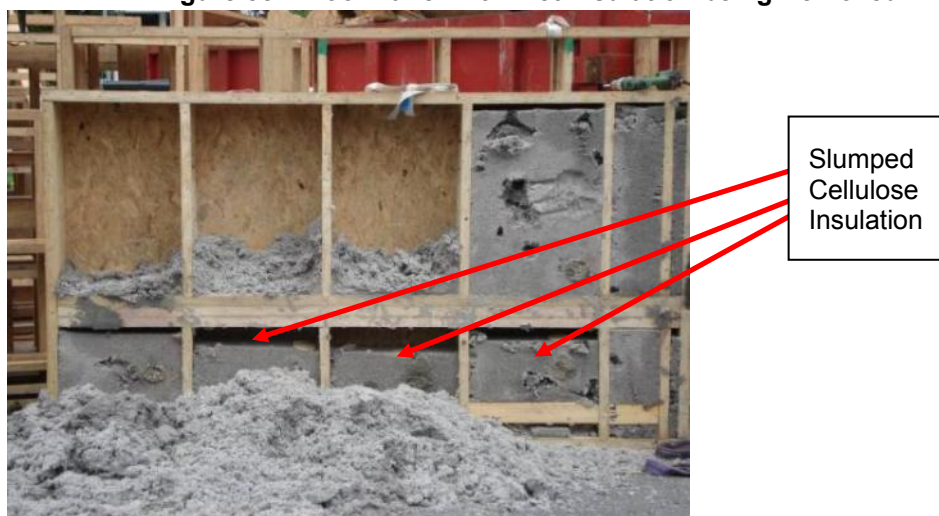
93 Perhaps the most critical of the on site issues were the problems associated with the insulation in the wall and ceiling panels. This manifested itself in two ways. Firstly there was slumping of the factory-filled insulation, which would likely have been induced by vibrations during the road transport shipping of the panels from the factory to the site. Secondly, the insulation in the unprotected panels became wet and slumped further following several weeks of heavy rainfall. As a result, the inside facing OSB sheets were removed from all panels and the cellulose insulation removed (Figure 58). The panels were then allowed to dry before being refilled. The risk of water damage to the panels could perhaps have been reduced with better protection of the erected panels, but there will always be some level of risk using this sort of construction system.

Figure 58 – Roof Panel with Wet Insulation being Removed

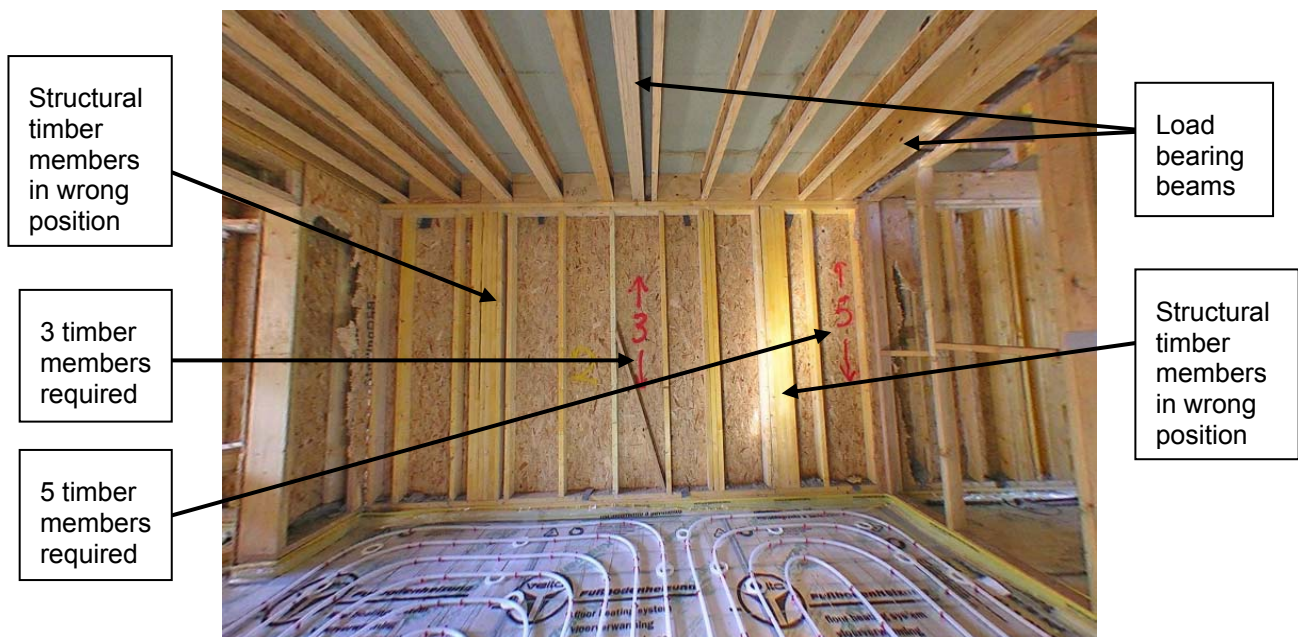
94 Another area of concern relating to the erection of the timber frame was the incorrect placement and orientation of some of the party wall panels. This meant that some of the timber members

hidden in the panels that were there to support loads from above were not in the correct alignment. This had the potential to result in structural problems and was only noticed during the period when the internal facing panels were removed and an inspection carried out by the structural engineer. In order to rectify this situation, additional timber strands were inserted at the appropriate locations by the main contractor. The photograph in Figure 59 shows one of the party wall panels with the inner OSB facing board and cellulose insulation removed. It can be seen that there is no structural timber in the party wall panels to transfer the load from the load bearing timber beams. Structural timbers can be seen in the wrong locations. The markings made by the structural engineer can also be seen in the photograph where new timber members need to be inserted into the panels (red 3 and red 5). This problem could have been avoided with better training of the timber frame installation teams and with better labelling of the panels. Indeed, the use of Lean Manufacturing Poke-Yoke (fault proofing) techniques could have been used in this situation to make it impossible to erect the panels either in the wrong location or wrong orientation. The classical Poke-Yoke method for fault proofing the assembly of components is to create a series of unique cut-outs and/or inserts along the edges of components during their manufacture⁵. These are designed to ensure that components can only be assembled in one orientation and only with the intended matching piece.

Figure 59 – Photograph of Exposed Party Wall Panels Showing Missing Structural Members

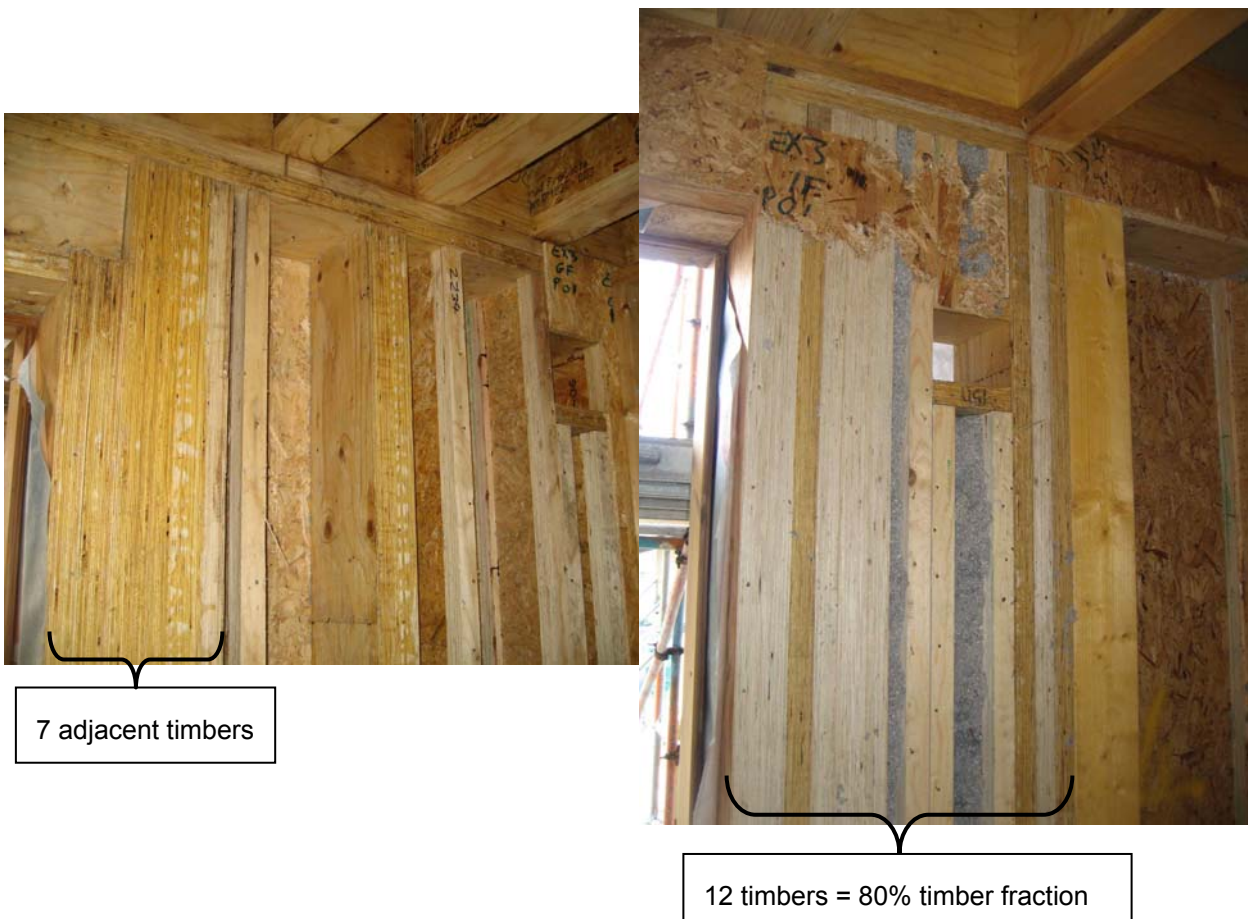
- 98 Photographs taken of exposed external timber panels illustrated in Figure 60 clearly show some of the additional framing and structural supporting timber in the panels. In the photograph on the left hand side it can be seen that around a patio door opening there 7 timber members together immediately adjacent to an I-beam. In the photograph on the right there are 12 timber members in a part panel adjacent to an opening where the timber fraction of the part panel is around 80%.

Figure 60 – Exposed External Timber Panels Showing Additional Timber

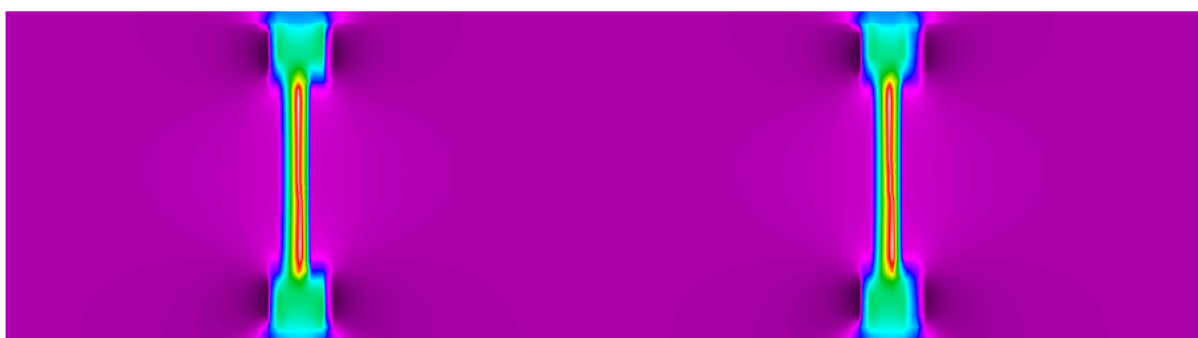
100 The nominal U-value of a standard panel with nominal 400mm I-beam spacing was calculated using 2-dimensional thermal modelling with the Therm v5.2 finite element simulator and also by the combined area method. The model used is shown in Figure 62. The model showing the calculated colour flux magnitude is illustrated in Figure 63. The calculated U-value from this Therm model was 0.1878 W/m²K, which is slightly higher than the value of 0.184 W/m²K calculated using the combined areas method (see Table 24). This is likely due to the bridging effect of the flanges which would not be taken account of in the simple combined area method.

Figure 63 – Colour Flux Magnitude for Model I-beam Wall Panel

101 The U-values for a range of wall panel constructions is given in Table 24. The nominal U-value of a panel construction with I-beams spaced at 400mm and including the effect of the inner plasterboard layer and service void is 0.18 W/m²K, both by the combined area method and using Therm. At a nominal 25% timber (solid timber not I-beams) and including the inner plasterboard layer and service void the U-value increases to 0.25 W/m²K. Where the 25% timber is for I-beam webs, the effect of the flanges increase the nominal U-value to 0.29 W/m²K.

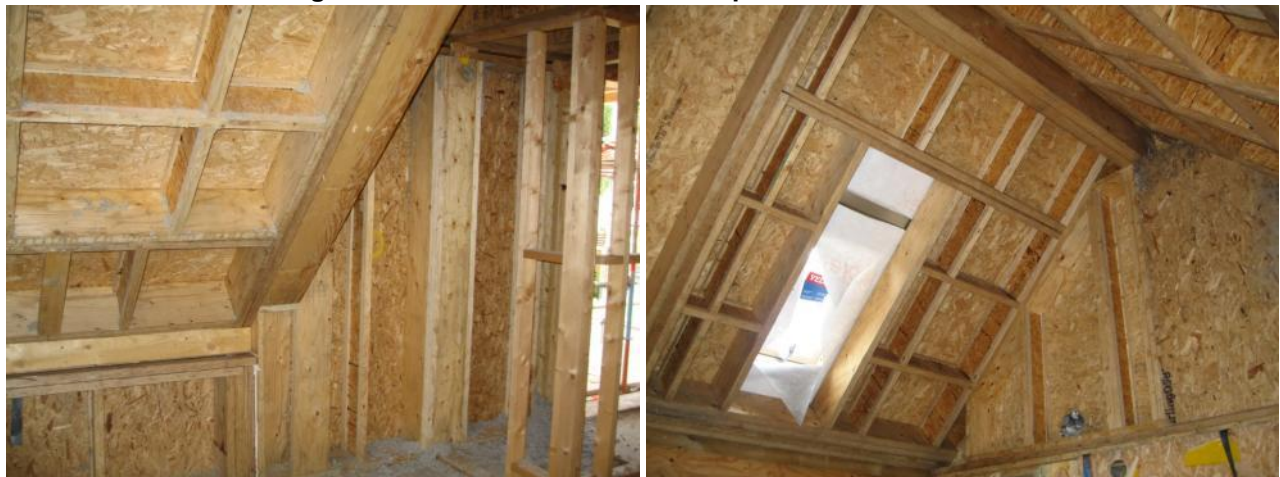
104 Photographs taken of the inside face of the roof structure during August 2007 when the inner OSB facing and insulation had yet to be refilled illustrate the level of additional timber in the roof panels (see Figure 65).

Figure 65 – Additional Timber in Exposed Roof Panels

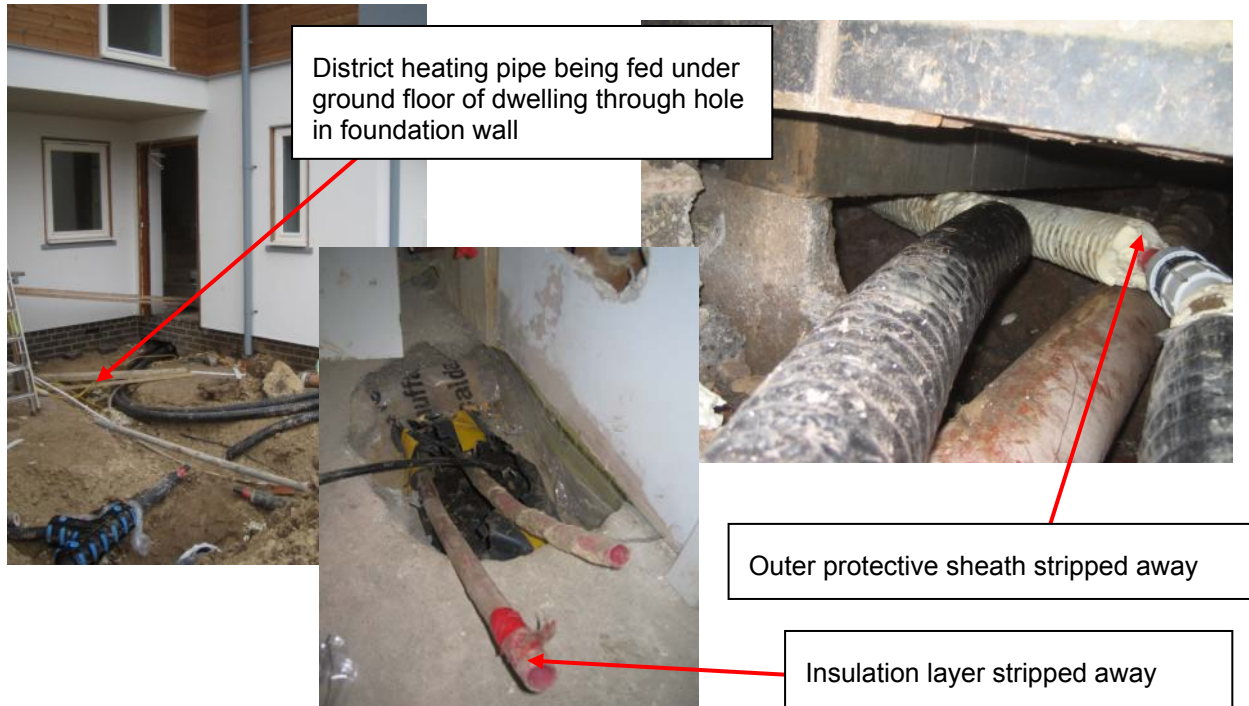
- 115 Another issue related to the laying of the district heating main was the sequencing of the heating pipe relative to the main structure of the building. It would have been easier to lay the pipe work at the same stage as the building foundations and before the construction of the beam and block floor. However, the main structure of the building had already been completed when the district main was laid. This caused significant difficulties as the pipe had to be fed through holes in the foundation wall in the side of the building and under the beam and block floor to the entry point in the floor in the middle of each dwelling (see Figure 70). As the pre-insulated Calpex pipe is relatively inflexible with a minimum bend radius of 0.7m (Calpex 2006), the construction operatives found it impossible to feed the pipe where required without stripping back the insulation layer from the outside of the pipe. In some cases the outer protective sheath of the pipe was removed which would allow water ingress into the insulation layer and mean that the insulation layer is much more easily damaged. The reason for the laying of the district main so late into the construction process is unclear but it is known that there were significant delays in ordering the pipework.

Figure 70 – Installation of District Heating Pipework

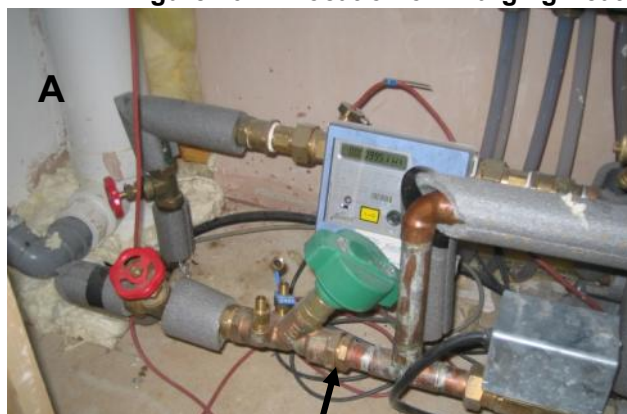
153 When the first monitored heat meter data were available from occupied dwellings in September 2008 it was found that the overall total heat input to some of the individual dwellings could not be resolved with the hot water input to the cylinders for those dwellings (on some days the hot water input was higher than the total input). Investigation of the installation of the heat meters in these dwelling showed that the incoming flow temperature sensor on the main charging heat meter was incorrectly positioned on the heating circuit after the split for the hot water circuit (see Figure 101A). The M&E contractors adapted the pipework and moved the flow temperature sensor to the correct position in the affected dwellings (see Figure 101B). If this problem had not been spotted then it would have resulted in some residents being undercharged for the heat that they had used.

Figure 101 – Location of Charging Heat Meter Thermocouple Sensor in House E

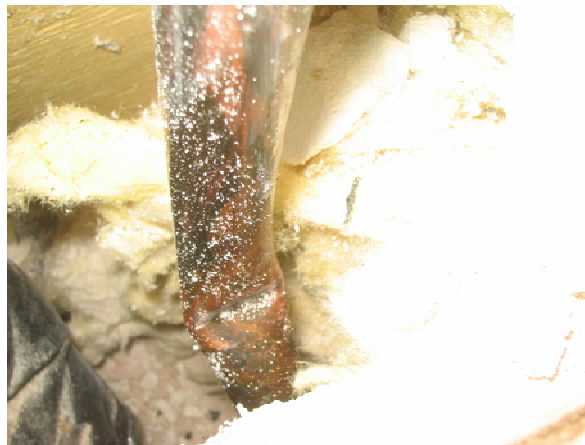
- b. **Kinked Pipework:** The monitoring data indicated potential problems with the restricted flow rates in at least 2 of the dwellings. Further investigations by the main contractor and solar system sub-contractor found that some of the solar pipework was kinked where the pipes changed direction from the wall to floor. Kinked pipe was found in two of the properties (House D and House B) and the faulty sections were replaced by the main contractor. An example of a kinked pipe is shown in Figure 105. In one case the pipe was also cracked at the kink which meant there was also a leak of glycol fluid which had stained the ceiling and also gave rise to a reduction in system pressure (See photograph of stain on ceiling plasterboard shown in Figure 106). It was suspected from the data that there were minor kinks at 2 of the other properties but it was decided that the reduction in performance was not serious enough to justify disturbing the residents. The piping material used was a pre-insulated copper which would be prone to kinking if the correct procedures are not used to bend the pipe or if elbow connectors are not used. It is likely that the insulation material covering the pipe would have prevented the plumbing engineer from seeing the damage at the time of installation.

Figure 105 – Kink in Solar Pipework (Pipe Insulation Removed)

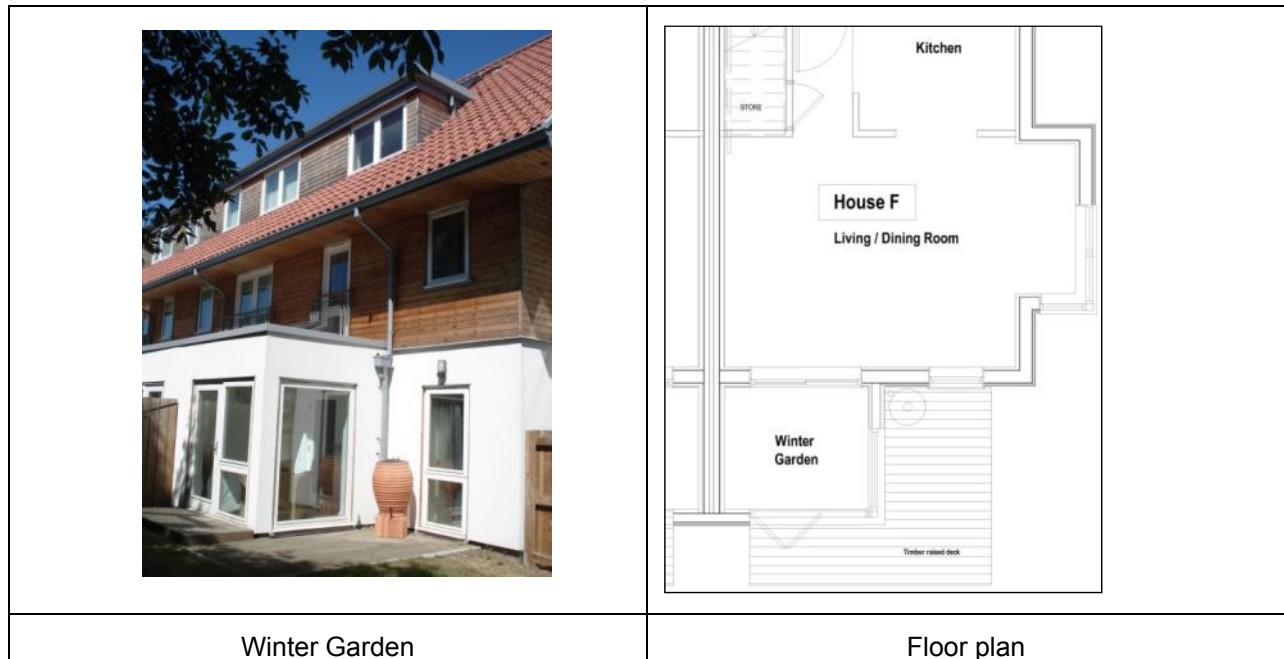
¹¹ A winter garden is a type of conservatory normally attached to the south facing façade of a building and designed to act as a buffer zone with potential for passive storage of solar energy. This type of feature is also sometimes called a sun space. The winter garden at Elm Tree Mews would be expected to provide some energy benefits in terms of reduced heat loss from the south facing wall on sunny days during the heating season. Although the walls of the winter garden are insulated and the glazing is of the same specification as the rest of the dwelling, the space is considered to be outside the thermal envelope and no provision was made for heating of the space using the under floor heating system. The patio doors between the winter garden and the living room are classed as external elements and are therefore also the same specification as the rest of the glazing. The nature of the site, which is over shaded by a tree belt on the boundary and a high wall, reduces the availability of solar energy in the winter and the lack of heating may make it a difficult space to use during the winter months, especially on cloudy days.

Figure 121 – Winter Garden on South Facade.

- 193 Similarly, the usefulness of the winter garden space¹¹, which is illustrated in Figure 121, was questioned by the residents of the mid-terraced properties. As one male tenant pointed out:
"You can't use it because there is no heating in it. We just use it as a dumping bin at the moment because you can't sit in it. You can't use it as a conservatory sort of thing. There's no heating in it. And it takes up [space], and the gardens very small anyway. It takes up a massive lump of the garden... If they came in and said, "We're asking people, would you have that or would you not?" I would say 'Knock it down. Today'."

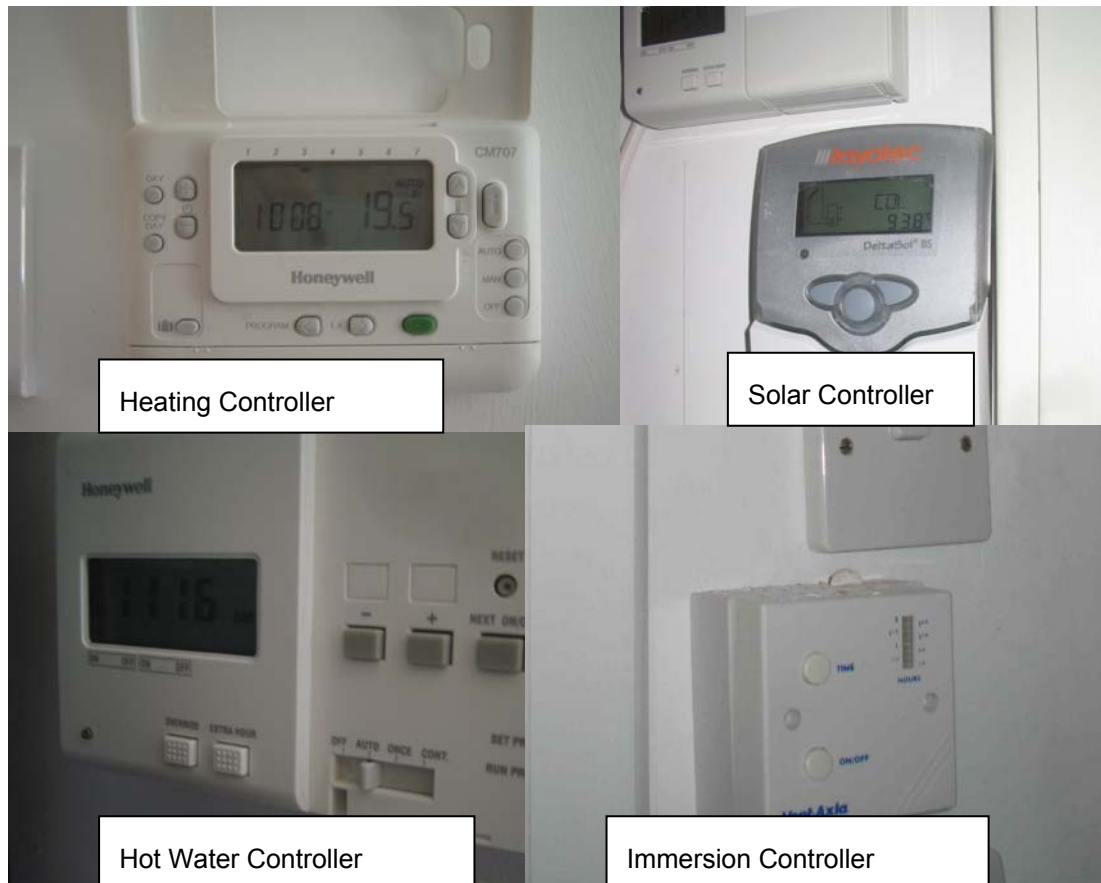
200 In the case of one Elm Tree Mews resident, feedback indicated that the operation of the heating and hot water controls was very confusing. The potential confusion is demonstrated in Figure 122 which shows the four main heating controllers in the dwellings, all of which have different displays and approaches to their operation. Residents need to feel that they are in control of their property and can 'manage it' on a day-to-day basis. This lack of clarity reduces this sense of control and their confidence and contentment in the property. In terms of the property's performance it is more likely to result in residents using the properties less effectively. Among residents, there were obvious concerns about the lack of technical knowledge of how things function and what to do to put them right, as one male tenant suggested,

Figure 122 – Heating System Controls

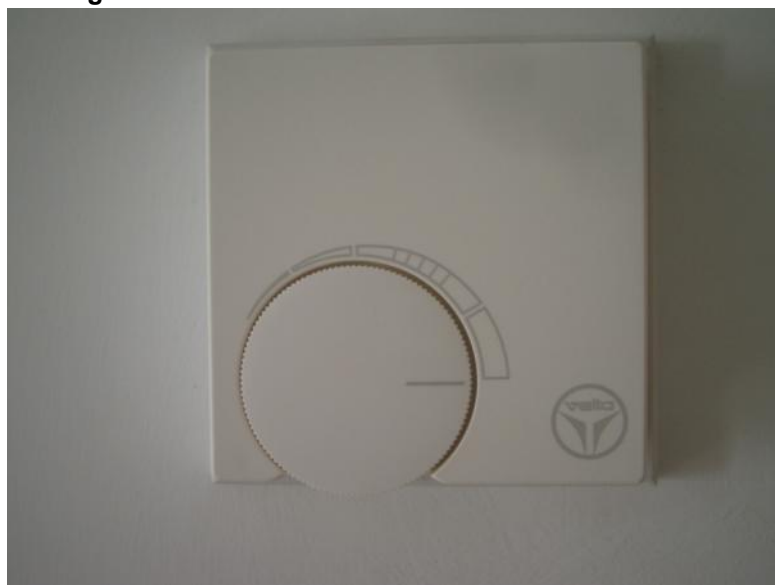
202 Crucially, the heating and hot water system was complex enough without seemingly simple technology such as a thermostat being difficult to understand and therefore to adjust. It also raises a more fundamental point about why such controls are used more generally in the construction industry when they are so clearly inappropriate for guiding residents on the internal temperatures of their dwellings. In the case of the room thermostats at Elm Tree Mews, the housing team at JRHT provided a description of the temperature scale of thermostats in the household information pack given to the residents (JRHT 2008).¹²

Figure 123 – Room Thermostat Dial at Elm Tree Mews

¹² The scale on the room thermostats ranges from a minimum of 5°C to a maximum of 30°C (Uponor, 2007)

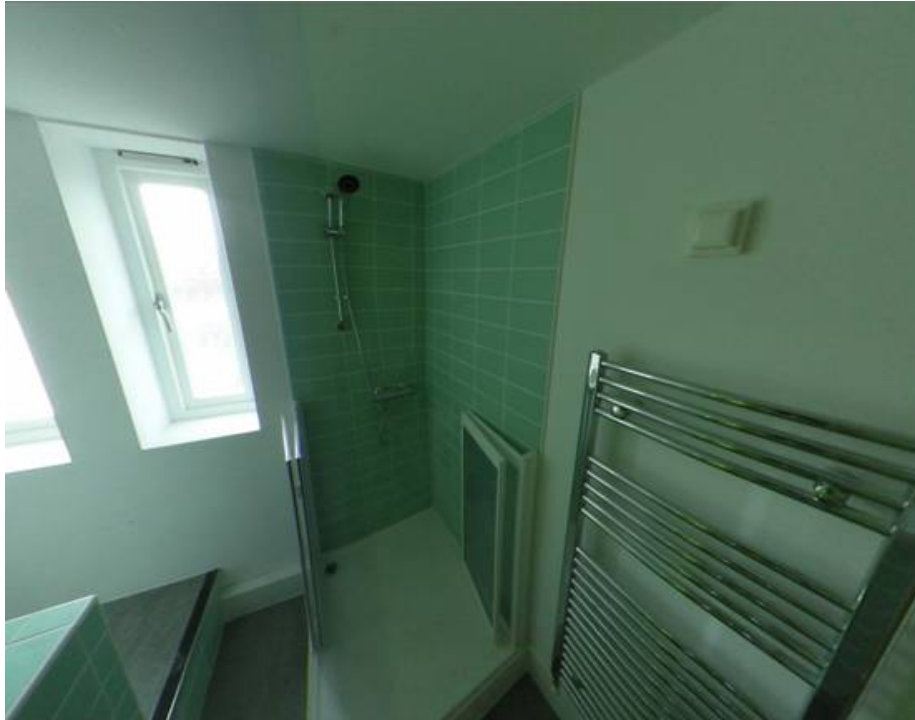
Figure 124 – Shower in En-suite Bathroom

- 209 A good example of how this intrusion has an effect on the way residents feel about the properties is the showers on the second floor. The doors to the shower cubicle in the en-suite bathrooms in the houses and duplex flat were a source of bewilderment and frustration to the residents. The showers were designed to be accessible for those with a disability and consequently the shower doors were of half height (see Figure 124).

- 210 However, the householders all noted that the showers leaked and asked for the doors to be replaced. However, it took a number of visits across a long period of time for the problem to be resolved because the type of shower unit being used was innovative but not functioning properly. The effect on residents was one of frustration as one resident noted,

- "Four months it took them to get that [fixed]. We couldn't use that shower for four months. Now I don't care who you are. Now that is ridiculous. And in the end after four months, they suddenly decided, that they would put a normal shower cubicle in. So we said to them, why didn't you just do that in the *** first place?" (Male resident with a family).*

- c) One resident mentioned mould issues in the en-suite bathroom. This was mostly a result of a leaking shower which was rectified during snagging. However, the same resident reported black mould on the window frames which may be an early indication of a lack of ventilation from the bathroom.
