## EVALUATING THE IMPACT OF AN ENHANCED ENERGY PERFORMANCE STANDARD ON LOAD-BEARING MASONRY DOMESTIC CONSTRUCTION

Partners in Innovation Project: CI 39/3/663

### Interim Report Number 5 – Post-Construction Testing and Envelope Performance

### Report Number 5: Post-Construction Testing and Envelope Performance

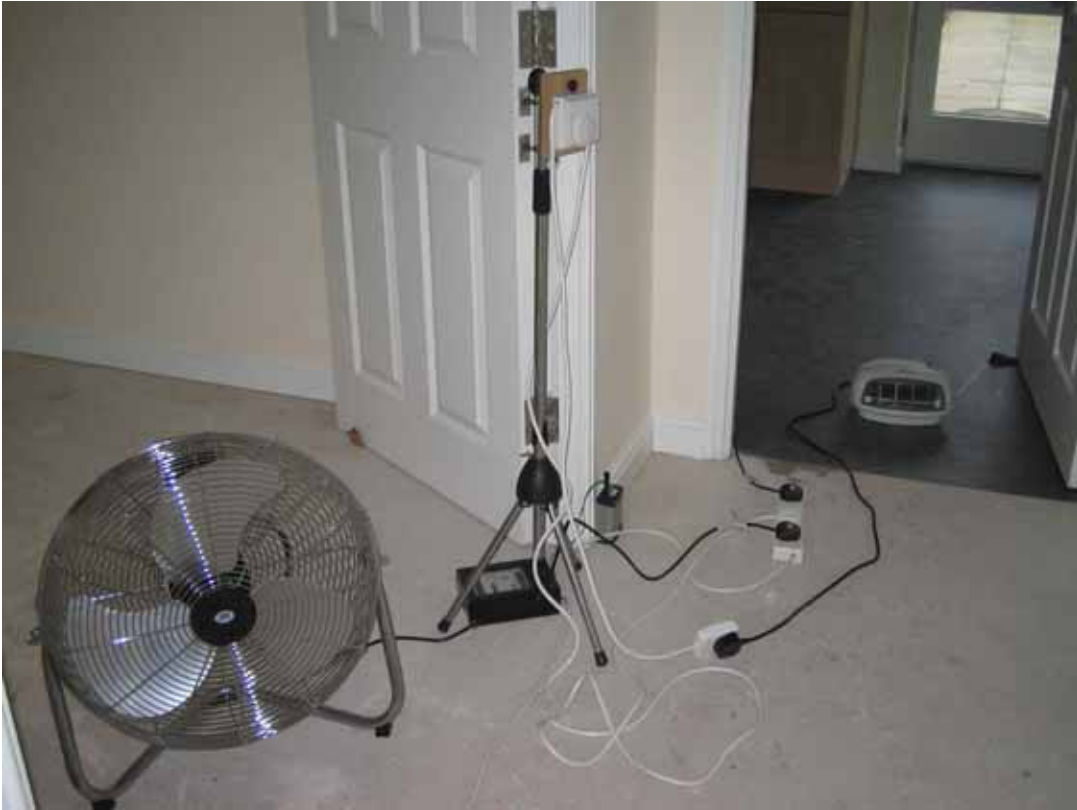
**Figure 1** - Co-heating Equipment on Location in Test Dwelling at Stamford Brook

- 23 The co-heating test equipment is illustrated in Figure 1. This photograph shows the fan heater, kWh meter, pulse transmitter, thermostat and one of the circulation fans in position on the ground floor of one of the test plots.

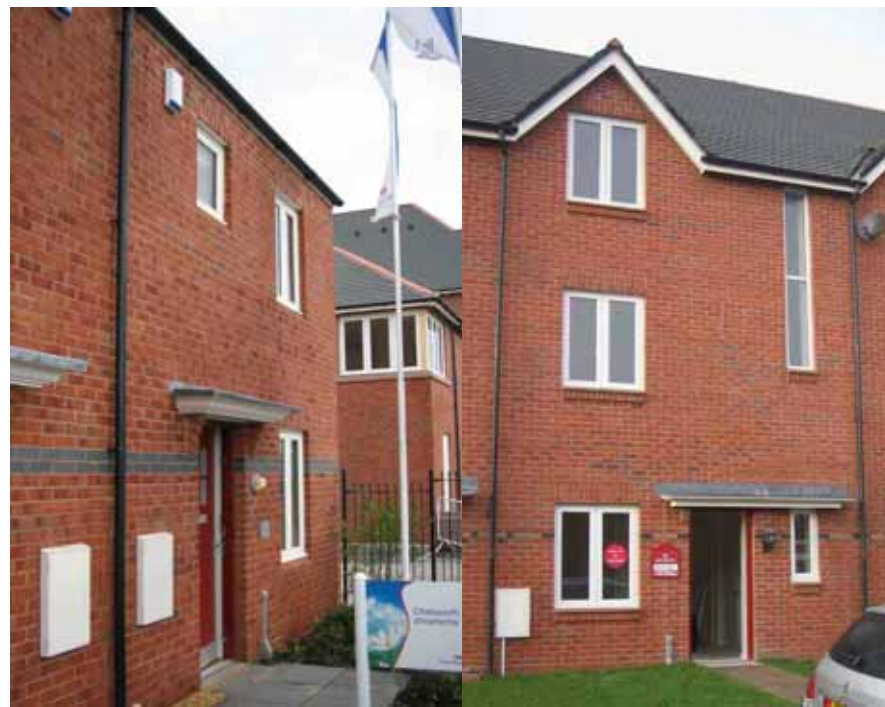
26 Photographs of the two co-heating test houses are illustrated in Figure 2. Plan, elevation and section drawings for the two different house types are illustrated in Figures 3 and 4.

Figure 2 - Photographs of the Co-heating Test Dwellings Plot 13 and Plot 402

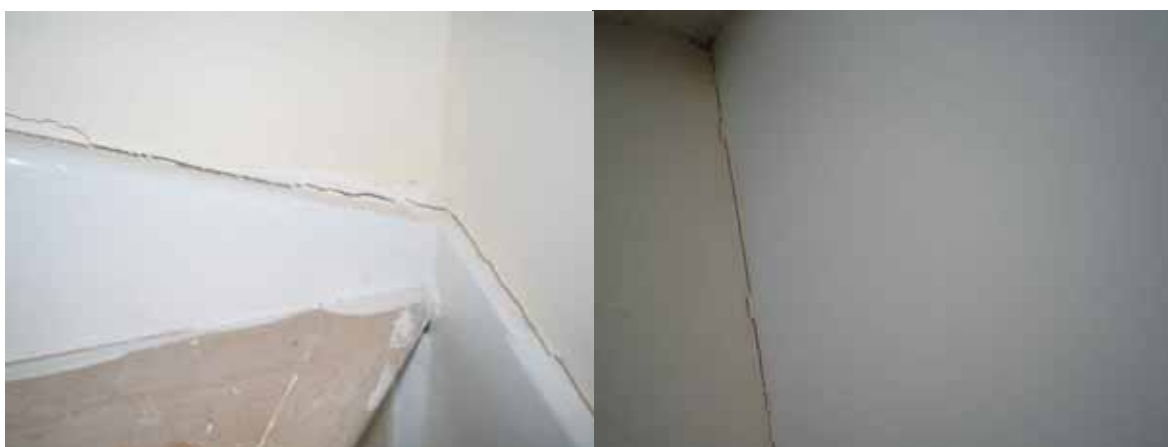
**Figure 10 - Cracks in Internal Walls of Plot 402 following Co-heating Test**

- 38 It is interesting to note that when the two dwellings were inspected visually after the co-heating tests, a large number of cracks were observed at internal junctions such as around the staircase and in corners, possibly due to shrinkage caused by the high internal temperatures during the tests. Some of these cracks are illustrated in Figures 10. However, as the air permeabilities did not increase significantly these internal cracks did not therefore indicate the presence of any large scale movement or cracking of junctions in the main air barrier such as the blockwork or parging layer.

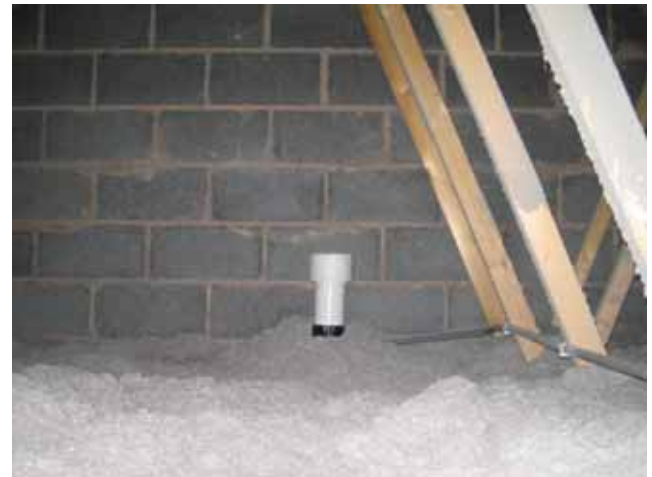
- 42 In comparison, an infrared image of the gable wall in the attic of plot 13 can be seen in Figure 15 alongside the equivalent photograph of the same location in Figure 16. The thermal image of the gable wall shows that its surface temperature is around 7°C, which is much closer to external conditions. The surface temperature of the waste pipe air admittance valve in Figure 15 is 11°C, which indicates another potential heat loss mechanism, although it is unlikely to be significant due to its small size. The thermal bridge at the junction between the ceiling and gable wall can be seen at the bottom of Figure 13 at around 12°C. This is at a lower temperature than the equivalent thermal bridge along the party wall. This difference is consistent with that predicted by the THERM modelling of these two junctions which gave a  $\Psi$  value for the ceiling-gable wall junction of 0.061 W/m<sup>2</sup>K and a  $\Psi$  value for the Bryant ceiling-party wall junction with 142mm cavity of 0.157 W/m<sup>2</sup>K.

Figure 16 Photograph Plot 13 Attic Gable Wall

- 43 The higher than expected surface temperature of the attic party wall during the co-heating test in plot 13 suggests that there may be some mechanism of heat loss involving the party wall and party wall cavity. However, it was not possible to investigate this further in plot 13 as the dwelling was due to be handed back to the developer.

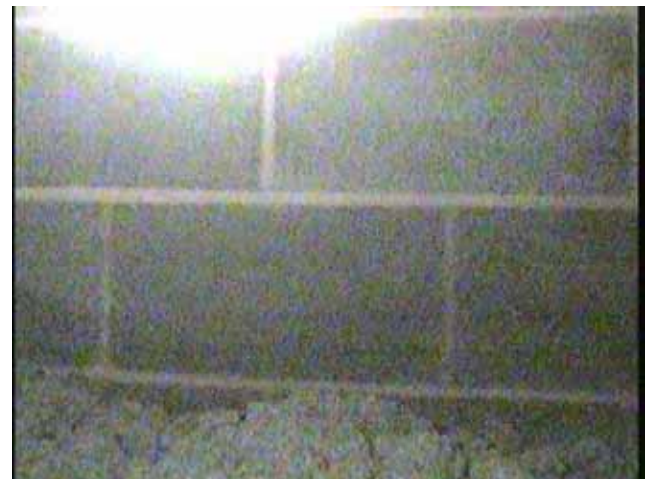
Figure 18 Photo Bottom Attic Wall 401-402

- 45 The thermal images show that the surface temperatures of the bulk of the surface of both attic party walls ranged from around 13.5°C to 15°C, with indications of increasing temperature towards the top. With the external temperature ranging between 3°C and 5°C at the time these images were taken, these attic wall surface temperatures are further evidence of a heat loss mechanism involving the party wall cavity as first indicated in plot 13.

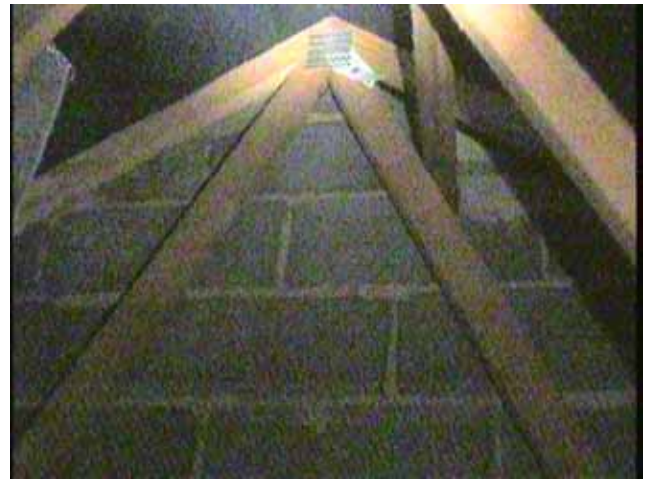
Figure 20 Photo Top Attic Wall 401-402

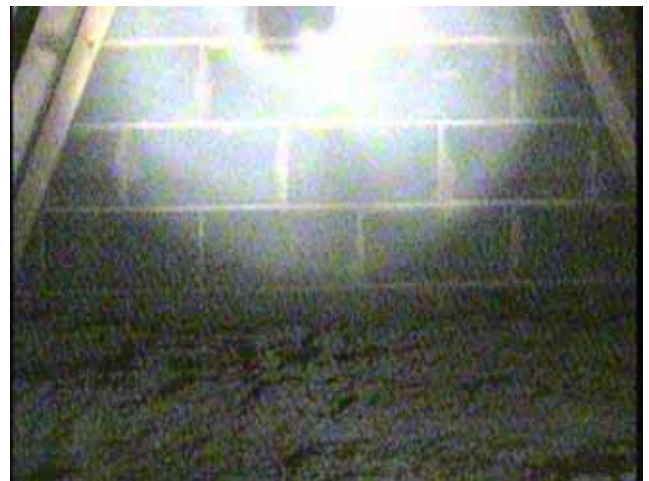
Figure 22 Photo Bottom Attic Wall 403-402

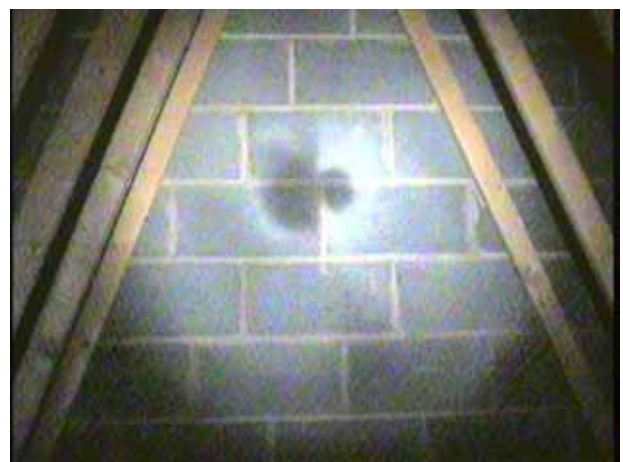
Figure 24 Photo Middle Attic Wall 403-402

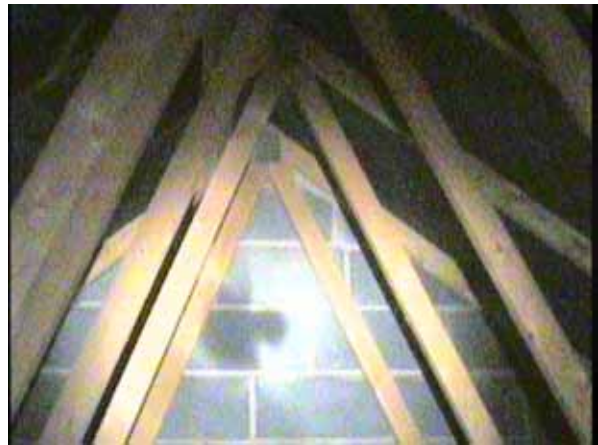
Figure 26 Photo Top Attic Wall 403-402

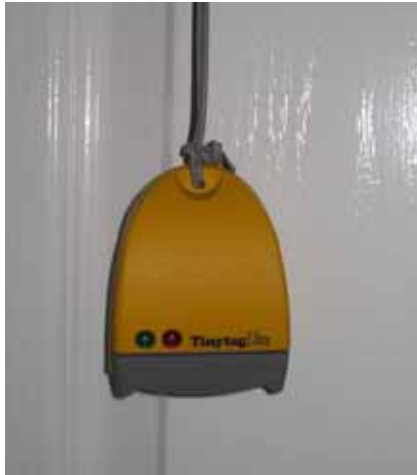
Figure 27 Tinytag Ultra Temperature Sensor

- 51 Photographs of a Tinytag Ultra sensor and a Tinytag Ultra sensor attached to a cable on location in the loft of plot 402 are illustrated in Figures 27 and 28. The internal temperatures inside the loft of plot 402 were logged by a combination of Tinytag Ultra sensors and Eltek GC-10 radio transmitter temperature sensors. For the temperature measurements in plot 402, the Tinytag and Eltek sensors were set to log both temperature and humidity at intervals of 10 minutes.

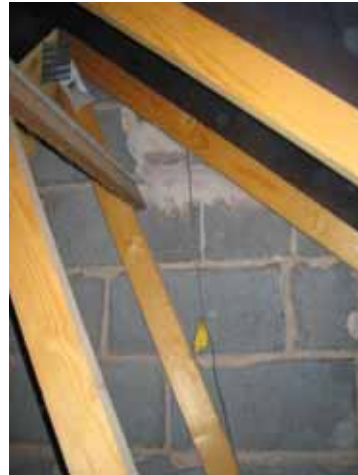
Figure 28 Tinytag Ultra Sensor in Plot 402 Loft

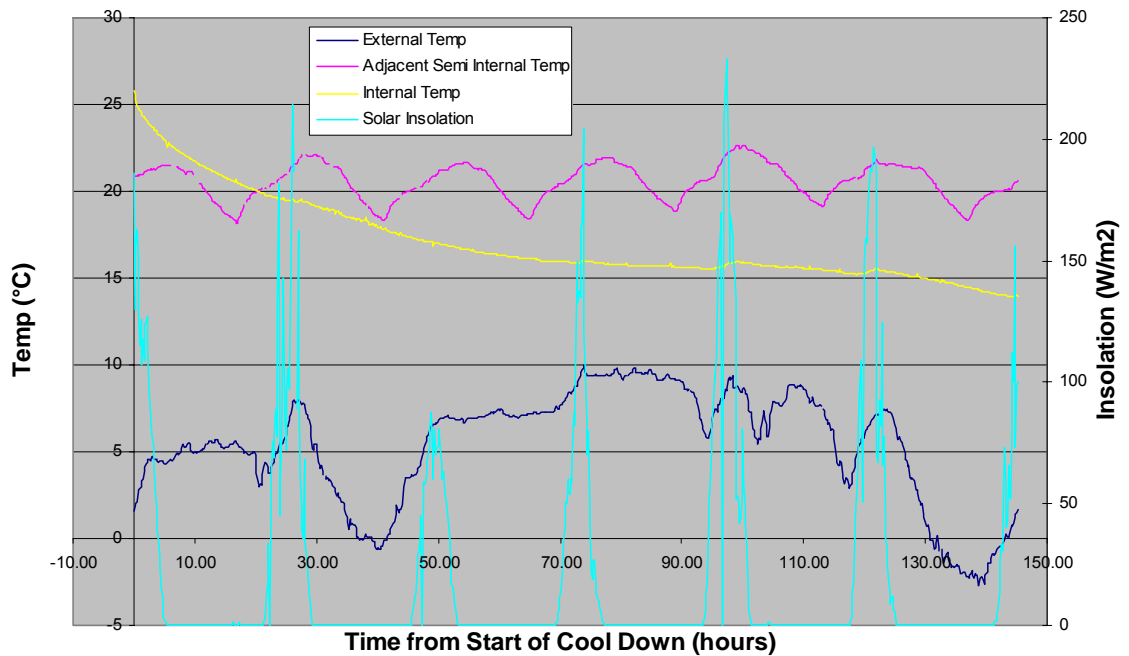
**Figure 35 - Co-heating Cool Down Curve for Plot 13**

- 72 The thermal capacity of a building is a measure of the ability of a building to store heat (Lowe 2005). It can be calculated from the product of the specific heat capacity and mass of all the materials within the thermal envelope of a building. Alternatively, it may also be calculated from the measured heat loss coefficient of a building and the thermal half life. The 1/e half-life constant of plot 13 was calculated from the first order exponential fit to the cooling decay curve as shown in Figure 36 to be 31.3 hours. The solar corrected building heat loss coefficient for plot 13 was measured to be 110.2 W/K. This gives a measured thermal capacity of 12417 kJ/K. This compares to a value of around 24000 kJ/K predicted from the thermal mass of the concrete block work and concrete slab. The thermal capacity value predicted from the thermal half life is therefore around half that we would have expected from the thermal mass of the dwelling. The reason for the discrepancy is likely due to the fact that the internal temperature had not yet reached the external temperature, giving rise to an underestimate of the 1/e constant.

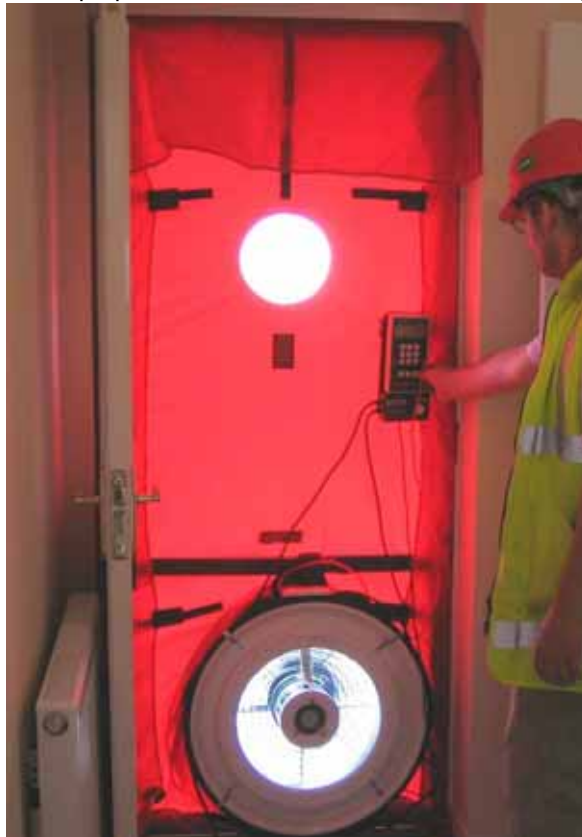
- 84 The test equipment used by Leeds Met to measure the air permeability of dwellings at Stamford Brook is summarised in Table 19. The blower door used was an Energy Conservatory Model 3 Minneapolis Blower Door. All tests, with the exception of inter-dwelling pressure tests, were conducted from inside the properties. The blower door is illustrated in Figure 37.

Figure 37 - Minneapolis Blower Door

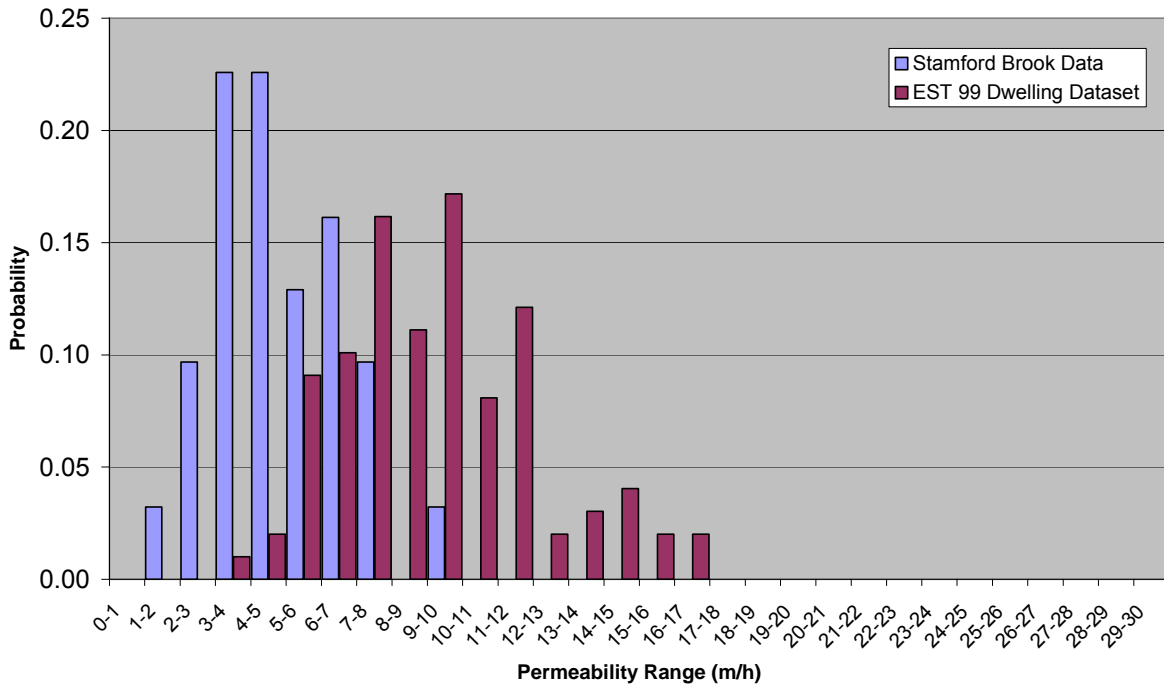
**Figure 42** - Probability Distribution of Stamford Brook Data and EST 99 Dwelling Dataset

95 A more recent study of airtightness for the Energy Savings Trust (EST) by Grigg (2004), reported the air permeabilities of 99 UK dwellings built to the requirements of ADL1 2002. The mean of this dataset was 9.2 m/h at 50Pa, and the values ranged from 3.2 m/h to 16.9 m/h. This indicates that the airtightness of dwellings at Stamford Brook is significantly better than dwellings built to meet the requirements of ADL1 2002. The probability distribution of the 31 dwelling Stamford Brook permeability data is compared to the probability distribution of the 99 dwelling EST database in Figure 42. The proportion of apartments in the 99 dwelling data set was 36% compared to only 10% for the Stamford Brook data.

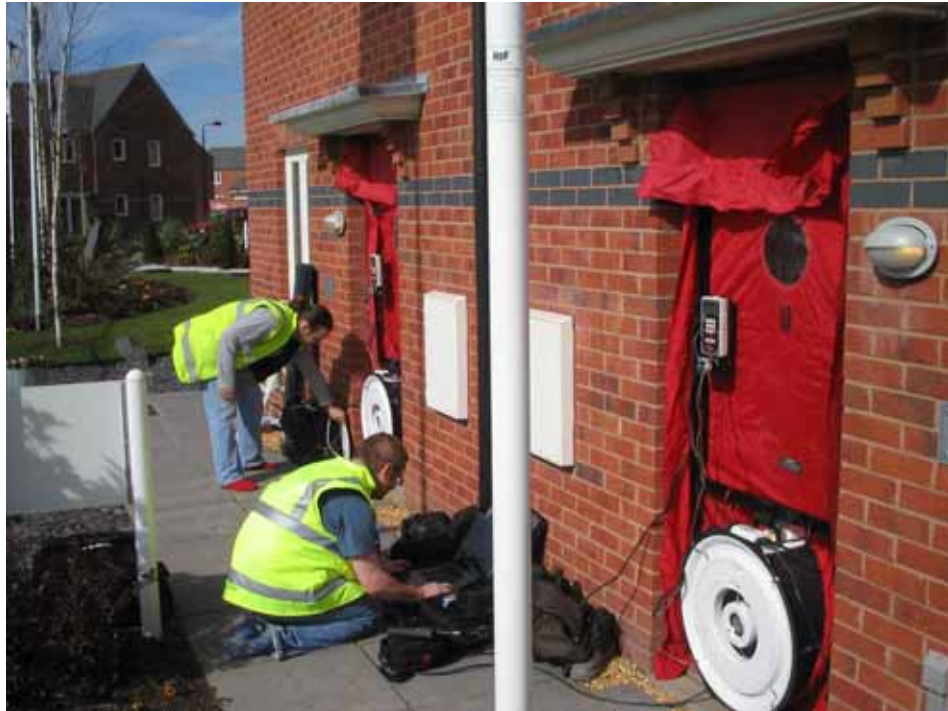
**Figure 46** - Photograph of Inter-dwelling Pressure Test using Two Blower Doors

- 102 A third test was conducted on plot 13, this time from the inside of the dwelling. The measured permeability was again 4.9 m/h. We therefore have three measurements on one day from one dwelling, all giving the same air permeability result of 4.9 m/h. This gives a degree of confidence in the repeatability of pressure test data from the Energy Conservatory Minneapolis blower door in conjunction with the TM23 pressure test procedure.

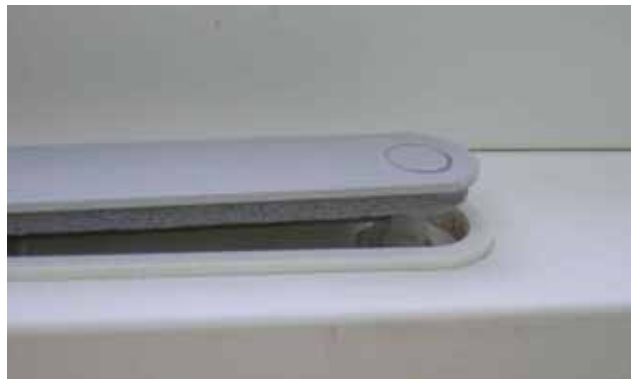
**Figure 47** - Trickle Vent on Rationel Window showing Foam Seal

- 104 The Danish Rationel windows were found to perform very well in terms of air infiltration, with no indications of any significant air movement at any point around the window seals. Some leakage had been noted on early dwellings at the junction between the framing elements of bay windows which had not been sealed correctly, but this was rectified on later dwellings. The Rationel window trickle vents (Figure 47) were found to have virtually no leakage in the closed position.

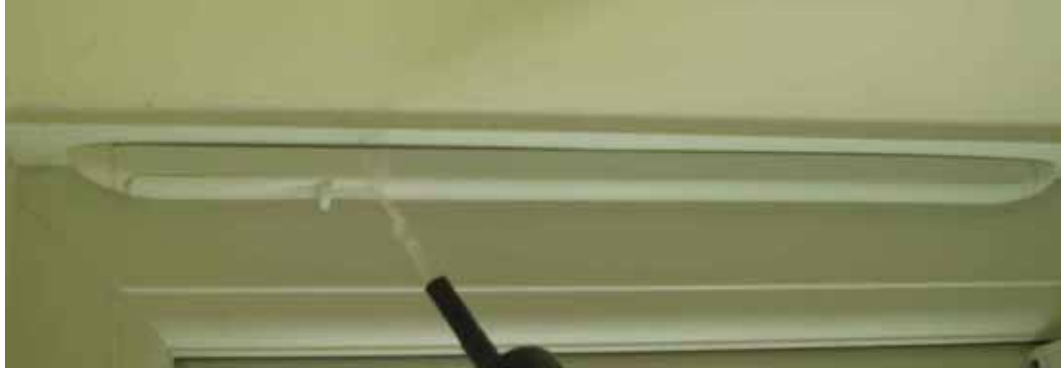
**Figure 48** - Leakage around Typical UK-sourced Trickle Vent (picture from Leeds Met L2 project)

- 105 The good performance of the Rationel trickle vents is in direct contrast to observations of significant leakage around various types of closed trickle vents on UK-sourced windows during airtightness tests undertaken on other developments during the L2 project (Johnston et al 2006). The Rationel trickle vents are supplied fitted with a compressible foam seal as shown in Figure 47. In comparison, trickle vents on typical new UK windows are usually closed using a simple plastic flap or some form of sliding mechanism without any proper seal (see example in Figure 48).

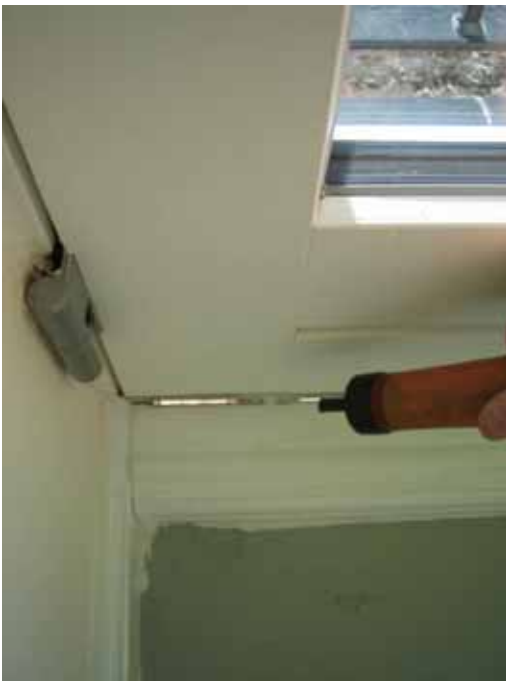
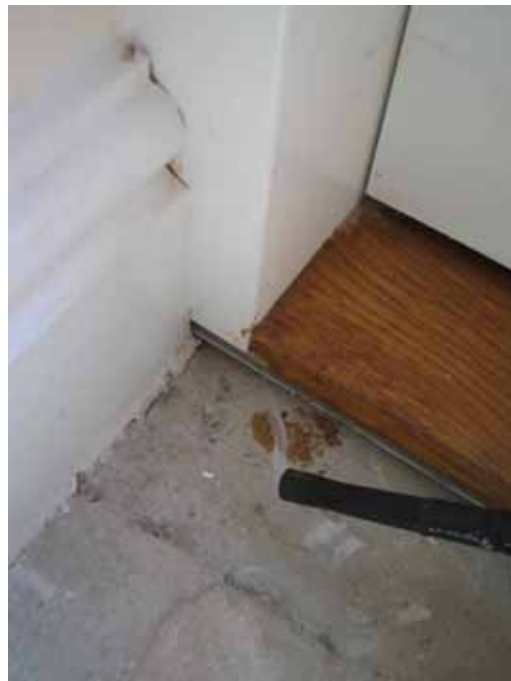
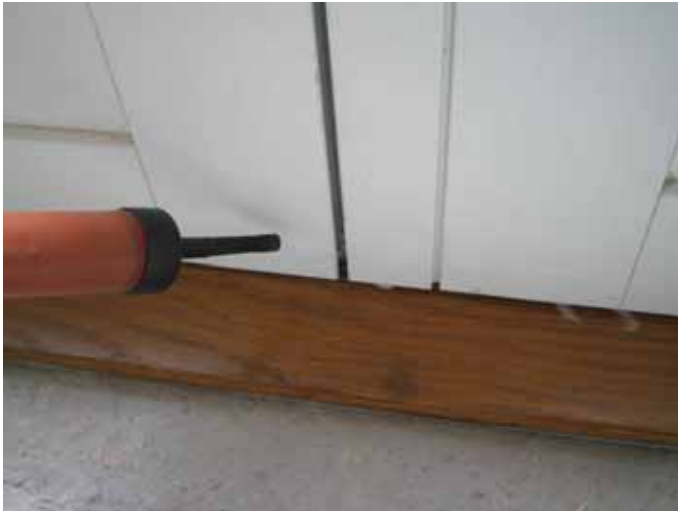
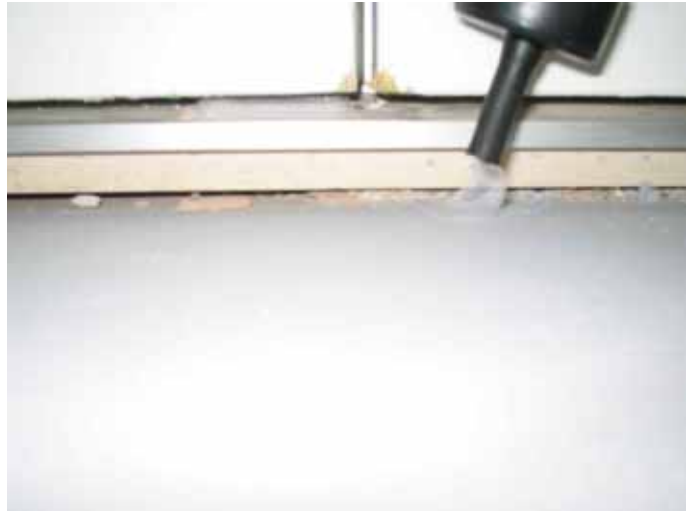
- 106 The Rationel back doors were in general free from any significant air leakage around the seal between frame and door. It was not possible to test the seal around any of the front doors or through the letterbox, as the blower door was always located in the front door frame during the pressure test.
- 107 Patio doors were found to be a common source of significant leakage on many of the dwellings tested at Stamford Brook. Leakage was found to occur at several different locations including under unsealed door thresholds, at the bottom corners at the junction of the threshold with the wall and also on several occasions where the door closing mechanism was faulty such that the door seals were not fully compressed giving rise to leakage between the frame and patio door. Some examples of leakage around patio doors are illustrated in Figures 49 to 52.

**Figure 49** Patio Door Leak at Unsealed Threshold

**Figure 50** Patio Door Leak at Threshold Corner

**Figure 51** - Leak between Patio Doors

**Figure 52** - Leakage under Threshold

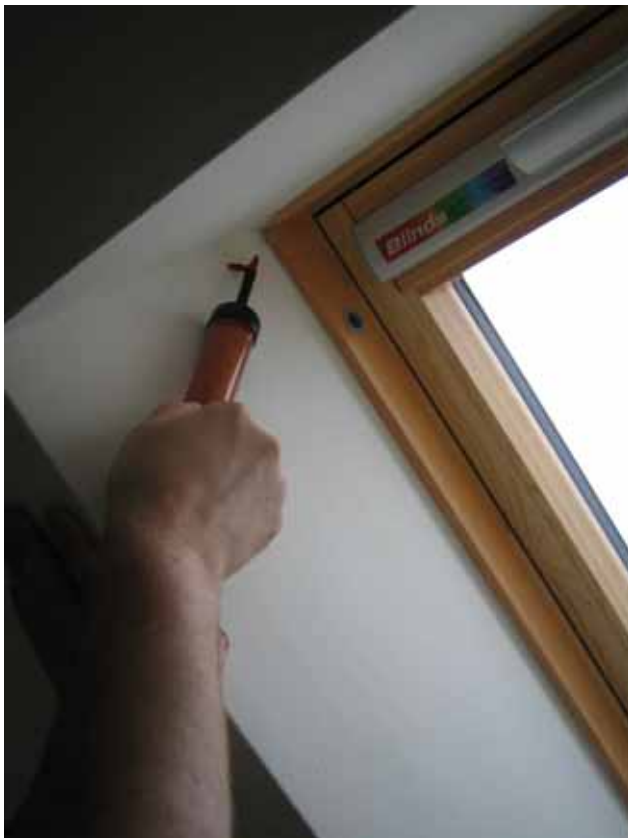
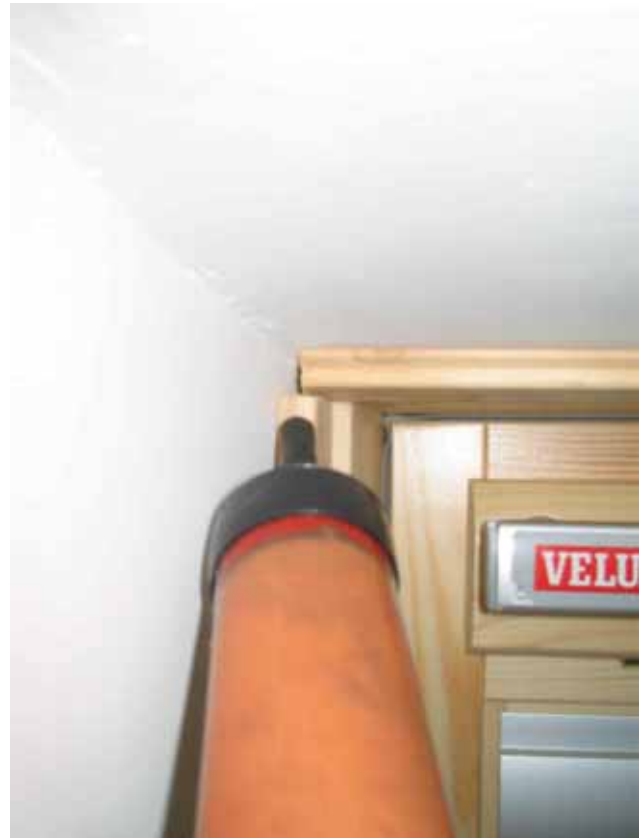
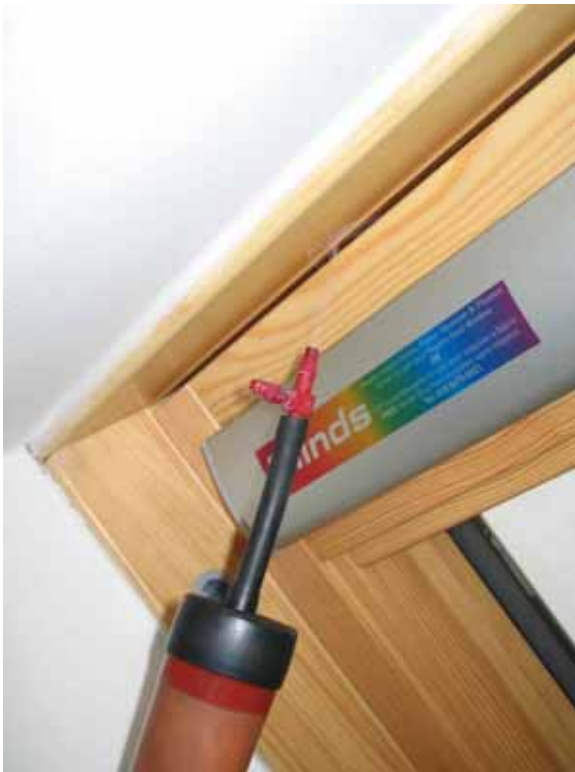
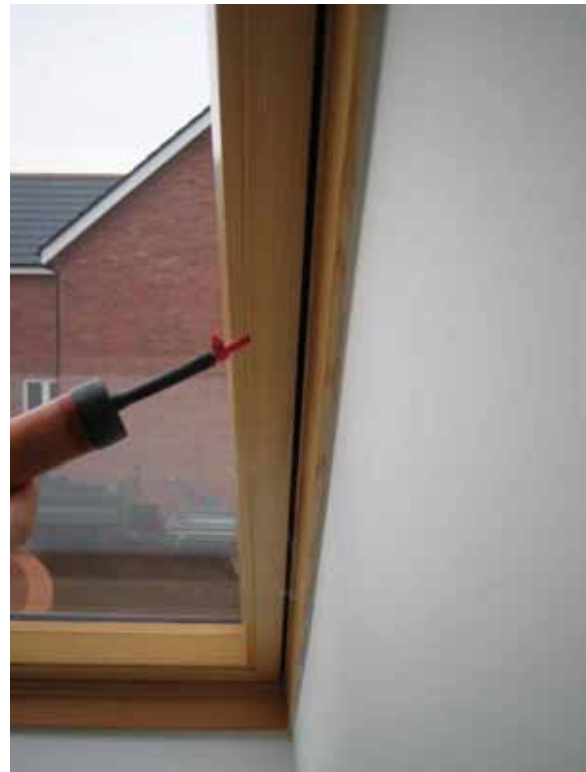
108 The rooflights used by both developers (Redrow rooflights were supplied by Keylite, Bryant rooflights were supplied by Velux) were found to be associated with significant leakage around the trickle vents, between window and frame, and at the joint between the frame and ceiling plasterboard. Examples of leakage around rooflights are illustrated in Figures 53 to 56.

**Figure 53** - Leakage around Rooflight Frame

**Figure 54** - Leakage around Rooflight Frame

**Figure 55** - Leakage at Rooflight Seal

**Figure 56** - Leakage at Rooflight Seal

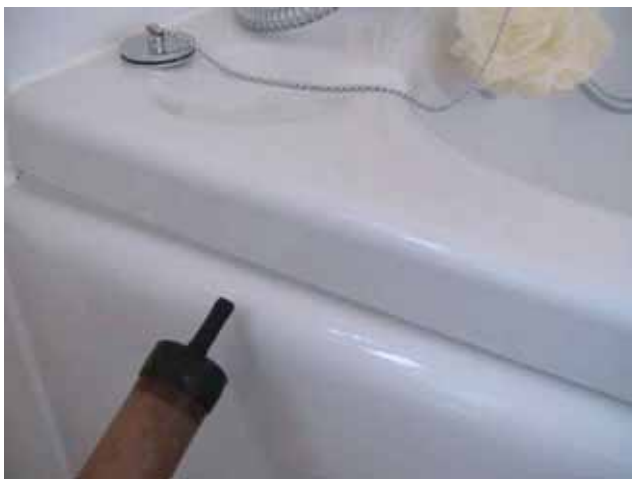
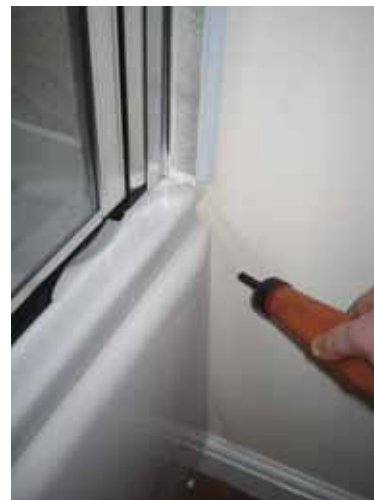
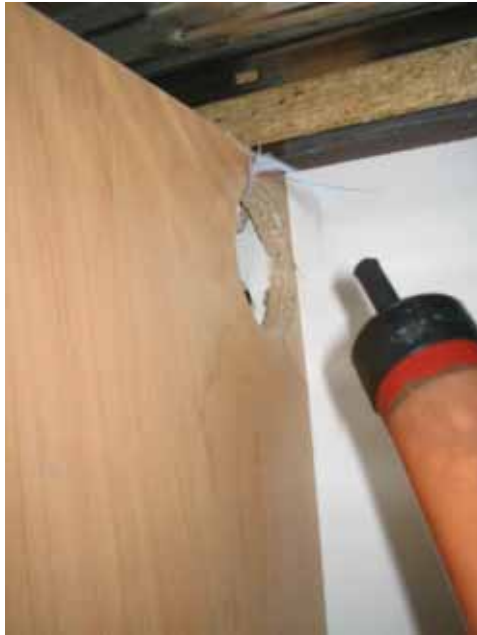
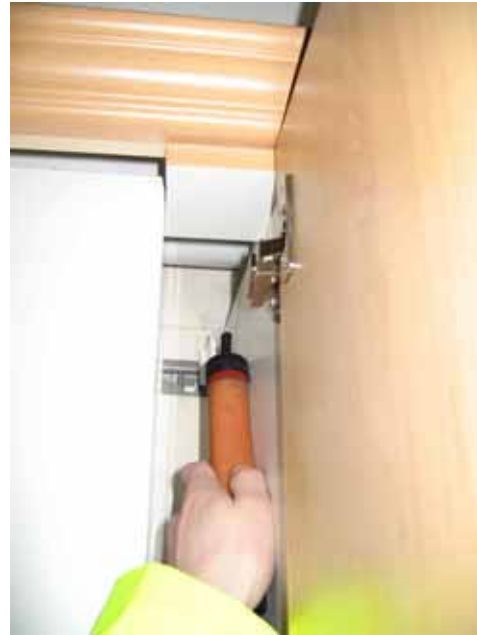
Figure 61 - Leak around Bath Panel

Figure 62 - Leak at Shower Tray

**Figure 63** - Leak behind Kitchen Cabinets

**Figure 64** - Leak behind Kitchen Cabinets

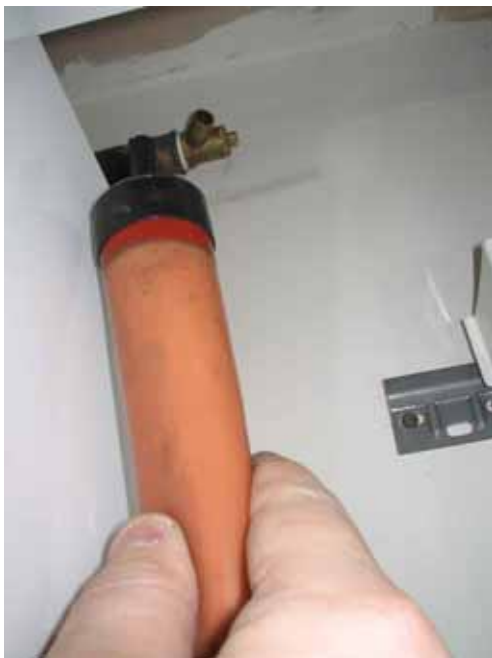
**Figure 65** - Leak at Boiler flue

- 112 In general, service penetrations were found to be well sealed. The main exception to this was the boiler flue outlet, which was found to be leaky in some dwellings (see example in Figure 65). Attempts had usually been made to seal the joint but were in some cases this had been unsuccessful, apparently due to difficulties in access to the rear of the joint closest the wall. A more common leakage point was behind the consumer unit as shown in Figure 66.

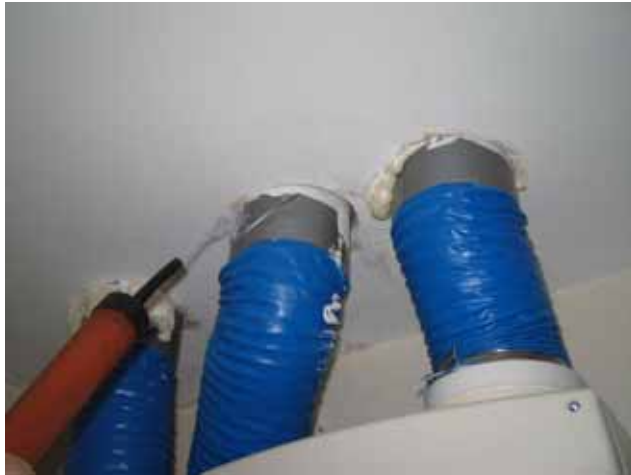
- 115 The Ventaxia fan unit for the MEV system was also located in the cylinder cupboard. This meant that the flexible and solid ducting for the ventilation system was routed through the cupboard ceiling. In many tested dwellings the penetrations for the ducts through the ceiling had not been properly sealed, if at all. An example is shown (Figure 71) where two of the duct penetrations had been sealed but one had been forgotten. In the worst cases, inappropriately large, sometimes

**Figure 71 - Unsealed Duct Penetration**

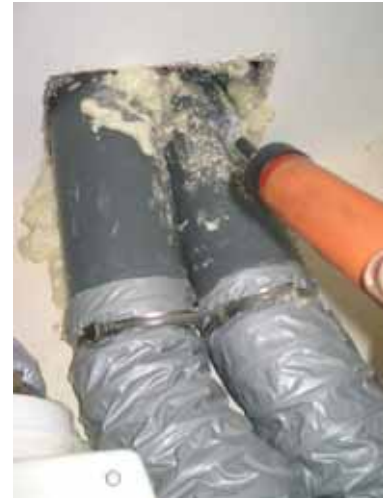
square holes had been made to route the ducting through. These large holes were often left unsealed (Figure 72).

**Figure 72 - Oversize Hole**

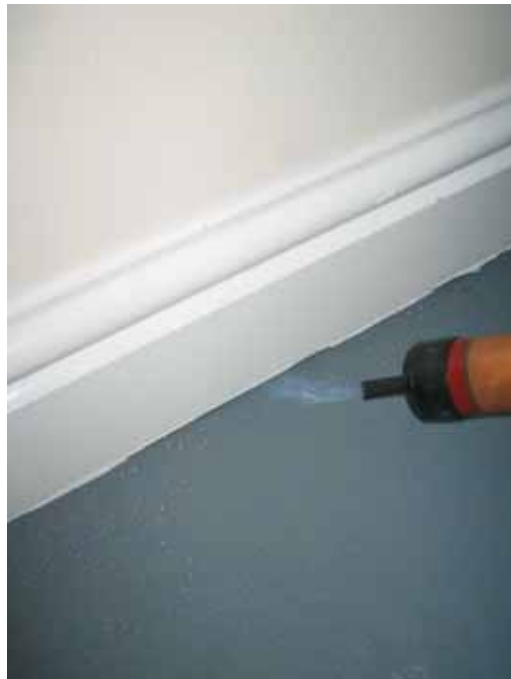
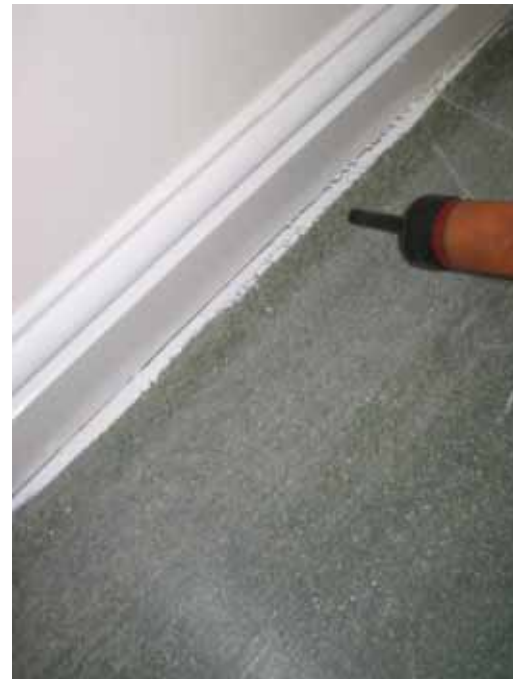
**Figure 73 - Leakage at Floor-Wall Junction**

**Figure 74 - Leakage at Floor-Wall Junction**

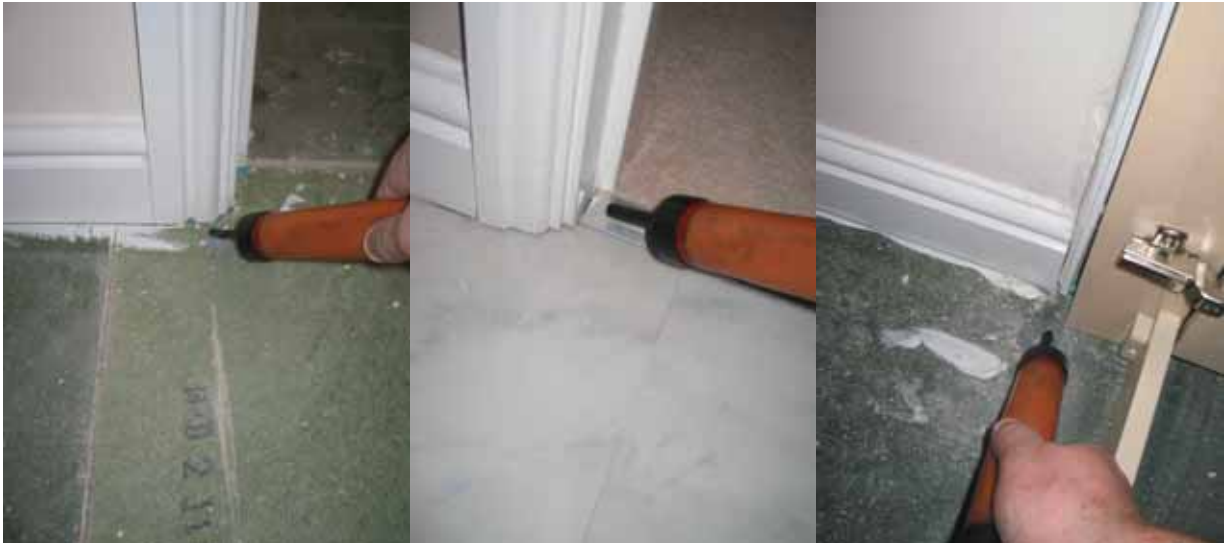
**Figure 75 - Leak at Partition Wall    Figure 76 - Leak at Partition Wall    Figure 77 - Leak at Partition Wall**

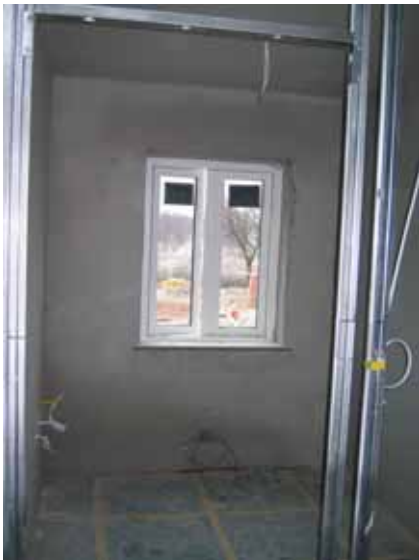
- 121 It is likely that the reason why plots 13 and 14 did not exhibit air loss via the partition walls, is due to the different construction method employed on these two dwellings, which were the first two properties constructed by Bryant. For plots 13 and 14, the top floor ceiling was erected before the partitioning (Figure 80). This meant that the ceiling air barrier formed by the plasterboard was continuous. All subsequent dwellings constructed by both Bryant and Redrow had the partitions erected before the ceiling as seen in Figure 81. This resulted in gaps in the plasterboard air barrier where the partitions were located. Air could easily move through the partition and into the loft via the cut-out holes in the steel frame that are provided for routing services.

**Figure 80** - Plot 13 Ceiling Erected before Partitions

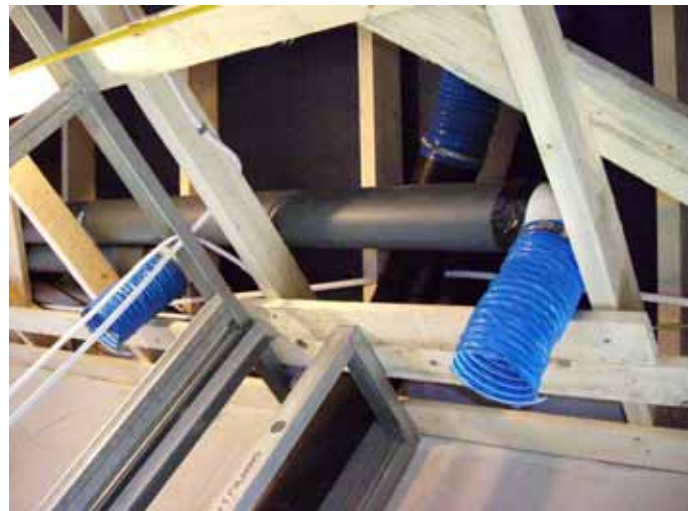
**Figure 81** - Partitioning Erected before Ceiling

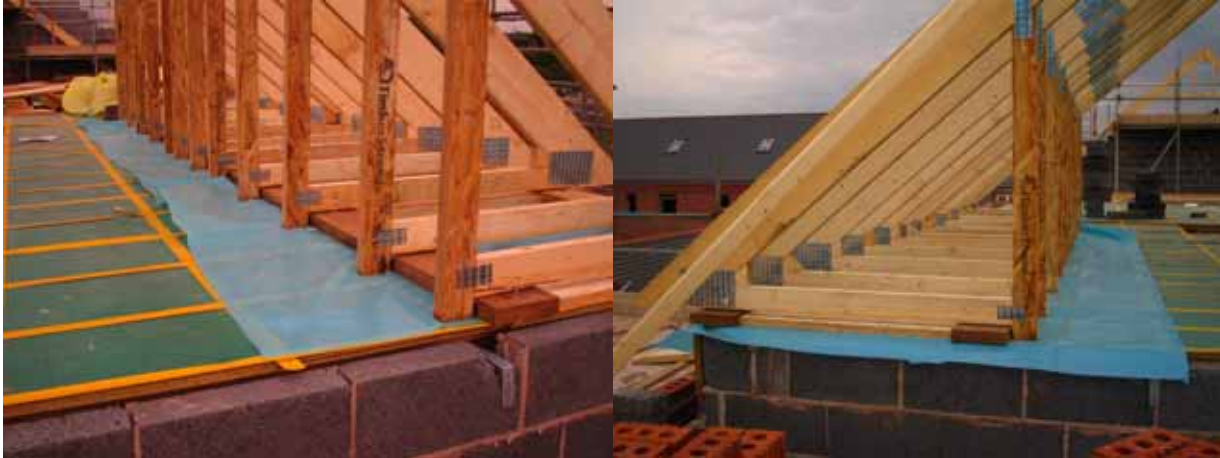
- 127 The solution proposed and adopted by the Redrow site team was to lay a sheet of polythene damp proof membrane under the roof trusses and above the chipboard flooring as shown in Figure 85, with the aim being to use the polythene to provide the link in the air barrier between parging and plasterboard.

**Figure 85** - Polythene Sheet Air Barrier under Roof Truss in Redrow Room-in-Roof Property

- 128 The pressure test results for Redrow roof-in-the-roof designs that were constructed using the polythene sheet method shown in Figure 85 do not however show any significant improvement in air permeability. The permeabilities of the two Derwent type dwellings plots 418 and 419 that were constructed using the plastic sheet method were 7.4 m/h and 7.8 m/h respectively. This is actually higher than the permeabilities for the two Derwent type dwellings (plots 309 and 311) constructed before the design change took place which came in at 6.1 m/h and 7.0 m/h. One of the reasons why this method was not successful is likely due to the fact the polythene sheet was not properly linked to either the parging or plasterboard. This can be seen in Figure 86 which shows that the bottom edge of the polythene is cut short and nailed to the end board and does not actually link with the parging layer. It can also be seen that the side of the polythene sheet also finishes short of the edge of the flooring. There is clearly more work to be done here in the fine detailing of this solution to make it airtight, though it should be possible to achieve a very tight roof.

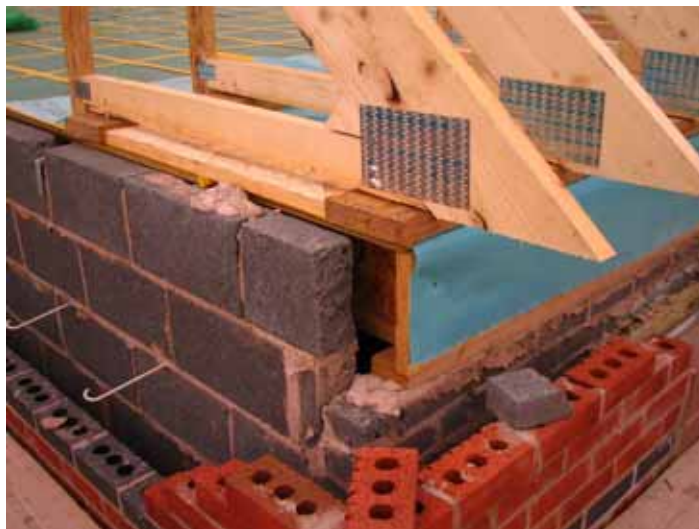
**Figure 86** - Polythene Sheet Air Barrier in Room-in-Roof Dwelling

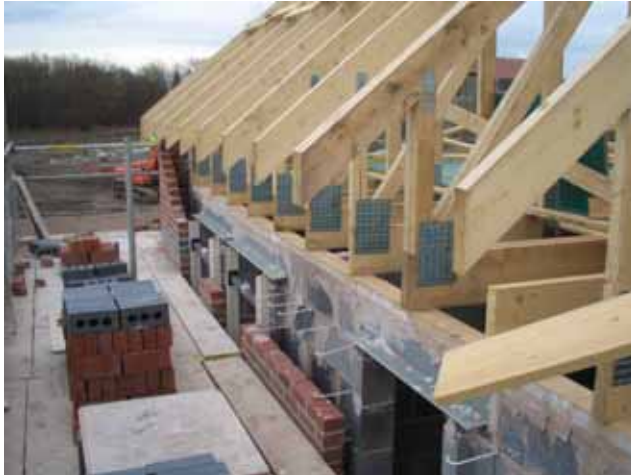
(TrusJoist 2006) used in earlier dwellings on the development. For example, attic trusses are being installed on Redrow Tweed type dwellings at Stamford Brook as illustrated in Figures 87 and 88.

**Figure 87** - Attic Truss at Stamford Brook

- 130 It would not be possible to use the same technique for attic trusses of laying a polythene sheet between the floor and truss, as the attic truss is designed as a single piece as can be seen in Figures 87 and 88. The Redrow design team submitted the proposed attic truss detail to the Leeds Met team for comment and the weaknesses of the design in terms of airtightness were pointed out to them. Nonetheless, Redrow decided to go ahead with the change, without incorporating any special measures for airtightness at the room-in-roof junction save a polythene layer at the knee wall. The permeabilities of the first two Tweed properties that were pressure tested both exceeded the 5 m/h target at 6.2 m/h for plot 517 and 6.0 m/h for plot 518. This is around twice the mean permeability for standard 2-storey detached houses at Stamford Brook of a similar size. Clearly, more thought must be given by the developers to the design of a continuous air barrier for room-in-roof houses with attic trusses.

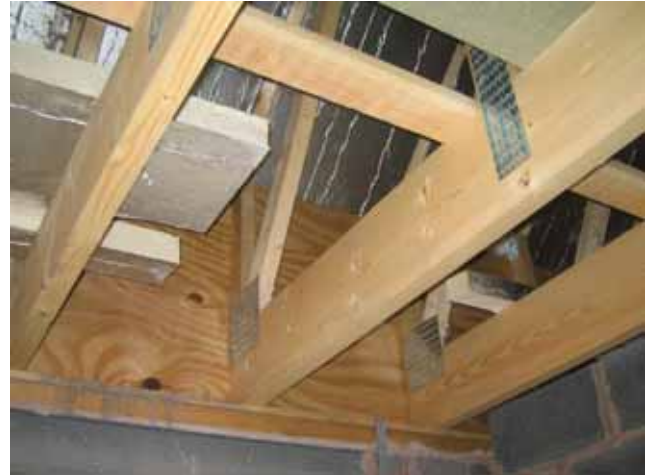
**Figure 88** - Attic Truss Viewed from Below

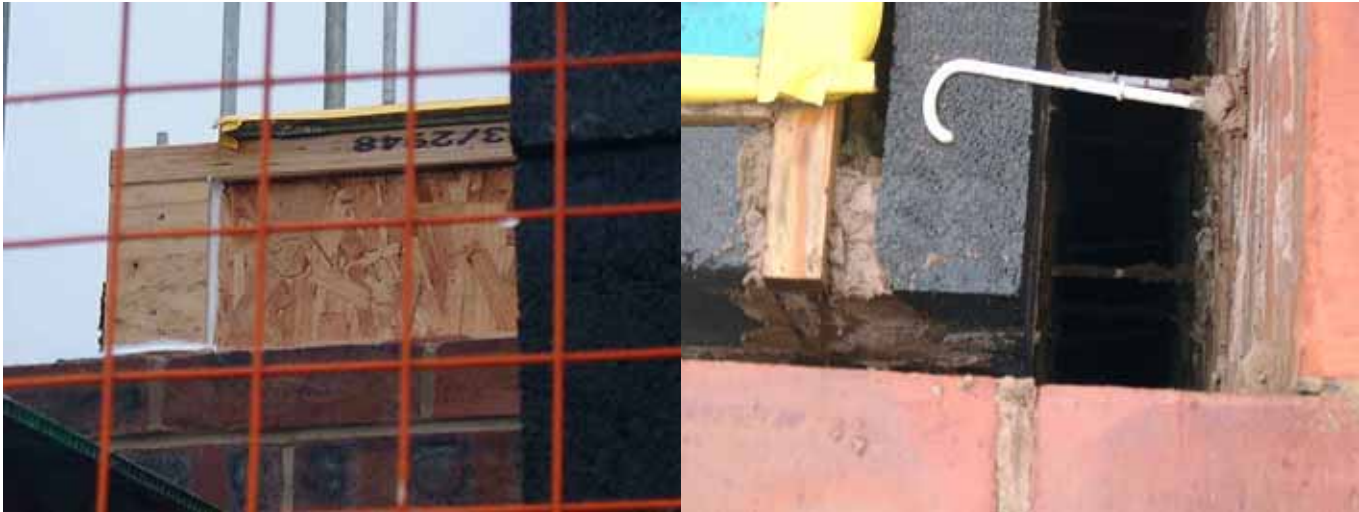
**Figure 91** Filler End Pieces on I-beam Web      **Figure 92** Gap Filled between End Beam and Wall

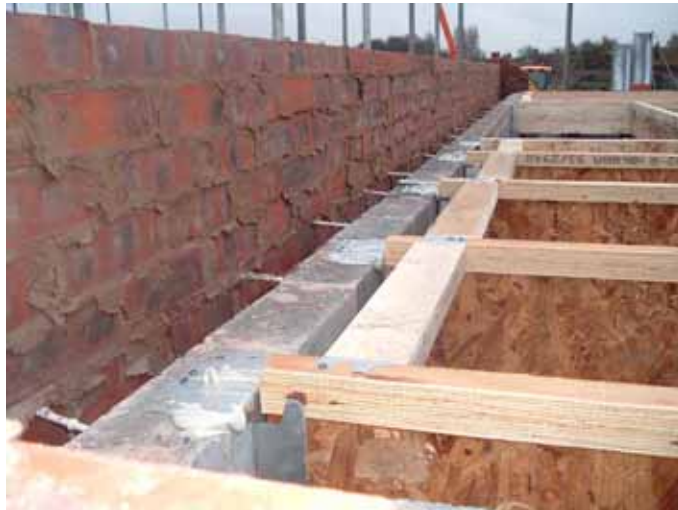
**Figure 94** - Intermediate Floor Being Installed on Joist Hangers

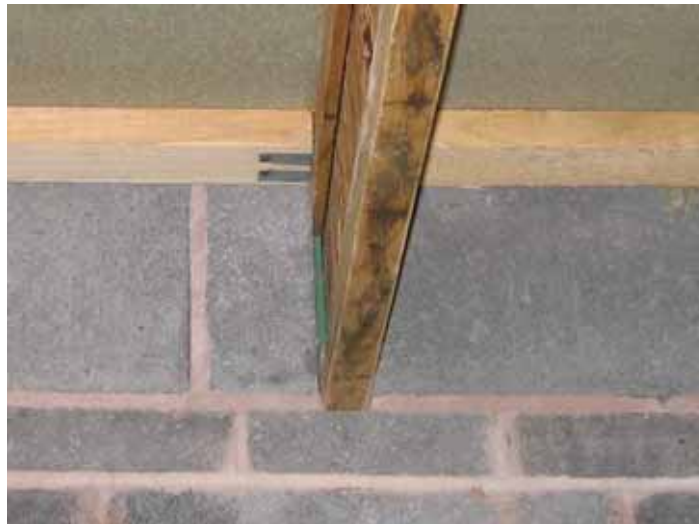
- 140 The developers have shown some initiative in trying out new ideas. An example of this is the use of foam inserts for I-beam joist ends as an alternative to the timber filler pieces. A foam insert is illustrated in Figure 95 and a foam insert in situ is shown in Figure 96. Since no tests on this approach have been conducted, it is not possible to comment on its effectiveness.

**Figure 96 - Built in I-Beam with Foam Insert**

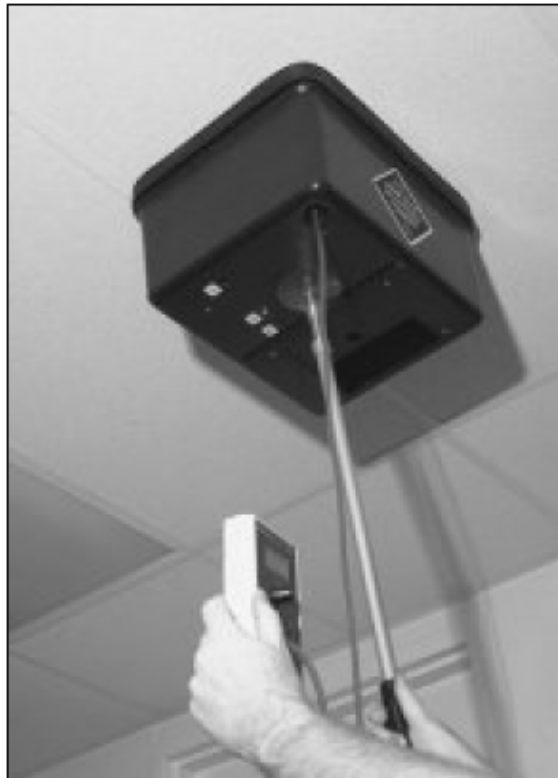
- 167 Flow rates from the MEV systems extract vents were measured using an Energy Conservatory Exhaust Fan Flow Meter in conjunction with an Energy Conservatory DG-700 digital pressure gauge. The test procedure is described in the operation manual (Energy Conservatory 2003). A photograph of the test equipment in operation is shown in Figure 98. The Fan Flow Meter has an effective flow measurement range of 13 m<sup>3</sup>/h (3.6 l/s) to 210 m<sup>3</sup>/h (58.5 l/s) with an accuracy of  $\pm 10\%$ . This range would be expected to be sufficient for all MEV vents at Stamford Brook which would be expected to have flows in the range 18 m<sup>3</sup>/h (5 l/s) to around 54 m<sup>3</sup>/h (15 l/s).

**Figure 98** - Exhaust Fan Flow Meter in Operation (Energy Conservatory 2003)
