## EVALUATING THE IMPACT OF AN ENHANCED ENERGY PERFORMANCE STANDARD ON LOAD-BEARING MASONRY DOMESTIC CONSTRUCTION

Partners in Innovation Project: CI 39/3/663

### Interim Report Number 5 – Post-Construction Testing and Envelope Performance

### Report Number 5: Post-Construction Testing and Envelope Performance

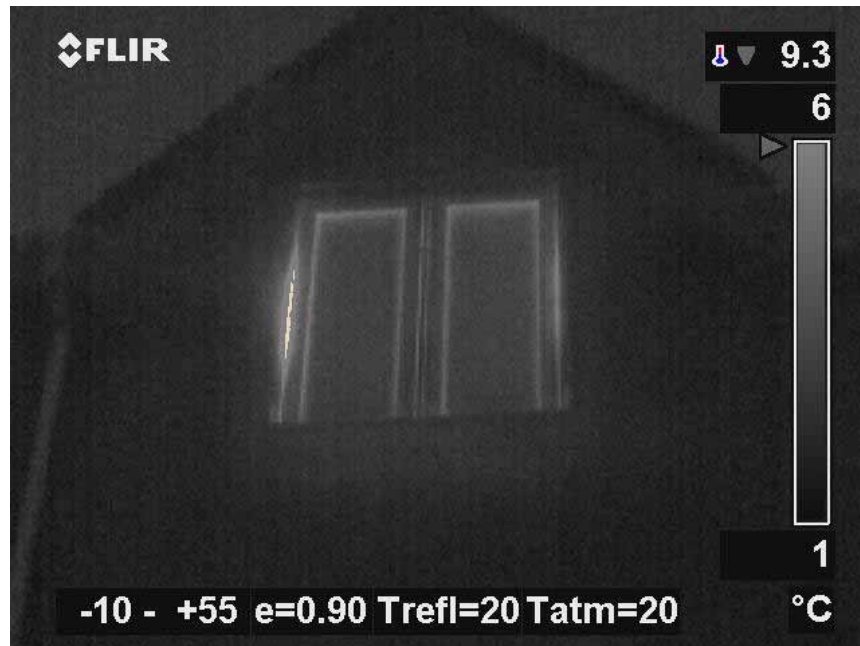
- 188 The external thermal image of plot 406 illustrated in Figure 104 indicates higher heat loss through the trickle vents of the Rational windows which are located along the sides of the window frame.

**Figure 104**- Thermal Image Showing Heat Loss through Window Trickle Vents

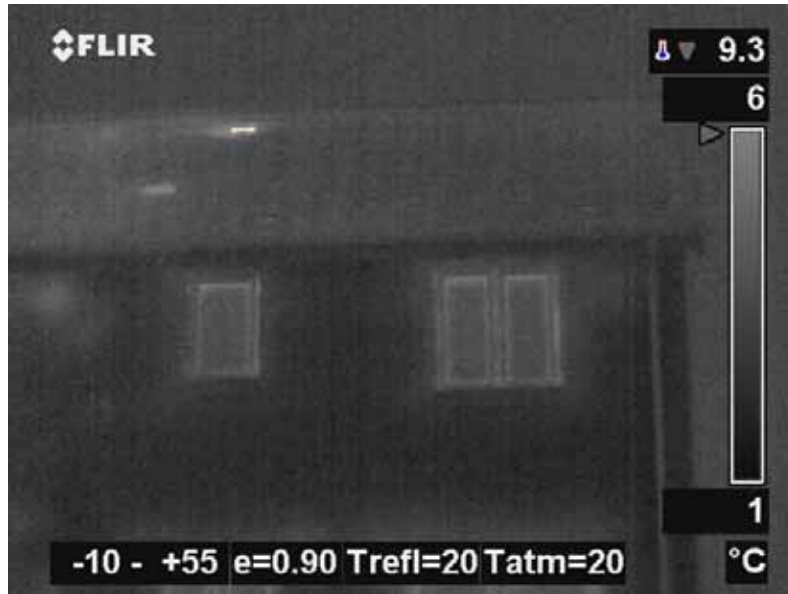
- 189 Figure 105 shows heat loss via the roof tile terminal vent of the mechanical extract system of plot 406. The vent shows as a white area to the top left hand side of the image.

**Figure 105** - Thermal Image Showing Heat Loss at MEV System Roof Terminal Vent

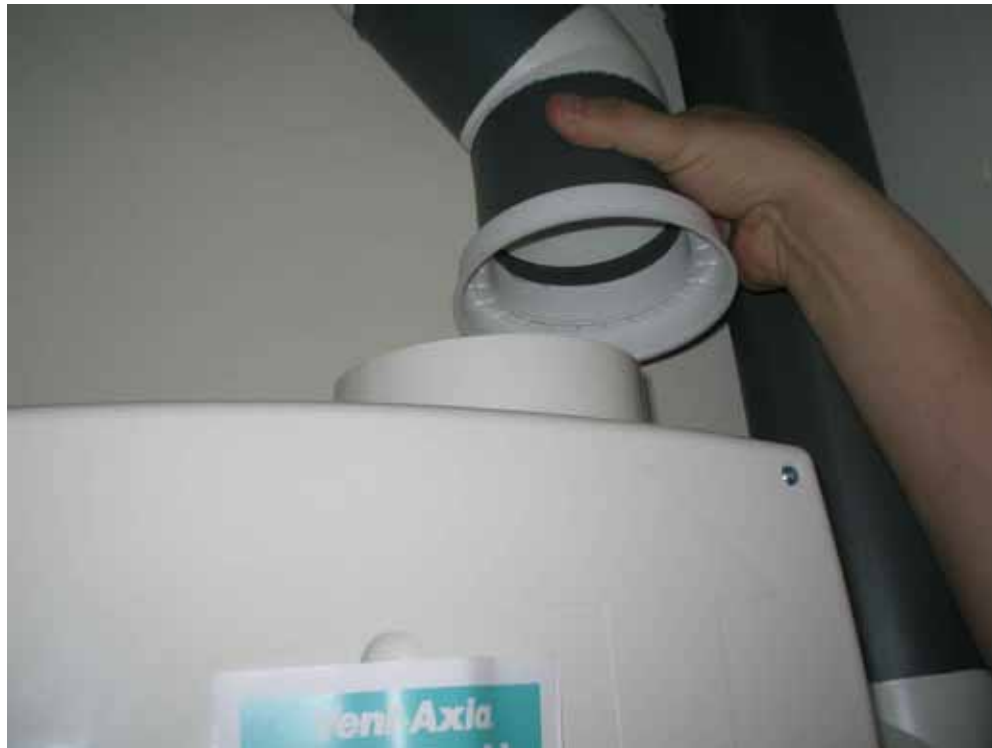
In test 3, the four extract vents were left in the fully open position and the duct that connects the outlet flow from the top of the Multivent fan unit to the terminal vent on the roof was disconnected. This is shown in Figure 4.

**Figure 4 – Disconnecting Outlet Duct**

The reason for disconnecting the terminal duct was to determine if there was any pressure loss between the fan and roof terminal. It can be seen from the results of this test (shown in Table 3) that disconnecting the extract duct had a dramatic effect on the measured flow rates. The flow rates from the bathroom and ensuite in normal mode nearly doubled from 20 to 36 m<sup>3</sup>/h and 18 to 30 m<sup>3</sup>/h respectively. However, the flow from the downstairs vents still remained below the measurement limit of 13 m<sup>3</sup>/h. These results suggests that there is some fault either in the ductwork between the fan unit and roof vent or at the roof terminal vent itself and are also indicative of some pressure loss in the ductwork between the upstairs and downstairs of the dwelling.

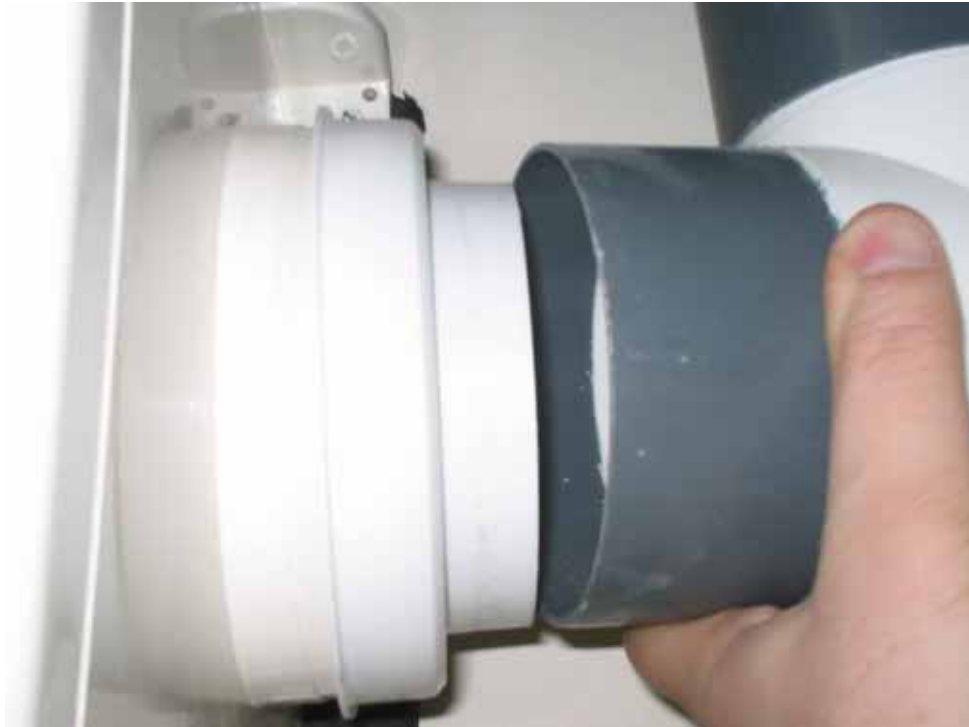
It was also noticed during inspection of the fan unit that the pipe connections to the spigots on the unit and all the connections between the ductwork that were visible in the cylinder cupboard were all loose and had not been properly sealed with tape or sealant. Escaping air flows could be felt with ones hand held close to any of the connections. An example of one of the loose spigot connections is illustrated in Figure 5.

**Figure 5 – Loose Spigot Connection**

Black duct tape was used to seal all the visible connections and the extract flows measured again. All other parameters were the same as for test 3. The results are given in Table 4. It can be seen that there was only a very small improvement in the measured flows which would be within the experimental error. This indicates that, although leakage was observed at these locations they were not significant enough to result in a major pressure drop.

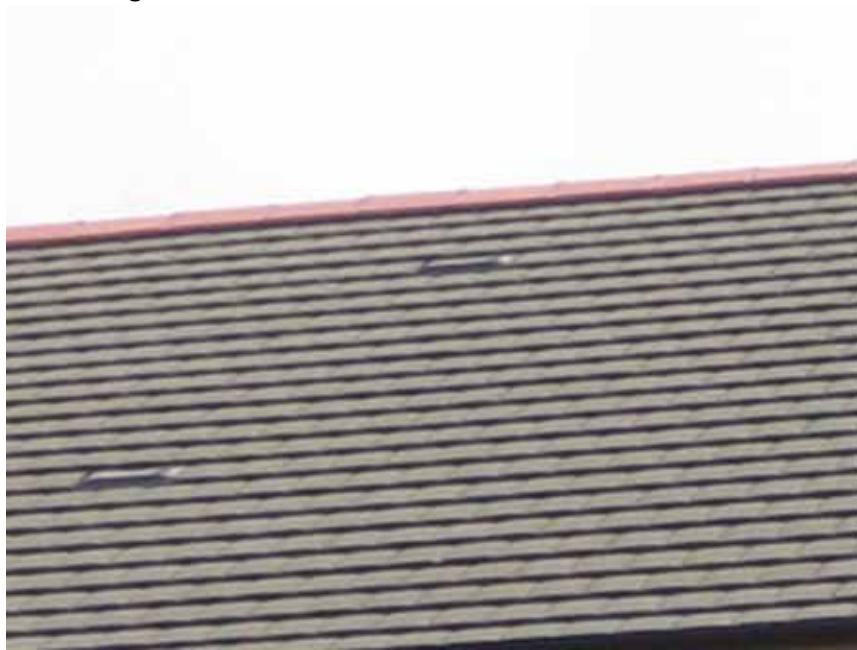
Observation from the ground of the roof of plot 405 by a Ventaxia representative was indicative to him that the type of terminal vents that could be seen could potentially be contributing to the pressure drop between the fan unit and roof vent as measured in the tests. His feeling was that this type of vent would be unsuitable for the required air flows. The vents are shown in Figure 6. The same low profile roof tile vents are used across the whole of the Redrow site.

**Figure 6 – Low Profile Roof Tile Vents on Plots 405 and 406**

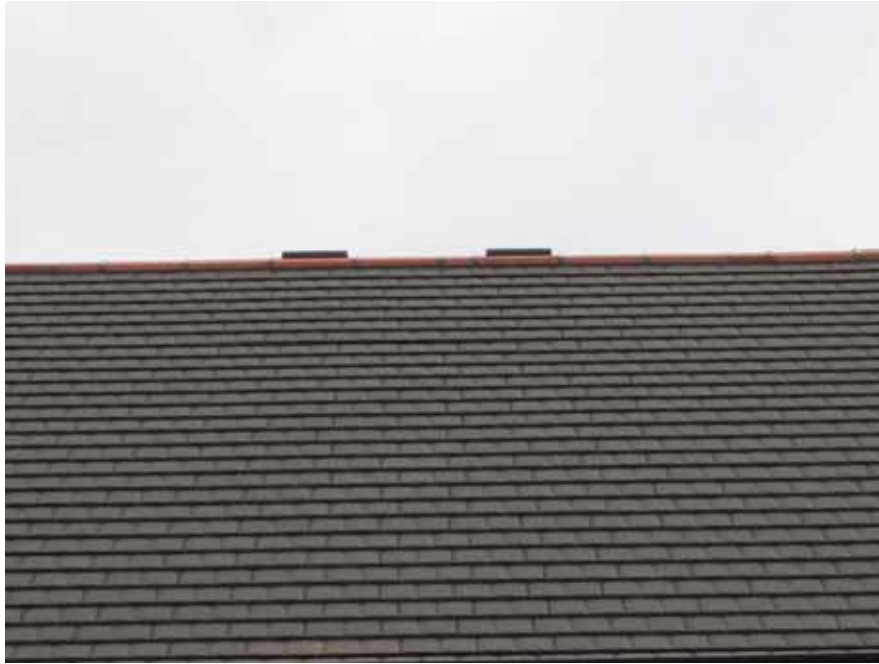
The roof vents in use on Bryant dwellings are of a different ridge vent design as illustrated in Figure 7.

Figure 7 – Ridge Vent on Bryant Property
