EVALUATING THE IMPACT OF AN ENHANCED ENERGY PERFORMANCE STANDARD ON LOAD-BEARING MASONRY DOMESTIC CONSTRUCTION

Partners in Innovation Project: CI 39/3/663

Interim Report Number 7 – Co-heating Tests and Investigation of Party Wall Thermal Bypass

Report Number 7: Co-heating Tests and Investigation of Party Wall Thermal Bypass

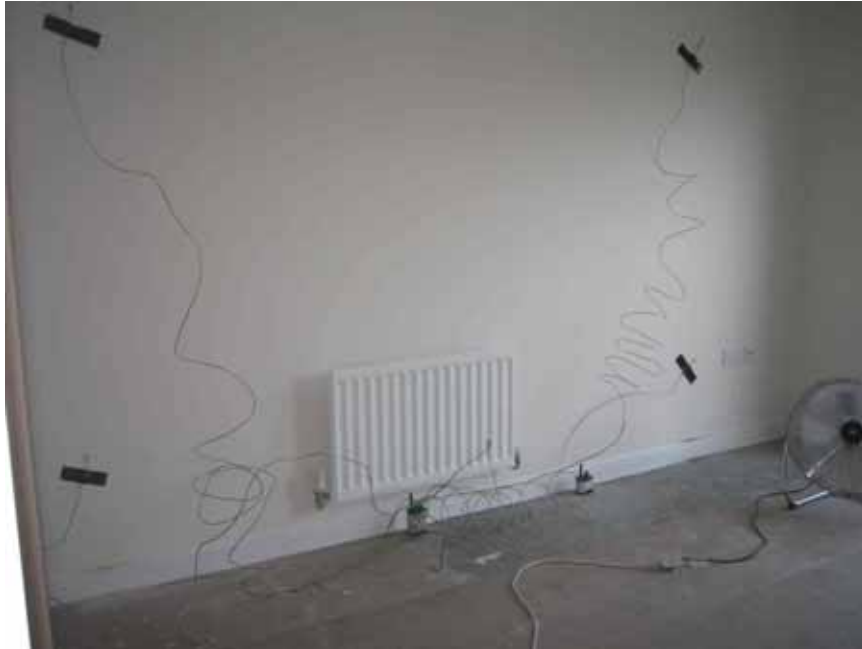
Figure 6 - Thermocouples in Position in Party Wall

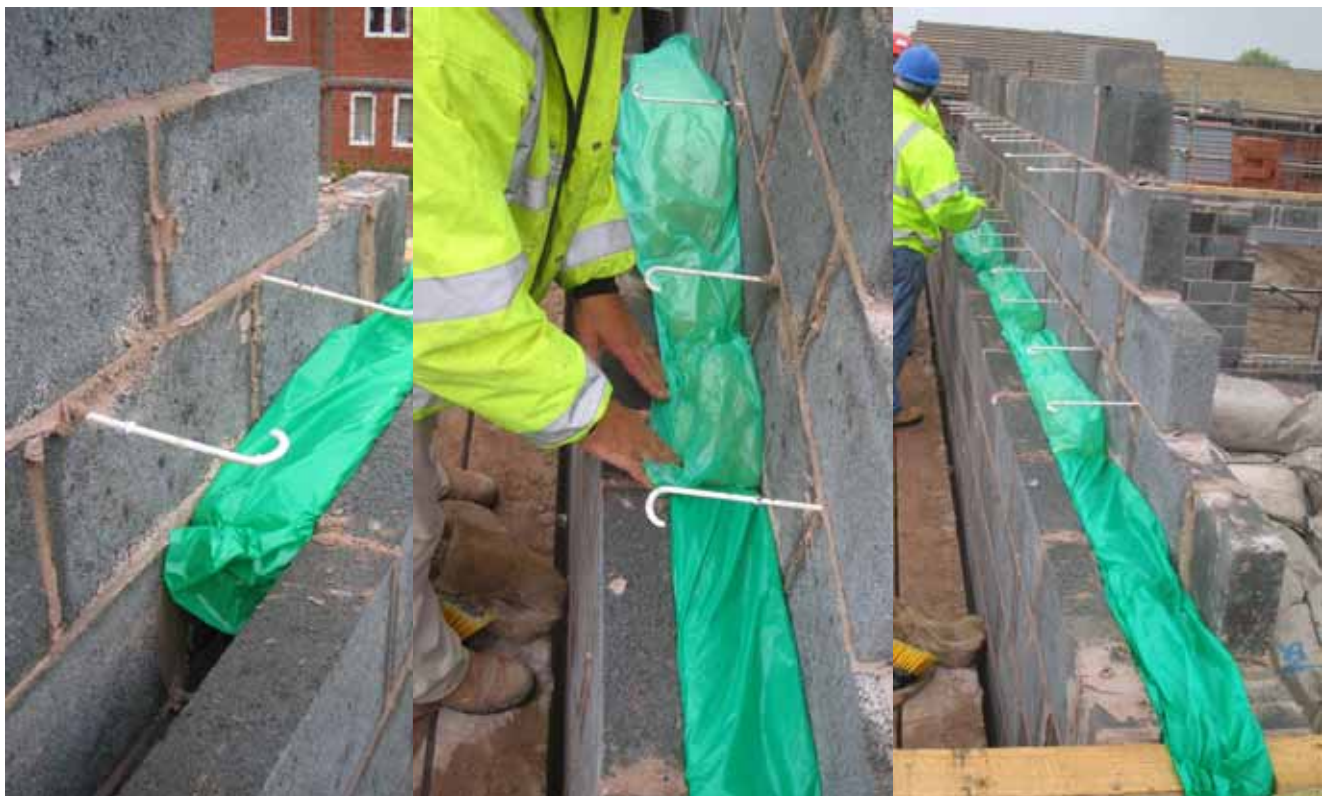
Figure 9 - Installation of Cavity Socks

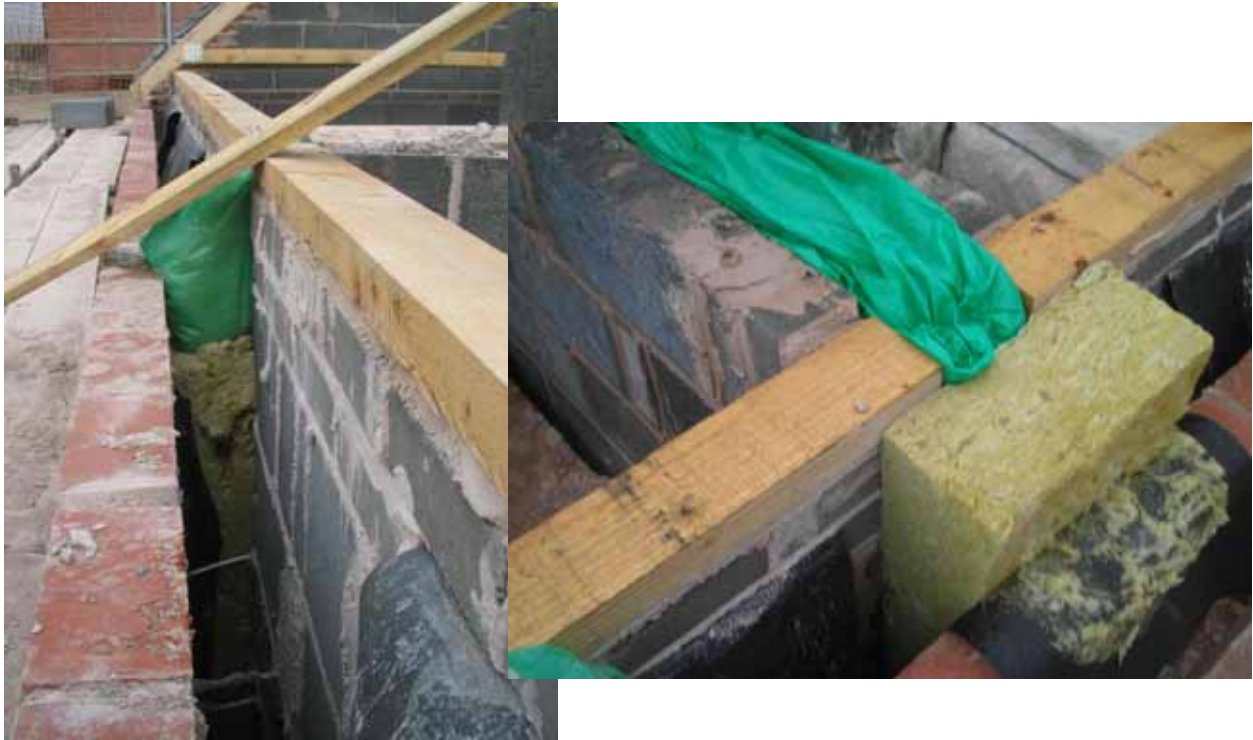
were extended across the ends of the cavity so that they met the vertical acoustic/fire cavity closer, as shown in Figure 10. In the case of the Bryant dwellings, the party wall cavity was 142mm wide which could be easily filled with the sock. The party wall cavity in the Redrow test properties was narrower at 75mm, and it was necessary to remove one of the two mineral wool batts from each sock so that it would fit snugly in the cavity.

Figure 10 - Junctions between Horizontal and Vertical Cavity Socks in Bryant Test Dwellings

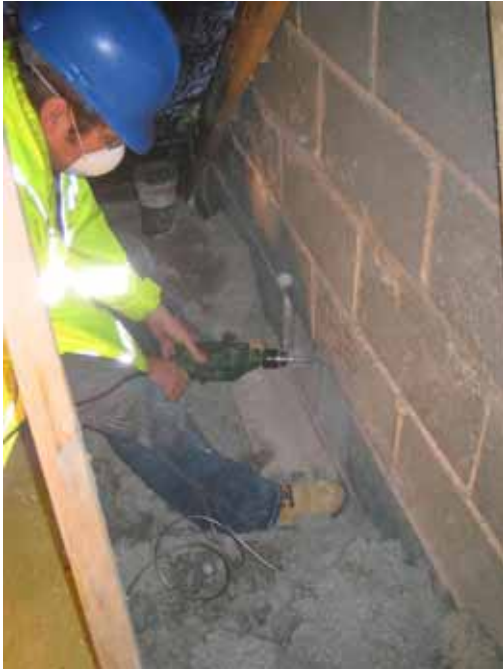
Figure 13 - Drilling out Mortar around Block

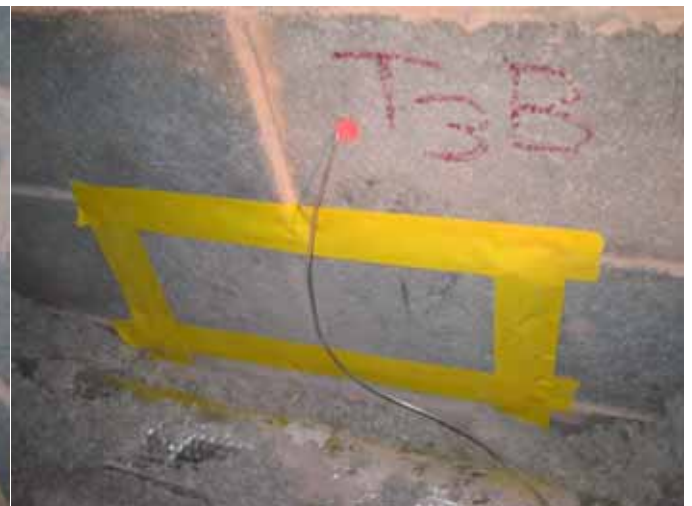
removed from the wall (Figure 14) and the cavity socks were pulled out from the cavity (Figure 15). Following removal of the socks, the blocks were replaced in the party wall, any gaps filled with mineral wool and the joints taped over as shown in Figure 16. The co-heating test was then continued to completion. It should be noted that in the case of both pairs of dwellings it took two sessions over a period of two days to completely remove the socks. This was due to the time taken to drill out the mortar, difficulties in accessing the sock (especially in the narrower Redrow cavity), and problems caused by mortar snots on top of the sock that in effect glued the socks to the walls of the cavity.

Figure 16 - Block Replaced and Joints Taped Over

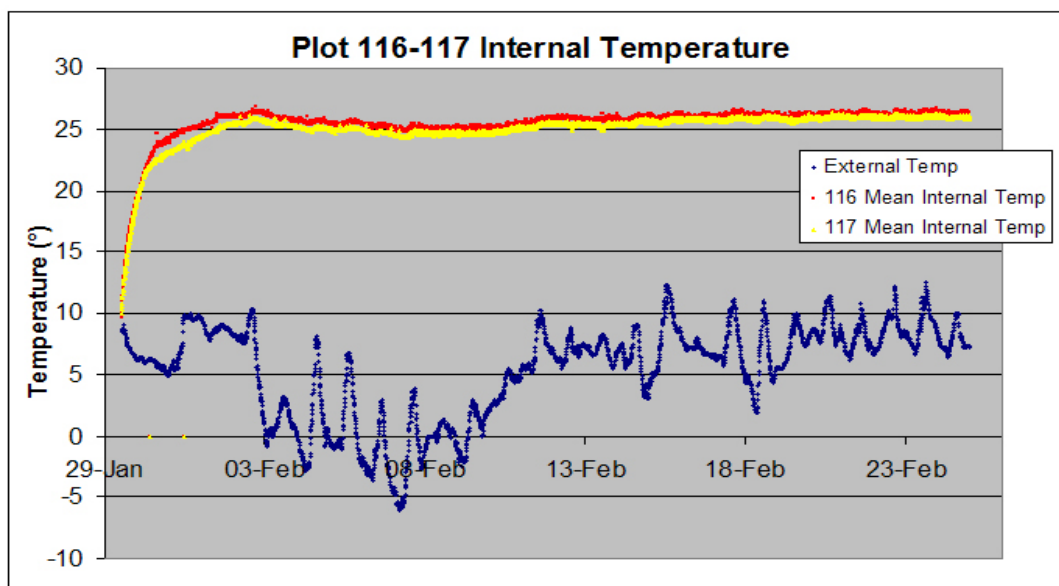
temperatures of the adjacent test dwellings were very similar and also relatively stable at around 25 to 26 °C in the case of the Bryant properties and around 27-28°C in the case of the Redrow houses. There were some short term spikes in the temperatures of plots 110 and 111. These were associated with solar gain via the windows on the west facing rear façade of the properties in the afternoon which could not be compensated for by the relatively crude temperature control system.

Figure 17 - Internal and External Temperatures during Co-heating Test Bryant Plots 116-117

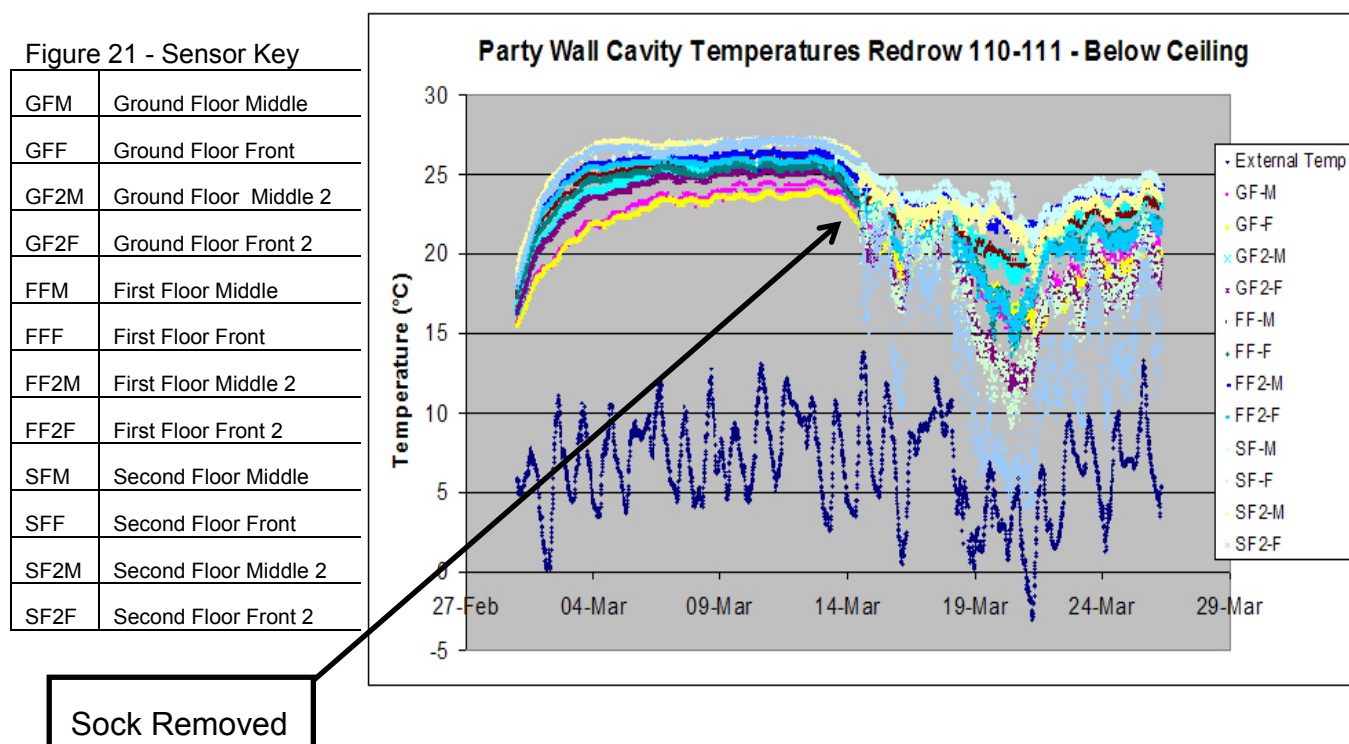
- 28 It can be seen in Figure 21 that, after the heat up period and before sock removal, the cavity temperatures below the ceiling ranged from 24 to 27°C. Those towards the top of the cavity are effectively isothermal with the internal dwelling temperatures of 27°C. The fact that there is a stratification of temperatures within the cavity again suggests that there is air flow from outside into the cavity from the sides or the bottom. There will also be some conductive heat loss to the ground at the bottom of the cavity. Following removal of the sock there is a significant reduction in all party wall cavity temperatures. In some cases this fall in temperature is dramatic, as is the case with sensors on the second floor at the front of the dwelling. This drop in temperature indicates a significant change in the air flow conditions within the cavity. It can also be seen that before sock removal the cavity temperatures were relatively stable with respect to fluctuations in external temperature, although there is some indication that those at the bottom of the cavity showed small perturbations that matched the external trend. After sock removal there are significant temperature fluctuations in all cavity temperatures below ceiling level that, in general, follow the external trend.

Figure 21 - Party Wall Cavity Temperature below Ceiling Redrow Plots 110-111

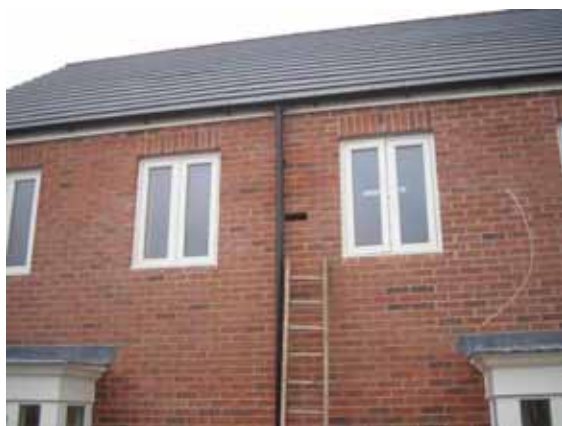
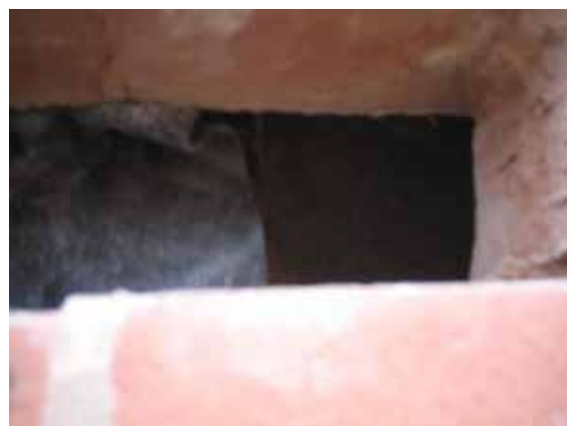
Figure 40 – Missing Insulation in Cavity of Rear Wall of Bryant Plots 116-117

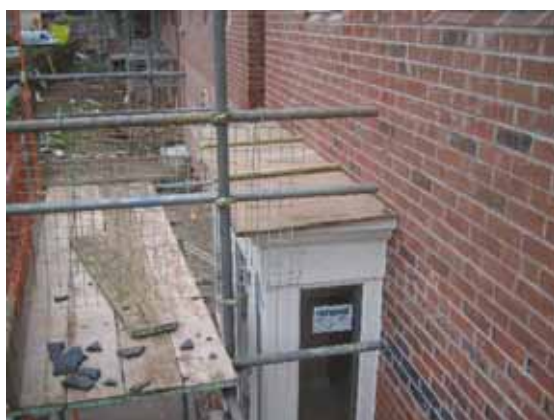
- 47 Other areas of high heat loss observable with the thermal camera coincided with known thermal bridges. In particular these included the heads of openings such as the head of the bay window in both the Bryant dwellings (Figure 41) and Redrow dwellings (Figure 43), and the head over external doors as shown in the example in Figure 42. A major thermal bridge in the two Redrow dwellings was at the threshold of the so called Juliet balconies as illustrated in Figure 44. There were two of these details in both Redrow test properties. Another thermal bridge was observed at the junction of the head of the recessed front door porch as shown in Figure 45.

Figure 41 – Thermal Bridge at Bay Window Head (Bryant Plot 117)

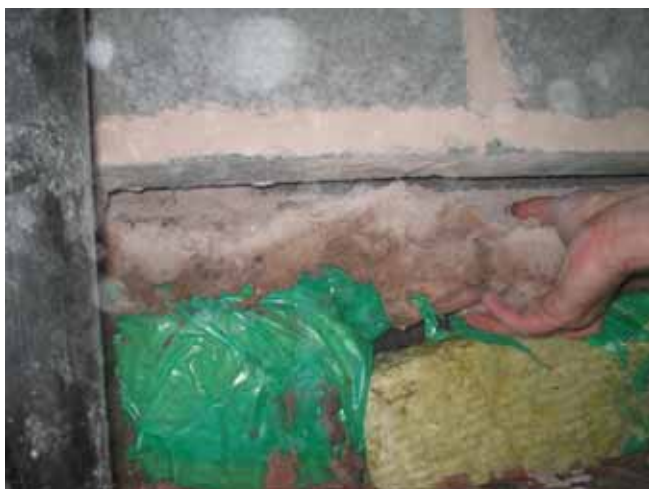
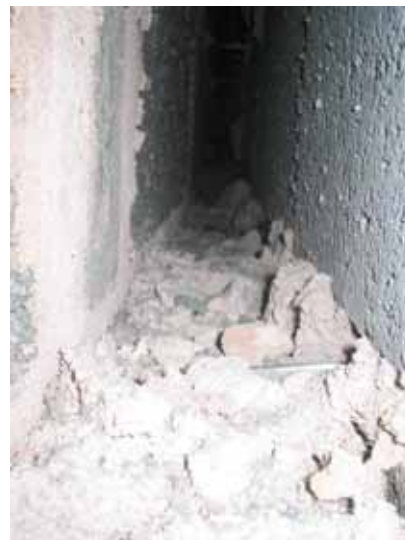
of the sock have implications for the Part E acoustic regulations because the mortar bridges the two walls.

Figure 48 – Mortar Layer on Top of Sock – Redrow **Figure 49** – Mortar Covered Sock - Redrow

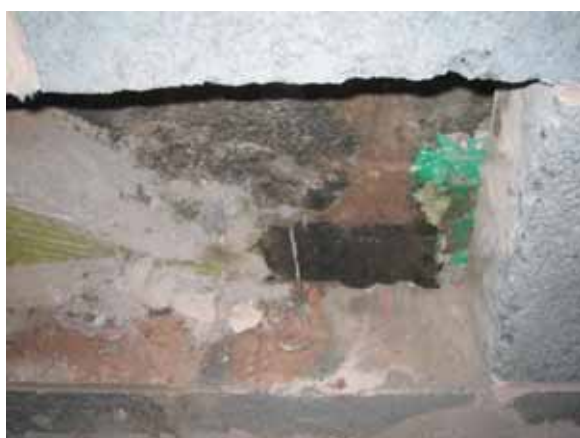
50 One potential issue with the installation of a horizontal sock in any party wall was that it could be damaged by falling debris accidentally dropped down the cavity during construction. One instance of this was observed in the Redrow party wall cavity as shown in Figure 50. When one of the blocks was removed at the half-way stage of the co-heating test, it was found that the sock immediately behind the block had been torn and one side had been pushed downwards by around 200mm. This could have occurred for example if a concrete block or tool had been dropped from above during construction. This small gap would have allowed some air to bypass the sock during the first half of the co-heating test, although this would have been mitigated to some degree by the mortar layer on top of the sock.

51 A photograph (Figure 51) taken inside the party wall cavity when the sock was being removed from the Redrow test houses showed that there would have been a gap of around 200mm between the end of the top of the horizontal sock and the vertical sock in the external cavity. This gap would have provided an unobstructed entrance point for external air into the party wall cavity below the sock during the first half of the co-heating test on the Redrow houses.

Figure 50 – Damaged Sock – Redrow **Figure 51** – Gap between Vertical & Horizontal Sock

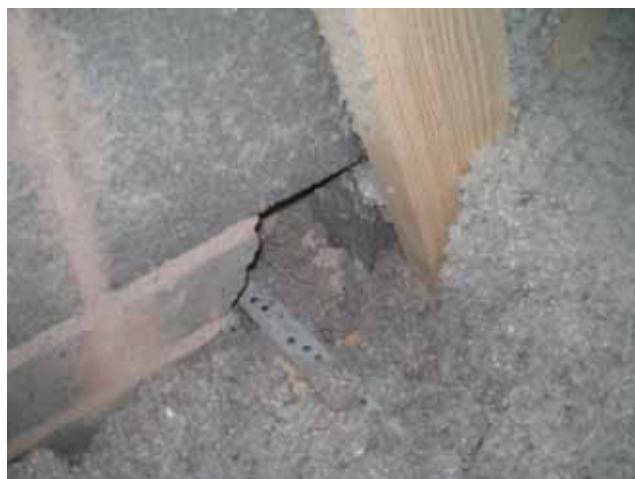
52 Thermal images taken in the loft of Redrow plot 110 at the start of the co-heating tests showed heat loss where restraint straps entered the party wall at the level of the ceiling. A closer visual inspection showed that the blocks that had been removed for the installation of the straps had not been replaced when the roof was complete. An example of this gap is shown in Figure 52. In order

that these direct paths into the party wall did not influence the co-heating test, all such holes in the party wall in the loft were patched up using blocks and mortar. Thermal images taken after the gaps had been patched confirmed that heat was no longer escaping by these routes.

Figure 52 – Gap in Party Wall in Loft for Restraint Strap - Redrow

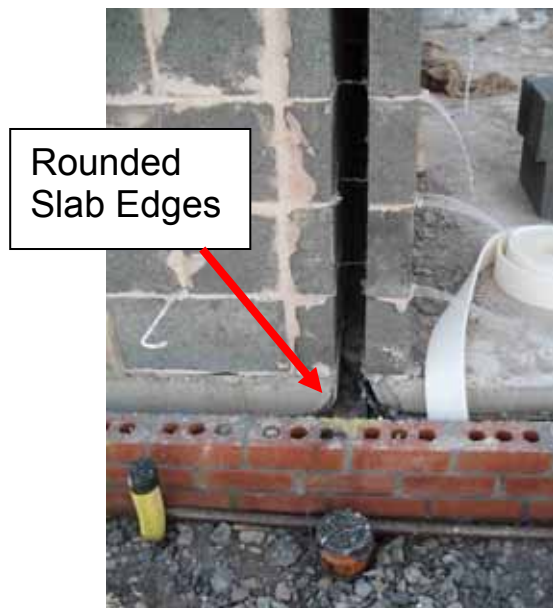
- 64 It was noted that the edge floor slab was not square as shown in Figure 56. This was caused when the DPC membrane was not pushed right into the edges of the former prior to casting the slab. This defect has resulted in a large gap at the bottom of the entrance to the party wall cavity which would be difficult to seal with the vertical cavity sock and would likely allow air to flow from the bottom of the cavity.

Figure 56 – Imperfect Floor Slab Edges

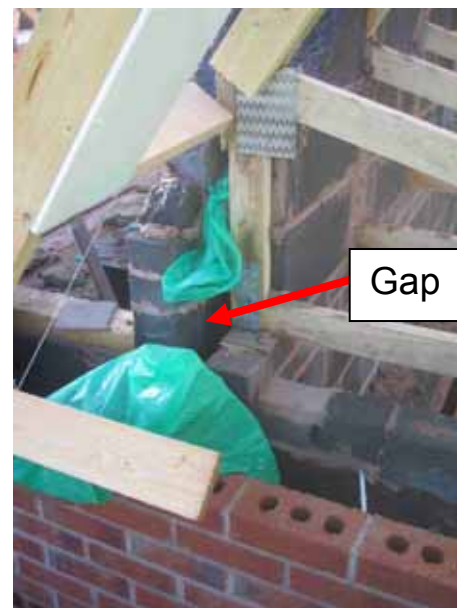
Figure 57 – Gap between Vertical and Horizontal Socks

- 65 Some gaps were observed at the junction between the horizontal sock in the party wall cavity with the vertical sock in the external cavity as illustrated in the photograph in Figure 57. This gap would have allowed air to enter the top of the cavity. In cases where the bricklayers had omitted to install the vertical sock as they were constructing the wall, this would have left opportunities for the top of the sock further down the cavity to become covered in mortar droppings as shown in Figure 58. This could potentially have created a thermal bridge across the cavity. Also, in such circumstances it would have been difficult to properly position the next vertical sock without leaving a gap at the junction between the two socks, which would have given rise to air path into the party wall cavity.

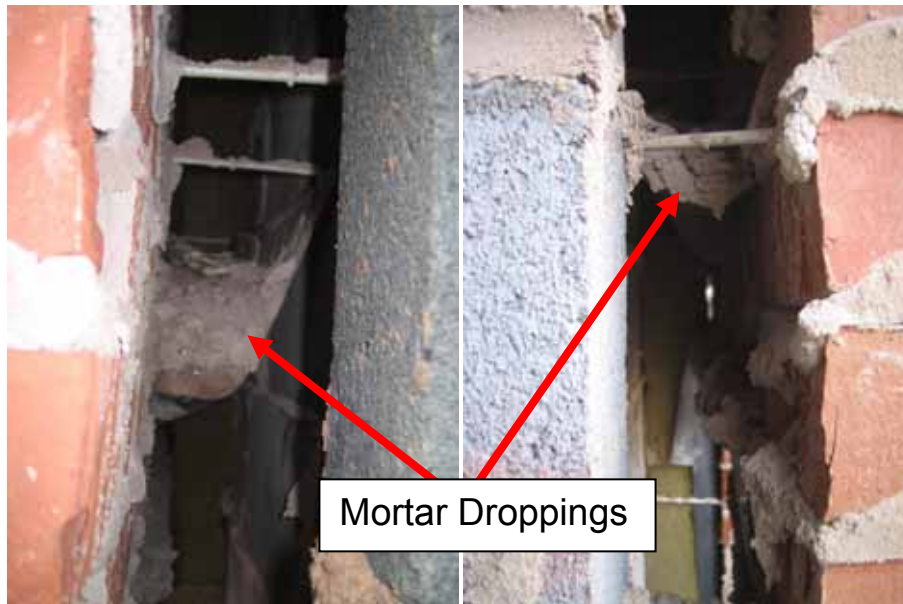
- 66 The build up of mortar droppings on top of the DPC membrane used to form the cavity trays was in some instances found to be severe. For example, the photographs in Figure 59 show mortar build up that effectively bridges the external cavity.

Figure 59 – Mortar Build up on Cavity Tray

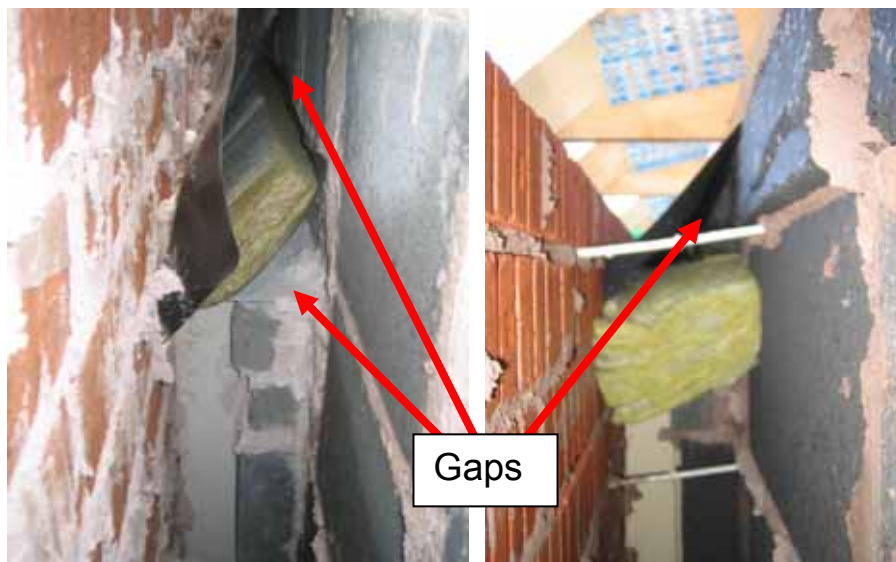
- 67 In order to provide insulation under the plastic cavity trays above window heads, the detailed construction drawings call for mineral wool batts to be installed at this position as the wall is built up. However, as can be seen in Figure 60, it was often the case that the insulation was inappropriately sized and there were air gaps all the way around the insulation. These gaps would not have been filled when the completed wall cavity was injected with loose fill mineral wool insulation. The effect of these gaps would have been to significantly increase heat loss at window heads compared to the expected losses from these linear thermal bridges. Similar defects have been observed by the Leeds Met research team on other construction sites (Bell Smith and Miles-Shenton 2005).

Figure 60 – Insulation underneath Cavity Trays at Window Heads

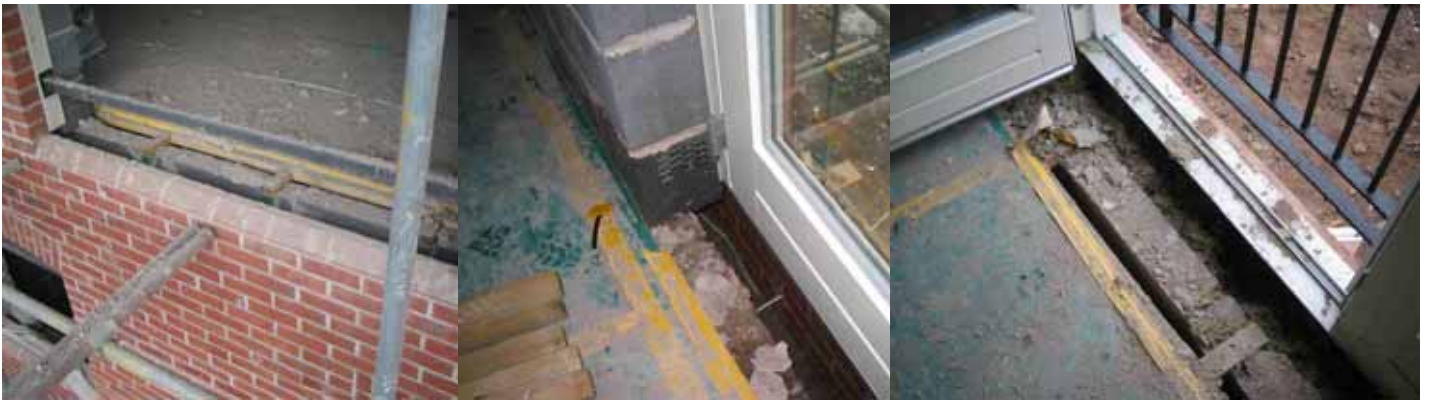
- 72 The thresholds of first and second floor patio doors (sometimes called “Juliet” balconies) were found to be a major location of both thermal bridging and air leakage as illustrated by the external infra-red thermal image in Figure 44. Construction of one of these balcony details in Redrow plot 111 is illustrated in Figure 67. It can be seen that the floor boards were left off the threshold for a large part of construction, which would have allowed multiple opportunities for material such as mortar, wood, waste plasterboard and other assorted debris to fall into the cavity. It can also be seen that the insulation does not come right up to the level of the door frame, which would cause considerable thermal bridging at this point. It can also be observed that there would be potential for air leakage between the top of the block work wall and the floor board unless there was very careful sealing at the junction of these components. The consequence of these failings can be seen in the infra red image shown in Figure 68 which was taken during the co-heating test in Redrow plot 110. The thermal image shows significant heat loss around the point of the threshold that is likely a combination of conductive losses and air leakage.

Figure 67 – Construction of Juliet Balcony Threshold Detail

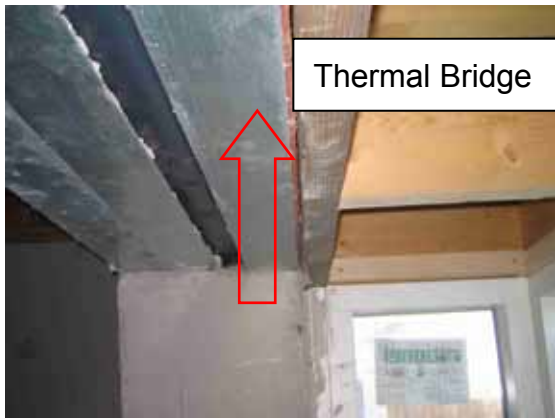
- 73 Both Bryant co-heating test plots and Redrow plot 111 were constructed with bay window details. In all three cases, these were constructed with block work cavity walls and a flat roof constructed from timber with mineral wool insulation. The junction between the timber roof and the wall opening (with steel lintels supporting the wall above the bay) was found to give rise to high thermal losses as shown in the infra-red images taken from outside the dwellings during the co-heating test (Figures 41 and 43). Photographs taken during the construction of the bay window in Bryant plot 116 are shown in Figures 69 and 70. It can be seen that the outer steel lintel supporting the external brick wall above the bay forms a direct thermal bridge into the dwelling. The thermal

Figure 69 – Bay Window Head before Boarding

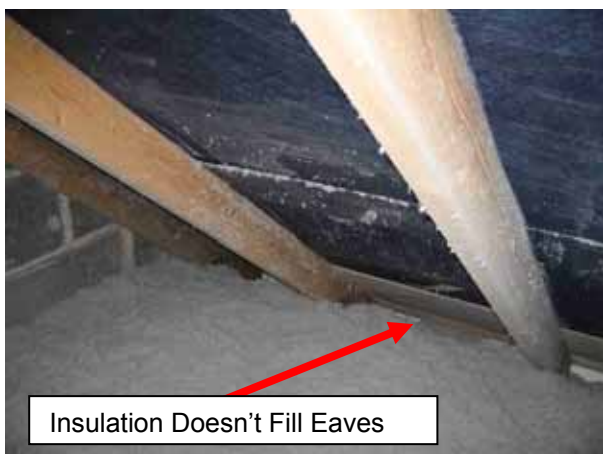
74 The loft insulation used in all four co-heating test dwellings was Warmcel recycled newspaper. This was installed as a loose fill material by blowing via hoses into the loft. The required final thickness of loft insulation was 250mm. It was also important to minimise thermal bridging at the eaves, that the insulation was continued right up the eaves board/ventilation stop and down into the external wall cavity.³ Observations during construction of the co-heating test houses showed that in most cases the insulation did not always continue all the way up to the eaves board, as illustrated by the example in Figure 74. Spot measurements of insulation depth at random locations within the lofts of the co-heating test houses demonstrated that large areas of loft insulation failed to meet the minimum depth requirement of 250mm. This is illustrated by the example in Figure 75 in Redrow plot 111, where the insulation depth is less than 200mm. This would have a significant detrimental effect on the *U*-value of the ceiling. Discussions with the insulation installers revealed that they aim to overfill to around 270mm to allow for some settlement. It is possible that the insulation is settling more than anticipated.

Figure 74 – Loft Insulation at Eaves

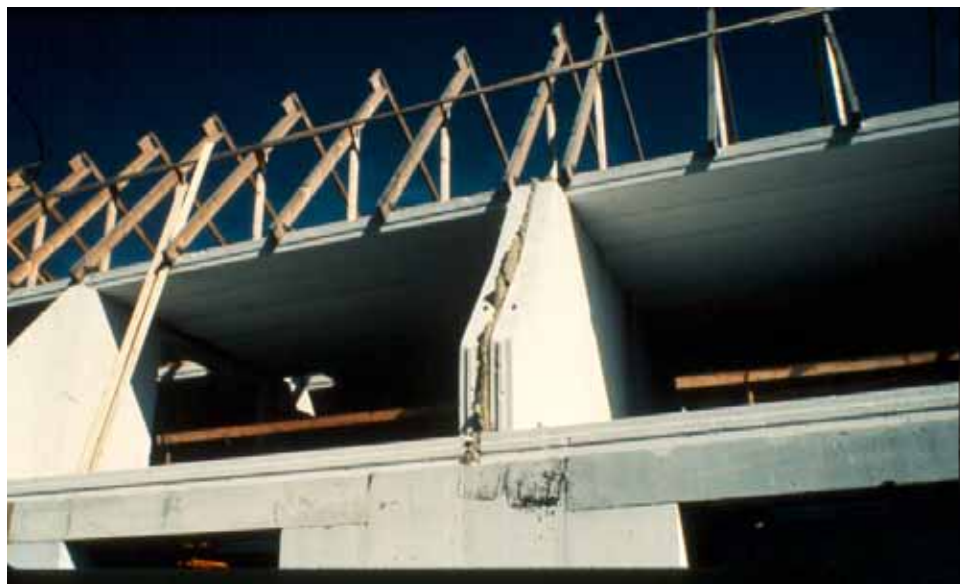
Figure 78 – Fully Filled Party Wall Cavity in Sweden (© R. Lowe and D. Olivier 1980)

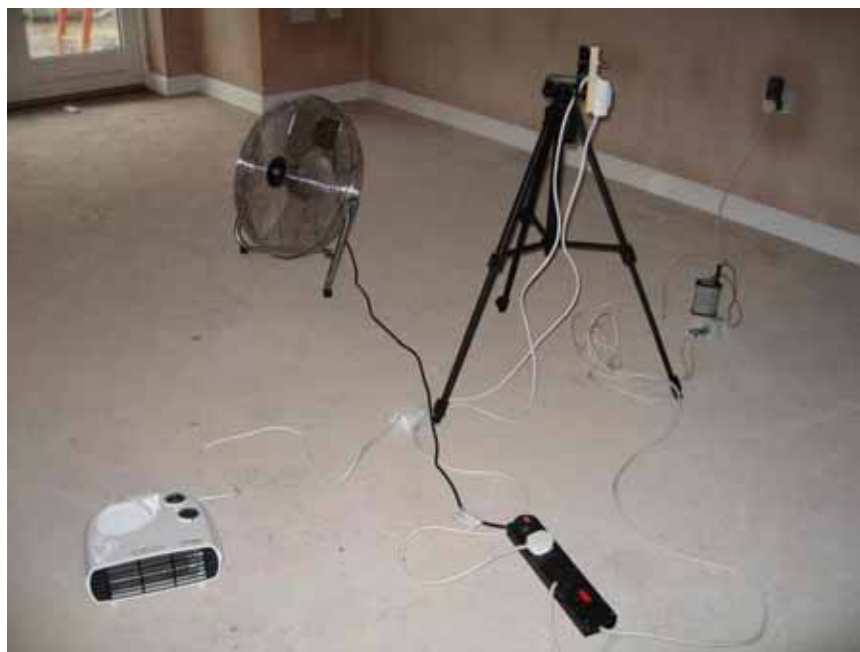
Figure A1 - Co-heating Equipment on Location in Room in Test Dwelling at Stamford Brook
