AIRTIGHTNESS OF BUILDINGS — TOWARDS HIGHER PERFORMANCE

Interim Report D8 — Site Assessments and Test Results

Dr David Johnston, Centre for the Built Environment, Leeds Metropolitan University

Reference Number: CI 61/6/16 (BD2429)

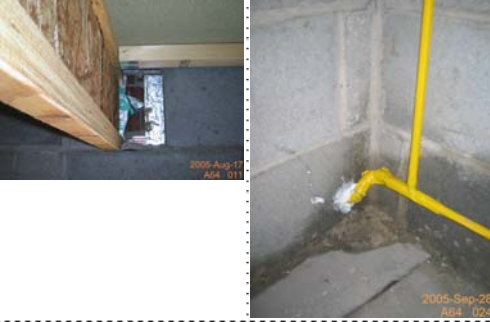
<p>Larger penetrations smashed through blockwork retrospectively (example shows a cooker hood extract duct). Many smaller penetrations remaining unsealed at dry-lining stage.</p>

<p>Larger penetrations have purpose made gaps left (as above for a cooker hood extract duct) or suitably sized holes bored. Smaller penetrations all sealed at pre-plaster stage.</p>
Built-In Joists

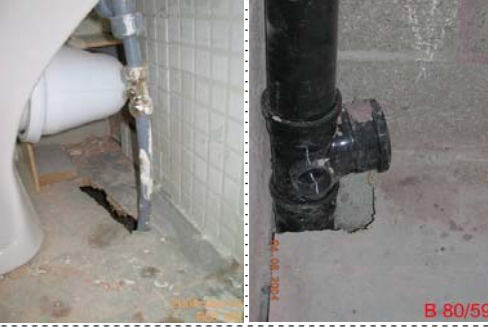
<p>Excessively sized and incorrectly located holes for penetrations commonplace.</p>

<p>More suitably sized holes. Incorrectly positioned holes have been repaired.</p>
Threshold

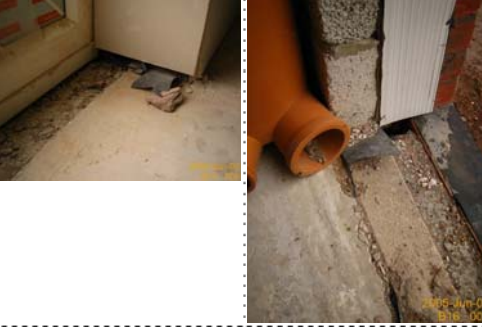
<p>Threshold not sealed until after dry-lining, creating potential air paths from behind the dry-lining into the cavity.</p>

<p>Cavity below thresholds filled prior to dry-lining, making it possible to seal the junction at pre-plaster stage.</p>
Jambs and Jamb/Head Junctions

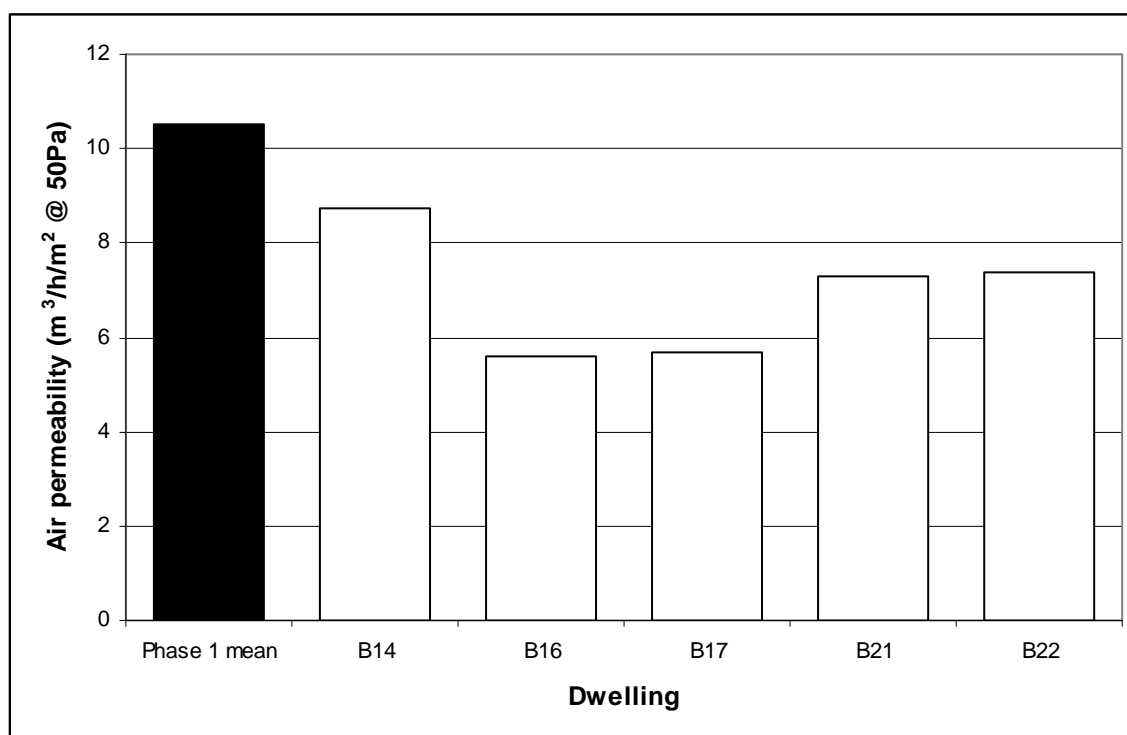
Figure 3 Air permeability of the dwellings tested for developer B.

- 43 Given the small sample size the results for developer B cannot provide absolute certainty of the success of each measure taken in this staged approach. However, this initial sample would suggest that the most important measures undertaken by this developer during Phase 3 of the project involved pointing all of the joints and apertures prior to the application of the dry-lining (B16)

and parging all of the external walls prior to dry-lining (B17). Both of these measures reduced the air leakage rate of the dwellings constructed by this developer, from a mean of $10.5 \text{ m}^3/(\text{h}\cdot\text{m}^2)$ @ 50Pa during Phase 1, to 5.6 and $5.7 \text{ m}^3/(\text{h}\cdot\text{m}^2)$ @ 50Pa, respectively in Phase 3. This represents a reduction in air leakage of almost 50% from the Phase 1 mean. In addition, these results also suggest that pointing and parging can have a similar impact on the overall reduction in air leakage rate.

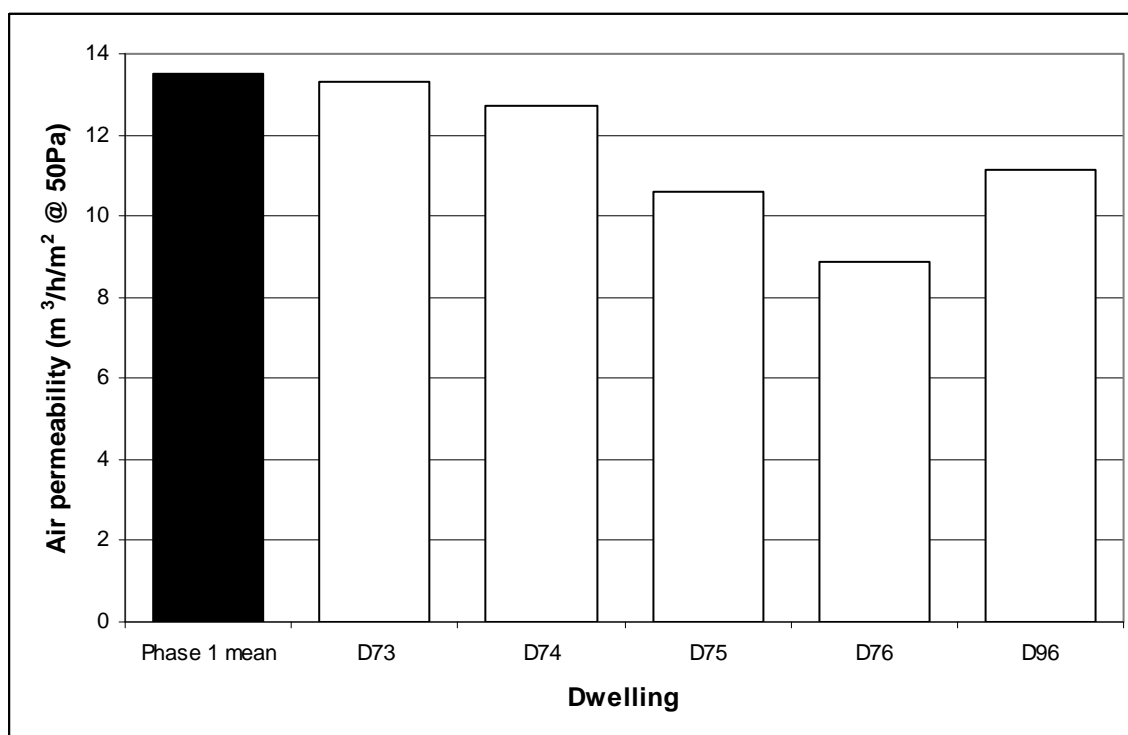
Figure 4 Air permeability of the dwellings tested for developer D.

- 54 The results for developer D indicate that in those dwellings that were built as standard using the new designs, and where no additional measures were undertaken to improve the airtightness of the dwellings (plots D73 and D74), the air leakage rates obtained were 13.3 m³/(h.m²) and 12.7 m³/(h.m²) @ 50Pa, respectively. These rates are comparable to those obtained during Phase 1 of the project, where the mean air leakage rate for developer D was 13.5 m³/(h.m²) @ 50Pa. This suggests that in terms of airtightness, the new dwelling designs do not perform significantly better than the old dwelling designs. In those dwellings where more care was taken to seal around the primary air barrier (Plots D75 and D96), the air leakage rate reduced to 11.1 and 10.6 m³/(h.m²) @ 50Pa, respectively. This represents a reduction in air leakage from Phase 1 of around 20%. The tightest dwelling constructed by developer D was Plot D76, where considerable effort was made by the construction team to make the dwelling airtight. The air leakage rate measured for this dwelling was 8.9 m³/(h.m²) @ 50Pa, resulting in a reduction in the mean air leakage rate of 34%. Dwelling D76 was also the only dwelling constructed by developer D to achieve an air leakage rate lower than the target of 10 m³/(h.m²) @ 50Pa that is specified within ADL1 2002.

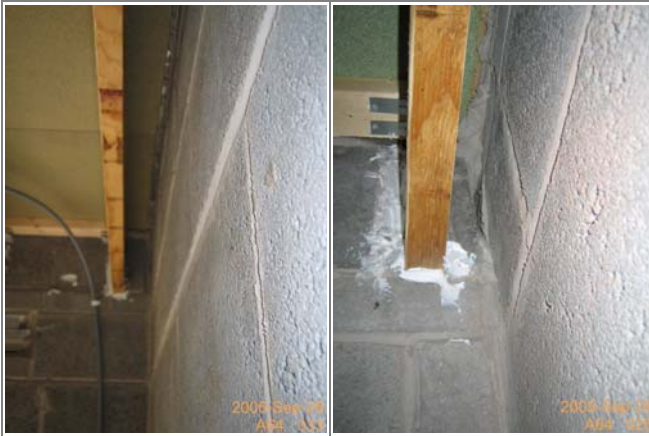
All the joists built in to the external walls have been successfully sealed around using mortar and mastic, with the exception of those where the close proximity of an adjacent wall has made access to the junction difficult. If necessary, additional work could be done to seal these awkward joints but would incur extra time and costs, efforts which may be better spent elsewhere in the dwelling.

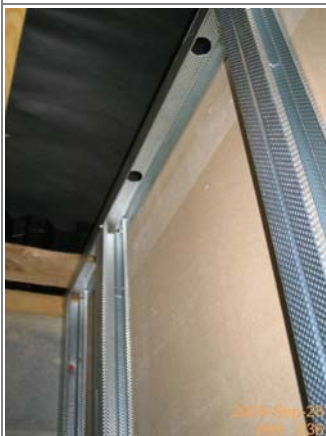
An unaddressed cause of air leakage; air movement into the ventilated loft-space through holes in the top of the metal studwork for internal partition walls. Loft insulation will be placed over the top of these holes, but will have very little effect in reducing the amount of air movement through them.

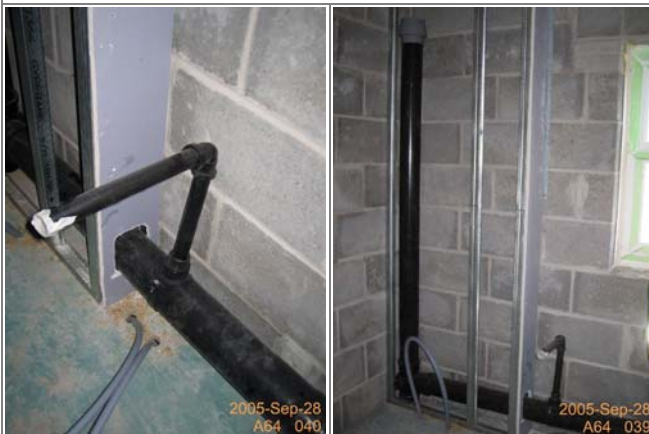
Both the boxing-in of the pipe-work and the soil stack have penetrations directly into the ventilated loft-space. These will be filled with mineral wool which will reduce smoke spread, but will still allow air to move between the void behind the boxing and the loft-space.

In both cases, air may be able to enter the boxing void from other voids. In the bathroom the void behind the boxing may be linked to voids behind the dry-lining and under the bath; in the case of the soil stack the boxing void is also linked to the intermediate floor void.

With air able to move throughout the dwelling due to these interconnected voids, complex 'hidden' air-leakage paths are created. A leakage path where air enters one void and escapes the building envelope via a different one may not only be difficult to identify and detect, but equally awkward to seal; particularly if the sealing is required to be done retrospectively.

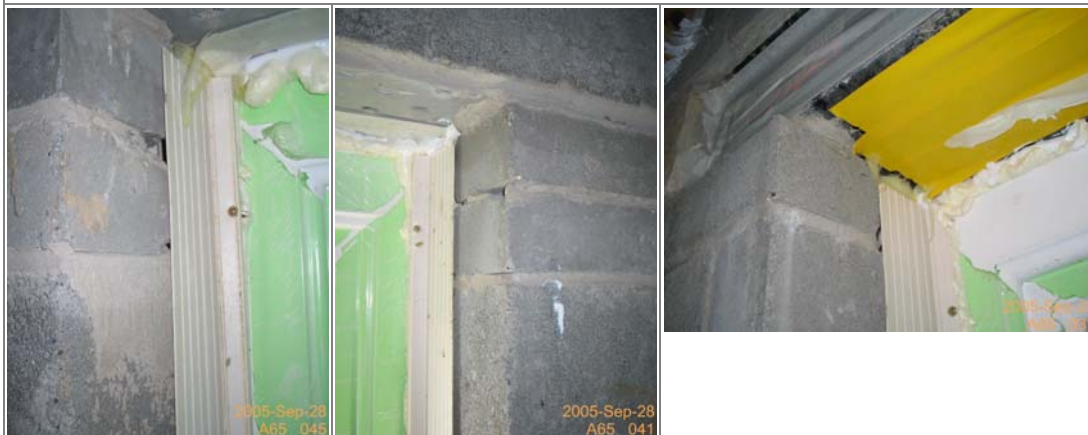
As in A64, the small gaps around the closers at the jambs will be sealed using plasterboard adhesive as the lining is positioned. The gaps at the tops of the closers have been sealed with mastic, and the perforations in the lintels sealed with tape.

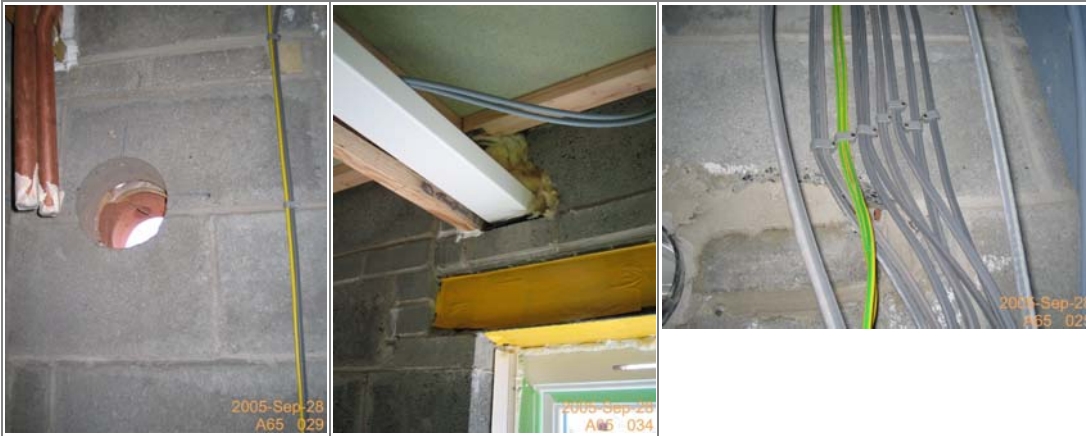
As in A64 service penetrations through the external walls have neat, suitably-sized holes which be easily sealed around after installation. The cooker hood extract duct and electrical consumer unit penetrations will again be plugged with compacted mineral wool and sealed with either mortar or expanding foam prior to dry-lining.

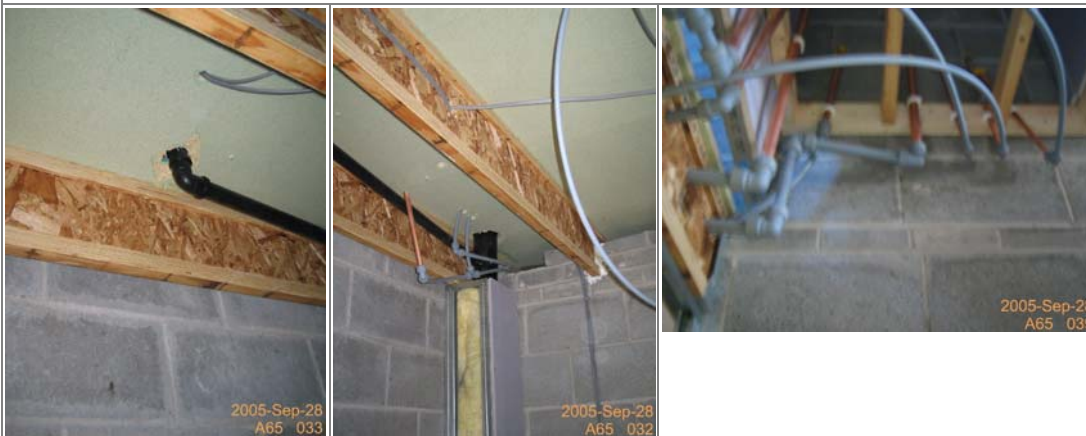
Holes made in the intermediate floor are more appropriately sized for the penetrations than in A64, which will prove either easier to seal or may restrict the air flow around them. As in A64, if services to the cylinder cupboard are to be sealed, this needs doing so before access is limited.

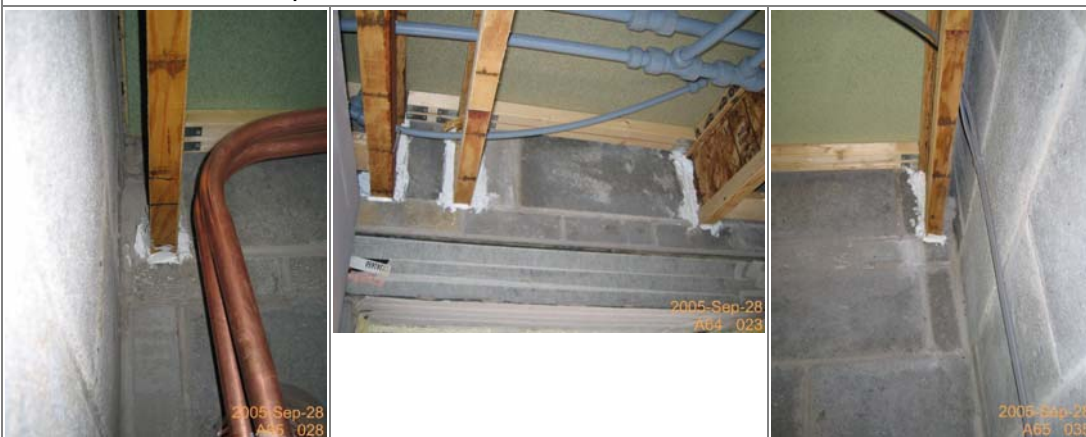
As in the previous plot, all the joists built in to external walls have been well sealed with mortar and then mastic wherever possible.

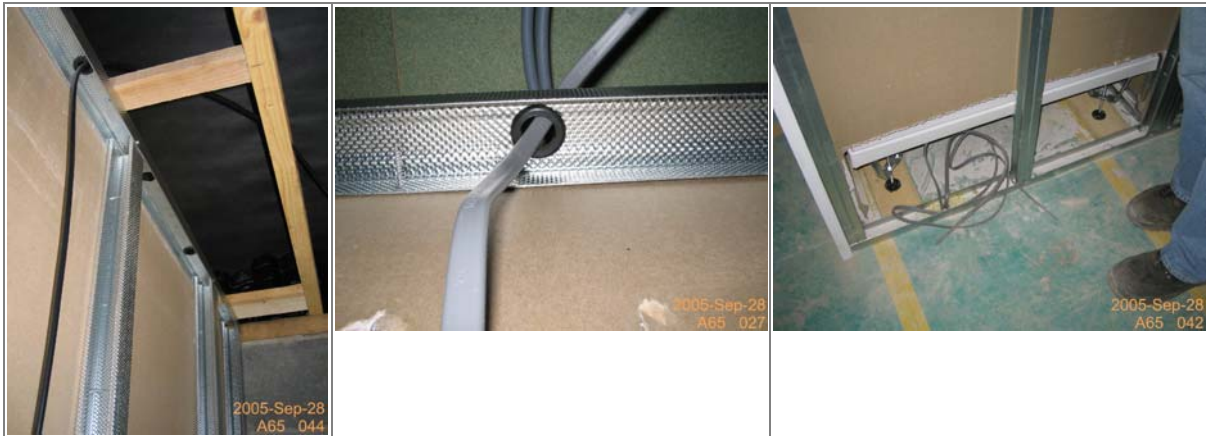
Apertures in the steel studwork allow air to circulate throughout internal partitions and, when fitted on the first floor, directly into the loft-space. When grommets are fitted to prevent abrasion to cables these gaps are reduced but will still allow air movement.

The shower is typically an area where air leakage through this path occurs. Air can enter the void beneath the shower tray from around the flexible plastic front panel (or via intermediate floor penetrations) and move directly into the ventilated loft-space through gaps in the steel studwork. Mineral wool placed in these voids for acoustic purposes may impede the air flow to some degree but will not stop air movement through this partitioning.

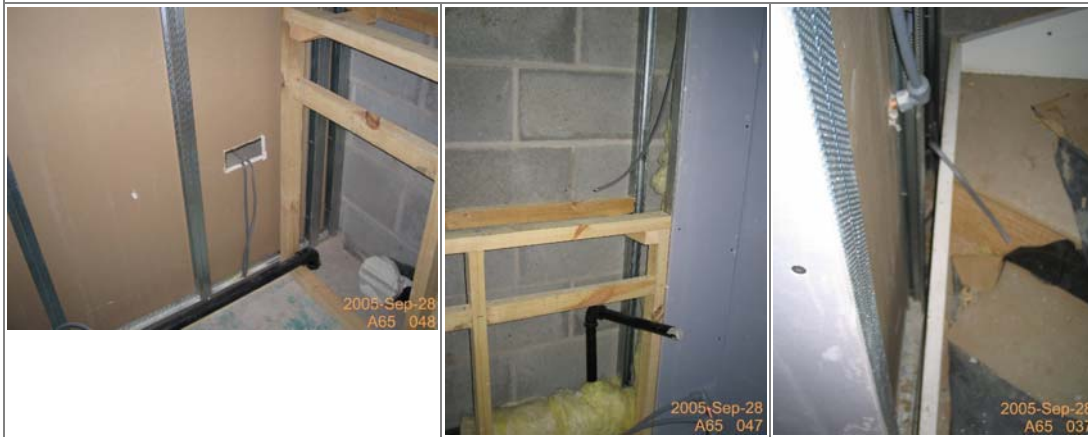
As in A64, the boxing-in of pipe-work in the bathroom links a number of voids (including voids in the partition wall, beneath the bath, behind the dry-lining, etc.) directly to the loft-space creating increasingly complex 'hidden' air leakage paths.

The voids around the stairs also link together various other voids which, although not leaking directly to outside of the building envelope, allow air to circulate more freely throughout the dwelling.

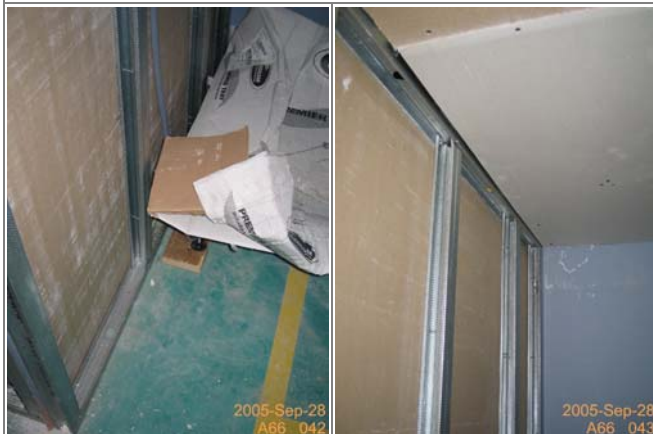
As mentioned in A65, the shower is an area where air moving through the steel studwork may be a major source of air leakage, as air entering the void under the shower tray (from around the panel, from the intermediate floor and through adjacent studwork voids) may move relatively freely into the loft-space.

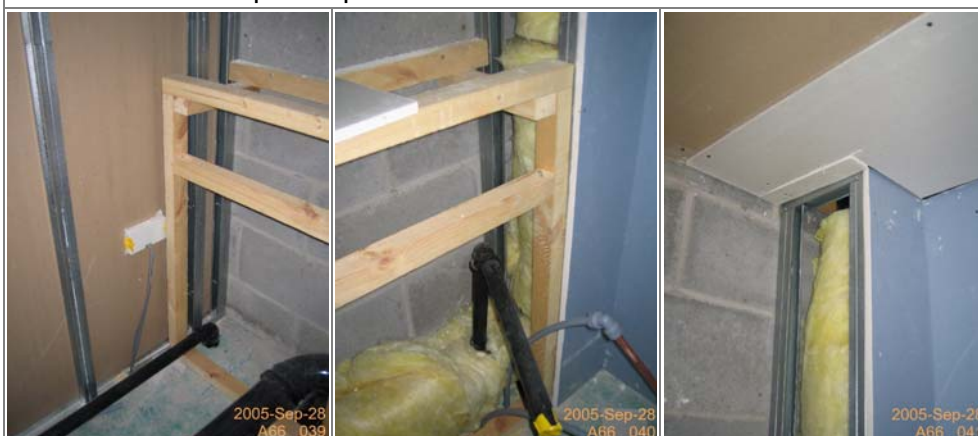
As described for A64, the dual problem of inter-linked voids and possible air-paths directly into the loft-space are apparent at both these details. These details have been constructed 'as designed', and it would appear that the issue of airtightness of these details is an issue of design rather than one of workmanship or supervision.

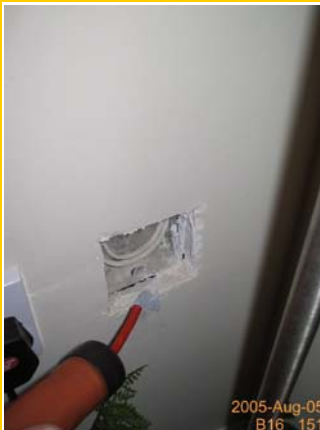
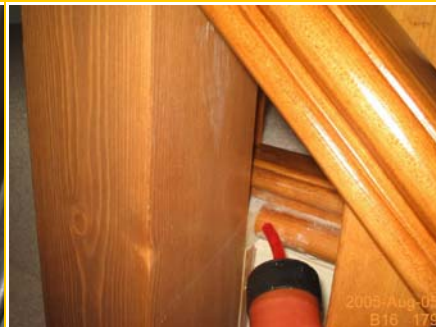
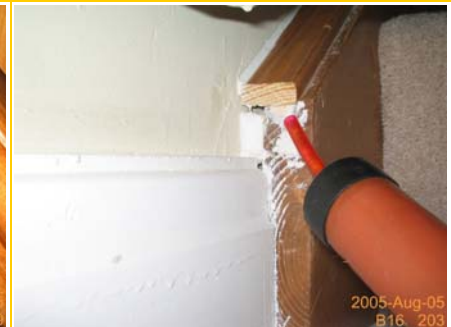
- Air leakage through an unfinished pattrass box in the hallway.
- Various points of leakage through and around both sets of stairs.
- Leakage into some junctions of door frames and intermediate floors.
- Slight air movement around the loft-hatch and its housing.

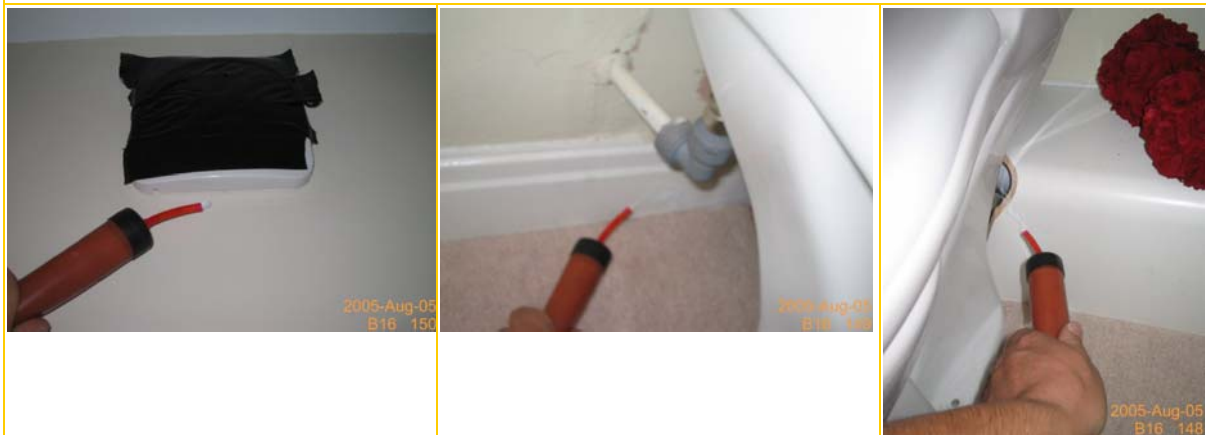
- Air leakage around the extraction fan housing.
- More significant air movement into the open-ended boxing around the soil pipe.

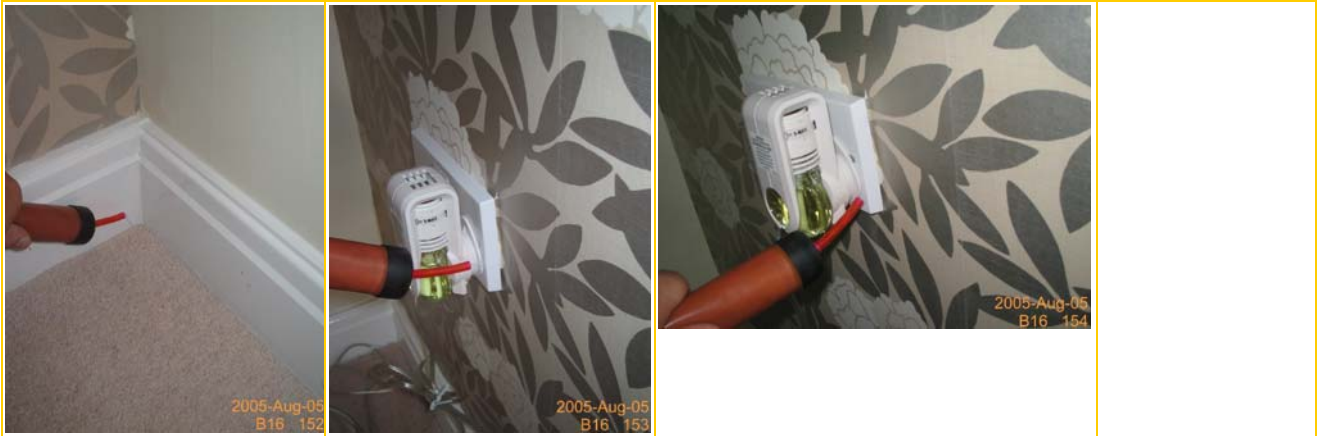
- Air leakage at the junction of ground floor/party wall/external wall.
- Leakage around the electrical socket on the party wall.

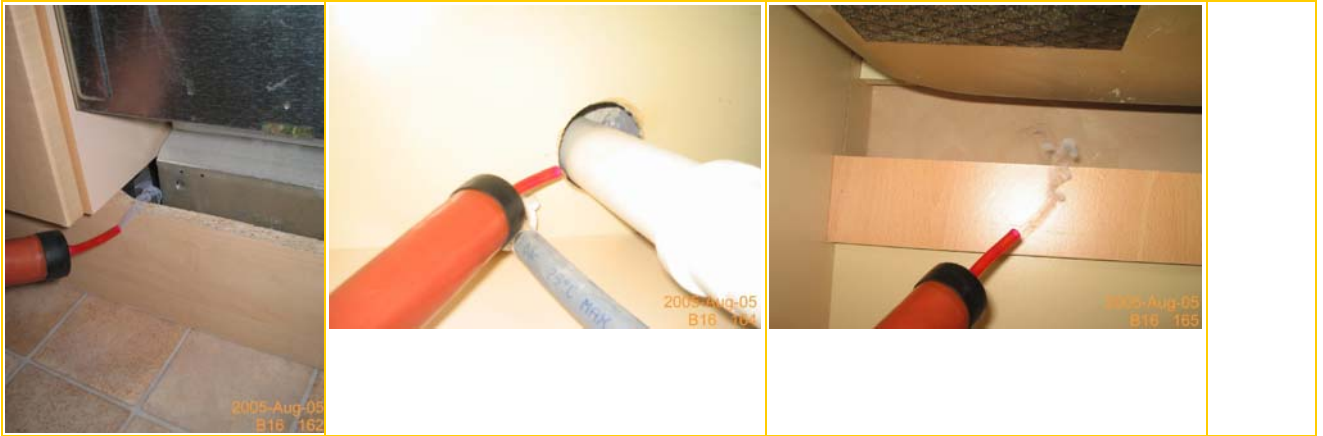
- Leakage along the ground floor/wall junctions, most severe in the corners.
- Significant air movement over the plinth into the void beneath the kitchen units through the gap observed under the corner unit.
- Air leakage into the space behind the wall units along the party wall.
- Significant air movement into the void beneath the kitchen units around the dishwasher.
- Inside the unit under the sink, significant leakage detected around the service penetrations and over the back of the unit.

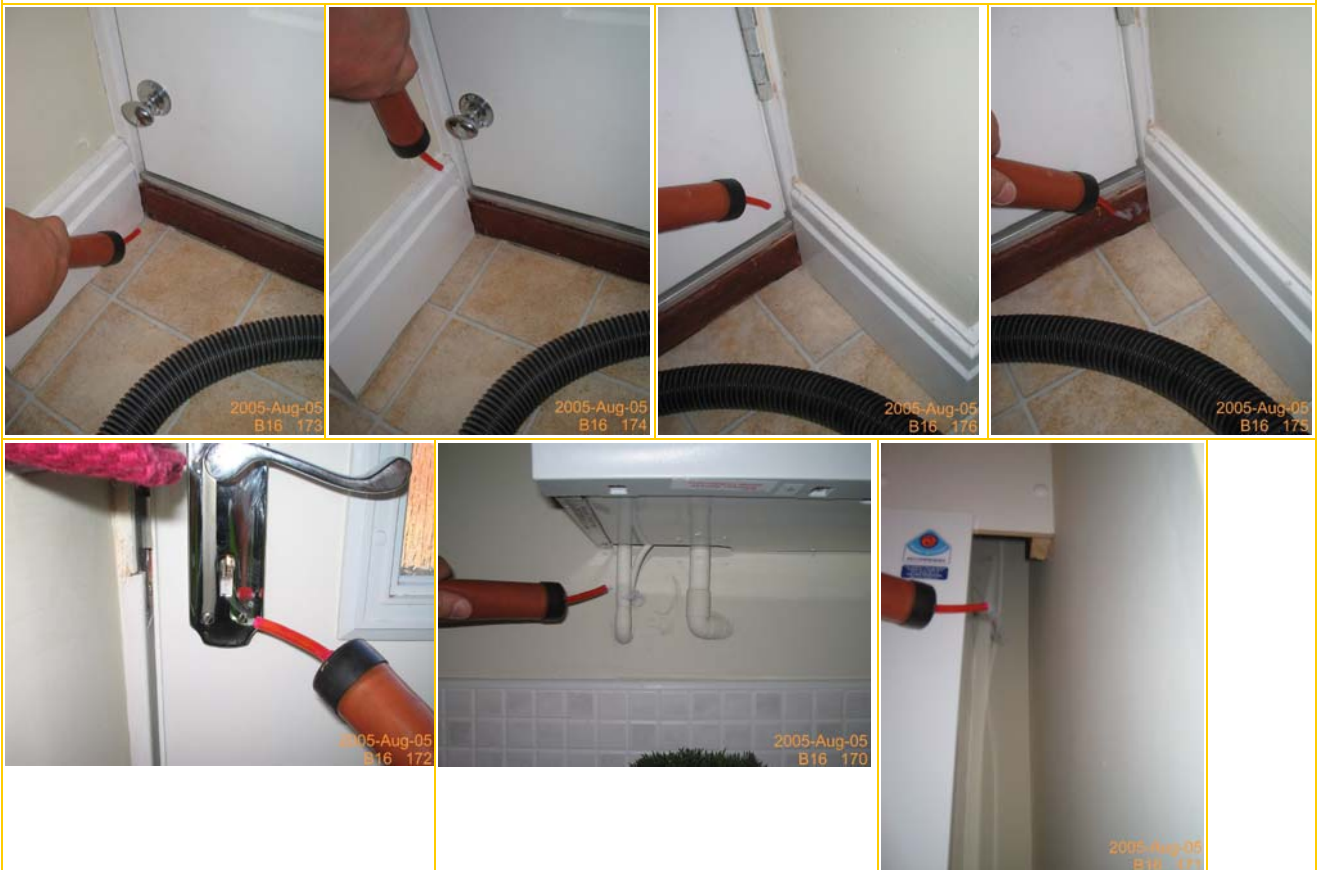
- Air movement around both sides of the threshold and bottom of the back door, and through the keyhole.
- Leakage detected around the boiler.
- As in the kitchen, air movement was observed around the base of the units, over the unit back under the sink and through service penetrations.

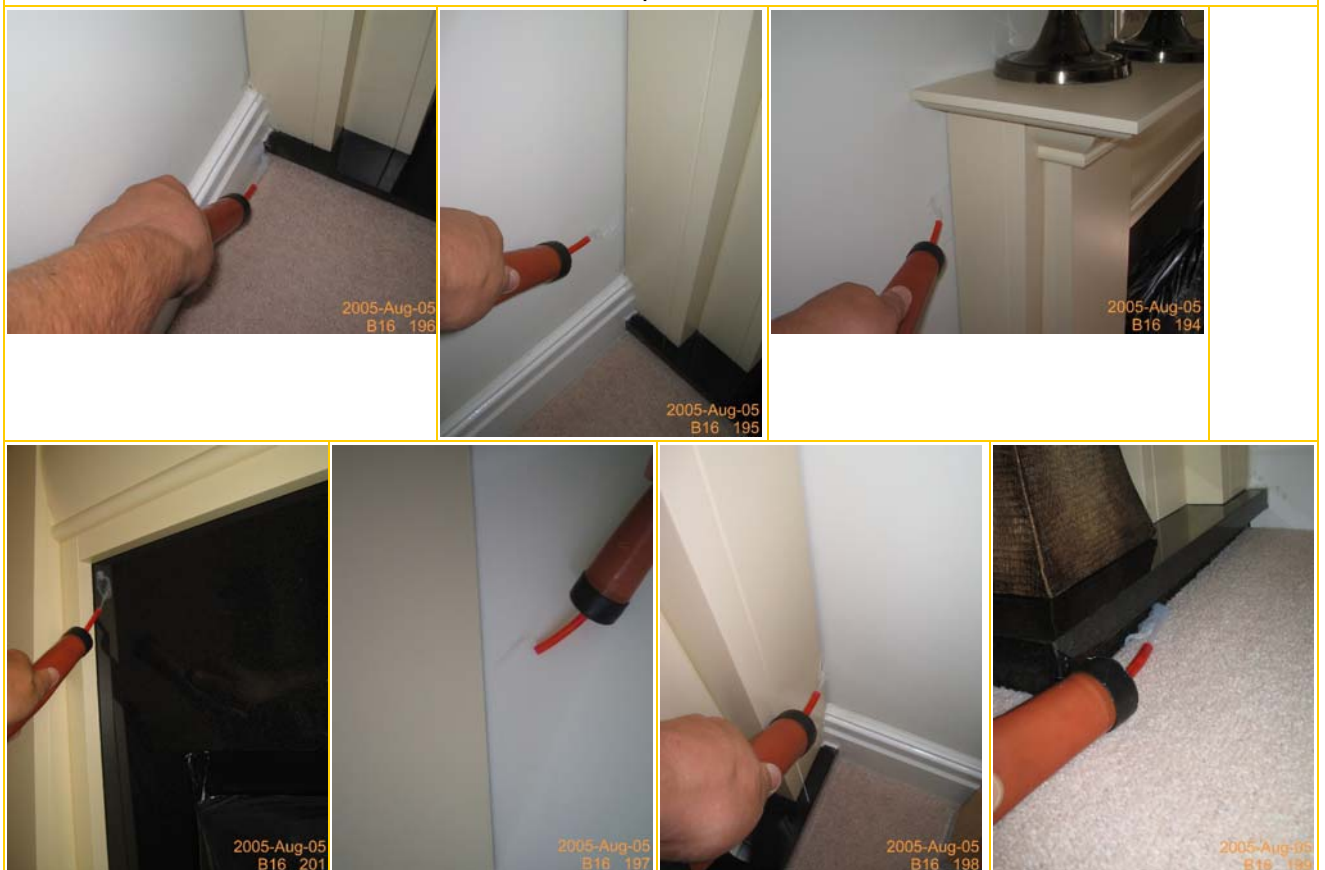
- Air movement was detected all around the fireplace surround.

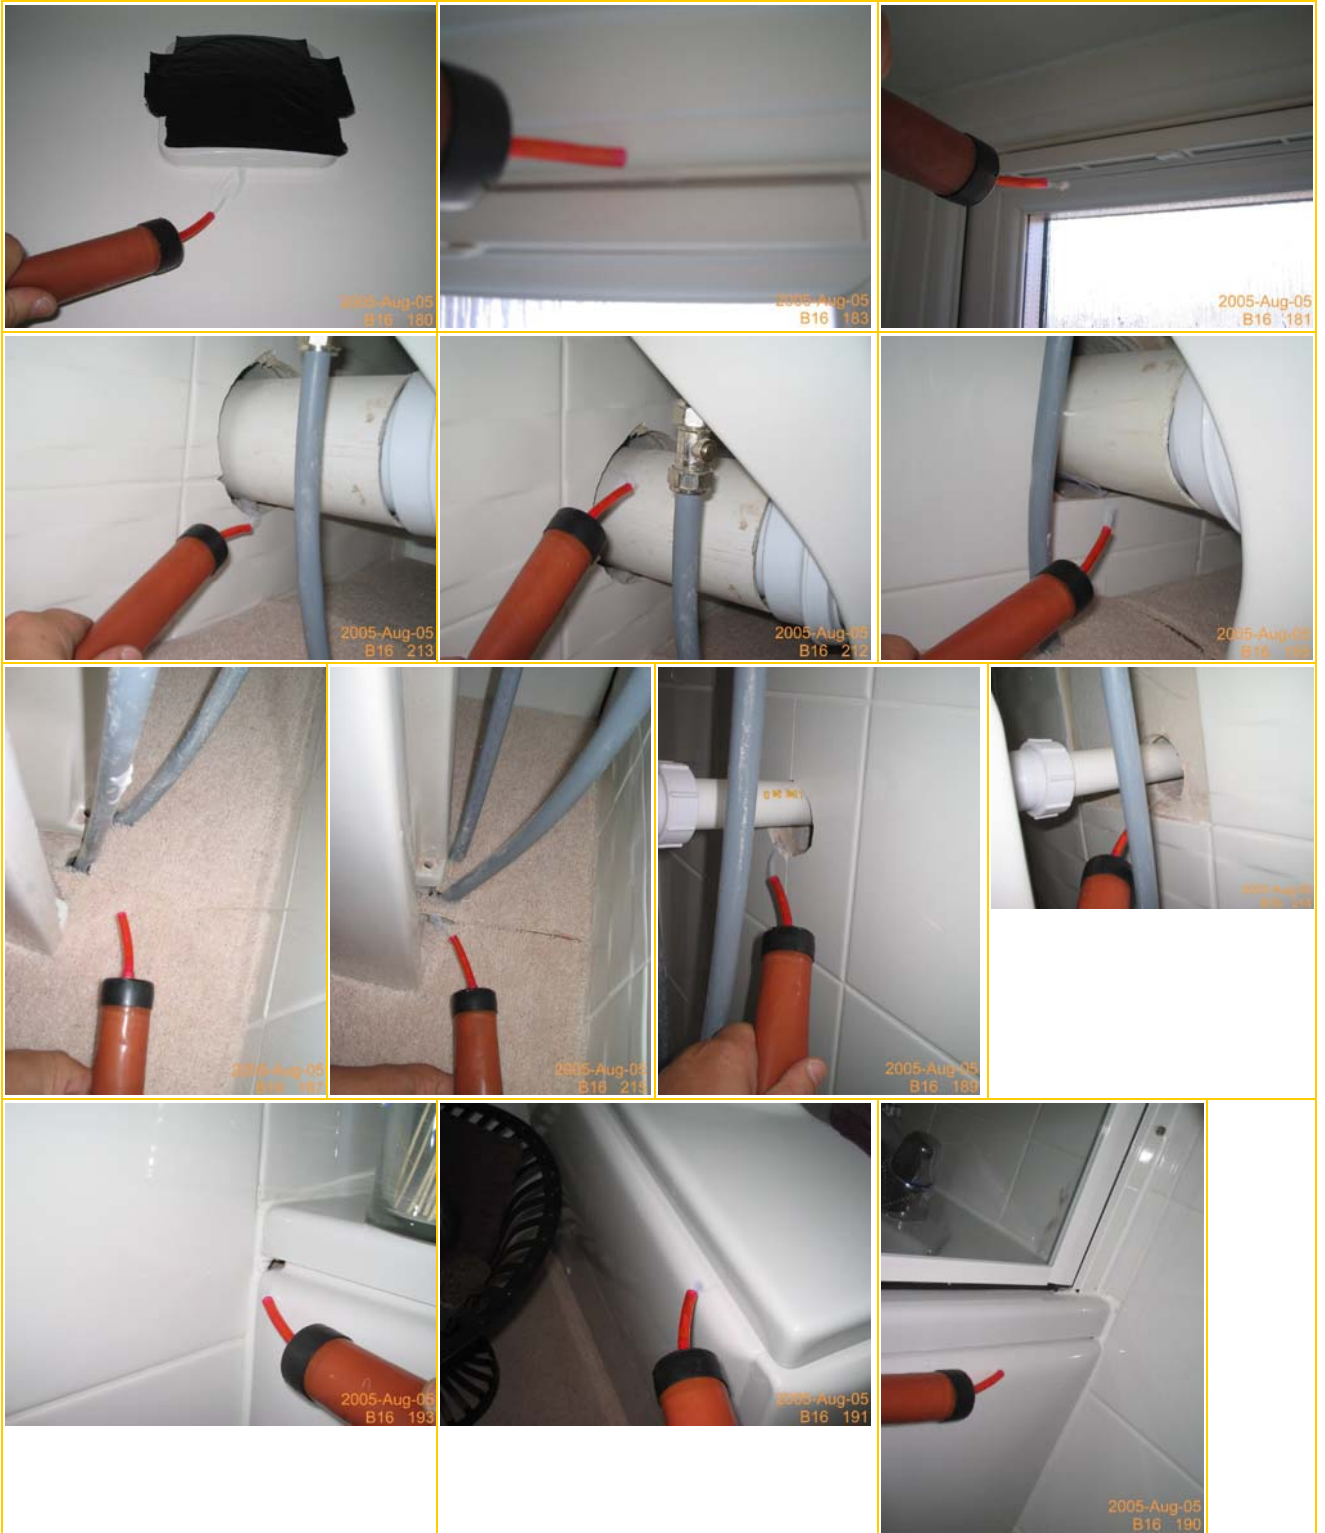
- Air movement around extraction and trickle vents, and through poorly closing trickle vents.
- Significant leakage around soil pipes in both bathrooms.
- Leakage into both intermediate floors around the water supply pipe-work to wash basins, and into

the external wall around both waste pipes.

- Leakage around all edges of the bath panels.

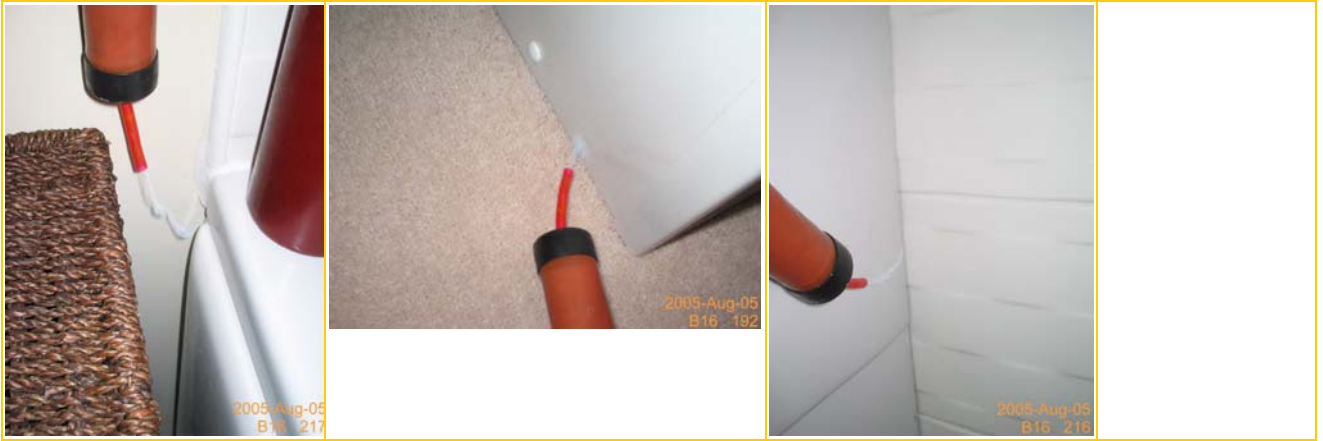
CPSU cupboard

- Significant air movement around both sides of the water storage unit, and through gaps in the skirting board placed in front of it.

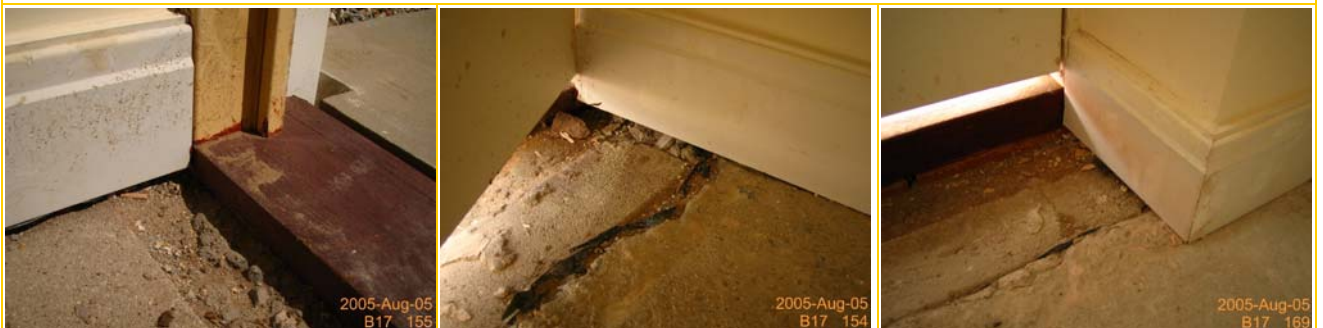
Back door/window frame

Although it is envisaged that this gap will be sealed where visible it is the part of this gap hidden below sill level that may remain, linking the void behind the plasterboard directly with the cavity and allowing unrestricted air movement between the two.

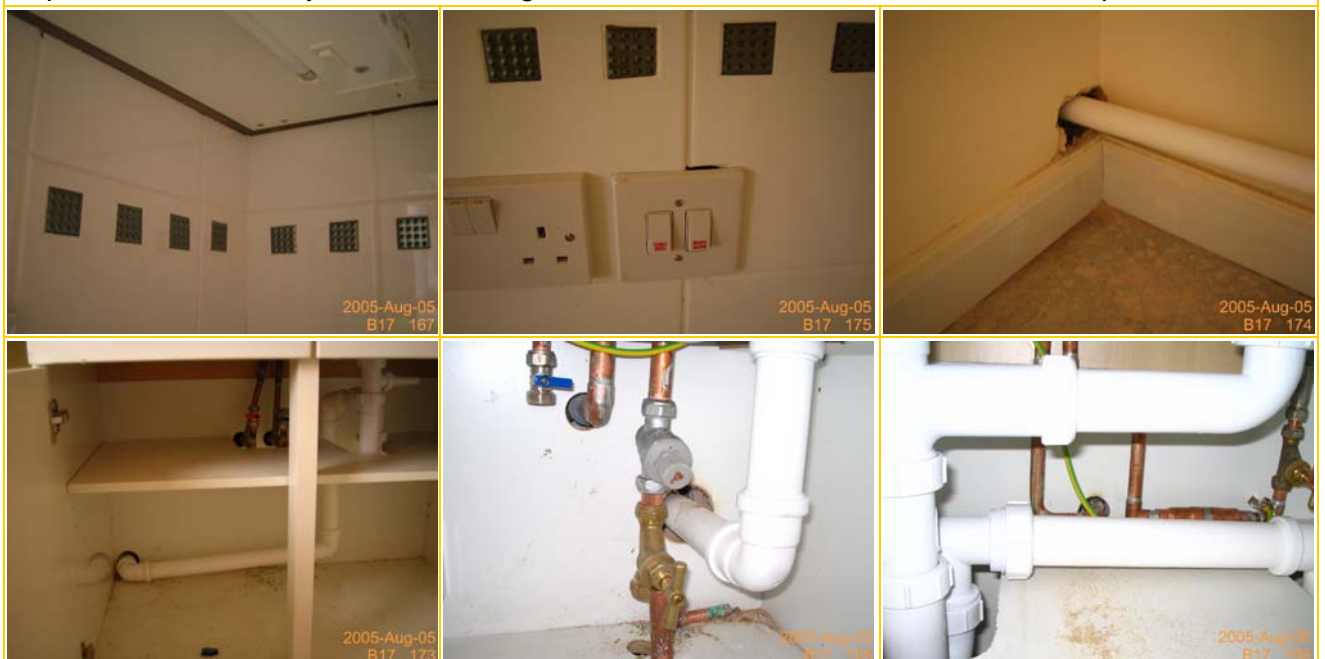
Other heating and plumbing penetrations

Potential leakage paths again exist at; radiator pattresses, where excessively large holes have been made in the intermediate floor beneath the water storage unit and where pipe-work runs from the CPSU directly into the ventilated loft-space.

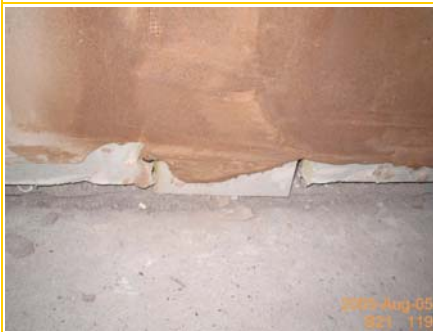
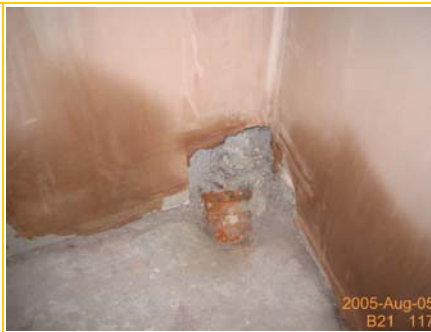
Thresholds

Possible leakage paths at both front and rear thresholds, as previously noted.

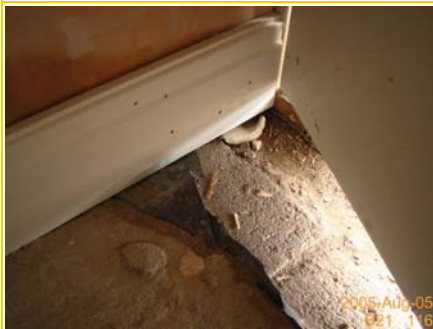
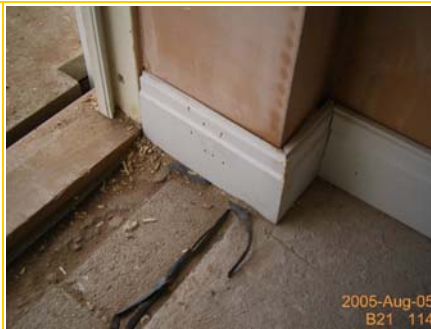
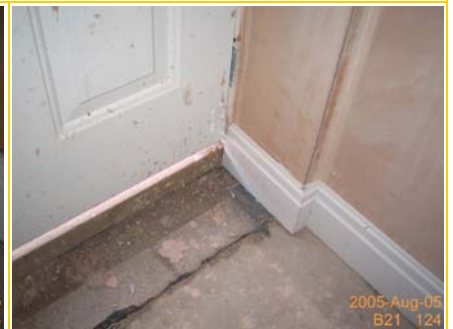
Intermediate floor

As in previous plots, slits can be seen cut into the intermediate floors that provide potential leakage

paths. At the floor perimeter air leakage may also occur under the skirting into the wall and floor voids, which are linked due to dabs of plasterboard adhesive (rather than continuous ribbons) being applied.

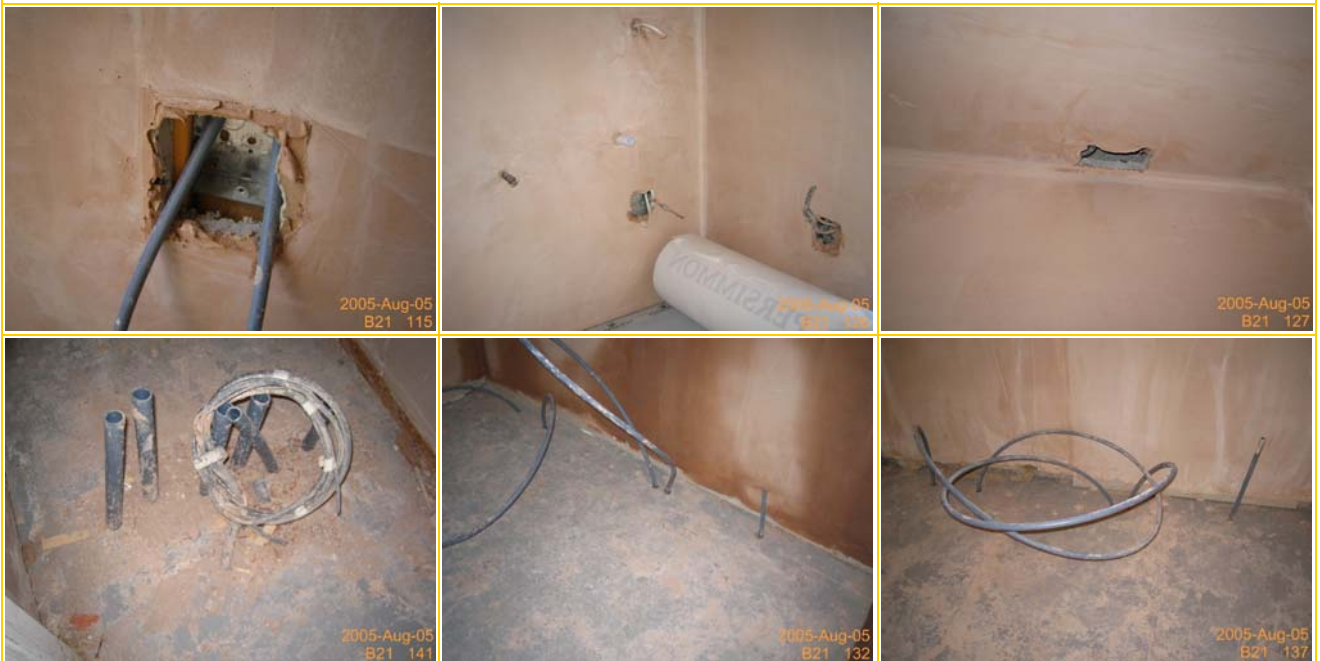
Potential for air leakage around the radiator pattress boxes exists as in previous plots. Penetrations for the boiler and electrical sockets/switches appear to have reduced gaps around them compared with previous dwellings, but it is around plumbing penetrations through the intermediate floor where this improvement is most noticeable, with little or no air-gap surrounding most of the pipe-work.

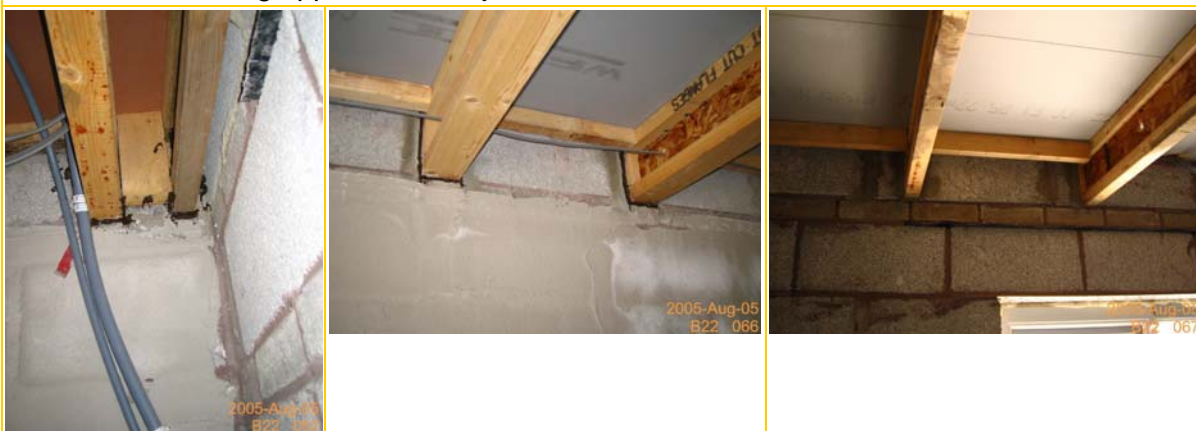
Loft/ceiling junction

Gaps around the perimeter of the plasterboard ceiling will allow air to move directly from the void behind the dry-lining on the walls directly into the ventilated loft-space; unless they are adequately

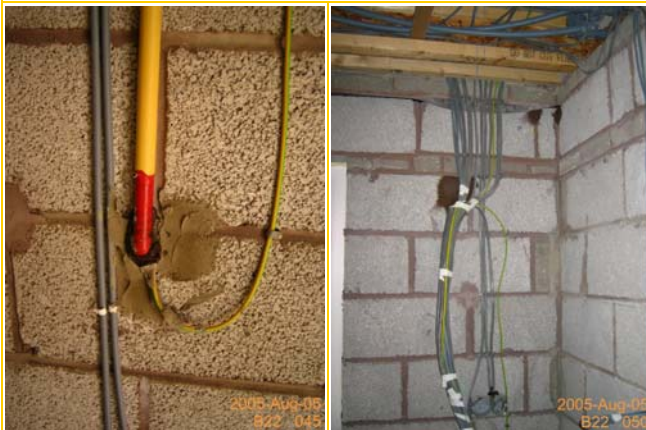
Service penetrations – intermediate floor

A mastic sealant had been used to seal unnecessary holes made in the intermediate floor, and to seal around most of the plumbing penetrations. Where no mastic had been applied, the holes bored for the pipe-work were of a suitable size with little space around them.

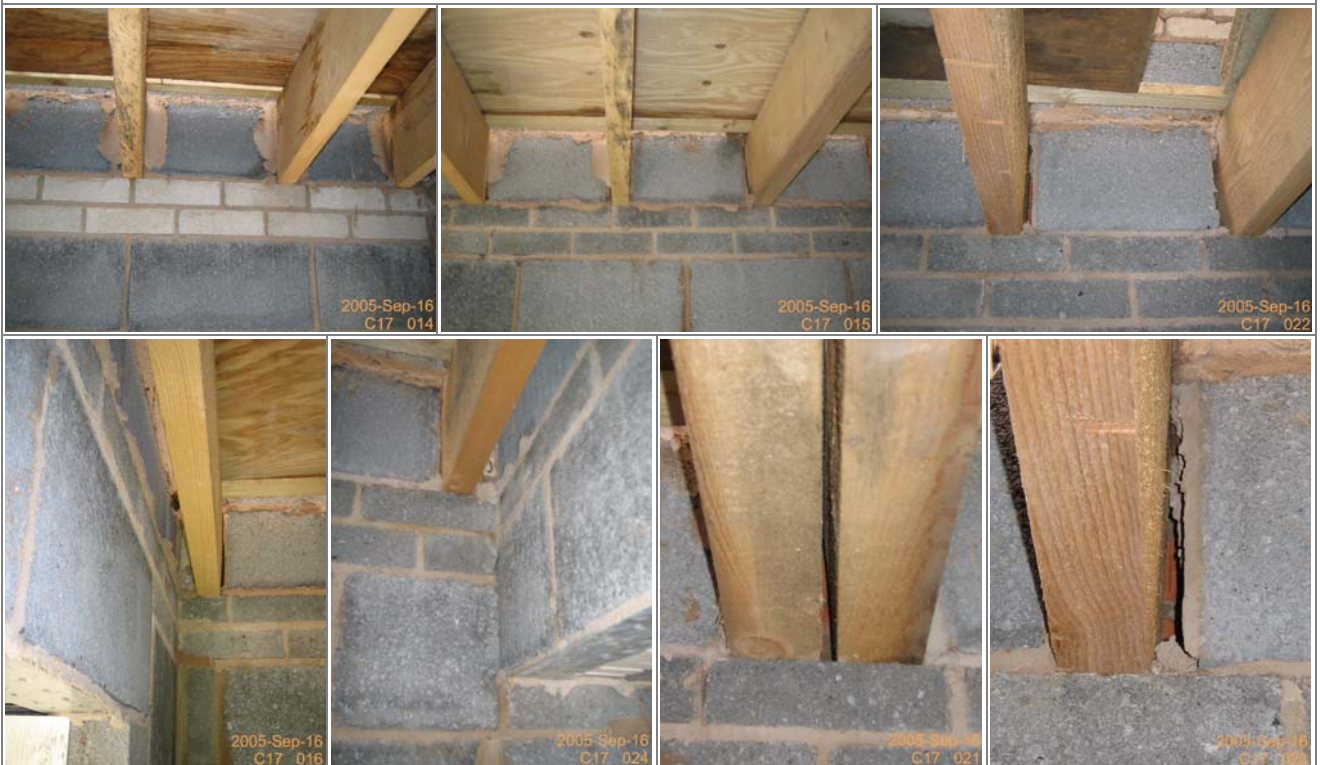
A mixture of good and bad examples. In some cases the joints around the joists have been completely filled with mortar which will assist in airtightness and the potential problem areas where joists are fitted closely parallel to walls have been well constructed. However, in some cases there are gaps around and between joists large enough to make the external brickwork visible, these may prove difficult to seal with mastic and could contribute to the leakiness of the dwelling.

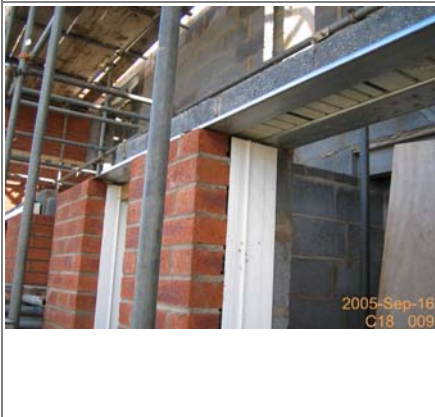
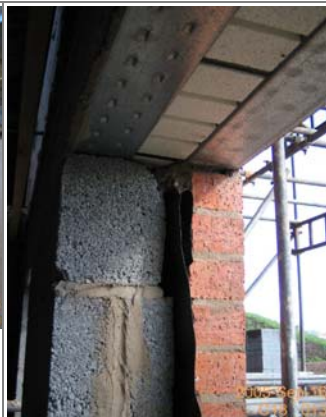
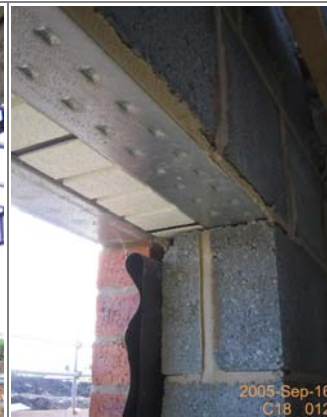
**Steelwork**

Gaps exist between the RSJs and between the joist and the steelwork, both of which may provide potential leakage paths if left unsealed.

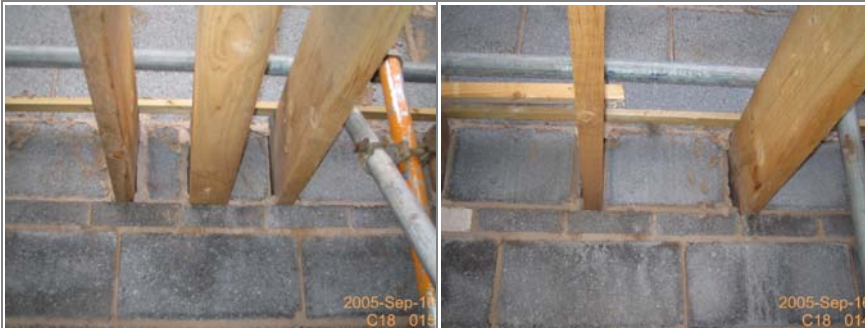
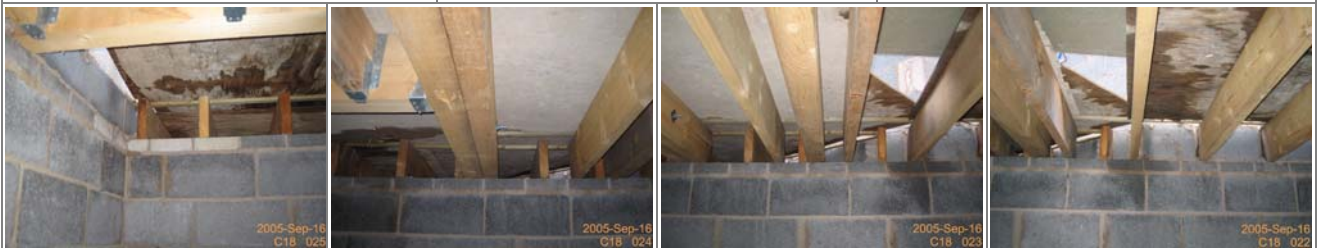
Built-in joists

Again, some joists are fully mortared in whilst others have gaps around, these gaps may get filled in when the party walls are rendered. A more complex detail, and potentially serious problem, occurs above the ginnel; where there is uncertainty over what constitutes the primary air barrier. Here the intermediate floor void extends over the ginnel underneath the bathroom, the drawings suggest the top of this wall is sealed by pushing in the 200mm mineral wool quilt placed in the floor void above the ginnel, this is not regarded as a satisfactorily airtight seal and further consideration of this detail is suggested before further construction work restricts access.
