AIRTIGHTNESS OF BUILDINGS — TOWARDS HIGHER PERFORMANCE

Interim Report D8 — Site Assessments and Test Results

Dr David Johnston, Centre for the Built Environment, Leeds Metropolitan University

Reference Number: CI 61/6/16 (BD2429)

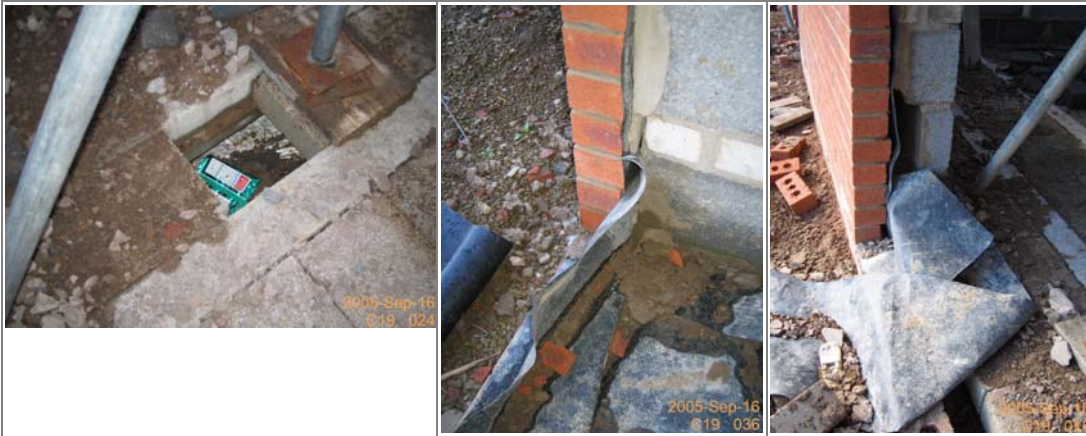
A29

Potential problems as mentioned in previous plots.

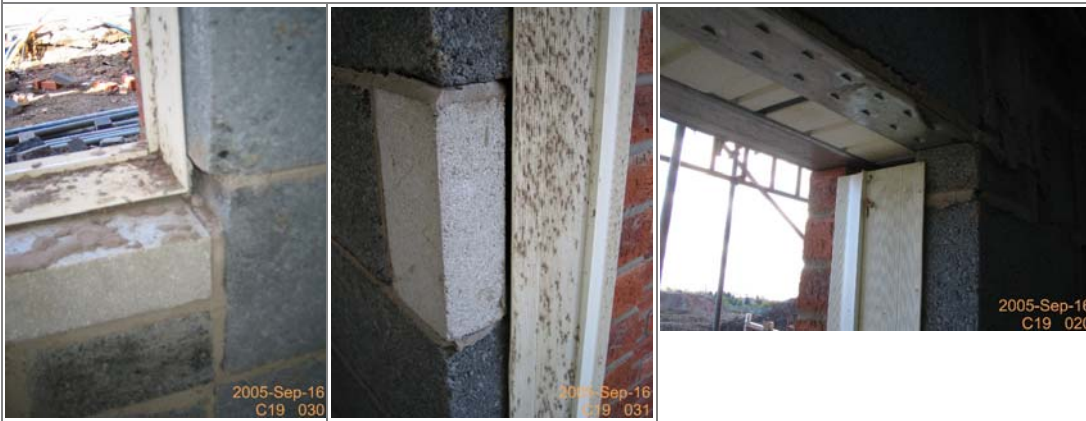
Openings

Small gaps at the sills and jambs should get filled by the parging layer. At the jamb/head junction the gaps are small enough to be filled easily with a suitable sealant.

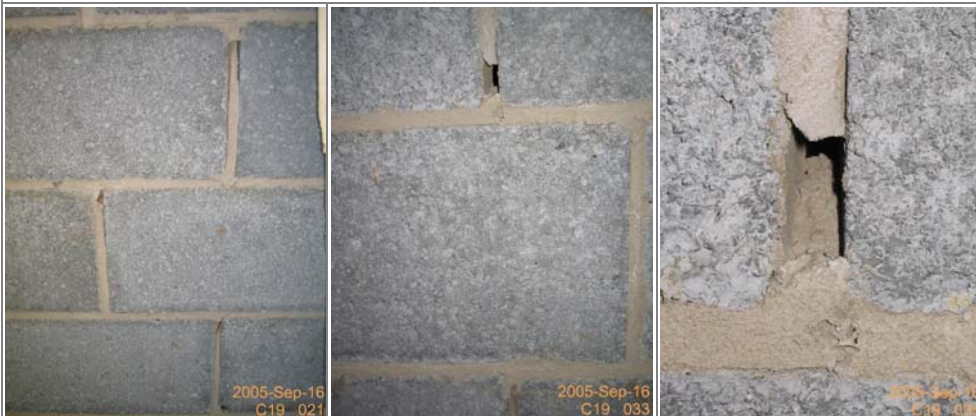
Blockwork

The application of the parging layer should seal gaps such as these, which otherwise would allow air to move directly between the void behind the plasterboard dry-lining and the cavity.

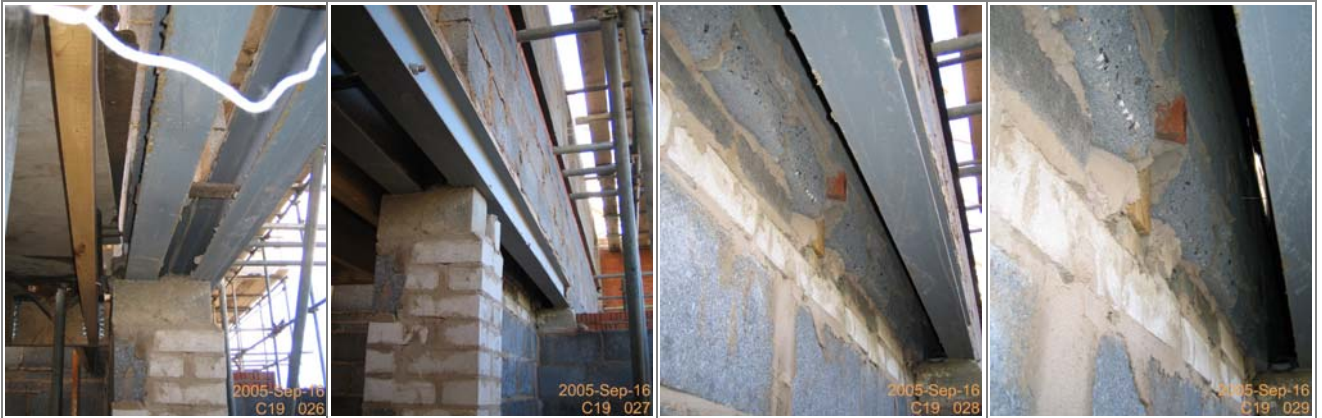
Steelwork

As with C18, there are concerns that air might be able to move from behind the plasterboard fixed on dabs up into the cavity between the RSJs if it is not effectively sealed.

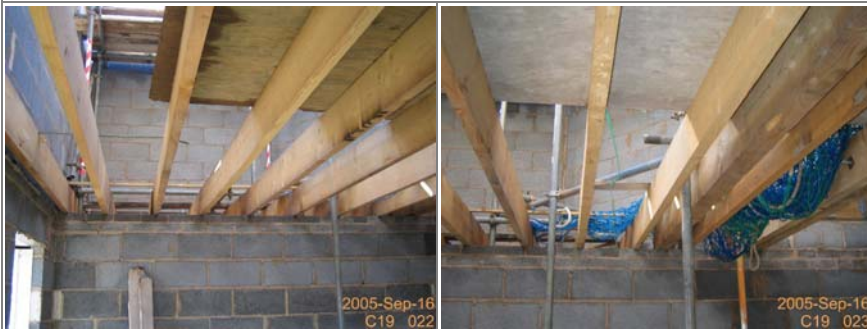
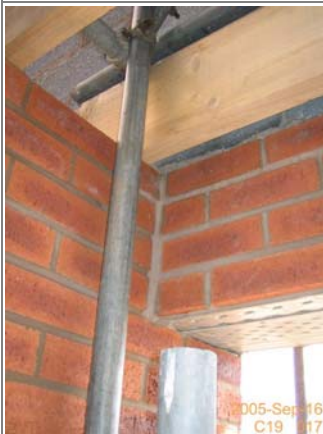
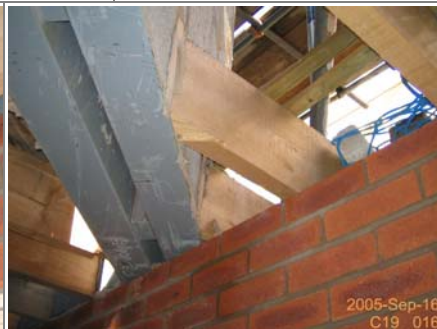
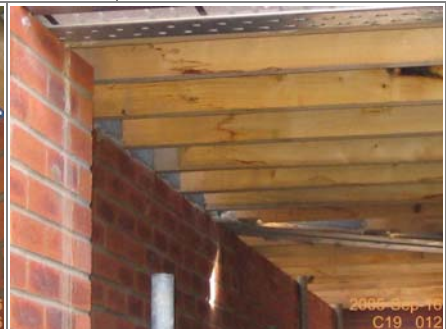
Built-in joists

As with C18, there are concerns where the intermediate floor extends over the ginnel.

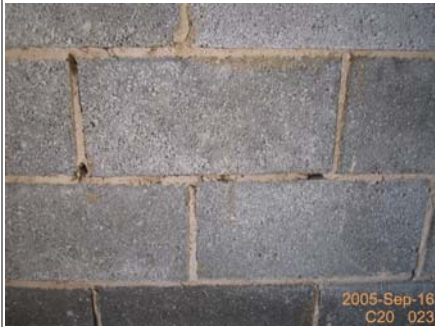
Blockwork

As with C19, unfilled perpend and gaps in bedding layers should not be a problem as they will be filled when the walls are parged.

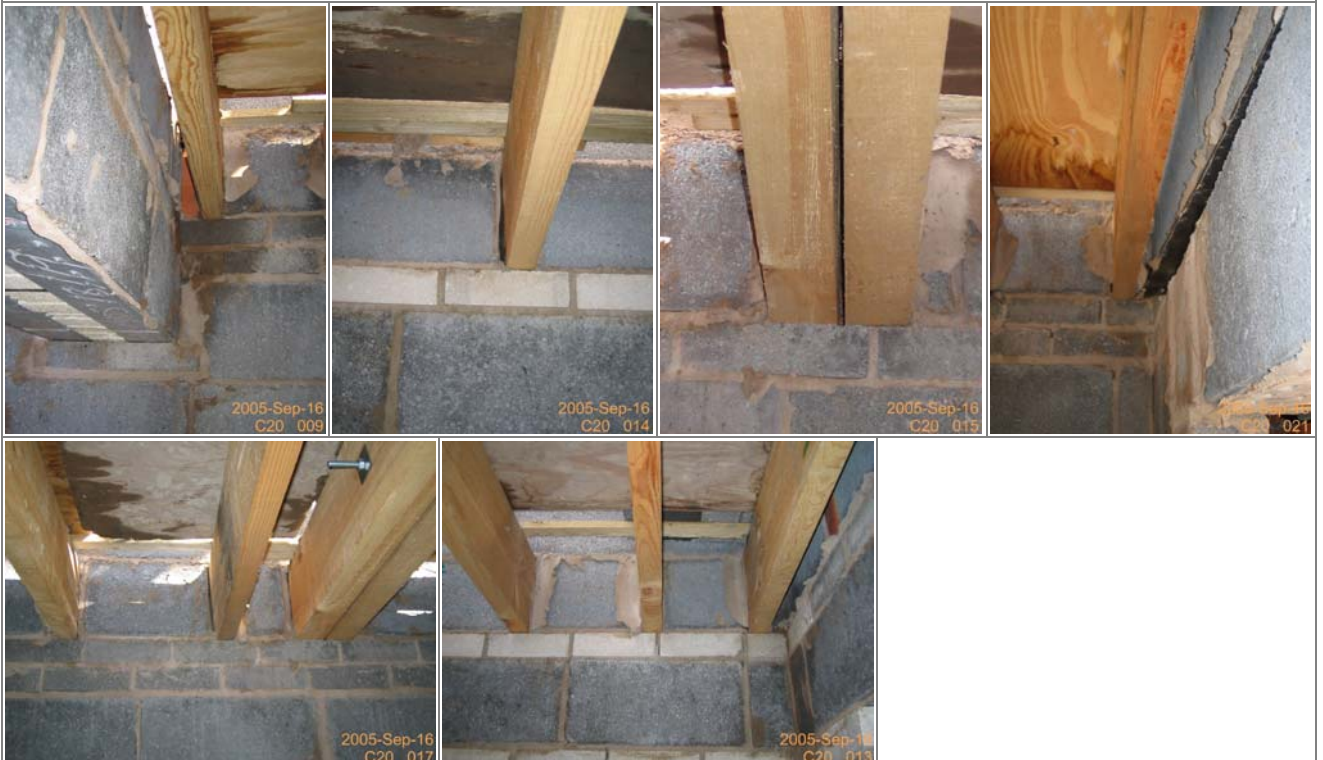
Built-in joists

Once again, some gaps have been effectively sealed (in the 1st example using a facing brick) and others not. Providing that the parging layer extends throughout the intermediate floor void, and right up to the joists, this should not cause a problem.

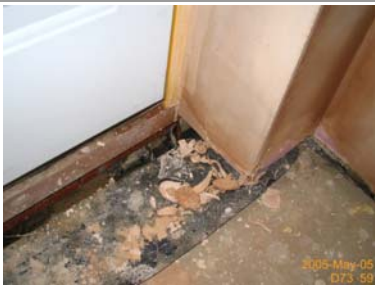
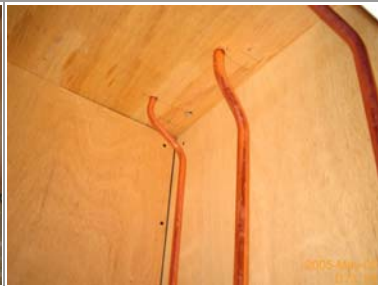
D73		
Threshold & cylinder cupboard		
Continuing potential leakage paths at thresholds, particularly where cavity-fill may not extend fully into base of reveal, allowing a direct air path from the wall void into the cavity.		
Roof of cylinder cupboard still a potential problem due to service penetrations and non-airtight seals at junctions.

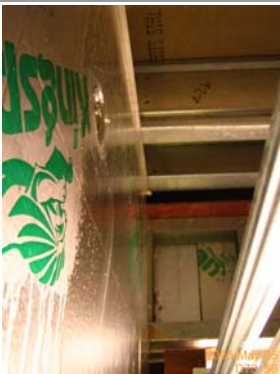
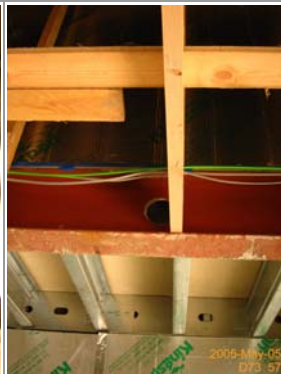
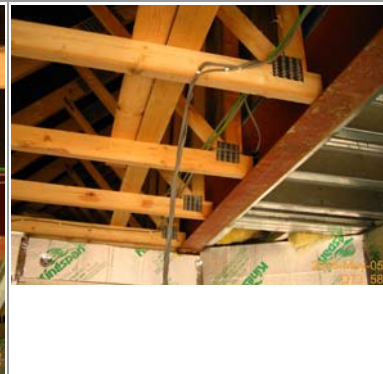
Integral garage		
The intermediate floor and wall voids of the main house are linked directly to the wall voids of the garage, allowing free movement of air between the two.		
Unsealed holes in the structural steelwork allow air leakage directly from the intermediate floor void into the roof-space above the garage.

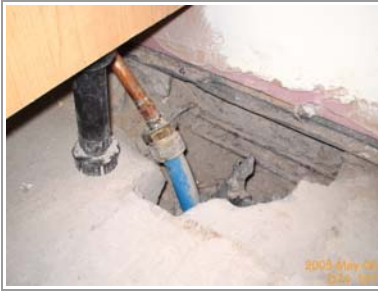
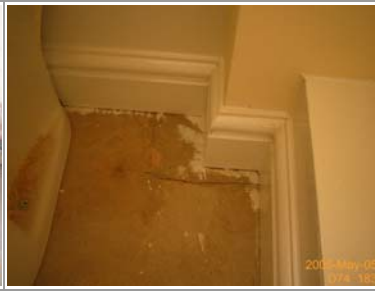
D74		
Ground floor		
Potential leakage paths where service penetrations are hidden (e.g. behind kitchen units) and where shrinkage of filling materials may occur.

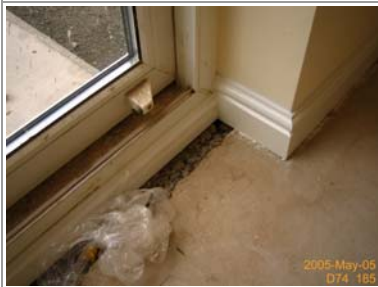
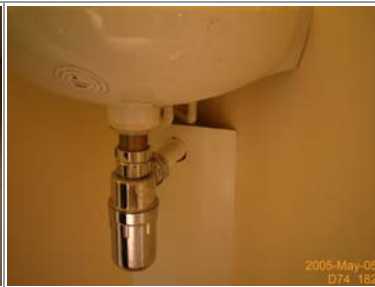
Threshold & boxed-in pipe-work

As previously mentioned, at thresholds, concerns over the treatment of reveal bases and shrinkage of filling material.

Unsealed ends of boxing-in of pipe-work allow unrestricted air leakage (via soil pipe stack).

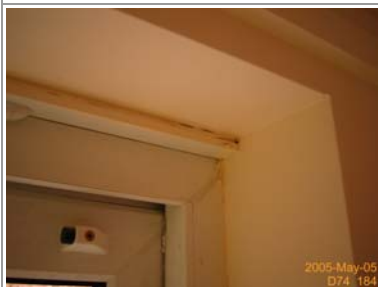
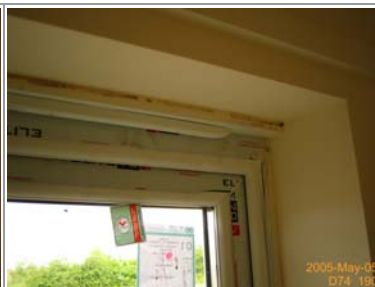
Window heads

Apparently unresolved potential leakage path at the window heads, with small holes in the corners allowing direct passage of air from inside the building into the cavity.

These holes are only small, but do have a cumulative effect on the overall air leakage of the dwelling.

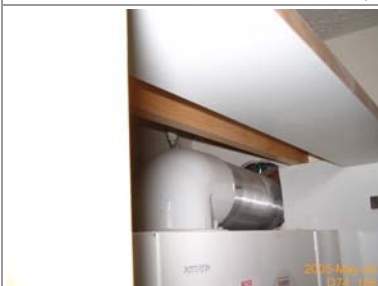
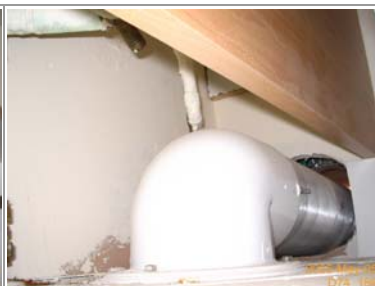
Boiler

Access to the boiler flue, to seal the air barrier around it, is becoming increasingly limited as construction progresses. Our initial concerns that this will only get sealed at the plasterboard and externally still apply, and there is a very distinct possibility that the substantial hole in the air barrier caused here will remain inadequately sealed at the insulation (air barrier) layer.

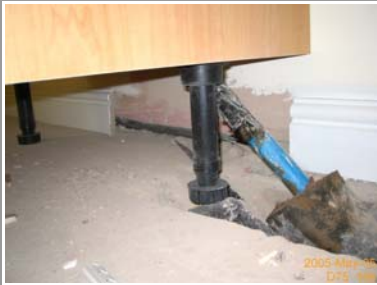
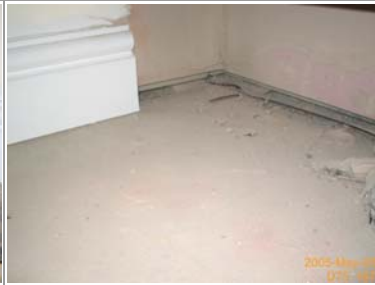
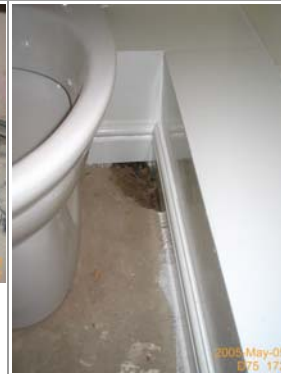
be sealed; also the junction between floor and wall presents an increased risk behind the units where it is more likely to remain unfinished/unsealed.

Service penetration in downstairs WC may provide path to unsealed area behind boxing-in of pipe-work.

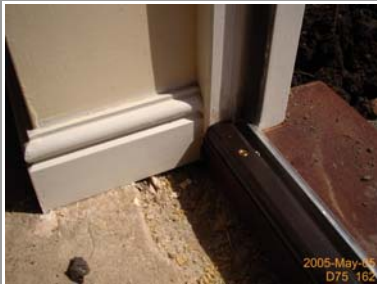
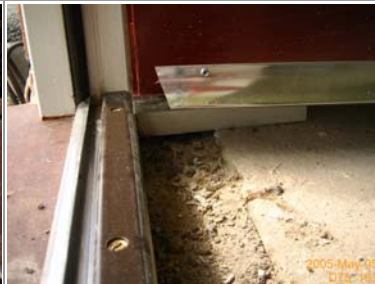
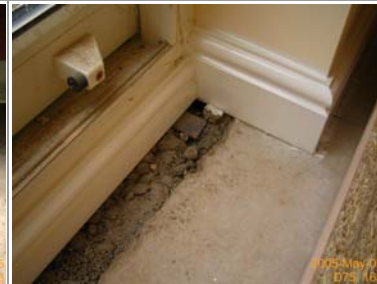
Thresholds

Potential risks as mentioned for both previous plots. Concerns over air leakage at both front door and at rear patio doors, due to air movement around base of reveals and potential leakage paths through joints and cracks caused by shrinkage of the filler material.

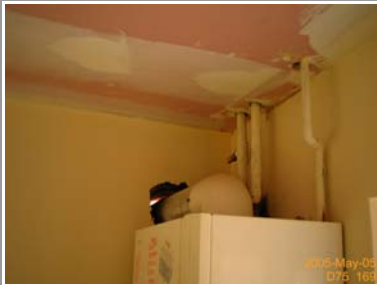
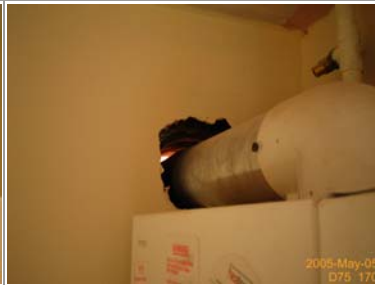
Boiler

As mentioned with previous plot, sealing at the air barrier becomes increasingly difficult (and more likely to get omitted) as further work is carried out.

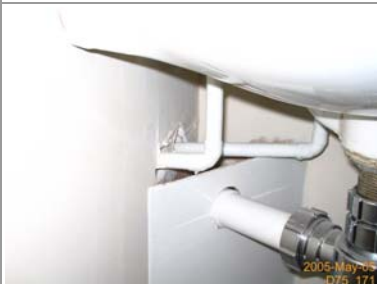
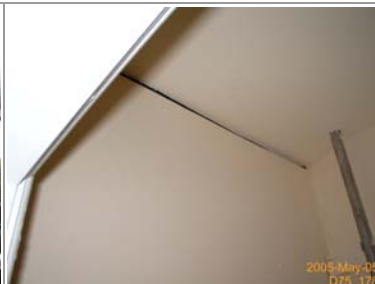
Pipe-work & cylinder cupboard

Gaps at the top of the boxing and in the cylinder cupboard roof; both providing potentially serious air leakage paths; via the soil pipe void and loft space, respectively.

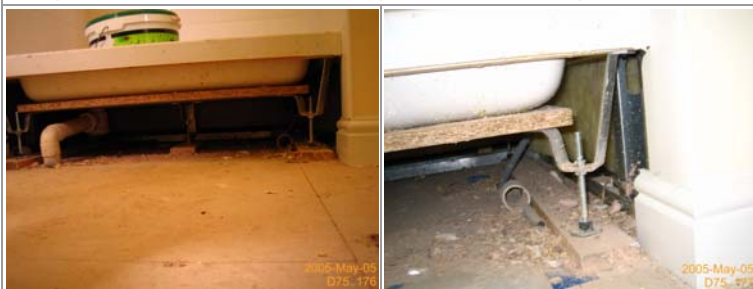
Shower

The problems noted for the bath are increased here as there is no facing on the partition walls beneath the shower tray. Air movement from underneath the tray, via the partition wall, to the loft space can be expected.

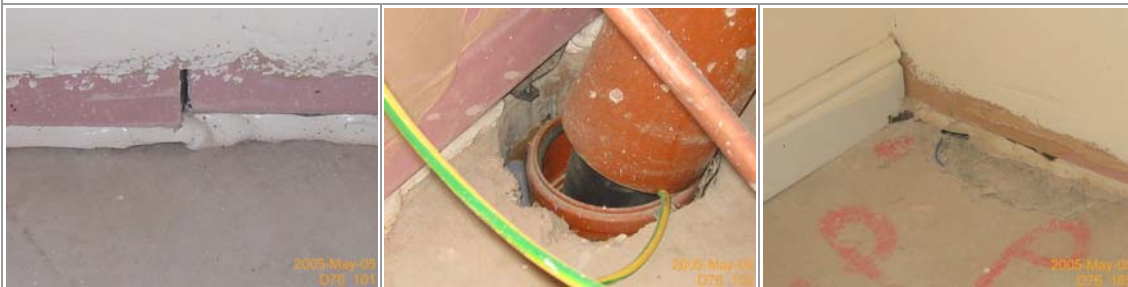
Ground floor

Caulking of the ground floor junction with the external walls reduces the likelihood of air leakage under the steel frame, where shims have been used for levelling. Generally this was done very effectively, some minor points: an opportunity has been missed to seal between vertical gaps in plasterboard, some missed areas at the ground floor service penetrations and access to some junctions with internal walls was impeded due to the build sequence.

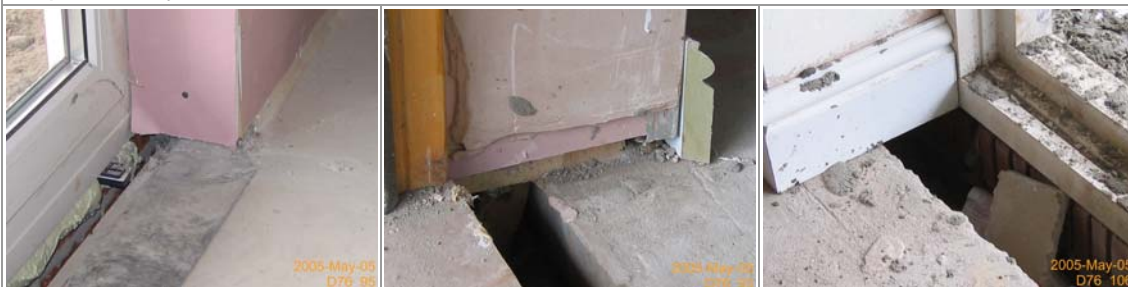
Threshold

As previously mentioned for all external doors

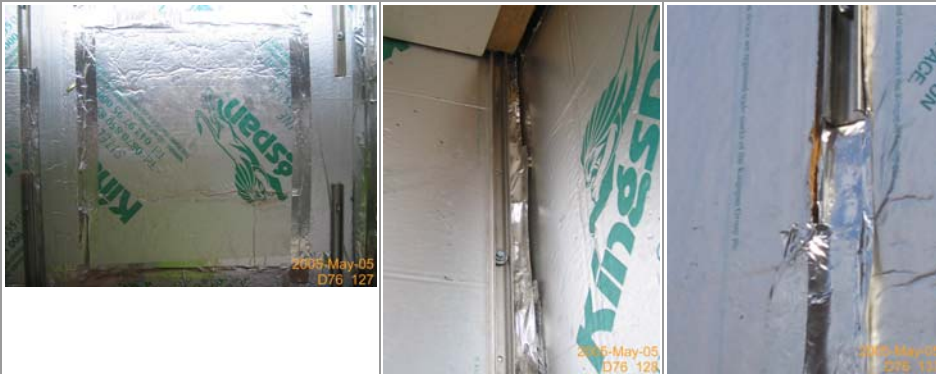
Insulation

Damage to insulation (and hence, air barrier) has been repaired successfully in most cases.

Problems still exist where the tape appears to be losing its adhesion, particularly at internal corners and where wall-tie channels are close to joints between insulation boards.

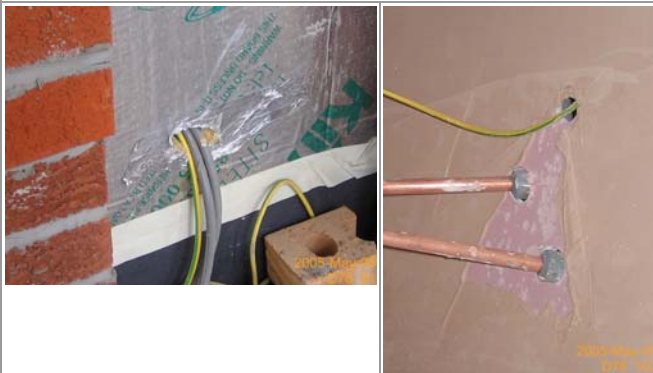
Service penetrations

Externally and internally, penetrations are still being created larger than necessary and rarely sealed by the trades creating them.

Areas illustrated here are penetrations which are more likely to remain unsealed (covered by the meter box and by kitchen units, respectively).

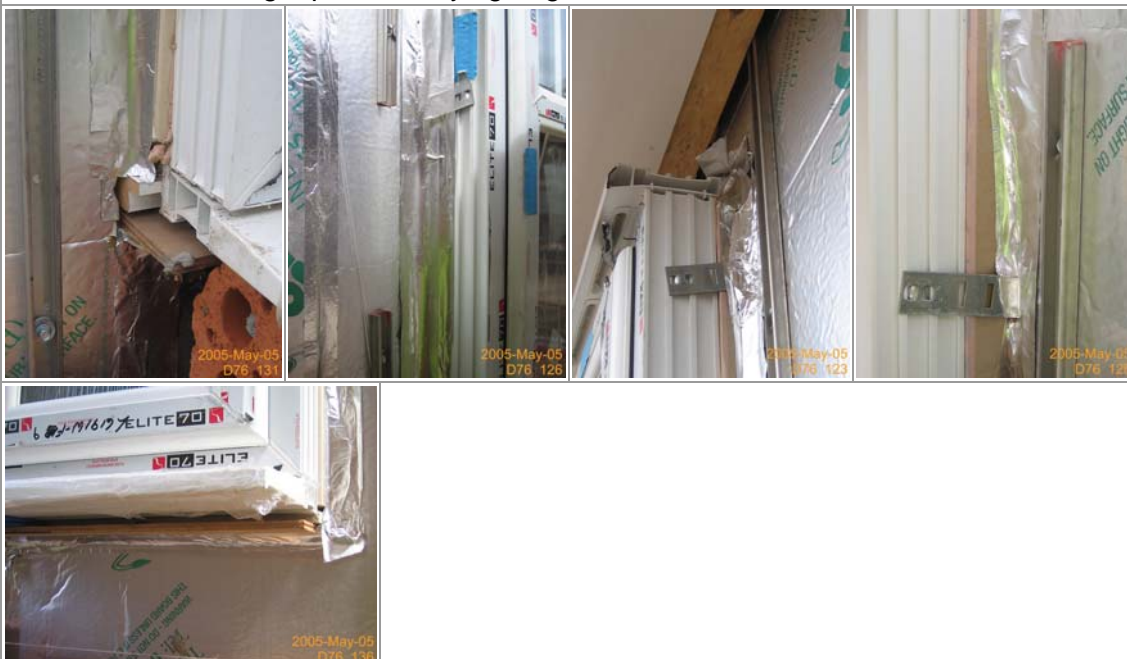
Windows – continuation of air barrier

Valiant attempts made to continue the air barrier between the insulation and the window frames using tape – to varying degrees of success.

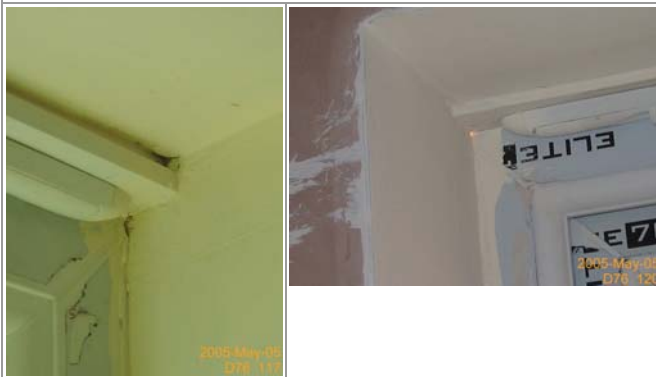
Window heads

Small gaps are again common at the window heads.

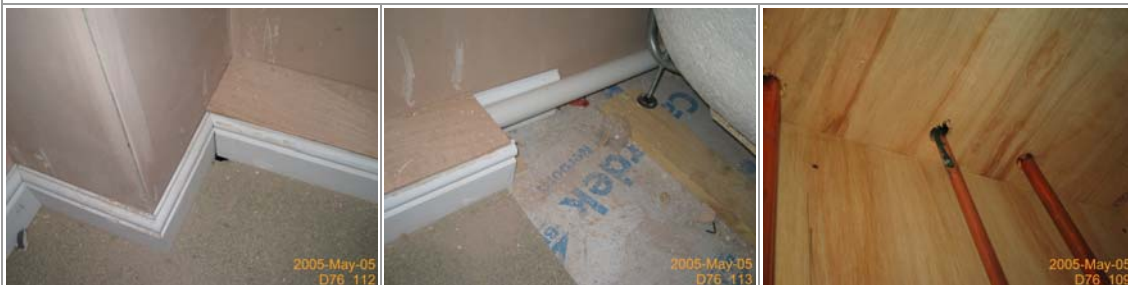
Pipe-work & cylinder cupboard

As mentioned for previous plots.

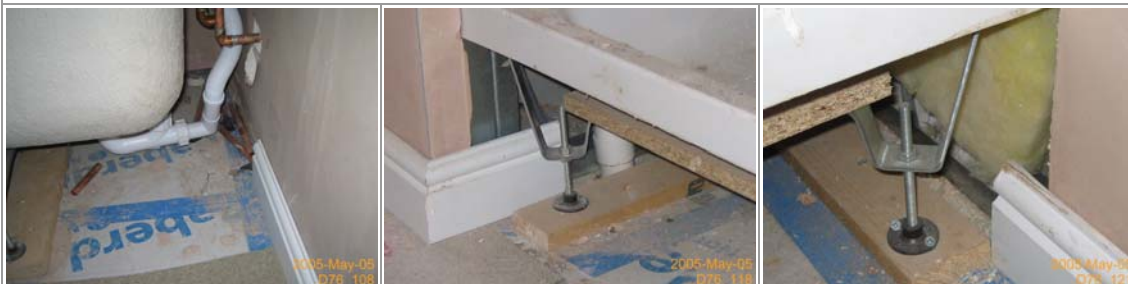
Bath & shower

As mentioned for previous plots.

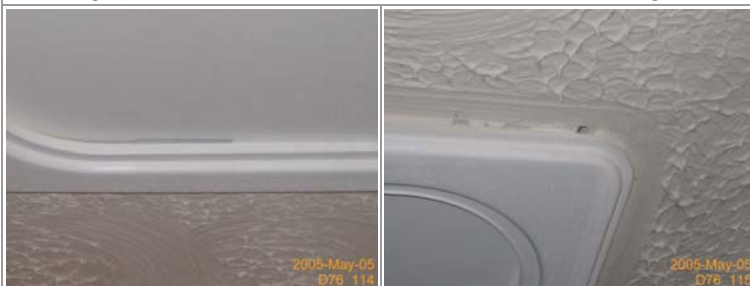
Loft hatch

Hinges are not fitted in the loft hatch where spaces are provided for them. Resulting in gaps at the end opposite the catch, and a lack of compression of the draught-stripping at that end.

Small gaps also exist around the loft hatch framing.

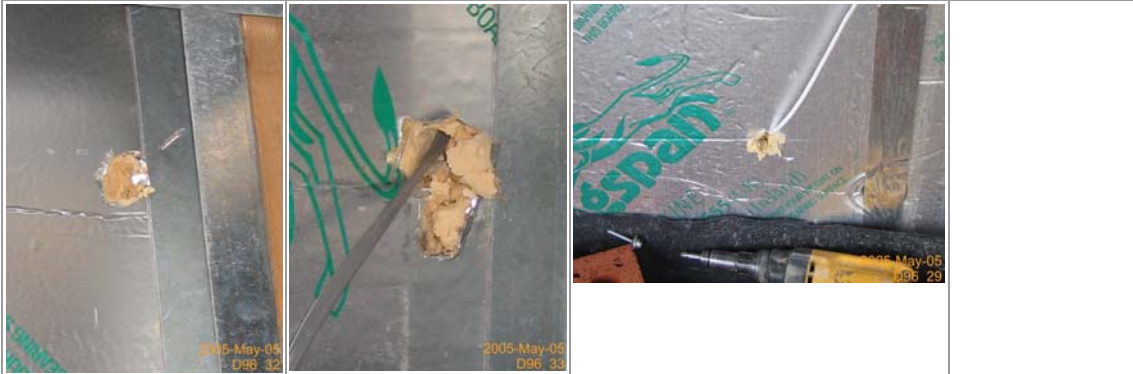
Insulation

Some damage caused to the insulation by scaffolding during the roof construction. Noticeable lack of care taken when puncturing the insulation for services.

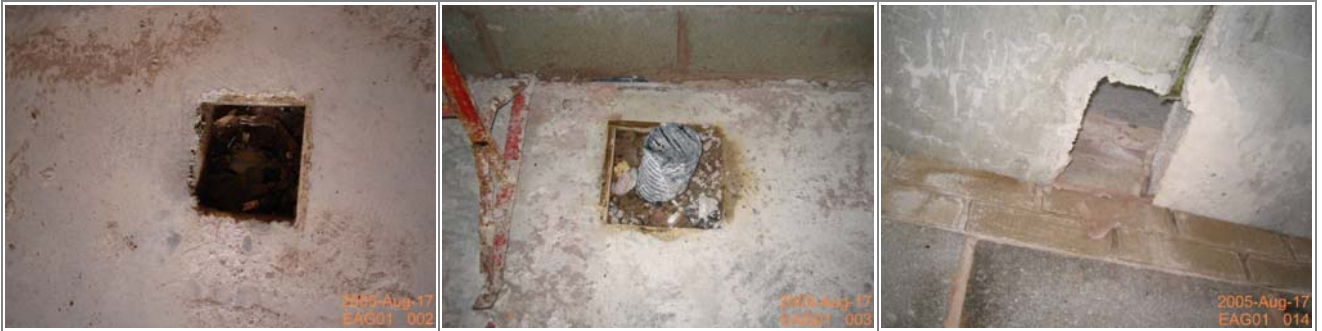
<p>Ground floor, 2-bed apartment</p>
<p>Service Penetrations</p> <p>Noted as a potential leakage path in Phase 1, penetrations here have been cut neatly, square and not excessively large, so they should prove easier to make airtight.</p>

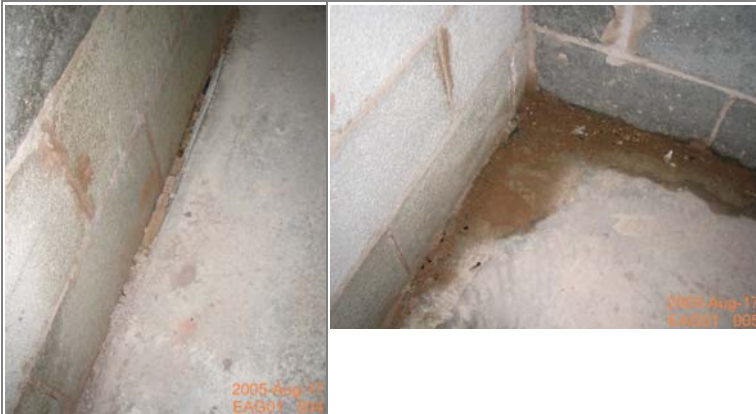
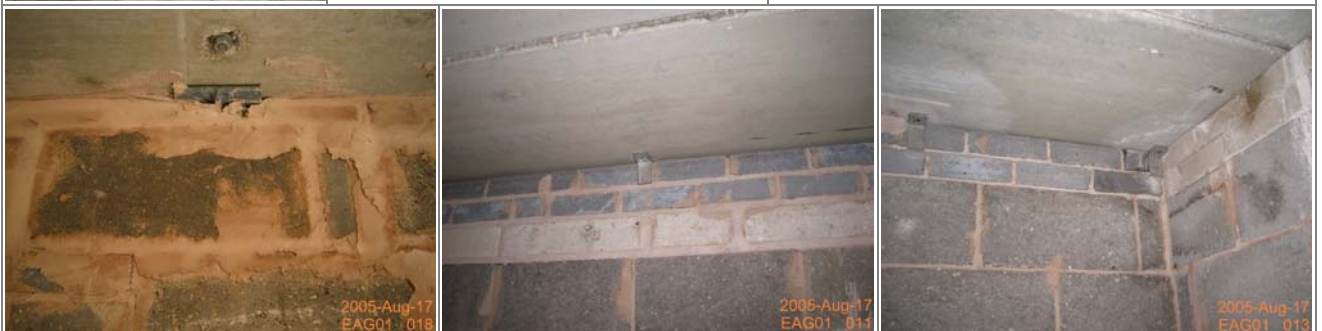
Wall/Floor Junctions

Possible slight gaps around the ground floor/wall junctions which should become airtight once the screed and plaster are applied. The intermediate floor/wall junction has been pointed up around the balcony supports, but nowhere else as yet. This junction is more likely to be a source of air leakage unless it is sealed before the suspended ceiling is fitted.

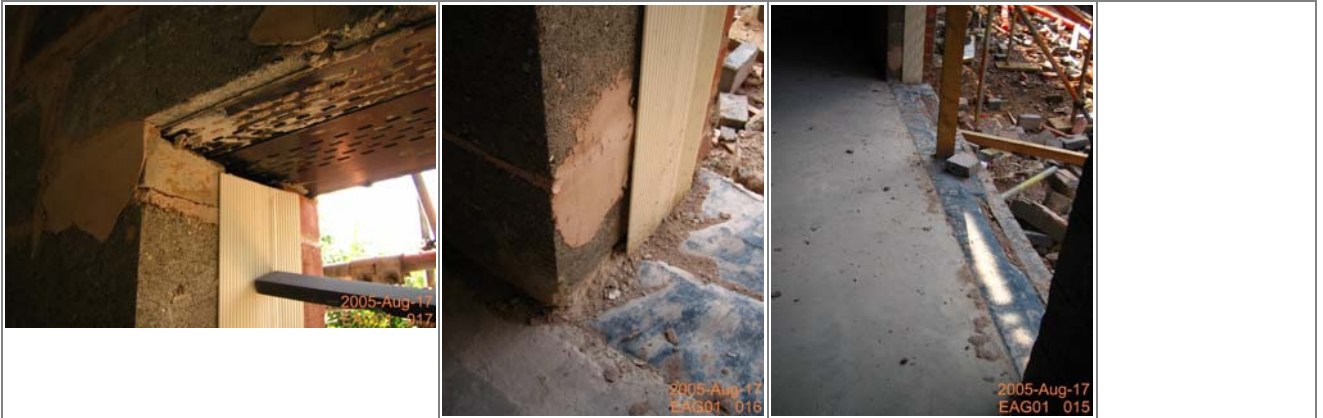
Balcony Door

Gaps exist between the cavity closer and lintel at the jamb/head junction, which may allow air to escape into the cavity if not sealed. Perforations in the lintel itself may also allow infiltration if not sealed (or sealed around). At the jambs, any gaps around the closers should be sealed when plastering except for the small gap at the threshold where the plaster may not be applied right down to the floor. At the thresholds, air was observed escaping into the cavity in Phase 1, this may again be the case here if the frame/floor junction is not effectively sealed.

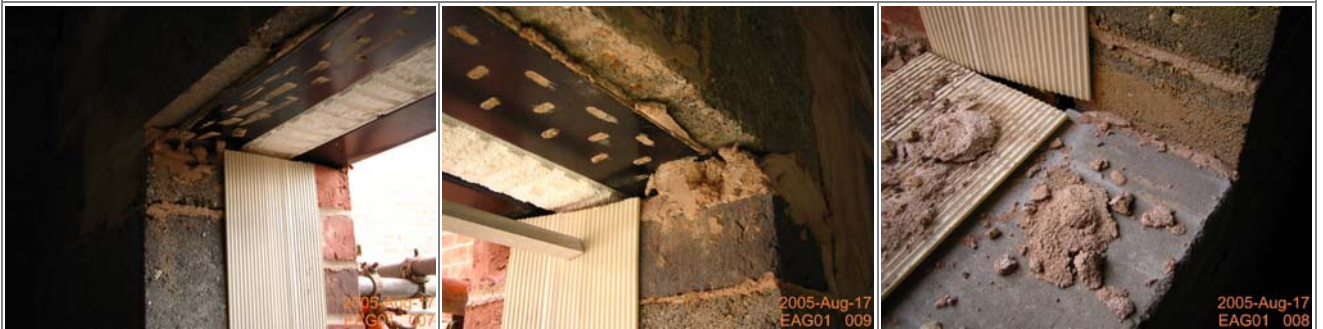
Windows

Potential problems at heads, jambs and sills as described above.

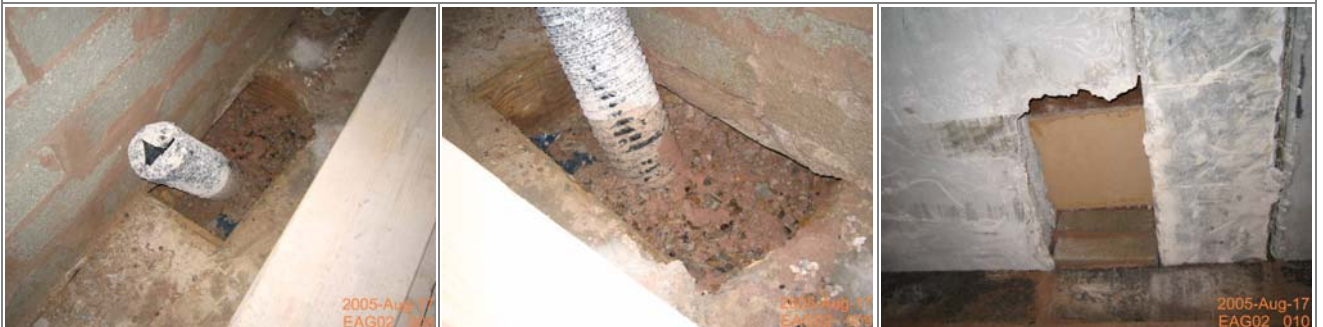
Service Penetrations

Larger than necessary holes for service penetrations requiring more effort to seal to an airtight standard at a later date, so increasing the likelihood of air paths remaining on completion. Mineral wool packing required around penetrations through intermediate floors (at min.10 Kg/m³ as specified in the design drawings) for acoustics purposes will not make it airtight, and air may still move between storeys and into the holes running through the concrete planks.

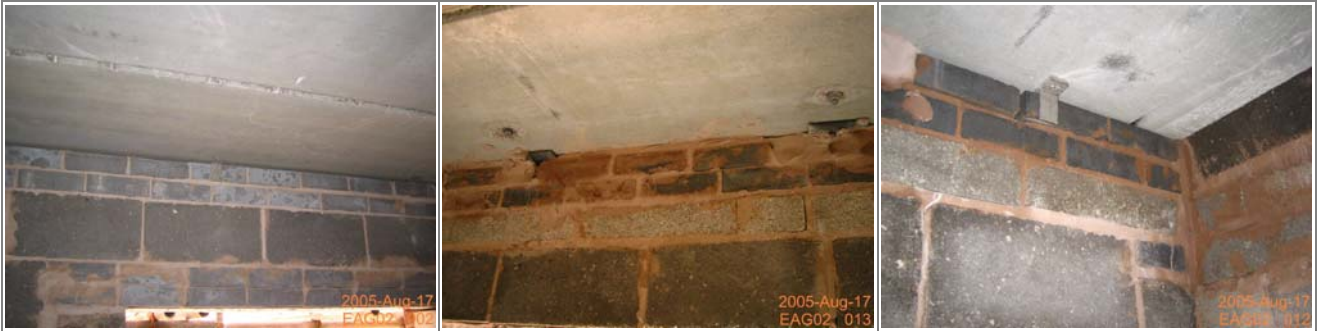
Wall/Floor Junction

Again, concerns over the intermediate floor/wall junctions, which will be hidden by the suspended

ceiling. Any air coming through the ceiling (e.g. through recessed light fixings and through partition walls) will rely on this junction being sealed to maintain the airtightness of the apartment.

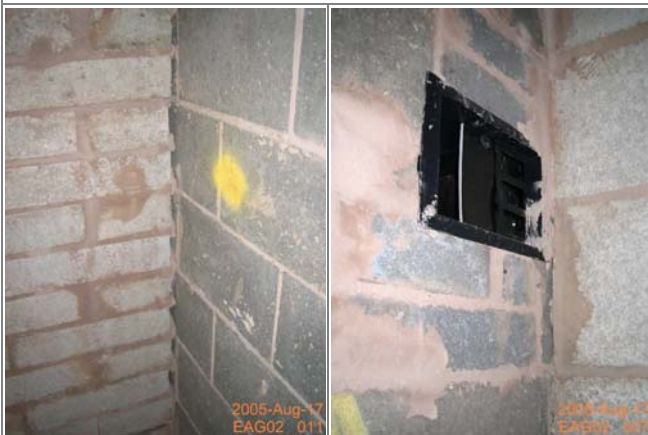
Wall/Wall Junction

It is expected that these junctions will get pointed up and then made airtight by plastering. The slight concern is the treatment at the very tops and bottoms of these junctions which will not be plastered over, and are hidden by the suspended ceiling and by skirting boards respectively.

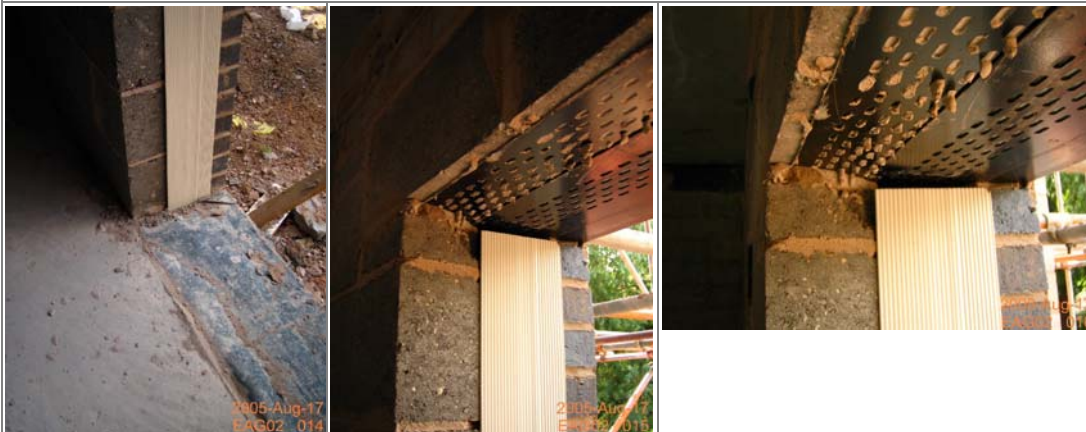
Balcony Door

As discussed for EAG01.

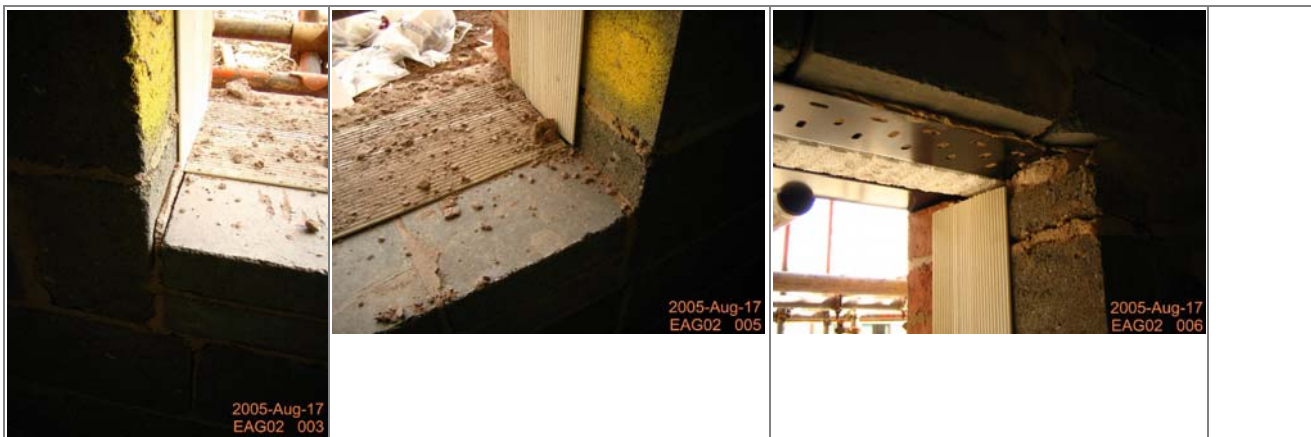
Window

As discussed for EAG01.

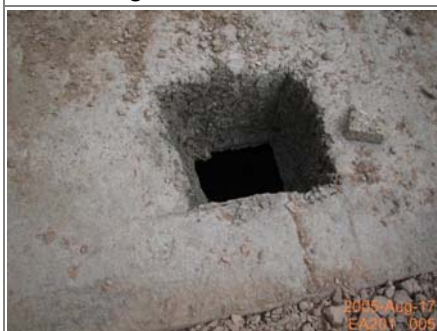
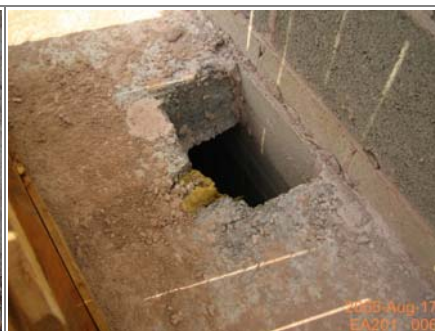
Service Penetrations

As with EAG01, the holes made for service penetrations are suitably small and should result in more effective sealing around than when larger holes are made. Again, packing/plugging with a minimum density 10 Kg/m³ mineral wool will reduce the air flow through these penetrations but will not make them airtight.

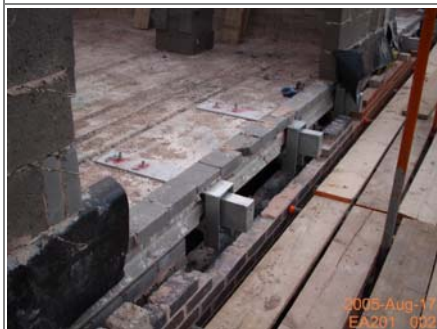
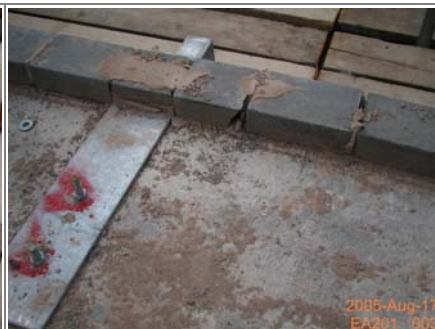
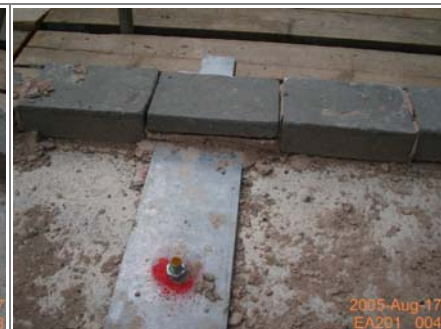
Balcony Door

Possible leakage paths around the brackets and through the blockwork should get sealed when the floor is screeded.

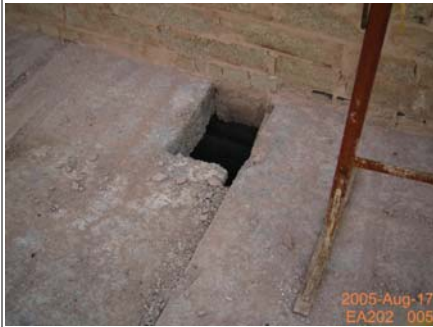
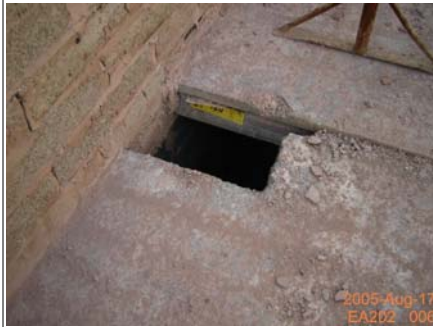
Service Penetration

As observed for previous plots.

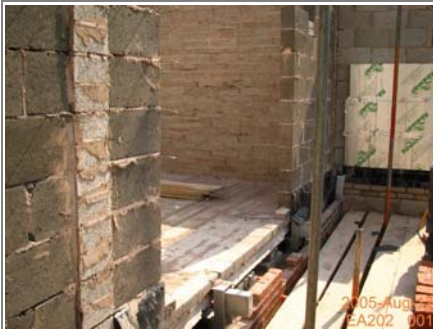
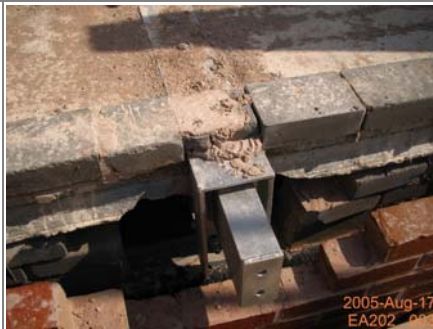
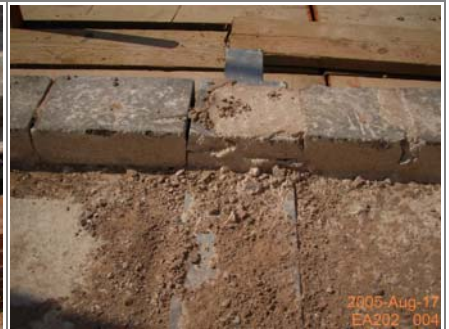
Balcony Door

As observed for previous plots.
