EVALUATING THE IMPACT OF AN ENHANCED ENERGY PERFORMANCE STANDARD ON LOAD-BEARING MASONRY DOMESTIC CONSTRUCTION

Partners in Innovation CI 39/3/663 - BD2324

Interim report number 6 – Airtightness monitoring, qualitative design and construction assessments.

Dominic Miles-Shenton, Centre for the Built Environment, Leeds Metropolitan University

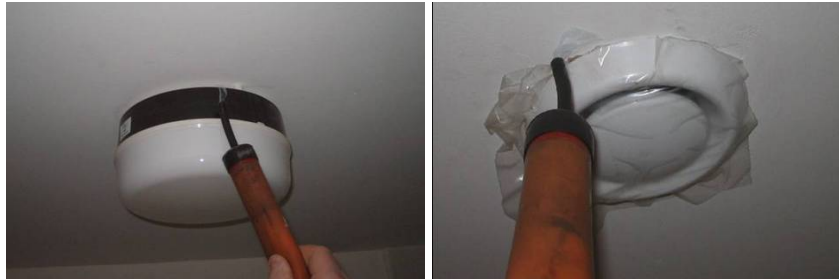
Figure 7. Detection of direct air leakage paths from the top floor bathroom of plot R111 into the attic, under dwelling pressurisation using smoke puffers.

- 22 The most powerful tool in determining leakage paths was a combination of both of the above techniques. Figures 7 and 8 illustrates the two methods being used in parallel; with the dwelling under pressurisation the movement of air can be observed into the roof space around both electrical and ventilation penetrations through the top floor ceiling of plot R111, under depressurisation cooler air can be observed entering the dwelling at the same points and also behind the plasterboard on an external wall at the loft boundary. Under different test conditions with an insufficient temperature differential between the roof space and habitable space, only leakage detection using smoke would have been possible and the “hidden” leakage path behind the dry lining at the loft perimeter would have remained undetected.

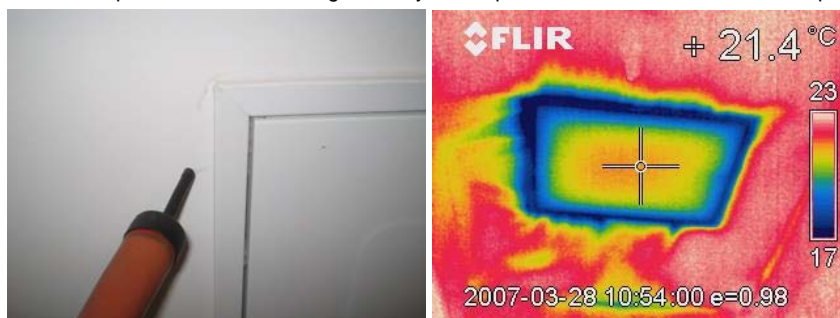
Figure 19. Direct air movement at the loft hatch between the roof space and living space.

39 Direct air leakage through and around the loft hatch was detected in each of the 9 properties included in this study (figure 19). This was observed around the loft hatch surround where the junction with the ceiling was either unsealed or shrinkage cracks had developed, through the open hole for the loft hatch key in 2½ and 3 storey dwellings, and between the door and the hatch where the compressible seals were often not continuous and rarely compressed along all 4 edges.

The photograph of the loft hatch in plot R110 indicates some air leakage, the IR image of the same detail provides further illustration of the extent of the problem.

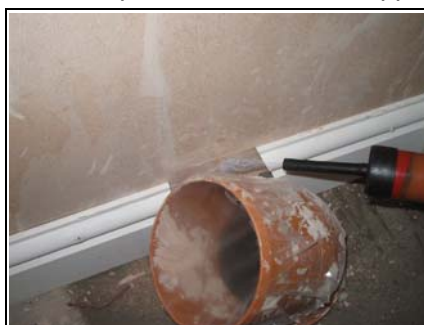
Figure 23. Air leakage around ground floor service penetrations.

In the Bryant dwellings there were instances where the screed had not filled the gaps between the soil pipes and walls, some smoke was observed to move downwards towards the insulation layer beneath the screed and may have escaped via a leakage path between wall and screed into the wall cavity. However, this could not be verified from smoke detection.

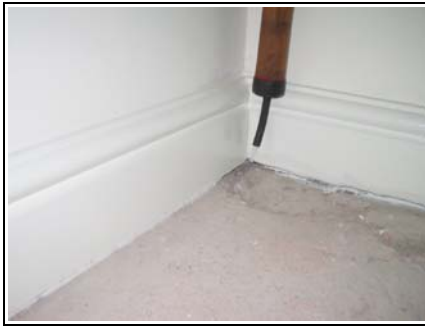
Figure 24. Air leakage at the ground floor/wall junctions.

Air movement was observed at the ground floor perimeter, with air leakage most commonly detected at room corners with unfinished or inadequately sealed junctions and also around the bottoms of internal door frames. Even in plots B119 and B120 where mastic sealant had been applied around all ground floor room perimeters air leakage was detected. The perceived severity of air leakage at points along these junctions was low in comparison with many areas of leakage.

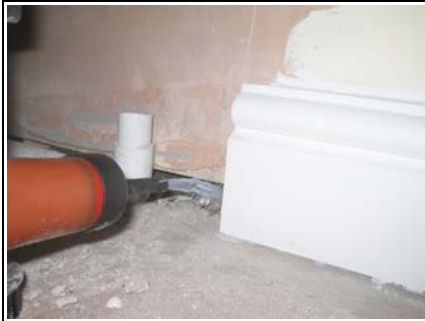
Figure 25. Air leakage under kitchen/utility room units.

Ground floor kitchens, utility rooms and WCs exhibited air leakage at the ground floor/wall junctions significantly worse in areas that were left unfinished, presumably because they were out of direct view. This mainly occurred underneath kitchen units and at spaces left for kitchen appliances, but was also frequently observed at boxed-in services or those hidden by sanitary ware. In dwellings where similar penetrations had been boxed-in or covered over it was normal to see air leakage around the boxing or around the plinths under kitchen units

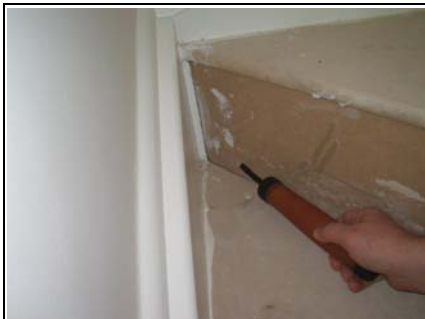
Figure 26. Air leakage around staircases.

The exchange of air between the habitable space and the complex of interconnected voids occurred through a number of points around the stairs, such as around newel posts, junctions with intermediate floors, around the edges of risers (particularly where the stairs turned a corner) and through shrinkage and settlement cracks at the top of the wall stringers.

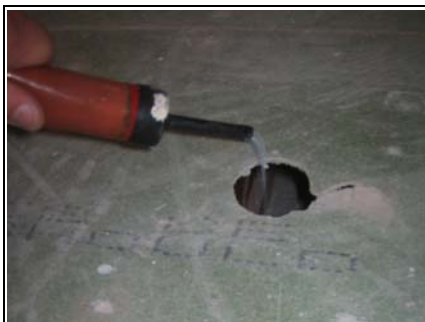
Figure 27. Air leakage directly into intermediate floor voids.

Air movement into intermediate floor voids through joints between flooring panels regularly occurred in circumstances where flooring panels had to be cut or altered. This was common at doorways over load bearing internal walls, where repairs had to be made to the floor due to damaged boards and where holes had been cut for access to services inside the floor voids.

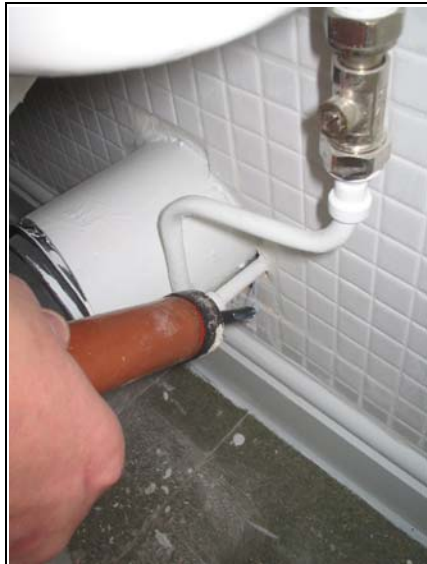
Figure 30. Detected air leakage at plumbing penetrations.

Accessibility problems arose from sequencing issues and the placement of plumbing penetrations close to wall/floor and wall/wall junctions, and from penetrations placed closely together.

In bathrooms Redrow favoured services entering the intermediate floor void and joining up with the service riser, Bryant favoured a service void along an external or party wall into which all penetrations would enter and get sealed when tiled. Service penetrations into the intermediate floor were usually sealed around well where they were visible, but not to the same standard where vision and access was restricted. The sealing of penetrations into the tiled service voids often relied on the grouting to provide an airtight seal rather than a more suitable flexible sealant. Gaps around the perimeters of bath panels and shower fascia panels habitually provided air leakage paths from the living space into the void beneath the bath or shower.

Similar problems were observed in other wet rooms with smoke detection around kitchen units and pipework boxing often leading to inadequately sealed service penetrations obscured by them.

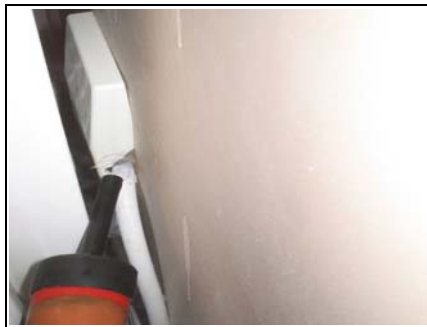
Figure 31. Air leakage detected around radiator pipework.

Air movement into the pattress boxes for positioning of radiator pipework was commonplace, and usually most severe on internal partition walls on upper floors. The placement of covers over the pattresses had little significance on air movement at this detail as they were not observed to be sealed around effectively. Although this is listed as an indirect leakage path, in the Avondale house types the radiators in the 2nd floor rear bedrooms were fixed to the knee wall behind which was a roof void, air leakage detected here was directly into the roof voids.

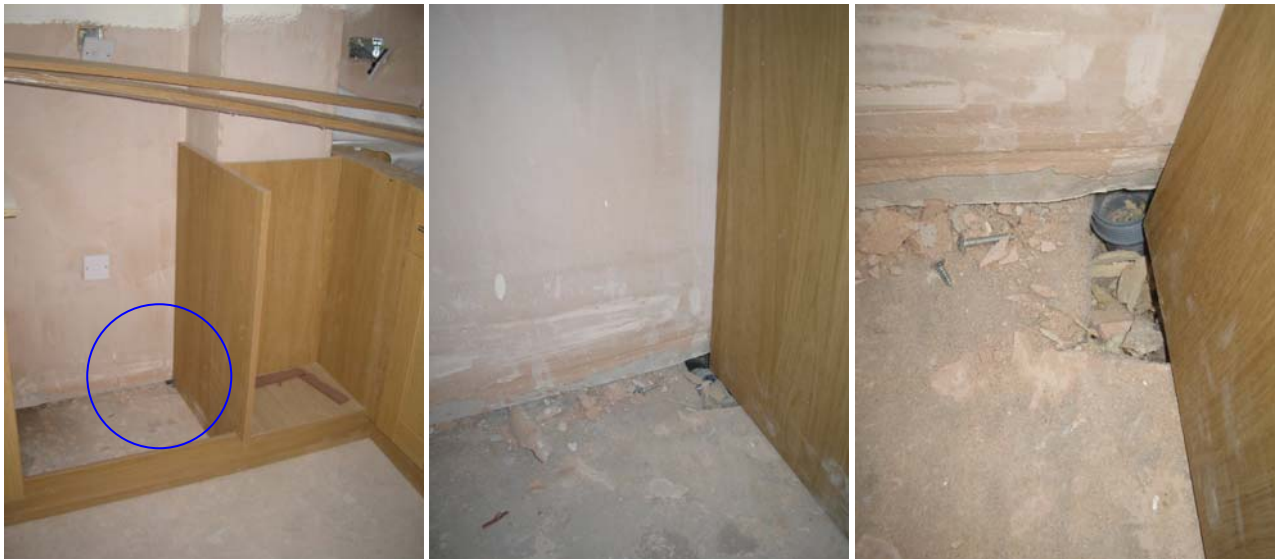
- 53 The build sequence can also raise problems where ground floor service penetrations are concerned. In figure 38 the gap in the floor around the service void containing the soil pipe has been boxed in and the kitchen units installed before the floor has been finished, linking the void behind the cooker to the service riser and potentially the void behind the plasterboard in the kitchen. Even if the fraction of the hole visible in figure 38 is sealed before the cooker is mounted, the inaccessible sections are likely to remain unsealed and will still permit air movement.

Figure 38. The gap in the screed at the base of the service void in plot B120 left which should have been filled prior to installation of the kitchen units.

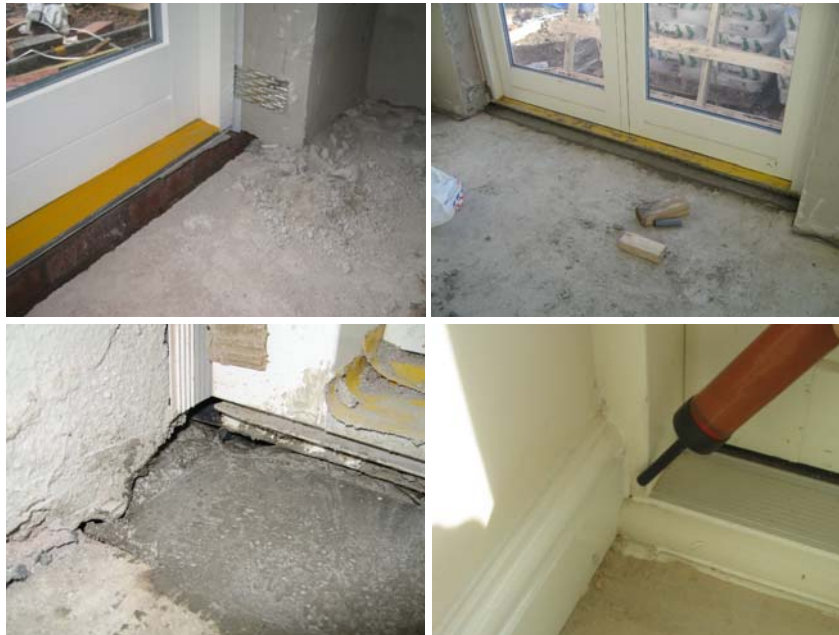
Figure 42. The patio door threshold in plot R116.

- 59 Figure 42 displays the patio door threshold in plot R116 where the cavity was filled after the door and frame had been installed, but prior to dry-lining and the 2nd fix joinery being installed. As in figures 40 and 41 gaps still remained behind the skirting and plaster board with air movement directly into the cavity a consequence.

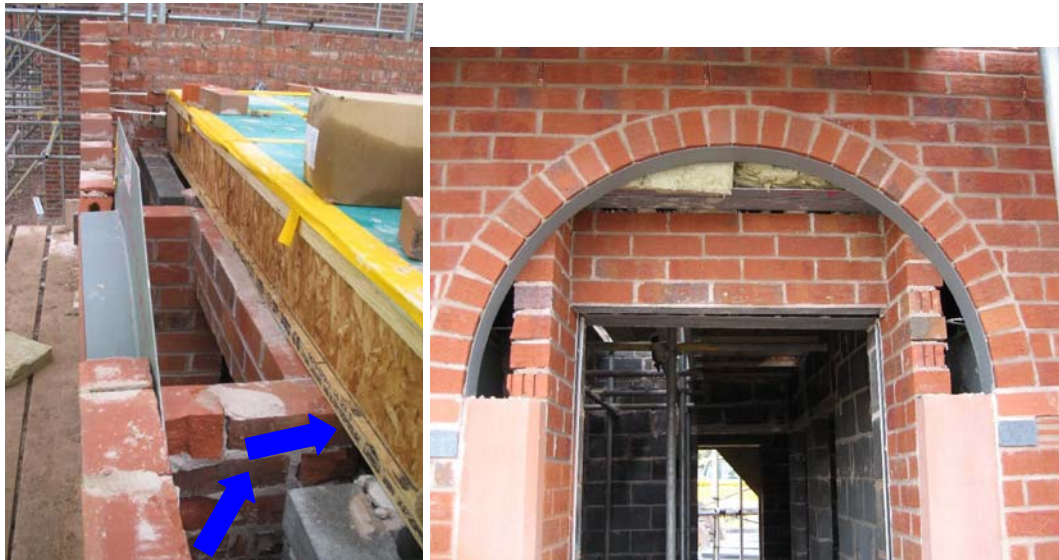
- 60 All 4 of the Redrow plots examined had front doors which were recessed to give an arched porch. This detail was picked up in the design review as both a potential thermal bridging and airtightness issue. Initial concerns that the jambs and recessed head would not get fully insulated were substantiated by the research team who examined additional plots on the site containing the same details and observed a lack of insulation injection holes, this was reported back to the site management and the problem rectified. However, the airtightness issues appeared to remain unresolved.

- 61 Figure 43 shows the front door detail during construction, illustrating the difficulties of maintaining air barrier continuity in the face of complex geometry and changes of plane. The cavity masonry is returned to form a door recess that extends below the first floor structure and effectively links the cavity in the external wall with the intermediate floor void. A cavity wall above the door itself also creates a link into the floor void. The various air paths are illustrated in figures 43 and 44.

Figure 43. The recessed front doors in plots R116 and R111.

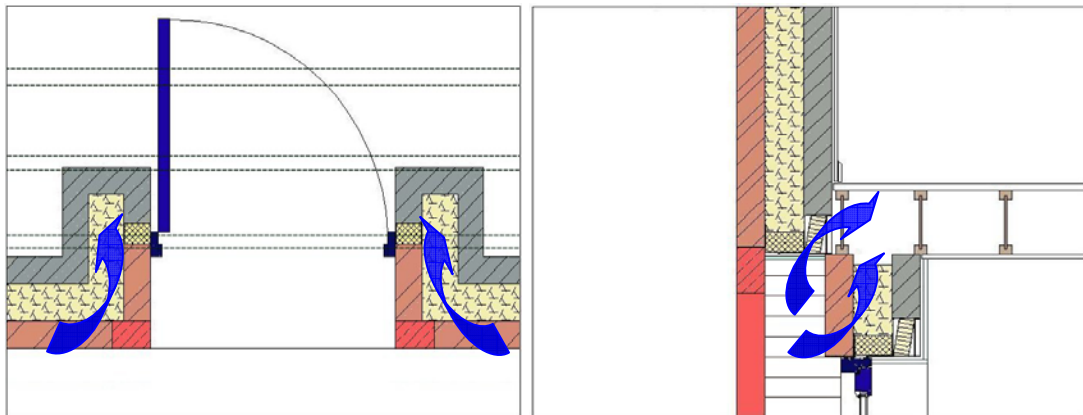
Figure 44. Typical as built plan and section of the recessed front door.

62 With many services running through the intermediate floor void above this detail, any infiltration above the door can result in complex pathways moving through such voids as this. The movement of air above the recessed front door into the floor void can also be seen using infrared thermal imaging with stratification of the temperature in the floor voids in the zones between the joists running parallel to the external wall (figure 45).

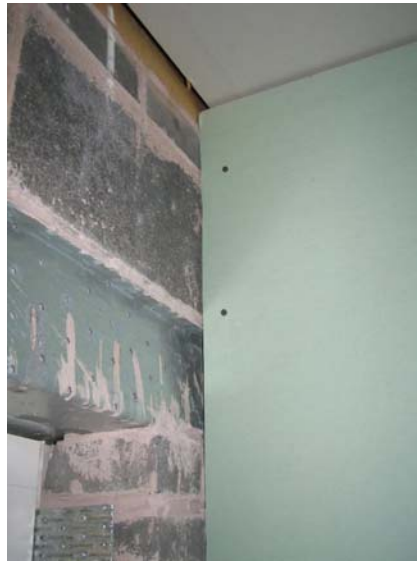
paring layer) to separating walls applied by the plastering subcontractor. The purpose of the paring layer being not only to seal the blockwork but also provide conceptual clarity of where and what the air barrier is. On the ground floor in each dwelling the paring layer was applied prior to the stairs being installed; however, on the upper floors as was shown in figure 4, it was not unusual for variations in the build sequence resulting in application of the parge coat occurring after the erection of the internal studwork (Figure 46).

Figure 46. Erection of partitions before paring; creating an air barrier discontinuity (plot B116).

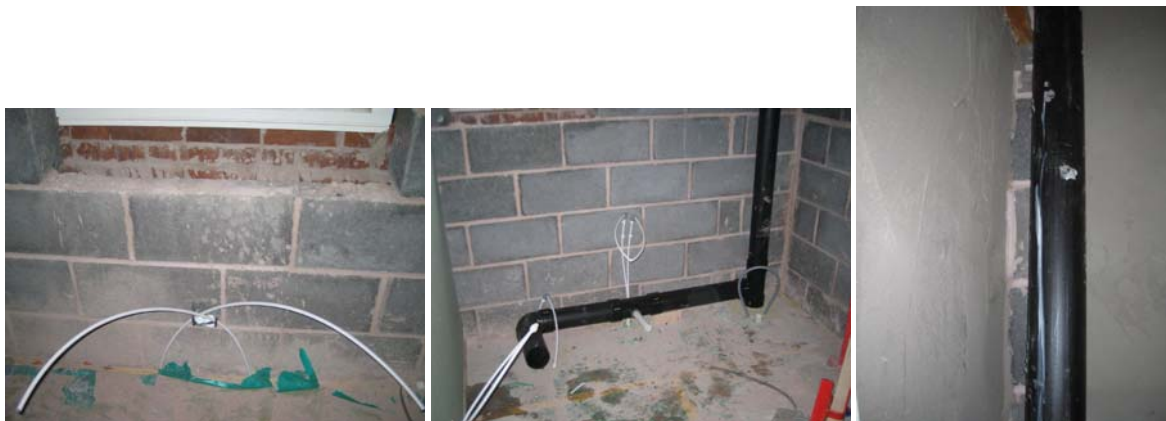
- 64 It was not only partitioning that made the application of a continuous paring layer difficult to achieve, where plumbing installations had been positioned before the parge coat had been applied discontinuities often occurred. Figure 47 shows radiator pipework in a bedroom and water and soil pipes in a bathroom on the 1st floor of plot B117 fixed prior to paring, and in the 2nd floor of plot R110 the area of unparged wall that can be left as a result of such an obstacle. If the build sequence had involved paring prior to any 1st fix plumbing work these potential problems would have been eliminated.

Figure 47. 1st fix plumbing installations in plots B117 and R110.

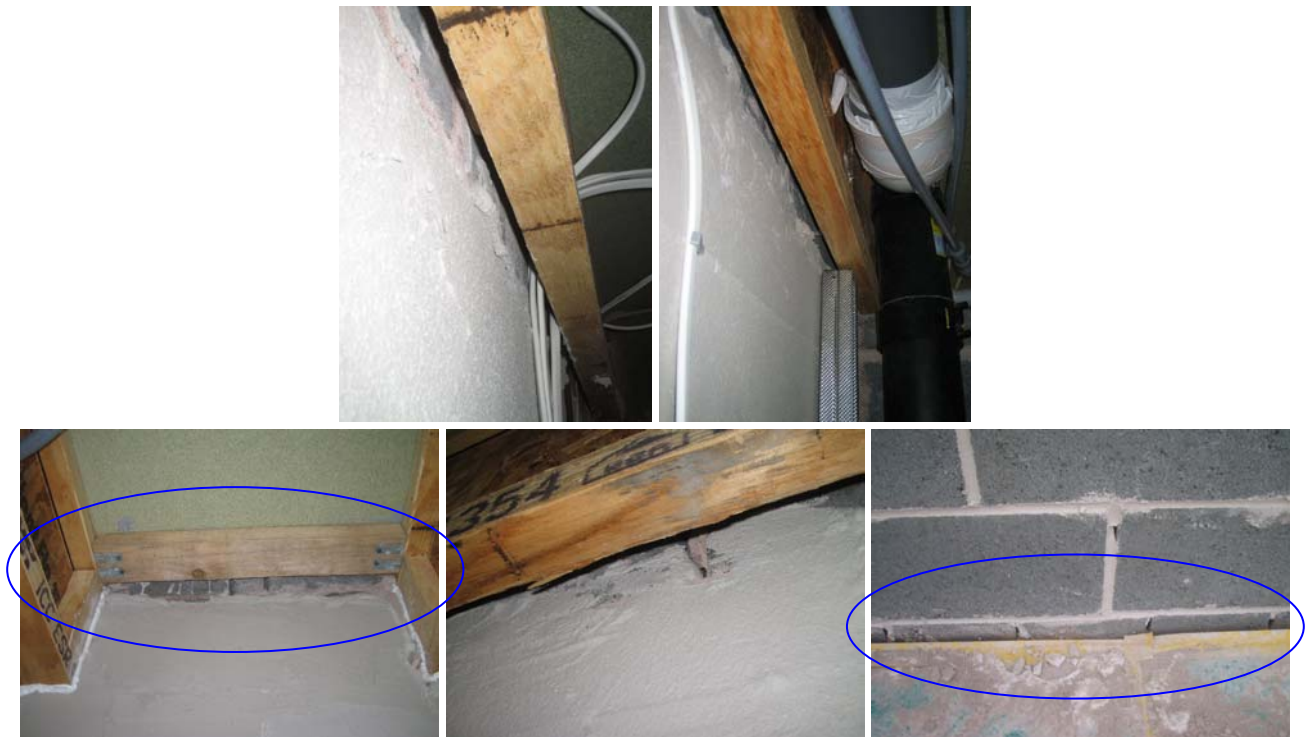
- 66 The other main discontinuity in the parging layer occurred at the interface between the walls and the intermediate floors. In all cases joists, edge struts and floor decking were fitted before parging was carried out, resulting in inaccessible areas of wall, particularly when joists ran parallel with the walls. Figure 49 shows a number of examples. This problem could be resolved by modifying the build sequence and access arrangements to enable parging behind joists before they were positioned.

Figure 49. Examples from all of the Bryant plots studied, illustrating where gaps in the parging layer behind joists, joist struts and floor decking appear.

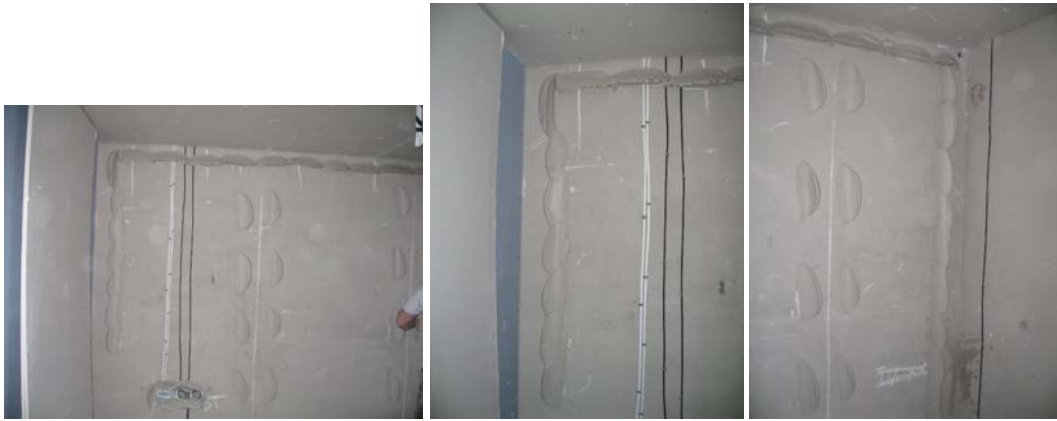
- 67 In common with standard construction practice, the specification at Stamford Brook calls for continuous ribbons of adhesive around the plasterboard dry lining on all external and separating walls. Figure 50 demonstrates the application of the ribbons of plasterboard adhesive as a continuous string of dabs, the plasterboard was pushed on to these ribbons to the desired depth, raised vertically by about 25–30mm with a board lifter and then 2 off-cuts of plasterboard placed underneath for support until the adhesive dried. This technique leaves a channel for air movement around the perimeter of the wall between the ribbons of adhesive and the perimeter junctions with adjacent walls, the ceiling and the floor as well as leaving gaps in the ribbons themselves.

Figure 50. Continuous ribbons of plasterboard adhesive on an external wall in plot R116.

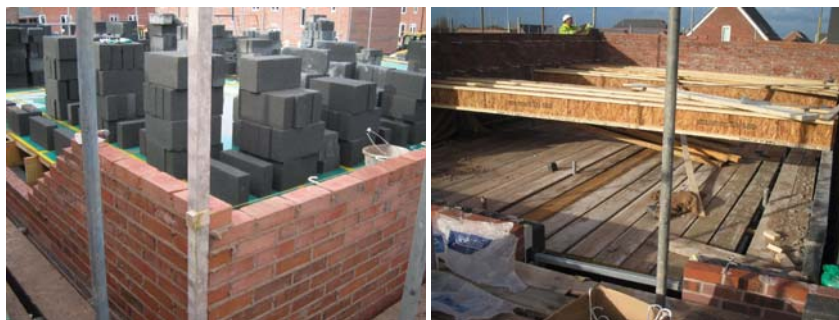
- 72 The same problems occurred on those occasions when the external brick leaf was laid before the internal blockwork, as illustrated in figure 53, creating difficulties in gaining access to the external face of the blockwork at the intermediate floor perimeters.

Figure 53. Intermediate floor construction – external leaf built before inner leaf.

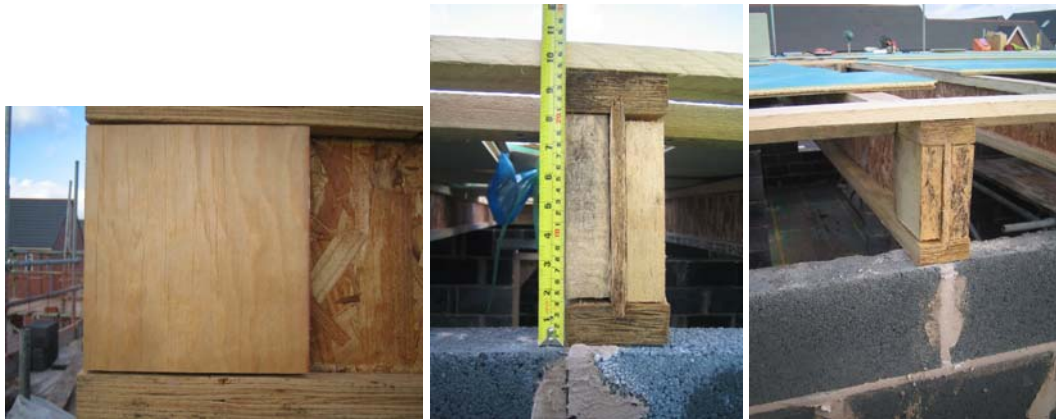
- 74 To provide additional structural strength to the joists and to satisfy the Part E Robust Details requirements, web stiffeners were placed at joist ends, either side of the web, where they were built in to the walls (figure 55). In accordance with the manufacturer's technical requirements a minimum 5mm gap has to be left between each web stiffener and one of the flanges, a 5mm gap which was seldom sealed on the inside with silicone sealant as required in Appendix A of Robust Details (2007) and often covered with wet mortar from the outside which would shrink when drying to leave cracks through which air leakage can occur.

Figure 55. Web stiffeners in plots B119, B120 and B121.

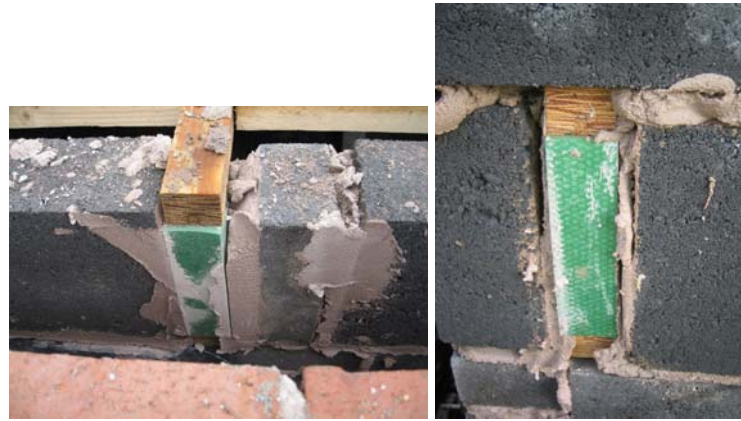
- 75 In order to tackle some of the problems of sealing the joist ends, Redrow fitted foam end caps to their built-in joists (figure 56) which were vertically compressed between the flanges of the joists but expectations that an airtight seal around the caps can be created (either with them under some horizontal compression or with a flexible sealant applied) were never fully realised. Achieving the necessary compression suffers from the same access and buildability problems as other forms of sealing and without the foam being subjected to significant compression it is difficult to see how the end caps can be effective in providing an airtight seal. The gaps between the blocks and the joist caps were filled with mortar which shrunk back on drying to leave gaps around the joists. Different sized foam caps were provided for different sized joist flanges and webs, however the research team occasionally observed the wrong sized foam caps being used.

Figure 56. Foam end caps fitted to joists.

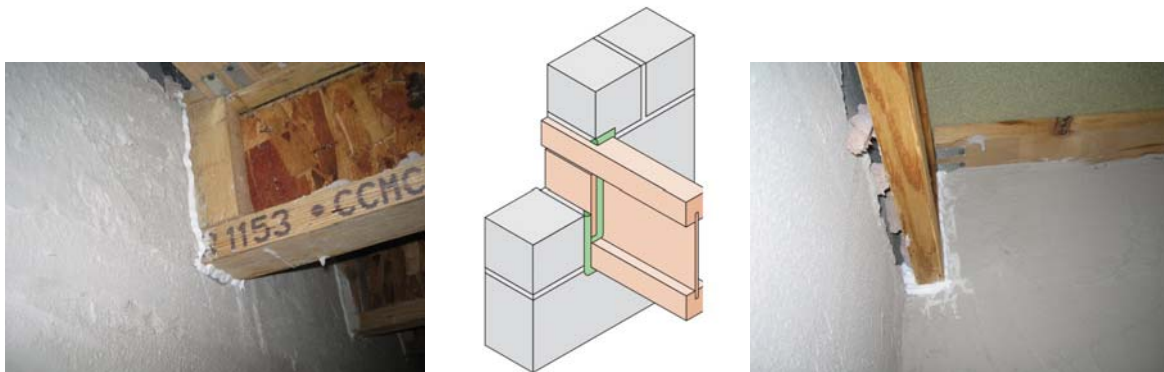
76 Flexible sealant was applied around the vast majority of the built-in joists, though this was not applied as well as it could have been. Figure 57 shows a typical application of the mastic around a joist and web stiffener, where no mastic has been applied around the junctions of the web stiffener and joist web or flanges and the mortar around the joist has not been chased out to provide purchase for the mastic as noted in Robust Details Appendix A (Robust Details 2007). Even if the joints were chased out effectively, it is extremely unlikely that the surface preparation recommended in the code of practice for sealing joints in buildings using sealants (BS 8000: Part 16, BSI 1997) would have been followed, substantially reducing the longevity of the seal and increasing the likelihood of failure. The other frequent problem highlighted in figure 57 was accessibility to one side of the joist to apply the sealant caused by joists in close proximity to parallel walls.

Figure 57. Mastic applied around built in joists and the recommend application of a silicone mastic from Robust Details (2007) Appendix A.

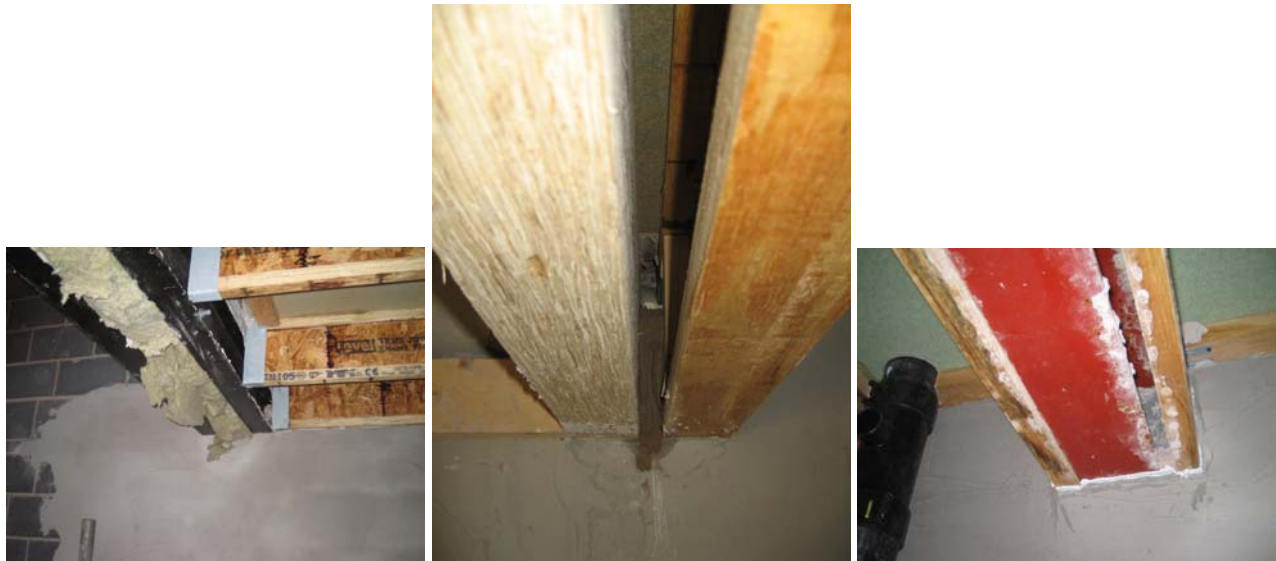
- 78 Where I-beams were sited next to RSJs or solid wood joists in the 2½ storey dwellings, or double RSJs were required, the same problems as observed with the double I-beams were apparent. Despite a number of attempts to seal the junction between blockwork and steel or timber beams, few could be said to achieve a successful or robust seal as operatives struggled to deal with the twin problems of accessibility and different material properties (figure 59).

Double steel beams with mineral fibre filling

Timber beam and I-beam joist – showing direct route into the cavity.

128 In both of the developer’s 2½ storey houses there were instances of multiple joists being fitted where the use of a single large I-beam or RSJ would have been possible (figures 58 and 59) which would have simplified the process of sealing around the joists, albeit at the potential cost of adapting blockwork for joists of different depths. In some cases, RSJs had wooden joists running adjacent to them in parallel (figure 59) in order to support the floor decking. By increasing the gaps

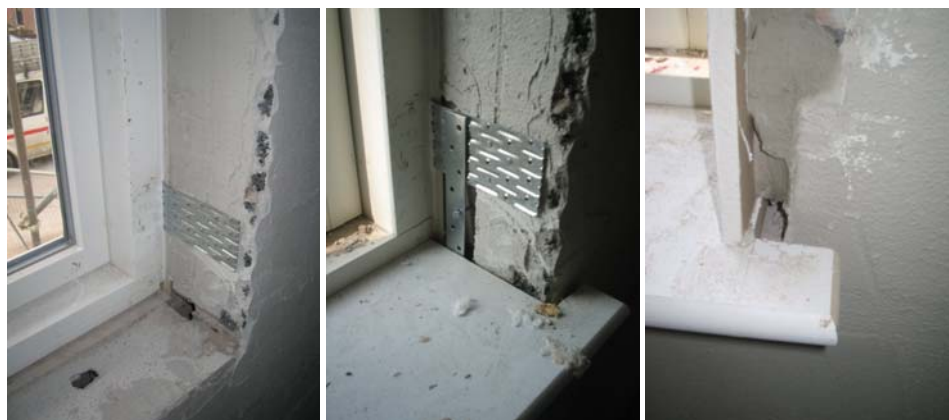
- 79 Leakage detection around the window sills during the pressurisation tests revealed that all the dwellings tested displayed some infiltration around the window sills, either directly into the living space through small cracks and gaps or indirectly into the void behind the plasterboard (figure 17). The actual leakage paths around the sills appeared to consist mainly of air moving between the living space and the cavity around the edges of the sill boards. Figure 60 shows a window in position and sealed at the junction between frame and jamb but not sealed at the sill/jamb junction. After the sill board is fitted the gap remains. Invariably the resultant gap is not fully sealed by the continuous dabs of adhesive behind the reveal board leaving an air leakage path at the base of the jamb.

Figure 60. Window sills at various stages of construction.

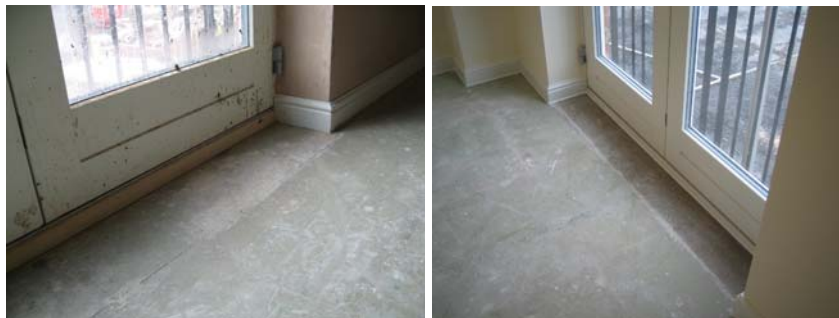
Figure 66. Balcony door thresholds with timber filler pieces inserted.

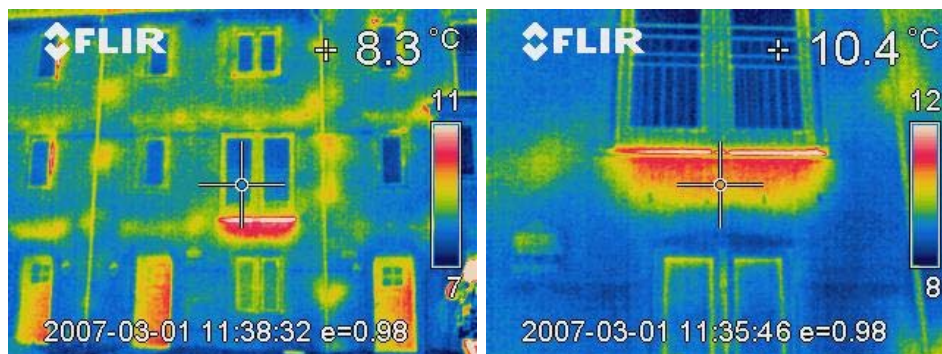
Figure 67. The front of plot R110 on 1st March 2007 during the coheating test, with thermal bridging observable beneath the 1st floor balcony at the front of the dwelling during the co-heating test.

84 Thermal images (figure 67) of the area around the balcony taken during coheating testing confirmed the existence of a significant heat loss, made up of a mixture of thermal bridging and air movement. The complex nature of the thermal performance of this construction and the likely impact on comfort as well as heat loss is illustrated in the following account of thermal imaging, air movement and pressure measurements undertaken towards the end of the coheating tests in March 2007.

- a) On 20th March 2007, during the co-heating test on plots R110 and R111, the thermal bridge and air leakage path that had previously been observed at the 1st floor balcony on the front of plot R110 (figure 67) had temporarily disappeared, even though the conditions inside the house were still 15~20°C above the external temperature. The weather was cloudy with the wind gusting almost directly onto the front of the dwelling at speeds of between 0.5 and 9.5 ms⁻¹. Plot R110 also had a balcony at the rear of the property on the same floor, which from the outside displayed the usual thermal bridge and air leakage normally also seen on the front of the dwelling (figure 68).

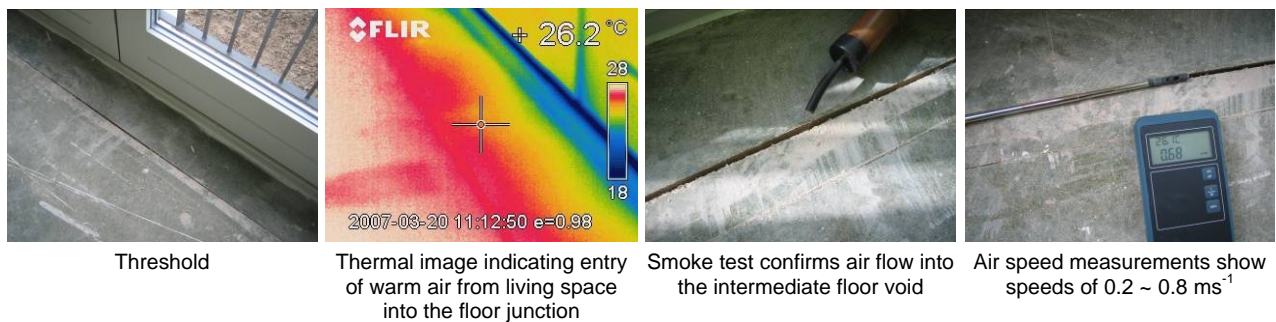
- c) Thermal images and measurements taken from inside confirmed that there was a significant difference in air movement and heat loss between the windward and leeward sides of the dwelling. At the front of the property cool air was observed entering the dwelling through the balcony threshold. Smoke detection confirmed that the direction of airflow was into the living space at a temperature of 10~15°C (roughly in line with external temperatures) and a velocity at the floor of up to 4 ms⁻¹ as the wind gusted (figure 69). At the rear of the property, however, the thermal imaging did not show a cold spot in front of the balcony doors, in fact, at this point, air was moving into the floor void at speeds of around 0.2~0.8 ms⁻¹ (figure 70). It would appear that the air leakage detected at both patio doors (see Appendix 3 for the pressurisation test report) was allowing air movement in at the front of the house and out at the back at 1st floor level under the influence of wind.

Figure 70. At the rear of plot R110, air entering the floor void directly in front of the balcony doors.

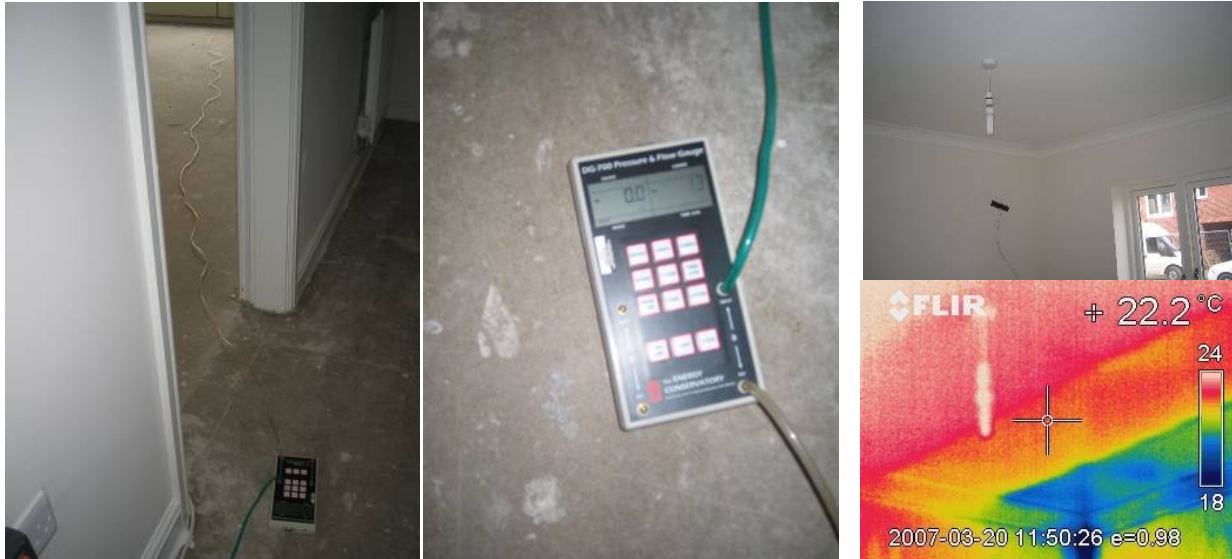
Measurement of pressure differential across the dwelling

- d) With circulation fans at work inside plot R110 for the coheating test it was not possible to measure air flow across the dwelling, but it was possible to measure the pressure difference. Using a differential pressure gauge, a pressure drop of between 0.3 and 1.5 Pa was measured from the front to the rear of the dwelling at 1st floor level. This is illustrated in figure 71 along with a thermal image of the intermediate floor directly beneath the balcony door at the front of the house, which suggests that the air movement was not just through the living space but also through the intermediate floor void. The floor joists ran normal to the direction of the wind and this resulted in a series of compartments through which the air flowed warming up as it did so and creating the striped pattern on the thermal image indicative of the stratification of temperatures within the floor void.

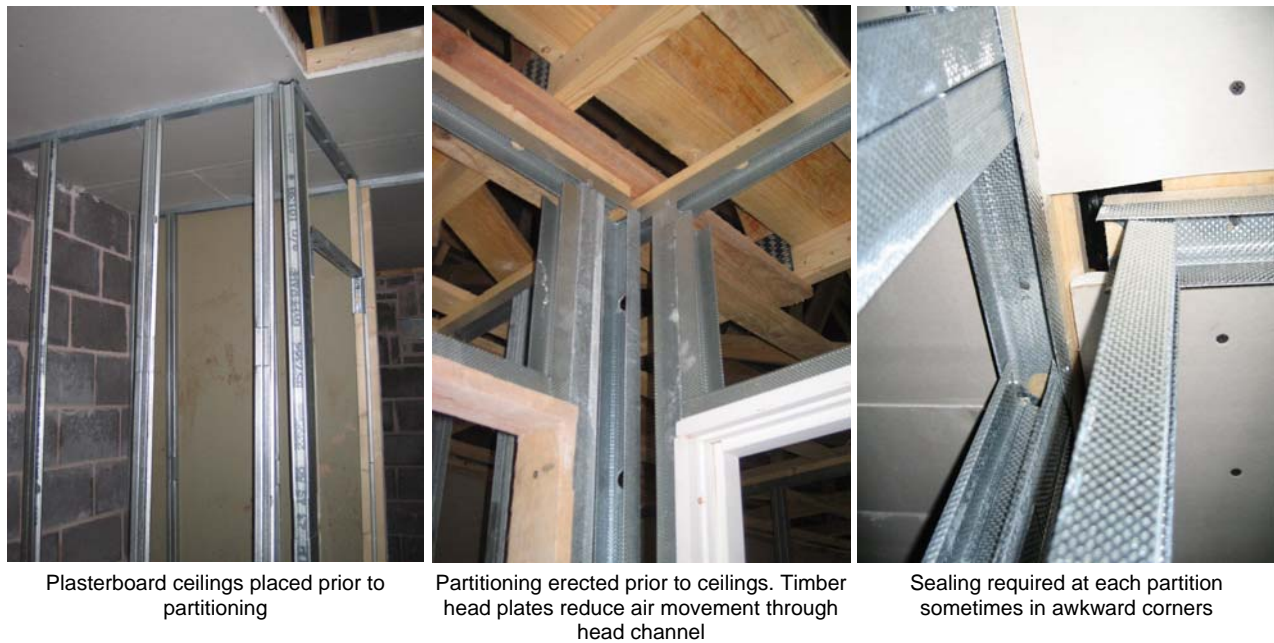
- 86 One of the most important differences between the two developers' methods of maintaining a continuous air barrier around the building envelope was the treatment of the top floor ceiling. Bryant had reverted to installing a full plasterboard ceiling on the top floor prior to mounting the stud partitioning, whilst Redrow continued to put the metal studwork up first with a timber head plate over the top of the head channel (figure 72). This variation in build sequence had a key influence on the air barrier at the top of the internal partitioning particularly at junctions between partition walls. The continuous plasterboard ceiling ensured that no gaps existed other than round the edges but installing the ceiling after the internal partitioning left numerous gaps between the studwork and timber head plates, gaps that remained after the plasterboard ceilings had been installed figure 73.

Figure 72. Full plasterboard ceilings before erection of the partition in Bryant plot B116 compared with Redrow's partitioning with timber head plate first approach in plot R111.

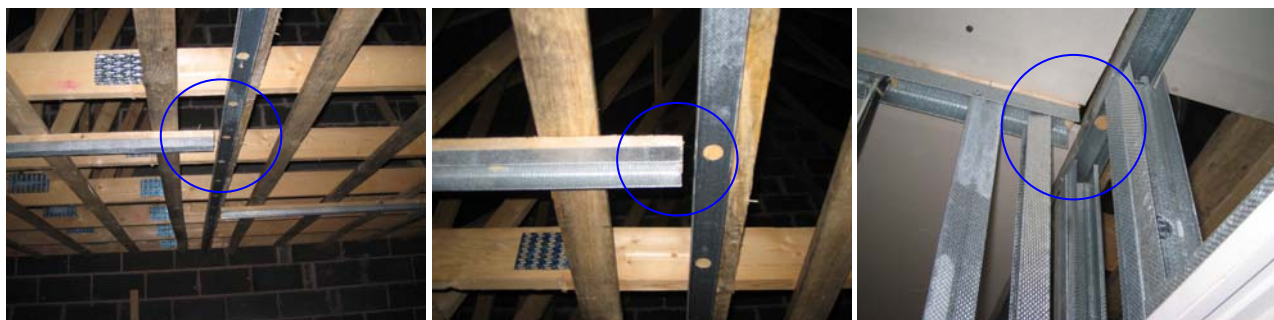
Figure 73. Gaps between timber head plates and metal studwork in plot R110.

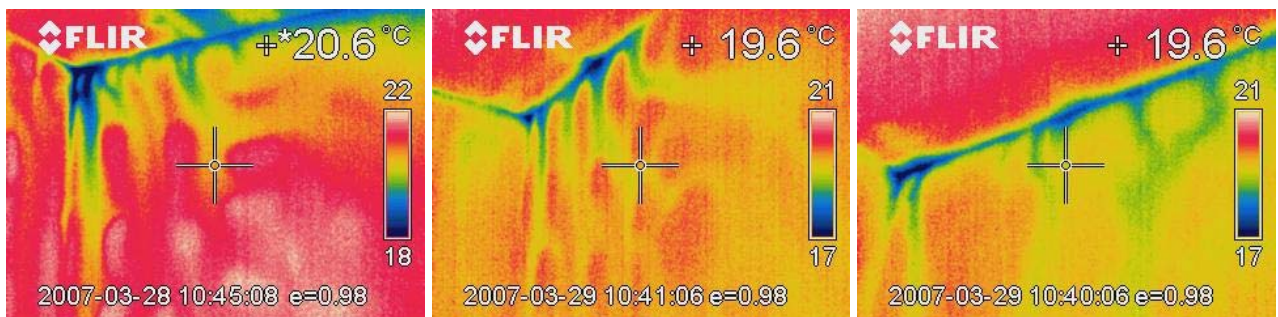
wall void with the roof space. A view is also shown looking down the party wall from the loft indicating the lack of a continuous plasterboard ribbon. The thermal images in figure 75 clearly demonstrate the flow of cold air (under depressurisation) from the loft into the space behind the plasterboard.

Figure 75. IR images of completed dwellings under depressurisation showing cold air being drawn into the space behind the plasterboard lining through gaps in the edge seal.

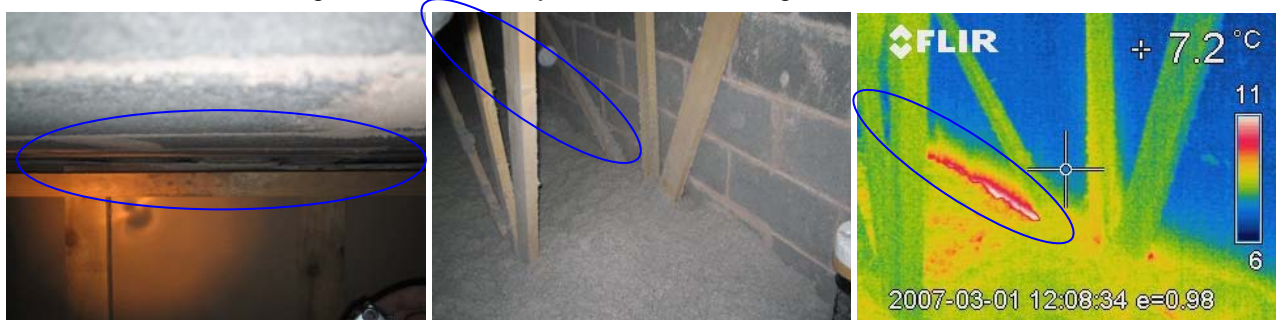
90 Further evidence of air movement between the gaps in the plasterboard adhesive ribbons was visible from inside the loft even when no pressure differential was being induced during a coheating test. Figure 76 shows photographic and thermal images of the same strip of party wall above a rear bedroom, before and after the recycled cellulose insulation had been blown in. In the thermal image a hot spot can be seen with air movement occurring at the gap between the party wall and the truss. Initially it was thought that this may be mainly a thermal bridging issue, but airflow measurements confirmed that there was a steady flow air moving into the loft space through the insulation indicating that it was actually related to air leakage.

Figure 76. Images taken from inside the loft of plot R110; looking down the party wall at the ceiling prior to insulation being installed, and with no induced pressure difference during the coheating test. A hot spot is clearly visible at the gap between the party wall and the truss. This was confirmed by airflow measurements.

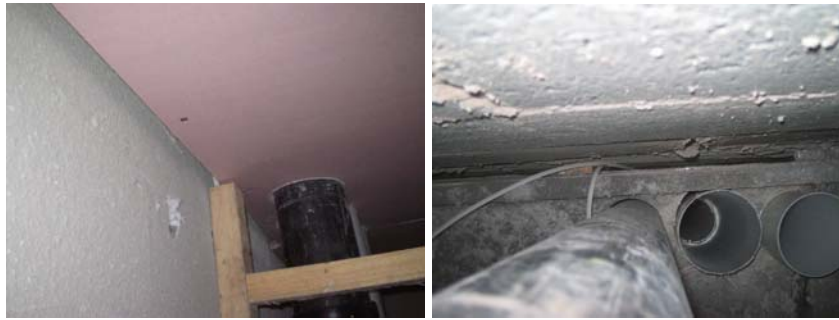
- 96 Figure 81 illustrates the same detail in the rear en-suite bathroom of plot B121. Once again the penetrations have not been sealed around, but this shows more clearly the problem at the wall/ceiling junction. With the developers' reliance on the continuous ribbons of plasterboard adhesive at the room perimeters to maintain the continuity of the air barrier at the wall/ceiling junction, in normal circumstances there appeared to be no contingency for areas such as those inside service voids where no dry lining, and therefore no ribbon of adhesive, was present.

Figure 81. The junction of the wall and ceiling inside the service void in the rear en-suite bathroom of plot B121.

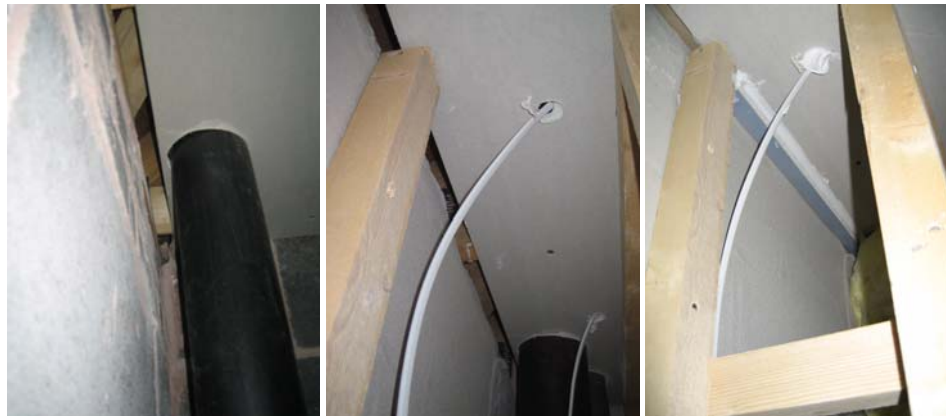
- 97 Where a particularly large gap was present at the wall/ceiling junction inside the service void in the bathroom of plot B117 the research team brought it to the attention of the site management team. Their response was to fit a narrow strip of plasterboard to the gap and seal the junction (figure 82), and also simultaneously seal other penetrations contained within the same service void. The result was that a continuous air barrier was preserved in this instance, but the same technique was never seen to be adopted in the same developer's subsequent plots during later observations.

Figure 82. Sealing at the service void head in the bathroom of plot B117.

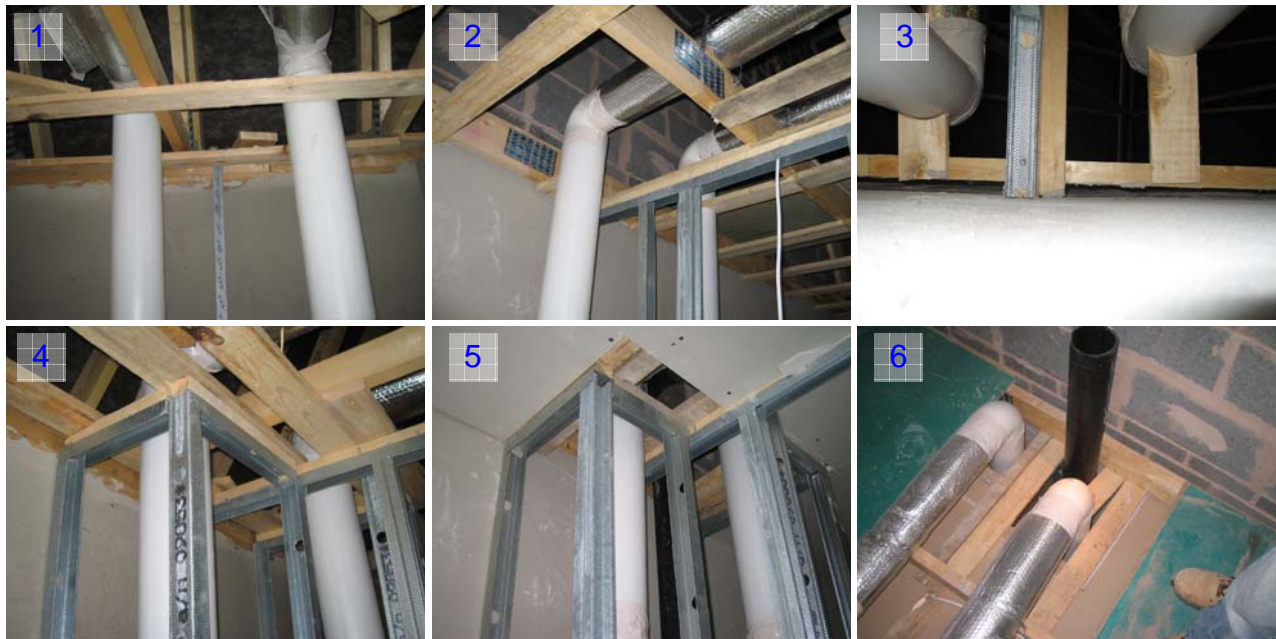
- 98 Redrow's sequence for their top floor ceiling construction of partitioning with timber head plates prior to boarding the ceilings made the heads of service voids even less likely to be airtight. In the Mendip house type (plots R110 and R111) the service void straddled the partition wall between bedroom and bathroom (figure 34 [A] and [B]). In both dwellings ventilation ducts and a soil stack were boxed-in in such a manner that the ventilated loft space was directly linked with the service void and the partition wall voids (figure 83). Due to the different roof orientations, in plot R110 this service void was adjacent to the party wall, in plot R111 adjacent an external wall at the eaves; but in neither case was the top of the service void fully sealed.

Figure 83. The service void straddling the partition wall between bathroom and bedroom in plots R110 and R111.

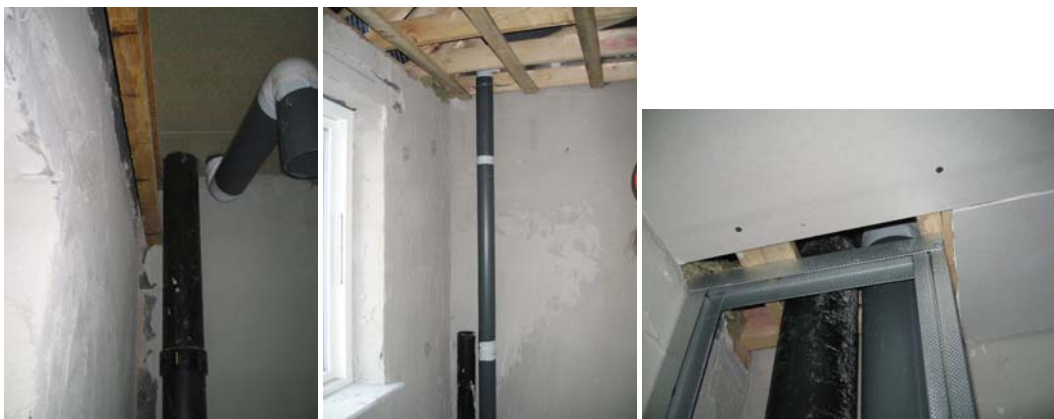
- 99 The other service void in the Mendip house type entering the loft (figure 34 [C]) also remained unsealed at the loft boundary. Figure 84 illustrates how this links up with the intermediate floor void creating very complex indirect air leakage paths. Even if the penetrations for the soil stack and ventilation duct through the intermediate floor were sealed (as was often the case) there was ample opportunity for air movement around the intermediate floor perimeter to connect the service void on the 2nd floor with all the other interconnected voids throughout the dwelling, with the unsealed top of the service void on the 2nd floor providing an eventual outlet.

Figure 84. The service void in the front of the Mendip house type, from the 1st floor en-suite, through the 2nd floor front bedroom into the loft in plots R110 and R111.

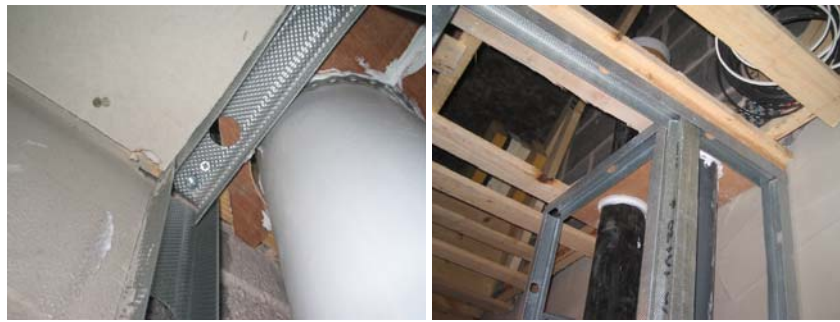
- 100 In the Avondale house type Redrow attempted to solve the problem of service voids venting directly into the loft by fixing plywood filler pieces at the top of the void. However, although the gaps between the plywood and pipework were generally well sealed at the loft boundary with a suitable flexible sealant, the perimeter of the plywood was typically not sealed to the ceiling plasterboard (the primary air barrier). In an attempt to seal the service void a plywood filler and sealing was also used where the duct passed through intermediate floors, illustrating once again a general level of confusion about where and what to seal⁵. Figure 85 shows the tops of these voids in plot R116 with the plywood heads in place.

Plywood plate at intermediate floor

Plywood plate at loft level

Figure 85. Service voids penetrating the 1st and 2nd floor ceilings in plot R116.

dwelling. To seek to provide airtightness by sealing the internal junctions of service voids is a lost cause since there are many air paths into the void that are almost impossible to seal. In most cases the only practicable approach is to treat the service void as a space within the dwelling air barrier and to concentrate on sealing only at those points where services pass through the primary air barrier.
