EVALUATING THE IMPACT OF AN ENHANCED ENERGY PERFORMANCE STANDARD ON LOAD-BEARING MASONRY DOMESTIC CONSTRUCTION

Partners in Innovation CI 39/3/663 - BD2324

Interim report number 6 – Airtightness monitoring, qualitative design and construction assessments.

Dominic Miles-Shenton, Centre for the Built Environment, Leeds Metropolitan University

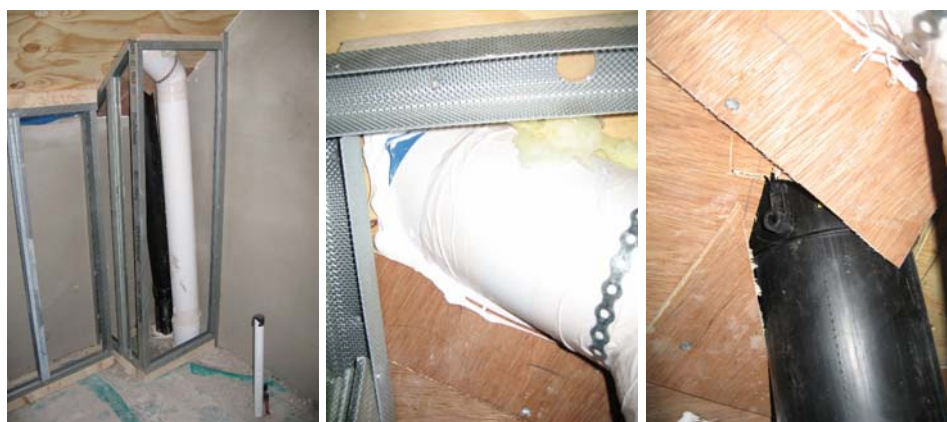
101 Where service voids on the 2nd floor in the Avondale house type entered areas of sloping roof the same technique of plywood void heads was used, again with varying degrees of effectiveness. Some penetrations and junctions were well sealed and others not (figure 86). However, where the service voids on the 1st floor led into the void between the eaves and 2nd floor knee wall no plywood filler was used despite that fact that it was penetrating the air barrier (figure 87).

General arrangement

Sealed penetration

Figure 86. Service void in the 2nd floor bathroom in plot R116.

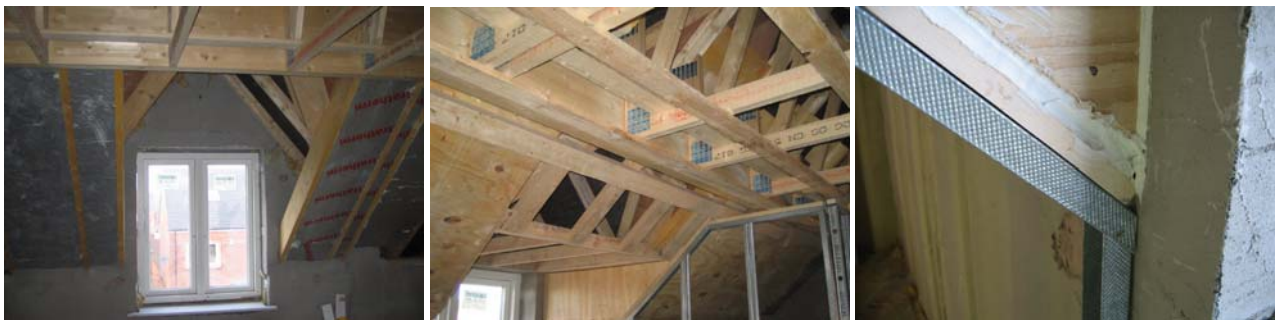
- 103 The design of the dormer windows at the front of the properties also varied between the developers, with Redrow having vertical dormer cheeks constructed with plywood liners that were sealed around with a flexible sealant between plywood sheets and between the dormer cheek lining and the parging on the external wall (figure 88). By comparison, Bryant had angled sections of sloping ceiling either side of the dormer windows and relied on the polythene vapour barrier to create the link between the parging layer on the walls and the plasterboard ceiling (figure 89) with the membrane stapled to a horizontal batten over the plasterboard ceiling and being fixed at the bottom and sides by enveloping the edges of the polythene into the ribbons of plasterboard adhesive on the external wall perimeters. The thermal image of the finished detail included in figure 89 indicates that this was not fully successful as there is noticeable air movement between the rafter space and the space behind the wall dry lining, indicating that the seal is incomplete.

Figure 88. Dormer window in Redrow house types with plywood sheathing on the dormer cheeks sealed prior to dry-lining.

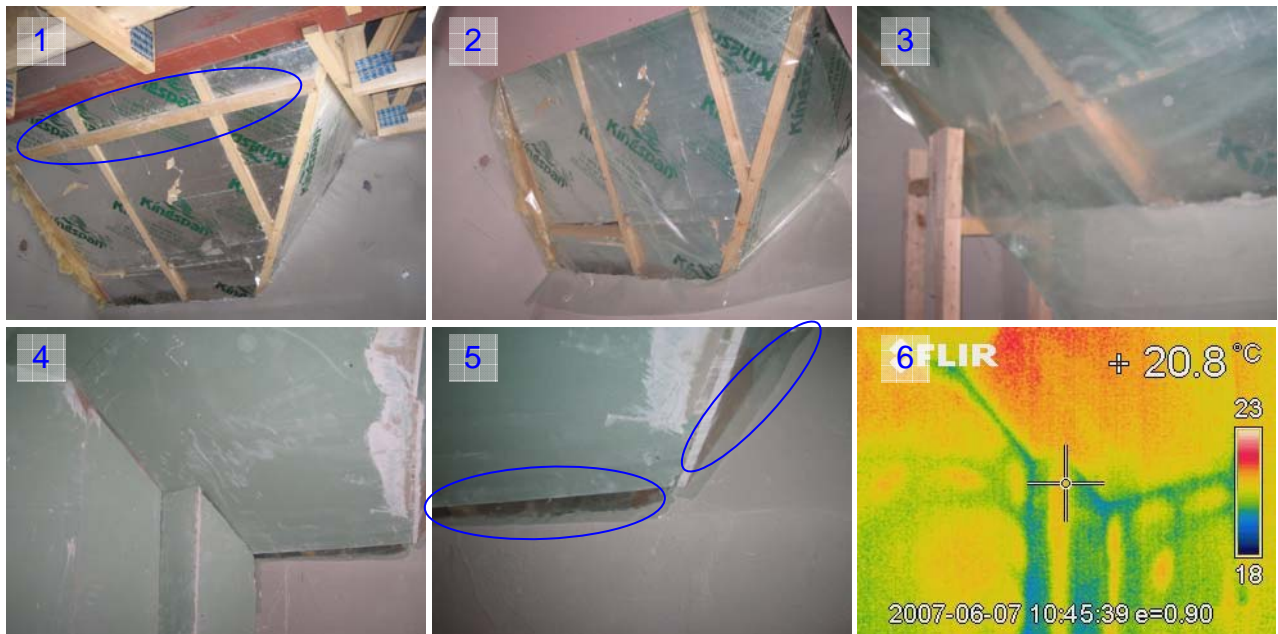
Figure 89. Dormer window in Bryant house types with the polythene air barrier in place but trimmed and not always forming a good seal with the wall air barrier.

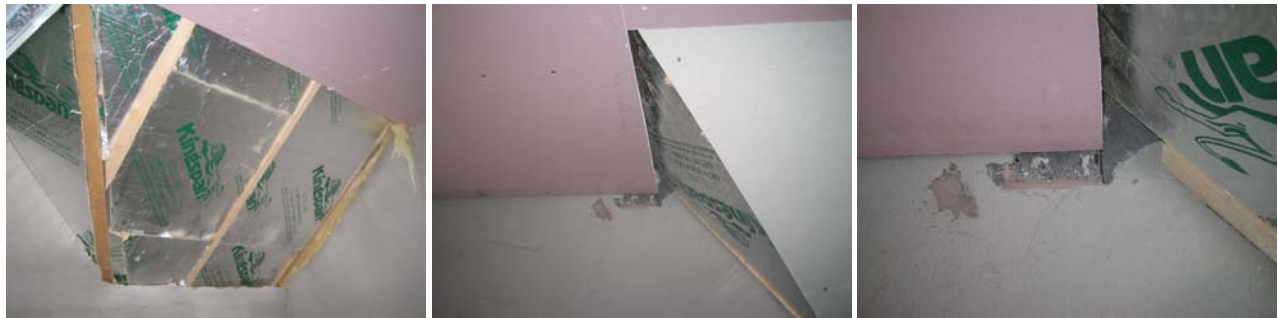
- 104 Sequencing again presented problems with the use of a polythene barrier on the sloping roof sections. The optimum solution would require the membrane to be fixed to the sloping areas prior to fixing the horizontal ceiling. This would enable the membrane to be lapped behind the ceiling plasterboard to form an airtight joint. In practice this did not always happen and the ceiling boarding

was installed before the membrane. As a result the membrane could not be lapped behind the plasterboard and had to be trimmed off thus compromising air barrier continuity. Figure 90 illustrates this in both plots B119 and B120, where there is a high likelihood of some discontinuity in the air barrier.

Figure 90. Sloping ceiling sections to the side of the dormer window in the XT2 and XT house types with the horizontal ceiling installed prior to the membrane in sloping sections.

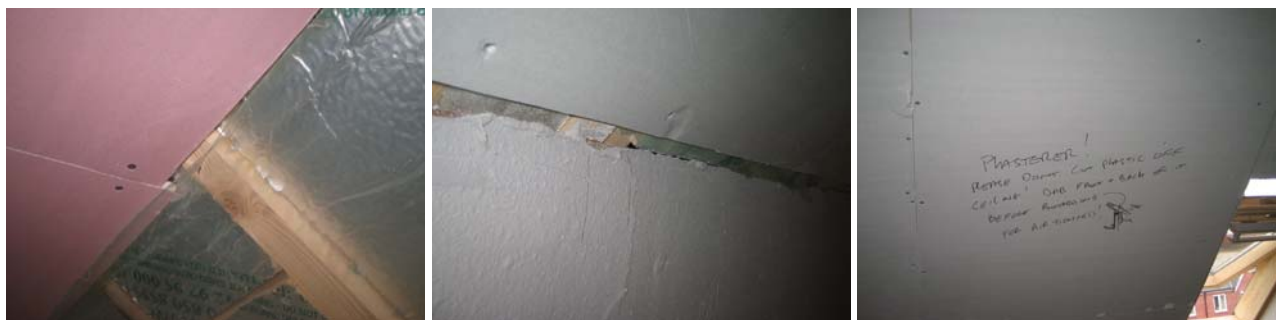
105 In other instances the membrane was trimmed back too far, with the result that there was not enough of a lap remaining to seal it to the parging layer on the wall. With the ceiling installed first and then the membrane cut short at the rear of plot B120 the vapour barrier was not linked either to the walls or to the ceiling (figure 91). In response, the Bryant site manager decided to write instructions and sketches for the plasterers on the plasterboard, requesting that they remembered to ensure that enough of a lap was left on the membrane for a more airtight seal to be made in subsequent similar details.

Membrane not linked to ceiling boarding

No lap between the membrane and the parging coat.

Figure 91. Lapping of membrane in sloping sections to the wall and ceiling.

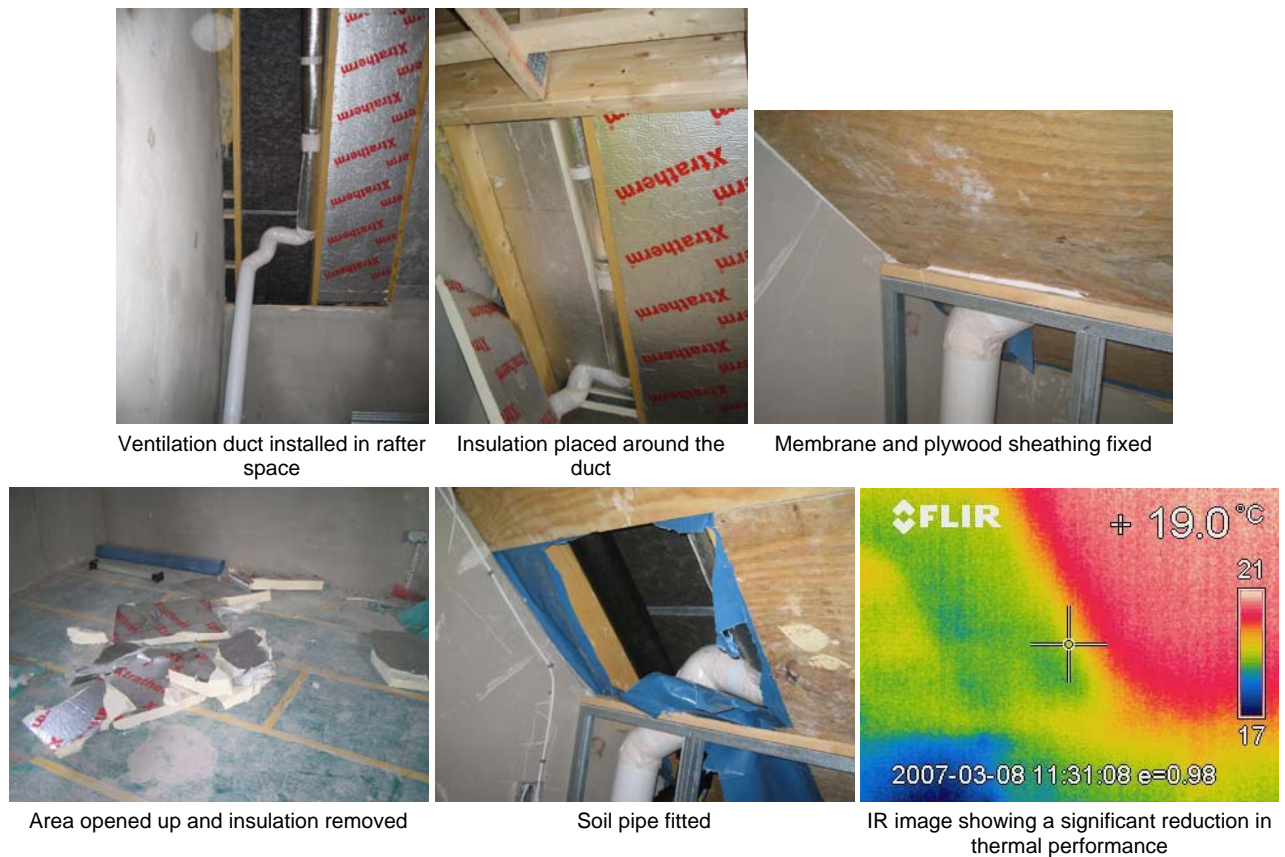
106 The build sequence also caused difficulties at the room-in-roof details for Redrow in the Avondale house type. Figure 92 shows a ventilation duct in the 2nd floor bathroom in plot R117 laid inside the polyurethane foam insulation between the rafters (not good practice from a thermal performance point of view), the membrane fitted, and finally the plywood sheathing fixed and sealed at the edges. Later in the build, the insulation was removed in order to install a soil pipe into the same gap between the rafters. This resulted in damage to the vapour barrier. The thermal image of this detail taken under dwelling depressurisation shows a cold area at this point. However, it is not clear whether this is due to air movement or thermal bridging, since it is almost certain that the insulation was not replaced into the rafter void without discontinuities. It is probably a mixture of both.

Figure 92. Installation of services in the rafter space.

with each other. Examples of this included the moving of an internal wall in B119 after the 1st fix because the two ends did not align, and the soil pipe having to be added to the rafter void in plot R117 after the ventilation duct in same rafter void had already been installed, insulated around, boarded over and sealed (figure 92).

- 154 The problems observed in plot R117 with the routing of the soil pipe and vent duct in the same rafter void (figure 92) would not have arisen if the vapour control membrane and boarding over the sloping roof section had not been fitted until after all the services had been installed in the dwelling. Whether or not adequate drawings had been available with both services entering the void, the dismantling of the insulation, AVCL and boarding to allow a second service into the same void involved extra time and material costs for rectification work as well as destroying the integrity of the

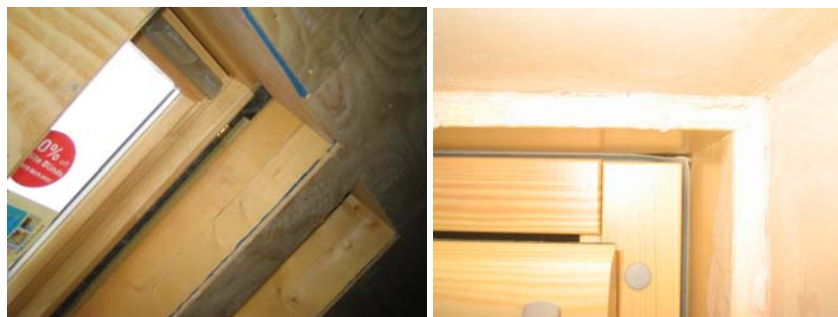
107 Figure 22 illustrated the air leakage that occurred through the rooflights in all properties in this study where they were fitted. The air leakage detected was both around the frame and around the rooflight casement itself. Figure 93 shows a typical detail in which the membrane air barrier is not returned into the reveals allowing the potential for air movement through any gaps that remain around the frame. Similarly visible gaps were evident around the casement seal in a number of cases.

Figure 93. Rooflights in plots R116 and B119.

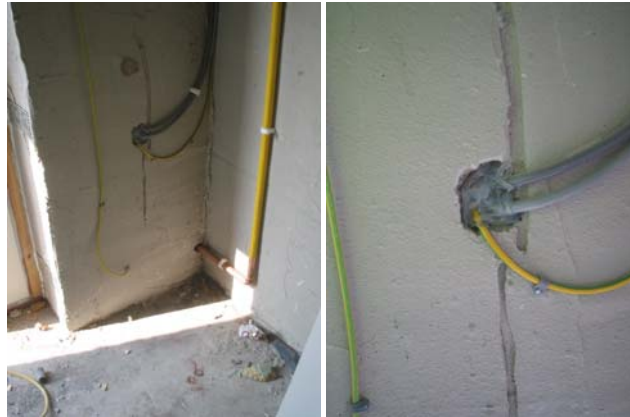
108 Many of the penetrations through external walls had been sealed effectively, using suitable sealants, sealed at a time before subsequent work made access difficult and sealed in the correct place to ensure the continuity of the primary air barrier. In figure 94, a suitable flexible mastic has been applied around the cabling to the external meter box, the earth cable and the gas supply pipe, ensuring that the penetrations are all airtight prior to the plasterboard dry lining being fitted. This is possible where the build sequence allows but in a number of cases penetrations were not made through the external walls until the dry lining had been completed, and in some instances after kitchen units had also been installed, making sealing of these penetrations less straightforward and

Figure 94. Sealing of the cables to the meter box in plot B120.

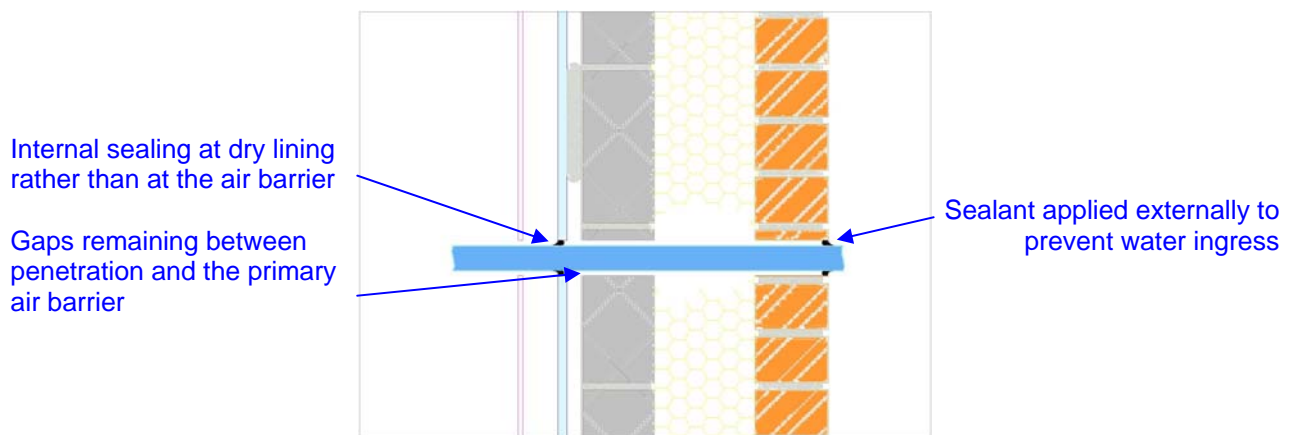
more prone to failure. Here a different solution needs to be sought for sealing penetrations at the air barrier, as the usual application of sealant using a mastic gun has proved to be inapt (figure 95).

Figure 95. Typical sealing application of wall penetrations made after dry lining.

- 111 Proprietary products such as suitable pre-compressed foam tapes and gaskets are available to seal wall penetrations such as those mentioned above but were not used in any of the properties included in this study. Alternatively an alteration to the build sequence to build in waste pipes and boiler flues and seal around before dry lining or kitchen unit installation could solve these problems, but this would require much more accuracy in setting out and much more control over sequencing.

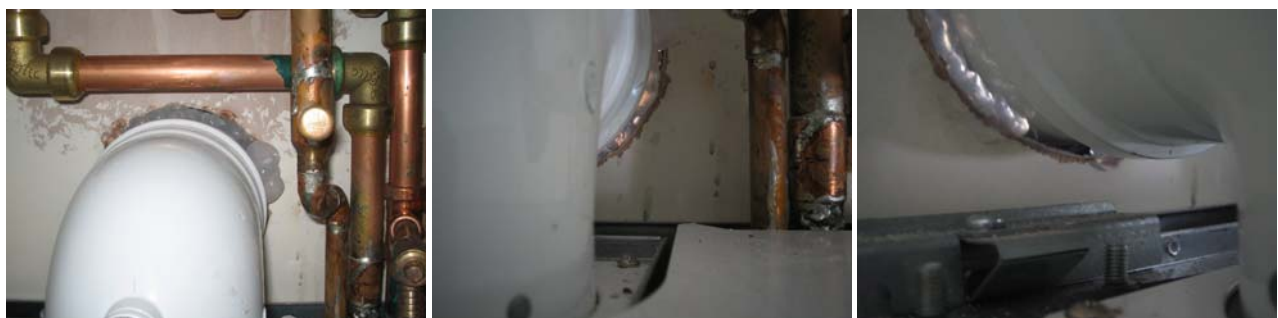
109 In all the dwellings examined in this project the hole for the boiler flue was not core drilled through the wall until after the dry lining had been performed. Sealing around the flue was then performed externally for weatherproofing and at the plasterboard, but not at the air barrier around the penetration through the blockwork. Figure 96 shows an example of sealing around the boiler flue internally in plot B121. The boiler and associated pipework significantly limited access to the whole circumference of the flue resulting in gaps in the sealant at the plasterboard layer and little hope for success in sealing at the air barrier (paring coat) itself.

Figure 96. Internal sealing of the boiler flue in plot B121.

- 152 Some penetrations through walls and ceilings suffered from inaccessibility due to subsequent construction and installations. Penetrations in the Redrow dwellings for kitchen sink wastes were made directly through the external walls after the kitchen units had already been fitted (figure 97), making sealing at the blockwork/parging layer difficult or impossible using their standard techniques. Boiler flues in all plots were sealed around internally at the plasterboard but not at the air barrier due to limited access once the flue and boiler had been installed (figure 96).

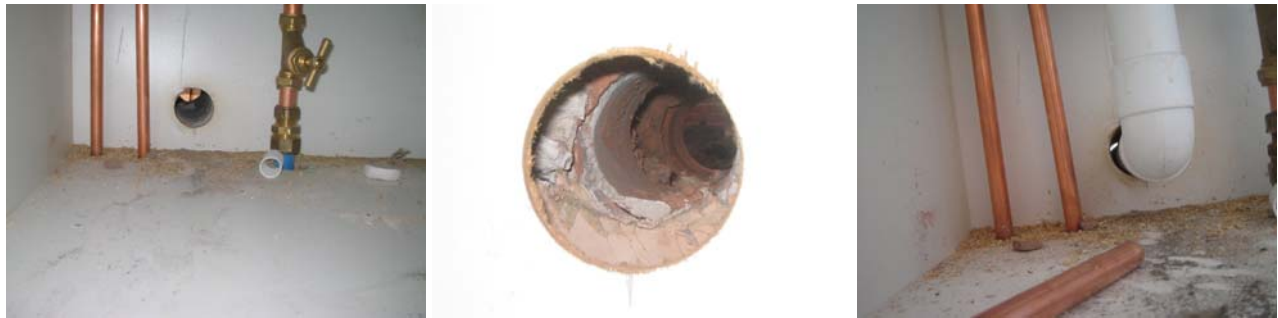
110 In most cases the holes for utility room and kitchen waste pipes were not drilled until after the kitchen units had been installed. This makes it almost impossible to gain access to the point at which the air barrier is penetrated. Any sealing at the level of the plasterboard (or even the kitchen unit) is of little value since air movement will take place behind the plasterboard. The kitchen sink waste pipe in plot R111 (figure 97) is a typical example illustrating the problems of sealing this type of wall penetration. Although a suitable size hole has been neatly drilled through the external wall,

once the waste pipe has been positioned there is no chance of satisfactorily sealing at the air barrier.

Figure 97. Kitchen sink waste pipe installation in plot R111.

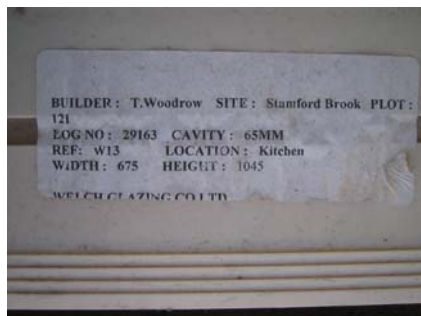
- 112 The proprietary insulated window formers used by Bryant all came with labels attached signifying which window on which plot they were designed for. It was not uncommon for these to be found on the incorrect house and in the incorrect location, the examples shown in figure 98 were for windows in the kitchen and bedroom 4 of plot B120 but found installed on the 1st floor of plot B121. In plot B117 no proprietary window formers were present in any of the 1st floor bedrooms and lengths of acoustic cavity barrier had been used instead, making airtight sealing of the jambs much more difficult to achieve prior to dry lining.

Window former for the correct plot but wrong room

Figure 98. Incorrect window formers found in plot B121 and acoustic cavity barrier used instead of the proprietary formers in plot B117.

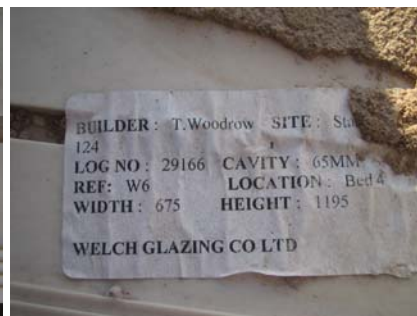
Window former installed in the wrong plot and wrong room

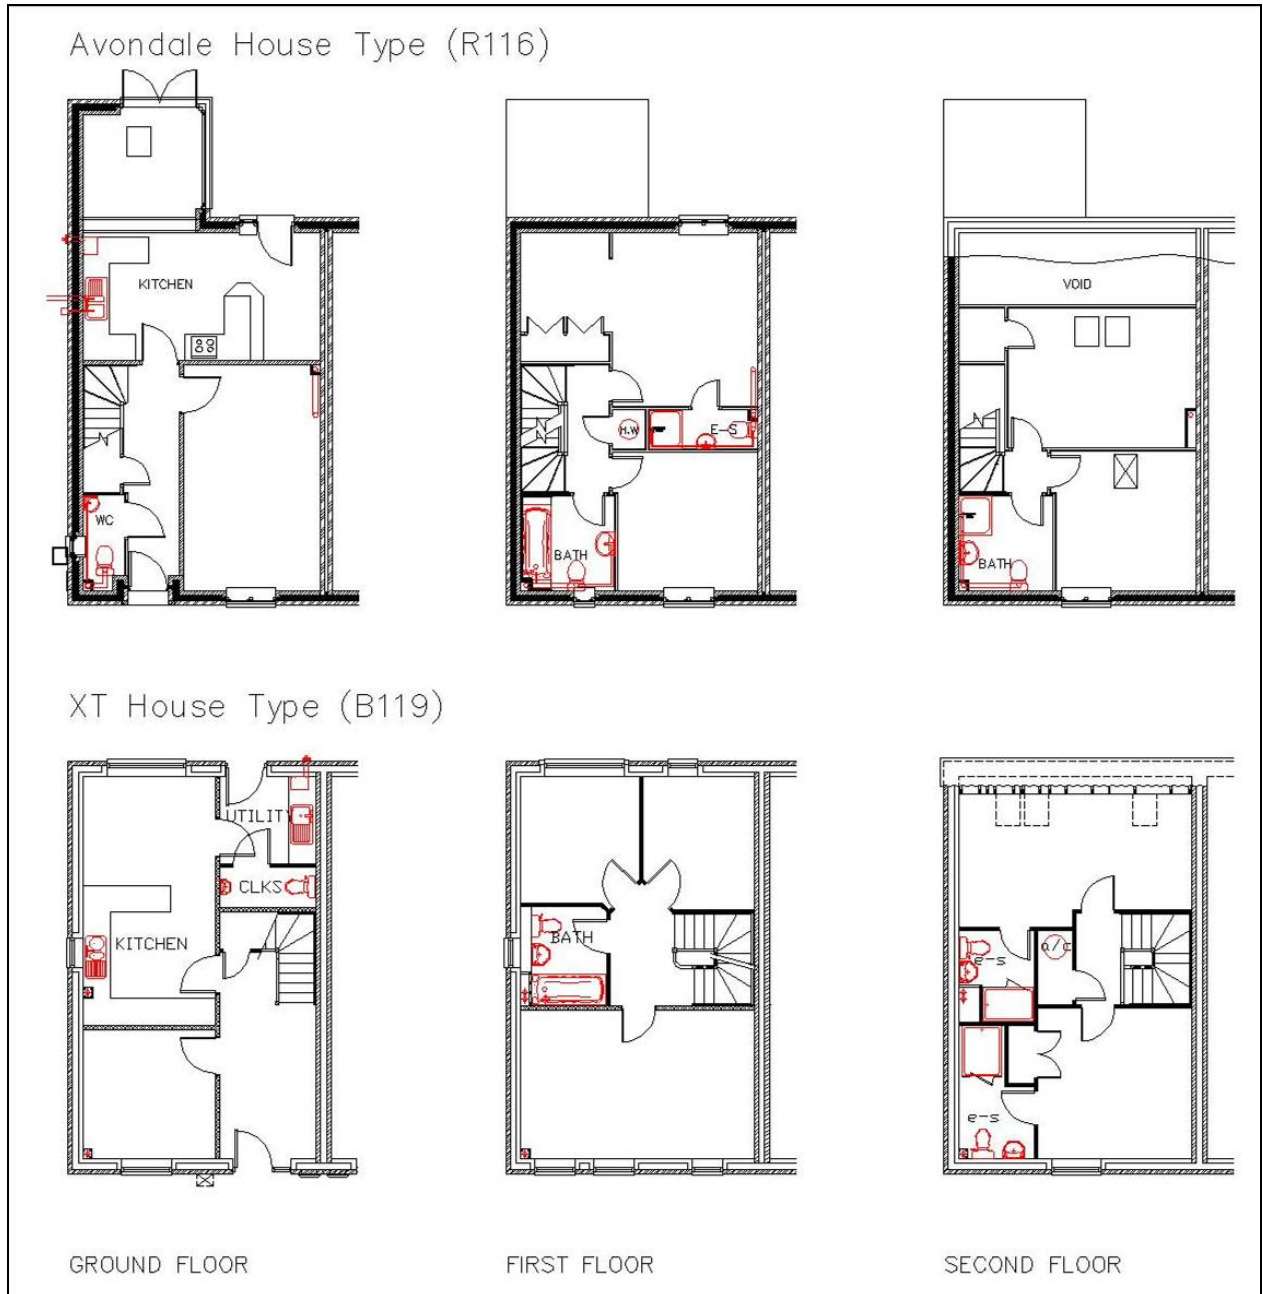
- 127 With significant air leakage detected around service voids, wet rooms and cylinder cupboards, airtightness appeared to have been low in the list of the design considerations for the positioning of these features. Figure 103 shows floor plans for Redrow plot R116 and Bryant plot 119 with the location of wet rooms and associated service riser marked in red. These dwelling types are both $2\frac{1}{2}$ storey dwellings. It can be seen that there are service risers entering the loft along angled room-in-roof corners and through the horizontal ceilings, as well as a number of ground floor

penetrations in each property. If airtightness had been given a higher priority as a design criterion, one possible design choice to minimise the potential for air leakage would have been to group the services together so as to minimise the number of service risers and associated service penetrations. This would have had the added effect of reducing pipe runs (and associated primary pipe work heat losses), construction complexity and cost. There are a range of factors that can influence the placement of wet rooms within a floor plan design and it is important that designers fully understand the potential benefits of optimising the location of services and associated pipework, ducting and service risers, not just in terms of airtightness, but also in terms of other benefits such as reduced costs, improved buildability, easier sequencing, reduced complexity and increased system efficiencies.

Figure 103. Drawings of Avondale and XT house types with wet areas highlighted.

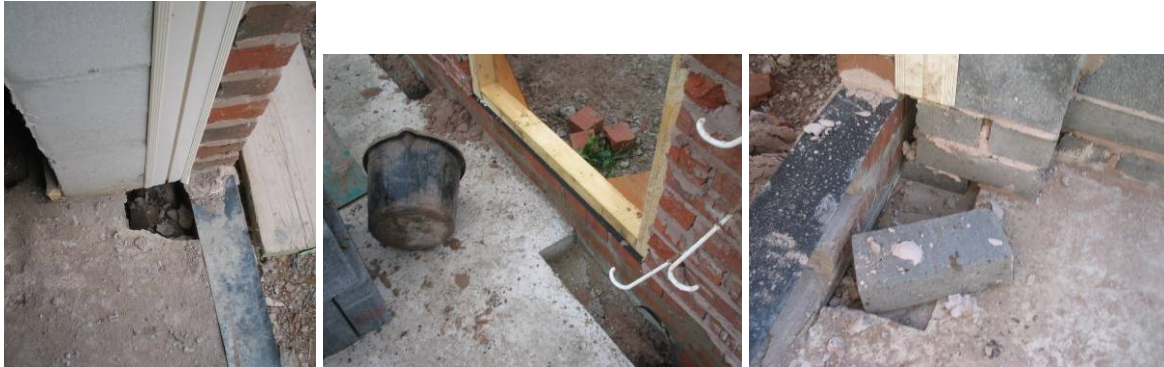
- 134 One benefit of an effective quality control system is that feedback from those errors and mistakes that do occur should result in a reduction in the risk that the same or similar mistakes are repeated. However, the recurring construction faults observed at Stamford Brook cast further doubt on the effectiveness of the quality control systems in operation. Figure 104 shows the ground floor slab for two of the plots examined in detail during this study and one from earlier in the project, where

the slab extensions at the threshold were up to 450mm away from their respective desired locations. This detail was observed closely by the research team because it was previously known to be problematic, with air leakage at these thresholds regarded as a common occurrence and the misalignment of slab and opening making subsequent construction more difficult. Observations of offset slab extensions had been observed several times by the research team and this information was always fed back to the site management teams at the time. The fact that the same error is still being made shows that the feedback loop to the existing current quality control system has not been set up to deal with such issues adequately.

Figure 104. Thresholds Bryant area 7 and in plots B120 and B119.

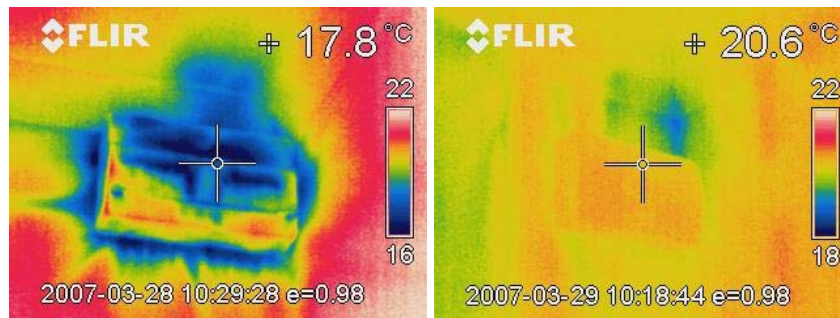
- 139 Inconsistencies in the levels of workmanship were often observed for the same plastering team on different properties. For example, although the plastering in R110 & R111 was carried out by the same team, a significant amount of air leakage was detected through and around the consumer unit in plot R110 but none observed at the same detail in plot R111, as illustrated by the thermal images in Figure 107. This suggests that they had sealed around the cable penetrations in R111 but not in R110. The question remains that if this particular plastering gang can work to the standard required of them in on one plot, why can they not do the same in the plot next door?

Figure 107. Air leakage detected with IR during the re-tests of plots R110 and R111.

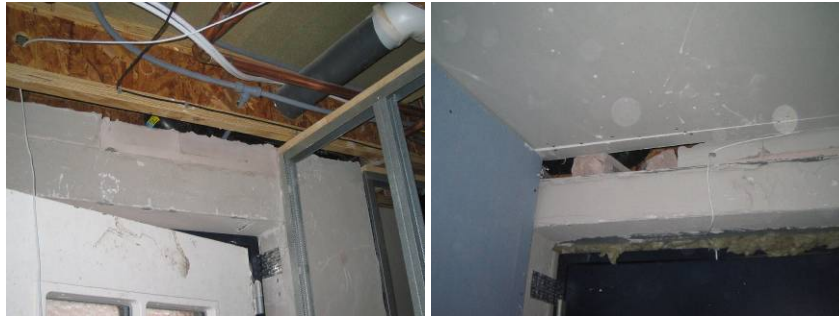
- 156 Figure 110 shows a further example of the tendency for existing construction to be cut away and then repaired. In this case access to the void above the head of the recessed front door was deemed necessary in order to fit a bend to a soil pipe. This required the removal of a section of the top course of blockwork above the door. The blocks were knocked out for the plumbing work to be completed then replaced and patched up. However, as the blocks were simply replaced and patched rather than being fully re-laid they were likely to be more prone to both airtightness defects and subsequent additional damage, as can be seen in plot R117 in figure 110 where the replaced blocks had been dislodged by the plasterers during dry-lining.

- 157 Not only is what might be referred to as a “damage, install and repair” approach inefficient and wasteful, it would be unnecessary if sequencing was considered at the detailed design stage and properly planned prior to construction. The problem would appear to lie not only in a general lack of detailed planning but also in an almost culturally based acceptance of the status quo. The questions raised by the sequencing issues raise a more general point in relation to detailed processes. This has an impact not only on airtightness but many other aspects of performance. It was not uncommon to see the same construction detail built using a different sequence on a number of different occasions. For example, the filling of cavities below thresholds was observed to be carried out at 3 different stages in the construction process; before the frame and parging, after the frame and parging but before dry-lining, and after dry-lining and the fitting of the skirting boards. Without a uniform sequence to this and other details, it would be difficult to maintain continuity of process. As a result, developing any sort of optimum approach to maintaining high standards of performance in airtightness and other aspects of dwelling performance becomes a constant battle, and results in costly inefficiencies, many of which are hidden and not considered in cost control.

Figure 110. Recessed front door head in plot R116 with patched up blockwork after access for the soil pipe, in plot R117 the weakened repaired blockwork damaged during dry-lining.

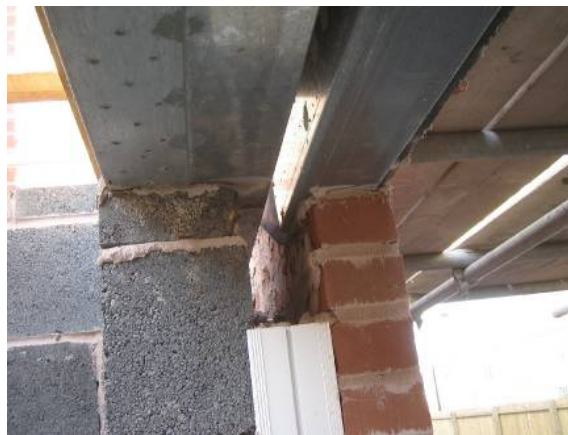
158 The observations relating to materials and components highlight both the importance of selecting airtight materials and components, as well as their installation. As has already been demonstrated, components such as window formers/closers were often installed in the wrong sized opening and even in the wrong dwelling. This was despite the fact that window formers were labelled, indicating which plot and room they were intended for. In one dwelling, the 1st floor formers were missing and dense mineral wool had been used to closer the cavities at the windows (figure 98). It is thought that this issue was sometimes related to component supply problems and that formers were often scavenged from buildings already constructed so that they could be used elsewhere. In such cases where specified products have not been used, the detail has to be made good on site, a process less robust and likely to result in errors and omissions, especially if an inappropriate material or untested solution is used in its place. Figure 111 shows a window former that is too short for the opening, leaving a gap at the top. The research team observed that this gap was not always made good, and frequently resulted in spillage of blown cavity insulation. It would also form a discontinuity in the air barrier. It was evident from observation of a wide range of construction details that, to ensure continuity of the air barrier, a more robust approach was needed in the design, specification and construction of junctions between the primary air barrier elements and between components such as windows, doors & roof lights and the elements in which they were placed.

Figure 111. An incorrect window former in plot B119 leaving a gap at the jamb/head junction which was not always sealed effectively.
