Project Title: Temple Avenue Project Part 1

Temple Avenue field trial – Evaluation of design & construction process and measurement of fabric performance of new build dwellings

May - 2010

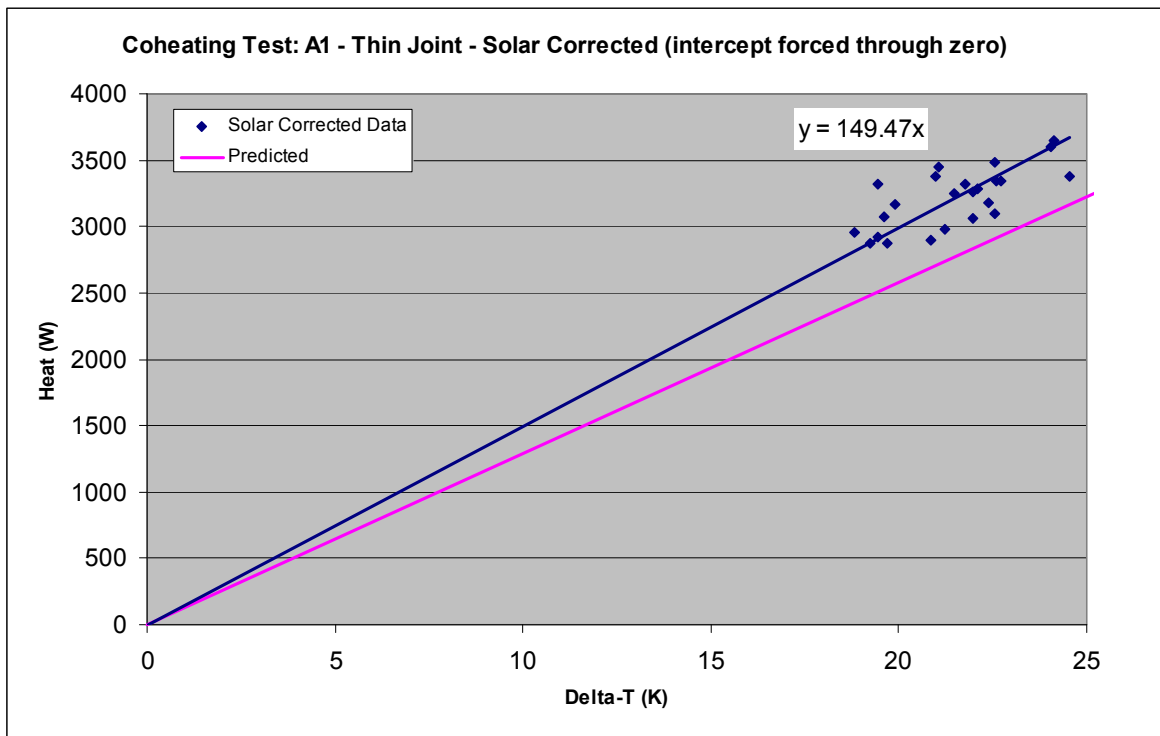
41 Figure 11 charts the solar-corrected daily total power consumption (in Watts) required to maintain the 25 °C internal temperature at the range of internal/external daily average temperature differentials experienced. Assuming no energy input is required when ΔT = 0 the gradient of the line of best fit through these points (shown on the graph) provides the measured heat loss coefficient, this is plotted alongside the predicted heat loss from Table 2. Figure 12 shows the comparable data for the A2 prototype. Using this method, the measured data provide a heat loss coefficient of 149.5 W/K for the A1 prototype with an R² correlation of 0.367, and a heat loss coefficient of 132.9 W/K for the A2 prototype with an R² correlation of 0.511. The lower correlation of results observed for the masonry prototype is likely due to wind effects, which affected the masonry prototype to a greater extent than the SIPs prototype due to its higher air permeability.

Figure 11 Masonry Prototype – Measured versus predicted heat loss performance.

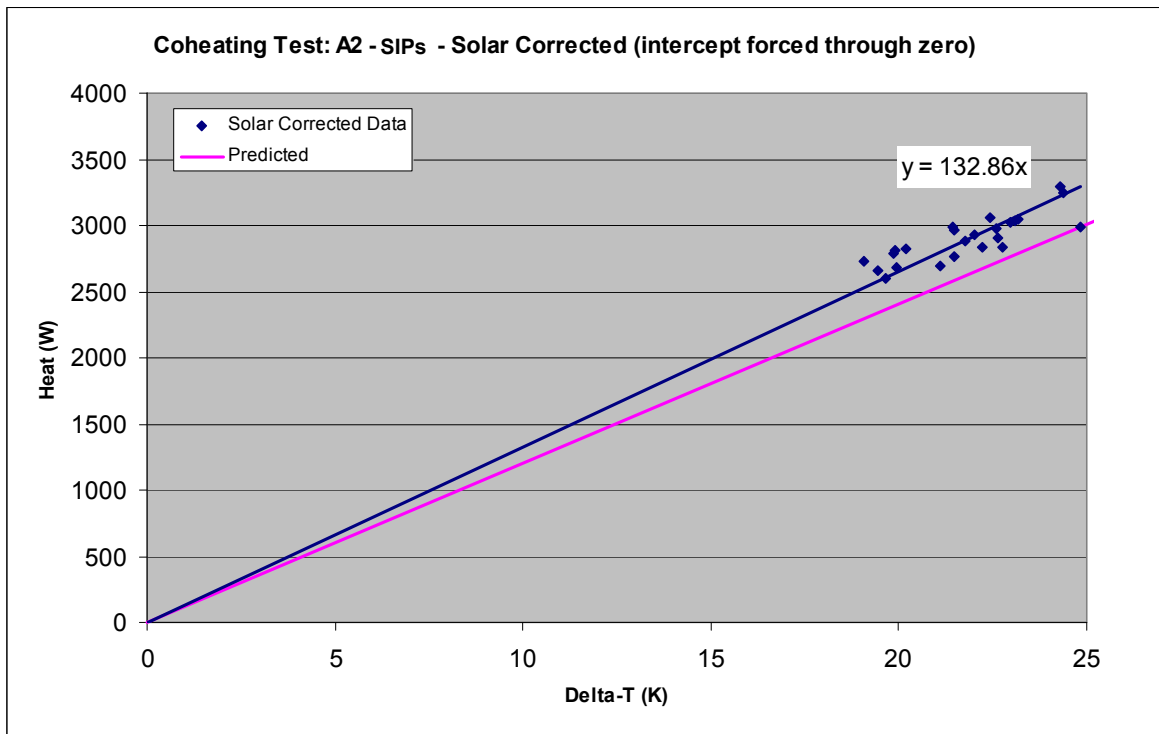
Figure 12 SIPs Prototype – Measured versus predicted heat loss performance.

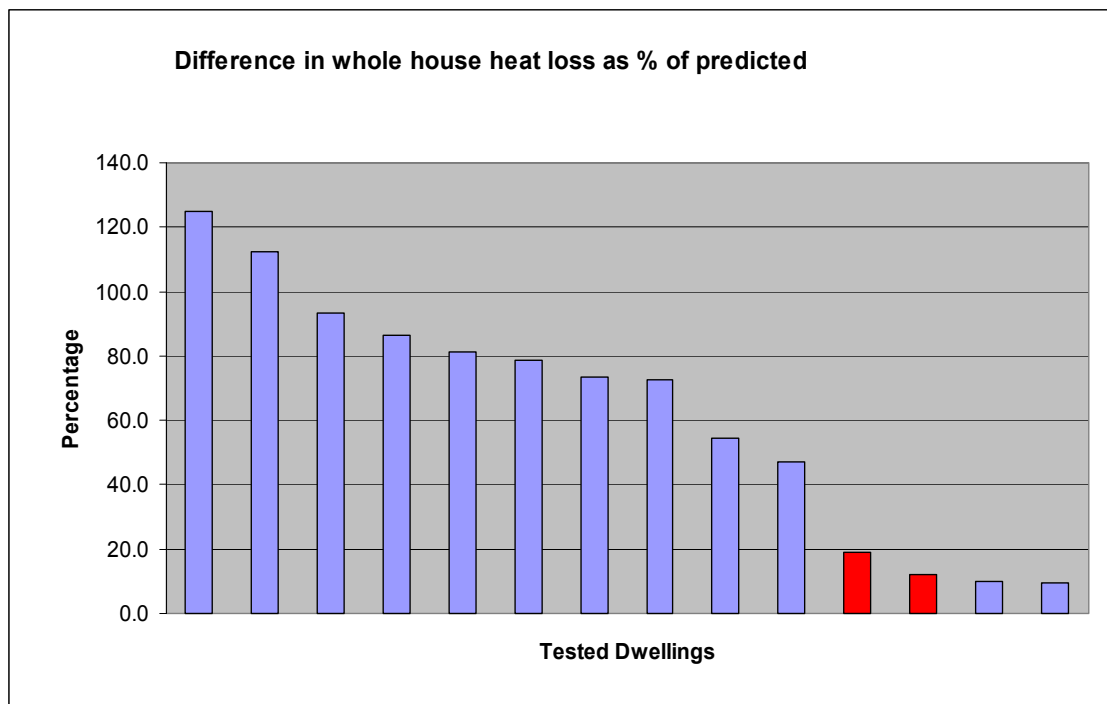
44 To put the results into context, the prototypes increased heat loss over predicted performance from the prototype dwellings is shown alongside other dwellings tested by the Leeds Met research team in Figure 13. The prototype dwellings are shown in red. The size of the differences detailed in Table 4 may be of concern, but they are amongst the lowest differences recorded by the Leeds Met research team in coheating tests on new build dwellings. As detached houses the prototypes were not affected by underestimated heat losses from separating walls as observed in the other tested dwellings. In fact, A1 prototype emerged as the closest to design values yet tested by the research team for a masonry dwelling and the A2 prototype was on a par with the best performing timber framed new build houses.

Figure 13 Variation between predicted and measured results in new build dwellings from coheating tests performed by Leeds Met since December 2005.

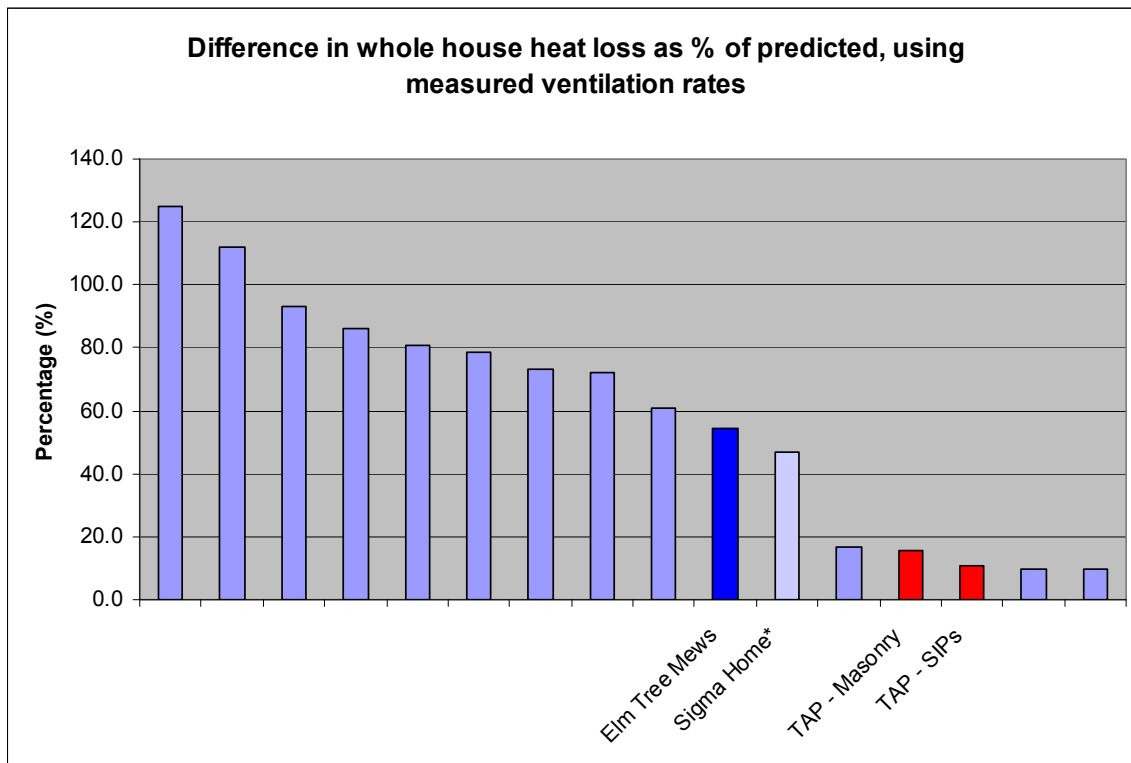
45 Using a ventilation heat loss value derived from the measured air permeability (the mean value of tests performed at the start and end of the coheating tests) to re-calculate the predicted heat loss of the dwellings allows the variation from designed performance to more accurately represent the thermal performance of the fabric by removing some of the variations caused by air leakage. These revised values are shown in Table 5. Figure 14 illustrated these revised values in context with other dwellings and highlights the high level of performance against two award winning projects, the client’s own Elm Tree Mews development (Bell, Wingfield, Miles-Shenton and Seavers, 2010) and the Stuart Milne Group’s prototype Sigma Home (Stevenson and Rijal, 2008) which was built on the BRE’s Innovation Park in 2007 using a MMC closed-panel timber frame system with designed elemental U-values comparable to the Temple Avenue prototypes.

Figure 14 Variation between predicted and measured results using measured ventilation rates.

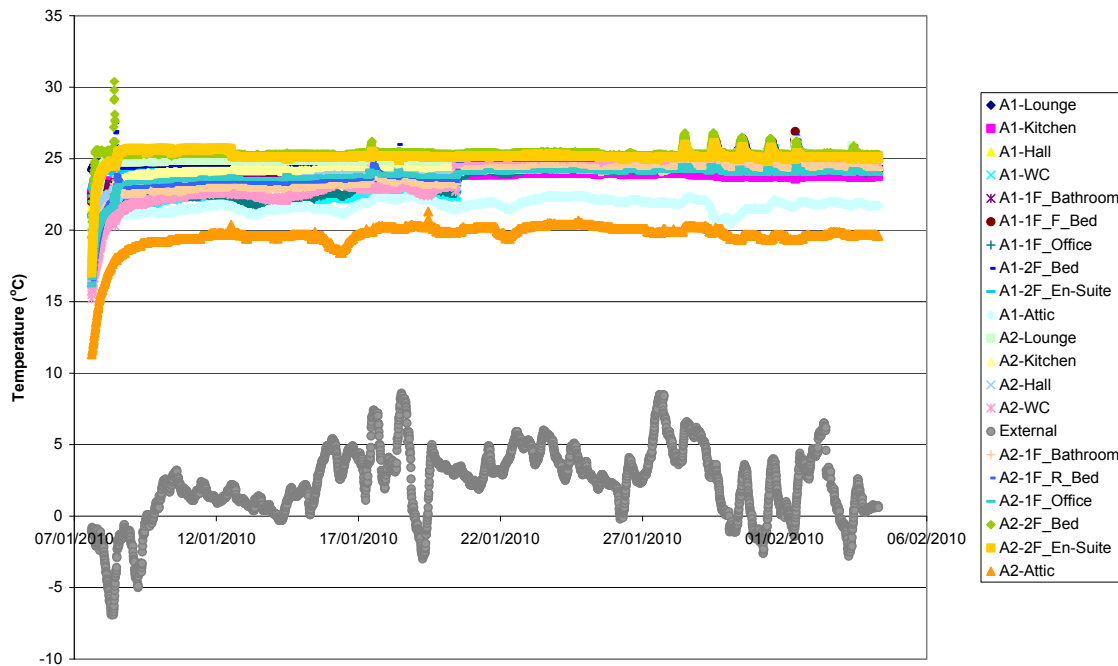
46 The internal temperatures recorded in the dwellings throughout the coheating tests are illustrated in Figure 15. They show the heat-up phase from 07/01/10 and a levelling off of internal temperatures occurring very quickly to allow useable data to be collected from 09/01/10. The unheated attic spaces remained relatively constant at 22 °C in the masonry prototype and 20 °C in the SIPs prototype, even when additional heaters and controllers were added on 20/01/10 to even out the variations in temperature within the dwellings. The series of temperature peaks observed between 28/01/10 and 01/02/10 were due to long periods of unbroken sunshine causing some overshooting of temperatures in rooms on the southern elevation. However, this provided a good variation to allow more accurate solar correction of the measured data. The variation in daily average temperature differential required for producing reliable trends from the recorded data was achieved; daily average external temperatures ranged from -2.5°C (09/01/10) to 4.9°C (27/01/10) over the test period. Figure 16 shows the total power consumption of the prototypes over each 10 minute interval throughout the coheating test period. The increased solar gains over the period 28/01/10 to 01/02/10, and consequential peaks in external temperature, can be clearly seen by the decreased electricity demand for heating during daylight hours.

Figure 15 Temperatures recorded in the prototype dwellings over the coheating test (10 minute data).

- 87 Temperature peaks between 28/01/10 and 01/02/10 in the rooms with South facing windows provide an indication of the potential for summer overheating. These days experienced long periods of unbroken sunshine and the resultant spikes in room temperature shown in Figure 15 occurred only in rooms with South facing glazing. In some cases the room temperatures were overshooting by $\sim 3 \text{ K}$ when the external temperatures were $< 5 \text{ }^\circ\text{C}$; with the thermostatically controlled heaters switching off at temperatures above $25.1 \text{ }^\circ\text{C}$ this overshoot was due entirely to solar gains. With the coheating tests occurring in January the direct sunlight was able to penetrate further into the rooms and the additional shading which would be provided in the summer by the sunspaces and balcony roofs was circumvented to some extent, but it provides a warning for the likelihood of summer overheating in both construction forms.

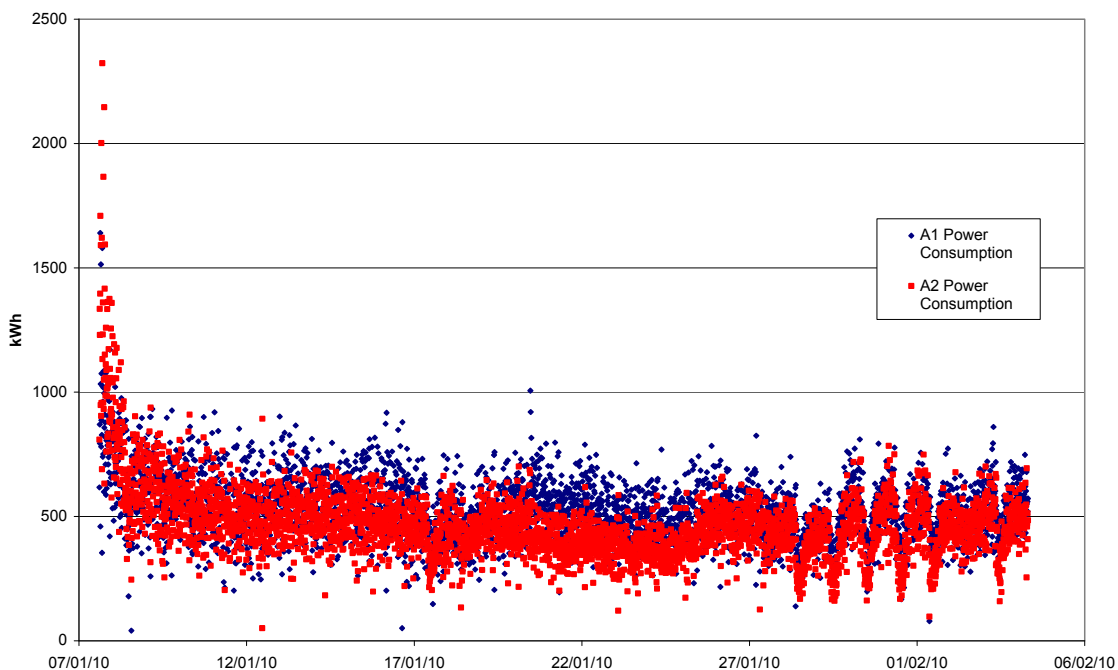
Figure 16 Total '10 minute' power consumption in each prototype over the coheating test.

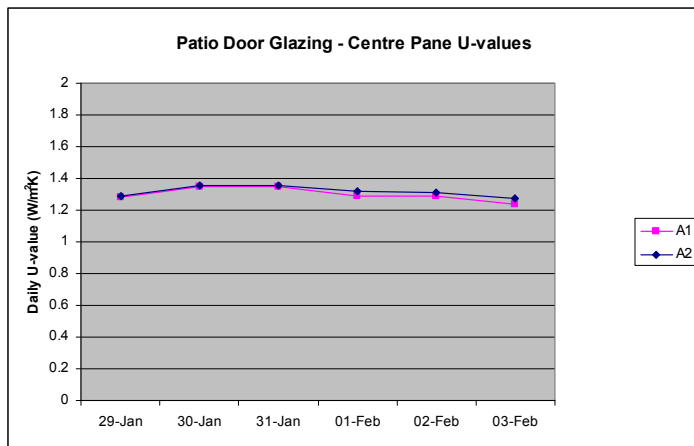
The measured U-values for the glazing provided by the high-performance double-glazed windows proved to be remarkably consistent, with both prototypes providing centre pane U-values of ~1.3 W/m²K.

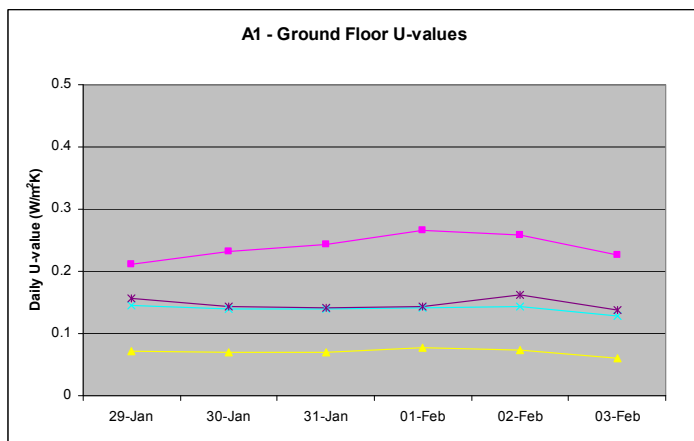
The floor U-values varied considerably with proximity to the external wall, but were very consistent between the 2 dwellings.

The highest values (~0.3 Wm²K) were recorded for the sensor in each house closest to the external wall-floor junction, with the A1 prototype outperforming the A2 by 10~20% closest to the slab perimeter. The other sensors away from the wall junction ranged from ~0.08 to 0.18 W/m²K.

Preliminary calculations provide an average U-value of around 0.15 W/m²K for the floors, which is consistent with the nominal calculated U-value for the floor used by the architects (0.16 W/m²K).

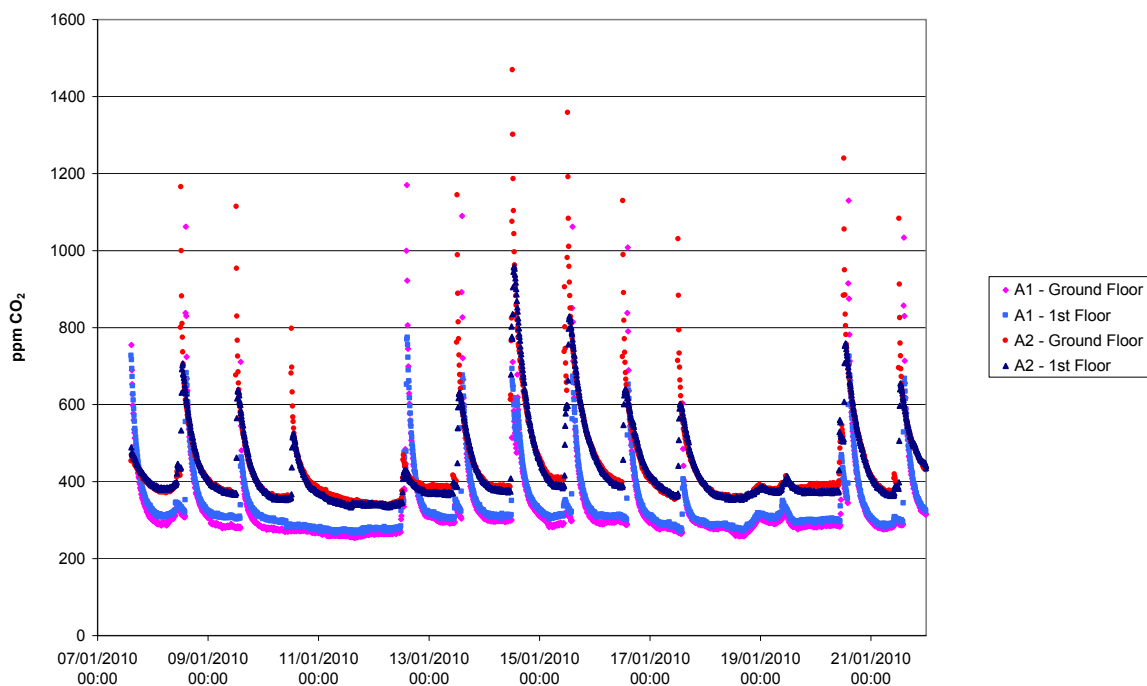
50 Throughout the coheating test daily, bursts of CO₂ were released into the dwellings and the CO₂ concentrations recorded on both the ground and 1st floors (Figure 18) in order to calculate the ventilation rate. The subsequent rates of decay allowed air change rates to be determined based on the period of time taken for the CO₂ concentration to return to the background levels (Roulet and Foradini, 2002).

Figure 18 Levels of CO₂ recorded in the 2 prototype dwellings (10 minute data).

51 The air change rates calculated for the A1 prototype varied from 0.32 to 0.42 h⁻¹ on the ground floor and 0.31 to 0.41 h⁻¹ on the first floor over the test period, in the A2 prototypes they were 0.21 to 0.28 h⁻¹ on the ground floor and 0.16 to 0.24 h⁻¹ on the first floor. No pattern of change over time was observed in either property, the variations appearing to be more consistent with changes in wind speed and direction, although this has yet to be fully analysed. That the air change rates varied little over the test period supports the pressurisation test data showing no significant change

in air leakage rates between pressure tests undertaken at the start and finish of the coheating tests, where the results of $3.5 \sim 3.7 \text{ h}^{-1}$ for the A1 prototype and $2.0 \sim 2.2 \text{ h}^{-1}$ for the A2 were measured at an induced pressure difference of 50 Pascal. The variation in measured background CO_2 levels of between 70 and 100 ppm is somewhat harder to explain and after due checking was confirmed as not down to instrument error. The background CO_2 concentrations observed in the A2 prototype were much more representative of environmental levels suggesting other factors at work in the thin-joint house. The variation will have been due in part to the variation in relative humidity in the dwellings, shown in Figure 19, where the mean RH readings for the ground and 1st floors were some 7 to 10% higher in the A1 prototype, but whether this can account for such large variations in concentration is difficult to determine; there may be some adsorption of the CO_2 by moisture contained within the building fabric or by the structure itself..

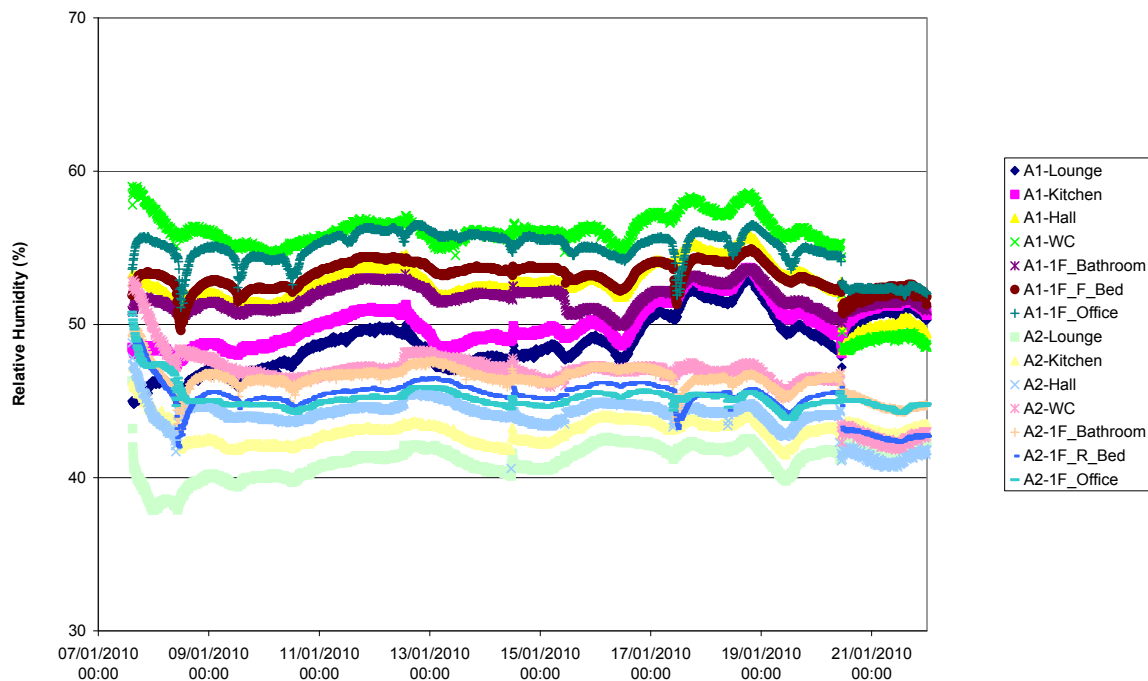
Figure 19 Relative humidity readings in ground and 1st floors of the 2 prototype dwellings (10 minute data).
