Final Report to Joseph Rowntree Housing Trust

Project Title: Temple Avenue Project Part 2

Energy efficient renovation of an existing dwelling: Evaluation of design & construction and measurement of fabric performance

March - 2011

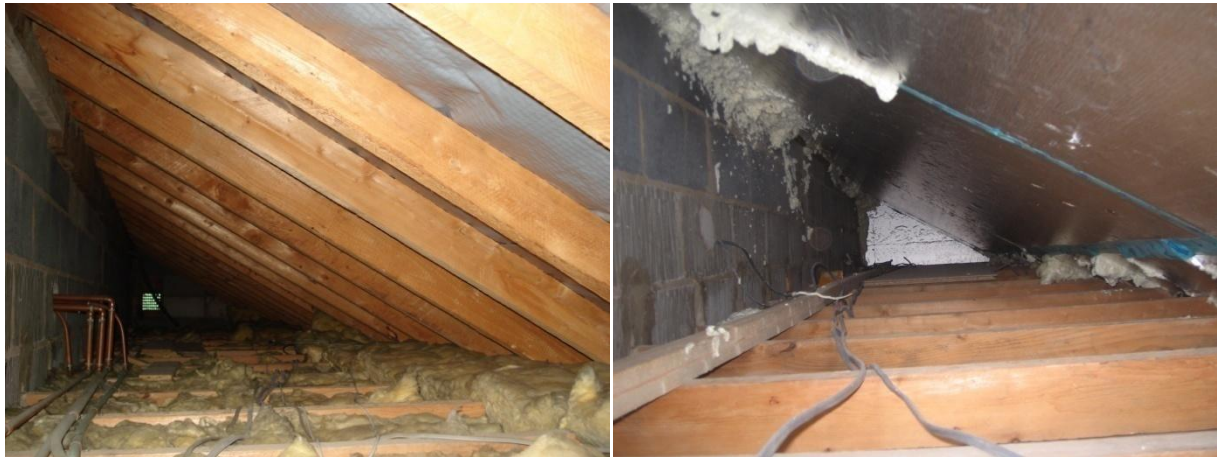
- 38 The insulation in the rear extension loft space was relocated and changed from a nominal 100 mm between the ceiling joists to 75 mm phenolic foam placed under the rafters (Figure 12). Transforming this void from a cold to a warm space was intended to provide a simpler continuation of both the thermal layer and the air barrier once the stage 2 renovations were completed with external wall insulation applied. The newly placed insulation providing a direct link between the EWI at ground and first floor levels, and the services running through this roof void were now all internal to the air and thermal layers so no longer penetrated the primary air barrier. An “intelligent” air tightness membrane was sourced rather than the standard membrane used elsewhere in the dwelling to regulate the potential for condensation due to its placement on the cold side of the insulation, between the insulation boards and rafters.

Figure 12 The rear extension insulation was relocated from mineral wool between the joists to phenolic foam beneath the rafters.

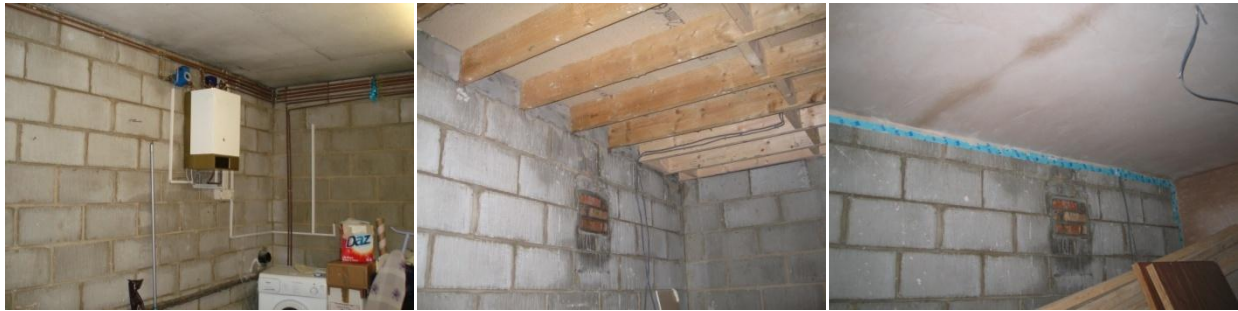
Figure 15 The boiler and associated pipework were removed and a new intermediate floor constructed over the garage.

62 Additional renovation work that had significant beneficial effect on the December 2009 airtightness test results included the removal of the boiler from the garage (Figure 15) and the hot water cylinder from the loft along with their associated pipework; this allowed service penetrations into the garage and loft to be sealed, either by patching up the walls or filling the gaps with expanding foam. Other service penetrations which had provided direct air paths to outside were also removed, including; bathroom, downstairs WC and kitchen waste pipes; kitchen and downstairs WC extraction fans; the downstairs toilet and the recessed lights in the bathroom ceiling. The moving of the air barrier at the rear extension from ceiling level to rafter level meant that some gaps in the external wall outer leaf now became gaps in the air barrier and needed to be repaired. Figure 37 shows a hole where service penetrations into the extension roof void were not sealed around for the 1st coheating test then sealed with expanding foam for the subsequent tests, as this effectively became part of the air barrier. Questions also arose regarding other linking up of the edges of the new airtightness membrane to the existing air barrier of the internal wet plaster linings. Reparatory work performed to level the intermediate floor of the side extension allowed further leakage paths to be addressed, but also delivered some missed opportunities. Removal of the original flooring allowed some sealing to be performed around the intermediate floor perimeter joist-ends and service penetrations. However, gaps were filled with expanding foam (for speed and convenience) rather than a more robust mortar and mastic which would have sealed better into corners and provided a better link between the wet-plastered 1st floor walls and the new garage ceiling. A mortar or mastic seal would have been more successful in achieving a continuous air barrier, and may also have coped better with the dirt, dust and debris. Whilst the floor decking was removed the opportunity to effectively seal the opening into the cavity of the original external gable wall by the top of the stairs was also missed.

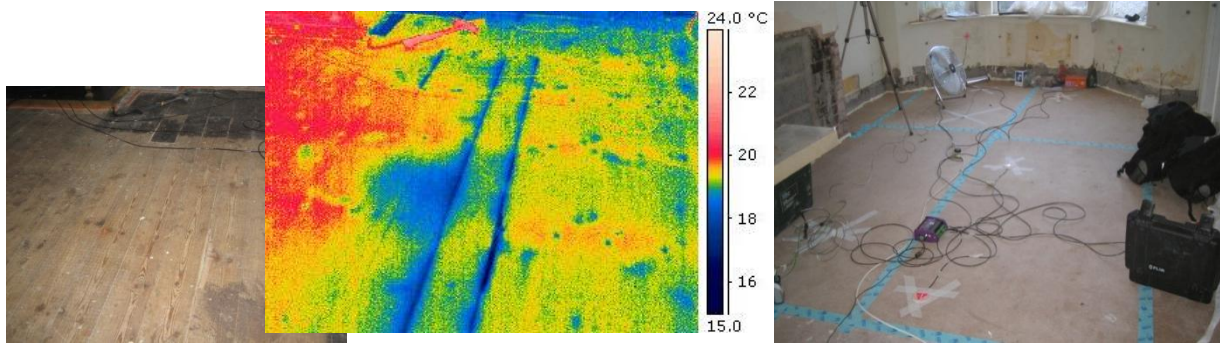
43 Various additional measures were designed to improve the airtightness of the dwelling beyond those normally carried out as part of a decent homes upgrade. The suspended timber ground floor was sealed using a temporary hardboard covering with expanding foam edge sealing and taped joints. Figure 18 shows the living room floor in its original condition with cold air infiltrating between the floorboards during the heat-up period for the 1st coheating test and the sealed floor during the 2nd coheating test. Service penetrations through the external wall were removed and either temporarily sealed, patched up or filled with expanding foam, these included bathroom and kitchen waste pipes and the recessed lights in the bathroom ceiling. Opportunities were taken to seal gaps and air leakage paths as they came about. An example of this is shown in Figure 19, where the exposed intermediate floor void above the living room bay window allowed the joists to be sealed around and the cracks and gaps in the inner leaf brickwork to be pointed up.

Figure 18 Living room floor during phase 1 and phase 2 coheating tests

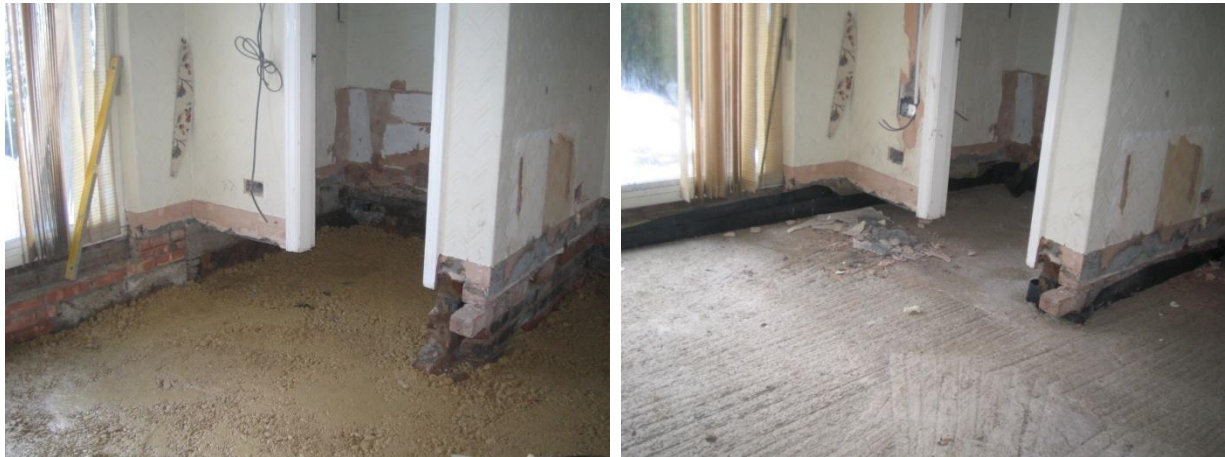
- 45 Both the assumed un-insulated solid ground floor and the suspended timber ground floor were removed and a replacement solid ground floor to a U-value of 0.195 W/m²K installed throughout. The removal of the suspended timber floor proved straightforward as plumbing and electrical services previously located in the floor void were either re-routed or decommissioned. Removal of the solid concrete floor in the dining area and kitchen was more difficult and time consuming, with particular problems at the room perimeters and where internal masonry walls had been constructed on top of the old slab (Figure 20). Laying the new floor did not appear to present many problems apart from the large amount of moisture generated which proved difficult to remove given the extremely cold weather and that the windows were only open whilst workers were present, due to security issues. The new floor was laid in a single slab without any expansion joints and subsequently a crack developed in the doorway between the kitchen and dining area. This crack appeared to affect just the top surface of the floor and did not appear to penetrate by more than a few millimetres; subsequent leakage detection performed during air tightness tests did not identify the crack as a significant air leakage path.

Figure 20 New ground floor construction in the dining area and previous downstairs WC.

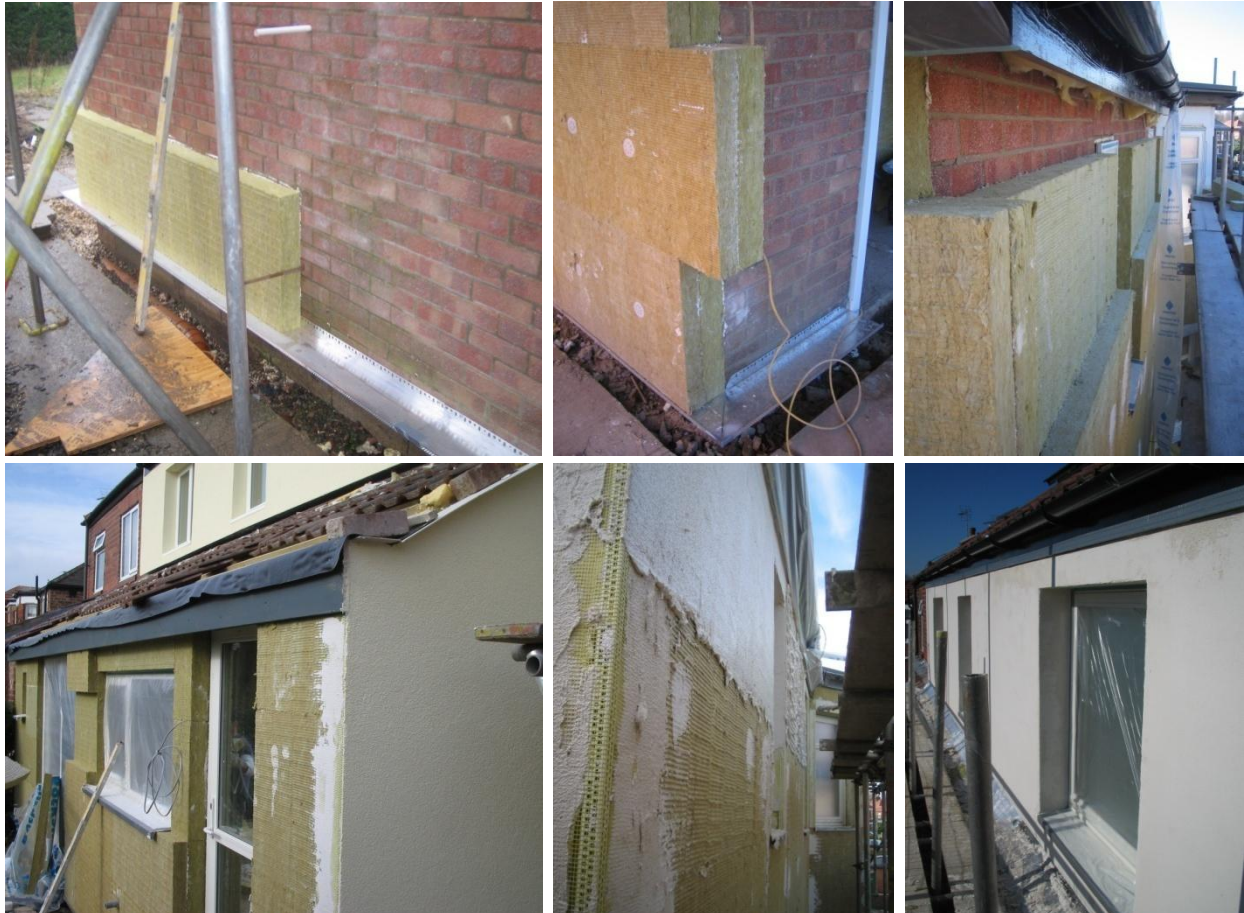
the insulation batts were dry-positioned and marked to allow them to be sawn to the correct size prior to applying the adhesive directly to the batt and then fitting it into position. This method appeared to be very successful in minimising the gaps around penetrations and junctions; where small gaps did emerge, the insulation material was rigid enough for the installers to cut thin slivers of insulation which were worked into any spaces to maintain the continuity of the insulation layer. Once the insulation layers were completed they were covered with a purpose-designed fine mesh polymeric scrim, attached to the EWI using thin dabs of the same adhesive, and finished with a pre-coloured and pre-mixed textured silicone resin render.

Figure 22 EWI installation, February to March 2010.

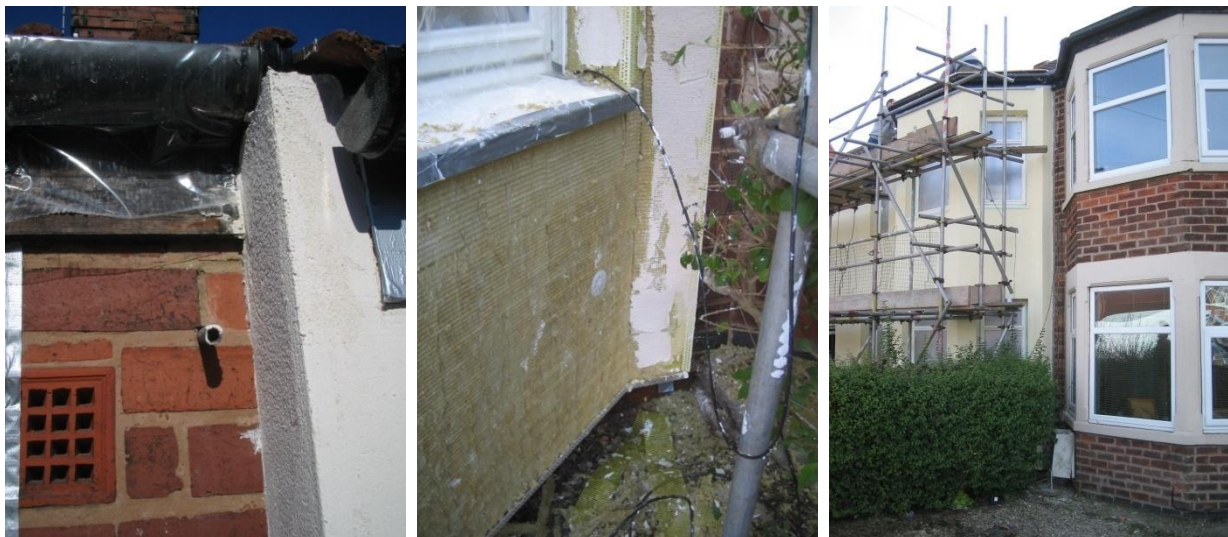
- 50 The EWI detail at the party wall junction had been a concern at design discussions due to the protrusion of the insulation from the external wall and the associated extension of the eaves and bay roof to accommodate the increase in wall thickness. The anticipated difficulties in detailing at the rear of the house, due to the extended eaves of both the main roof and the ground floor extension, appeared to present little problem to the insulation installers once the extensions to the eaves had been completed. A discontinuity in the external insulation layer resulted at the junction of the rear extension roof and the first floor EWI (Figure 25), although this did not appear to be a major issue in thermal images taken from either inside or outside the house during the 3rd coheating test. At the front of the property the EWI edge detail at the party wall was more straightforward, and any concerns over the aesthetics of the increased wall thickness compared to that of the adjoining property were allayed (Figure 26). Similarly, concerns over the appearance of the bay window mullions with EWI fitted prompted much discussion, but the finished detail (Figure 27) met with the approval of all concerned.

Figure 26 The edge detail of the EWI at the party wall junction at the rear and front elevations.

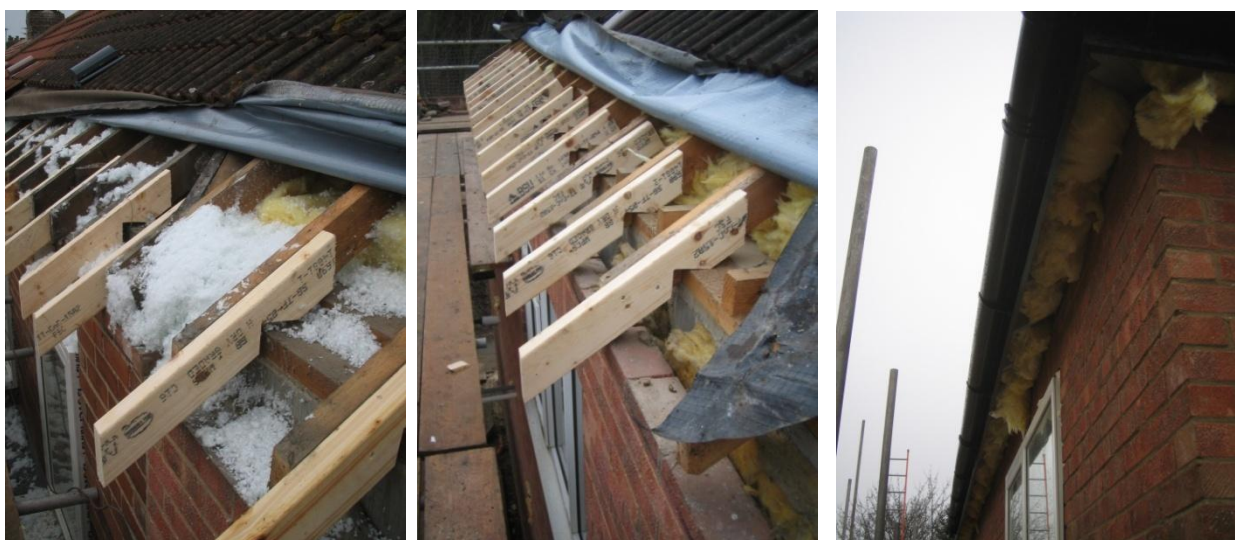
52 The bulk of the loft insulation remained unchanged following the stage 1 renovation; however, the roof extension work necessary to accommodate the EWI presented an opportunity for an extension of the loft insulation to meet up with the forthcoming wall insulation. With the roof tiles removed and felt lifted back (Figure 28) it was possible to observe how short the loft insulation fell from meeting up with the CWI to create a continuous insulation layer at this junction. Prior to the tiles being re-laid additional mineral fibre insulation was installed at the eaves to provide a link between the loft insulation and the EWI. Although the need to extend the roof for the EWI incurred additional costs it was fortunate from a thermal point of view, as it would have been highly unlikely to achieve the same level of integrity of the thermal layer without this advantageous access being acquired. Figure 29 and Figure 30 show the North East corner of bedroom 3 before and after the stage 2 renovations with the thermal images both displaying a 5 K range in temperature, they underline the beneficial effect of maintaining a continuous insulation layer between the walls and loft by the reduction in apparent thermal bridging at this junction. Some bridging is still evident through the roof timbers in Figure 30, but most of the large differences in internal surface temperature at the eaves junction observed in Figure 29 had been eradicated. Lifting the tiles for the main roof extensions at the eaves also provided an opportunity to close the tops of the external wall cavities which was not fully undertaken, this would have further reduced the likelihood of undesirable air movement in the external cavities and any associated bypassing effects.

Figure 28 Eaves extensions to the main roof at the rear and side elevations under construction, and with the roof extension completed prior to the EWI installation.

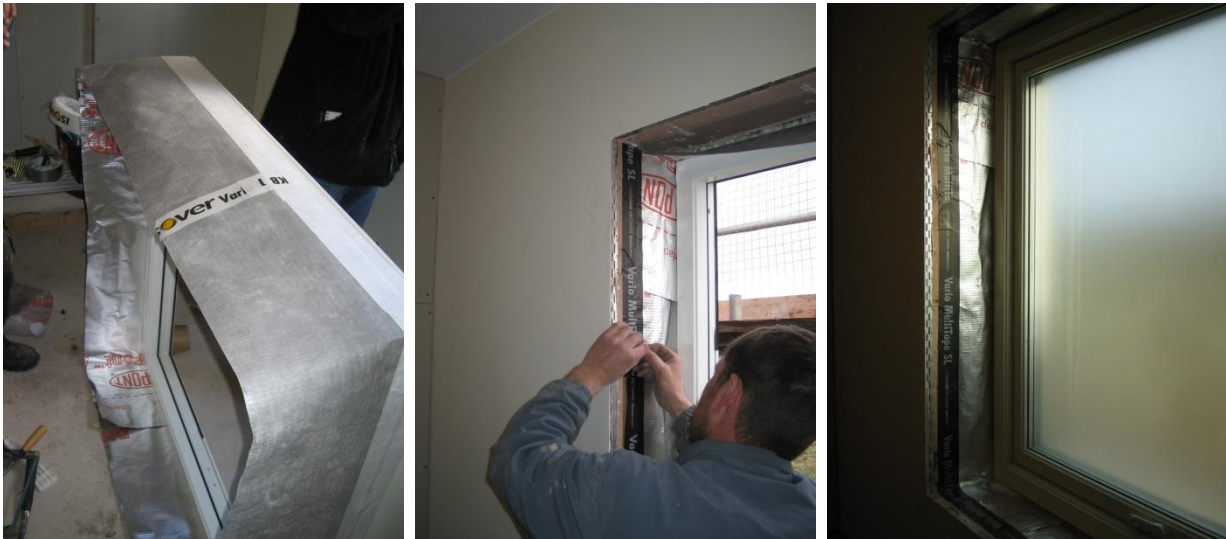
53 Figure 29 and Figure 30 also emphasize the difference in the thermal performance of the original windows and their replacements and the reduction in thermal bridging and/or air movement at the jambs, heads and sills resulting from the stage 2 renovations. The existing double glazed units were replaced with new argon-filled triple glazed timber windows throughout (U-value 0.83 W/m²K) and the external doors replaced with composite insulated doors (U-value 1.2 W/m²K). The kitchen to garage door was temporarily replaced. Placement of the windows in the external walls to more in line with the external wall insulation took place, but was limited by the weight of some of the replacement units. The replacement windows were planned to be fitted on brackets to extend them out into the insulation layer to optimise thermal performance, this was not always possible, with a number of windows fitted by screwing directly through the frames into the brickwork. This practical solution was decided upon by the window installer and site foreman and although the window placement was not optimal, it appeared acceptable as Figure 30 shows that there was no significant thermal bridging around the window frames. Similarly, with no formal design drawing, the insulation of the bay mullions appeared to rely on the vision and experience of the site foreman and no excessive thermal bridging observed during the final coheating test.

Figure 31 Installation of triple glazed replacement windows showing the air barrier.

- 54 Without any specific detailed drawings to guide the window fitter, it was left to him and the site manager to agree a practical solution as how to best achieve an airtight fit whilst keeping thermal bridging to a minimum. Airtightness was assisted by using a vapour barrier taped to the window/door frames prior to installation which was then returned and taped into the reveals using suitable adhesive tapes (Figure 31). This method of minimising air leakage was adopted both where window and door frames were secured by brackets or by screwing through the frames directly into the brickwork. Thermally, the expected optimum position for the frames would have been fully in line with the EWI to minimise thermal bridging through the frame and opening. However, the compromise between thermal performance and structural stability resulted in a final overlap between the frames and EWI varying from 30 – 70 mm (Figure 32) and appearing to depend on the size (or weight) of the window, with smaller (lighter) windows being placed further out into the EWI than the larger (heavier) windows and doors. No thermal bridging calculations were made available to the research team regarding the window placement, so it is uncertain whether the decrease in thermal bridging was in line with the estimated reduction in γ -value from $0.15 \text{ W/m}^2\text{K}$ to $0.08 \text{ W/m}^2\text{K}$ used in the SAP calculations.

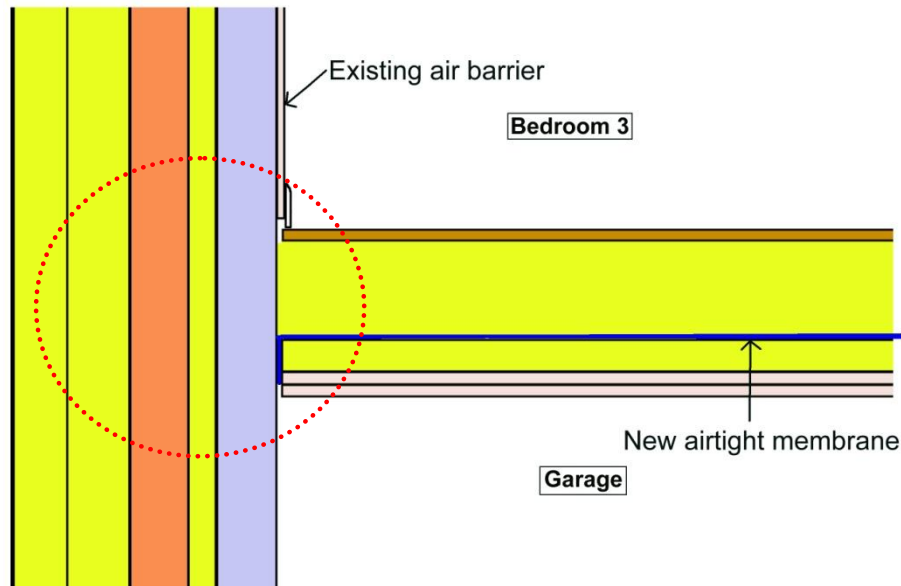
- k) Air barrier discontinuities – Some of the renovations included the introduction of materials which constituted the primary air barrier, but were not linked directly to the existing primary air barrier. The sloping roof membrane in the rear extension linked directly to the air barrier on the ground floor external wall (the internal plaster finish), but not directly to the air barrier at the side walls and 1st floor rear wall. The new garage ceiling did not connect directly to the plaster finish in bedroom 3 above it (Figure 45), leaving the intermediate floor void perimeter to complete the discontinuity in the primary air barrier.

Figure 45 Discontinuity in the primary air barrier between the new garage ceiling and the wet-plastered wall finish in bedroom 3 at the gable wall.

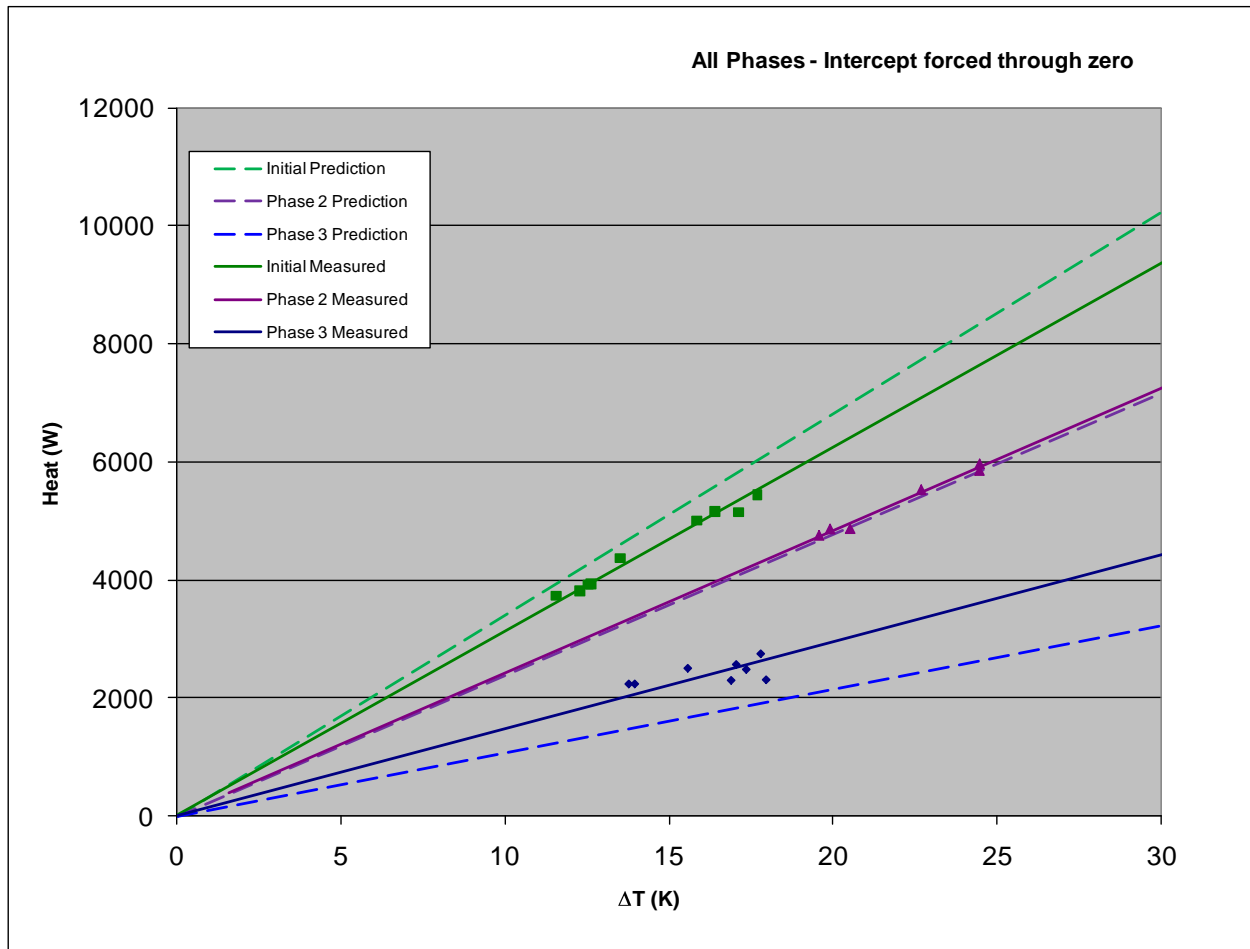
Figure 50 Comparison of predicted⁵ and measured⁶ heat loss for the 3 coheating tests performed on the existing dwelling.

- 78 What is immediately obvious from Figure 50 is that the measured heat loss coefficient is less than predicted for phase 1, roughly similar to the predicted figure in phase 2 and greater than predicted in phase 3. More importantly, in neither of the renovation stages did the measured reduction in heat loss coefficient achieve the reduction that had been predicted. This can be explained by either experimental error, underperformance of the renovation works undertaken, inaccuracies in the estimations made for the prediction of heat loss values, or a combination of any of these. The coheating test protocol used by the research team is a proven methodology, and there were no significant variations between the 3 test procedures followed. This indicates that the variations observed between the measured and predicted heat loss are a result of either underperformance of the measures introduced or inaccuracies in the predicted performance data, or both.

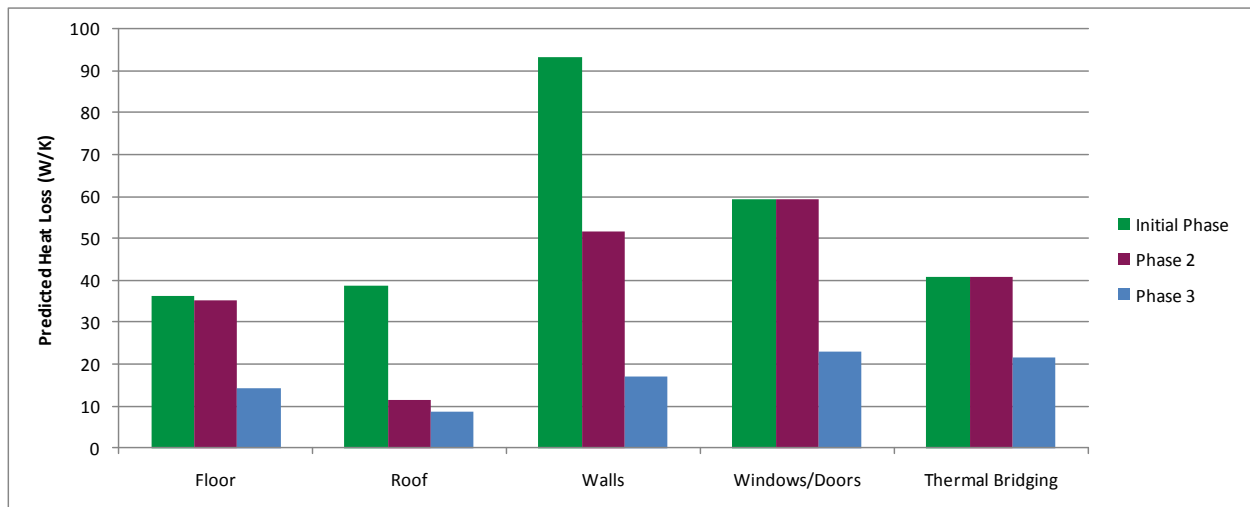
Figure 51 Predicted heat loss, by element, for each coheating phase.

81 The single largest predicted heat loss element for the initial phase coheating test was the external walls (Figure 51) and a number of issues exist relating to the accuracy of their predicted thermal performance. The estimated U-values of the insulated cavity walls in both the initial phase and phase 2 coheating tests were calculated using an assumed 25 mm of partial fill mineral wool cavity insulation in a 70 mm cavity between either a brick or block inner leaf and a brick outer leaf, with U-values >0.6 W/m²K. Once building work commenced it became clear that the partial fill insulation batts were nominally 50 mm thick (Figure 52). This is perhaps where the majority of the over-estimation in predicted heat loss coefficient for the initial phase coheating test occurs, with some over-estimation still present for the phase 2 coheating test (those wall values which remained unchanged in Table 3 between the initial phase and phase 2). The over-estimates for phase 2 will however be offset by the problems encountered with the retro-filling of the original cavity walls with blown fibre insulation as part of the stage 1 renovations, which will have resulted in a level of performance substantially below those predicted. Also, no adjustments to the U-values and heat loss figures in Table 3 have been made to take into consideration any thermal bypassing occurring in the cavity walls. Further evidence of existence of these bypasses and indications of their magnitude is discussed in more detail later (paragraphs 97 to 100).

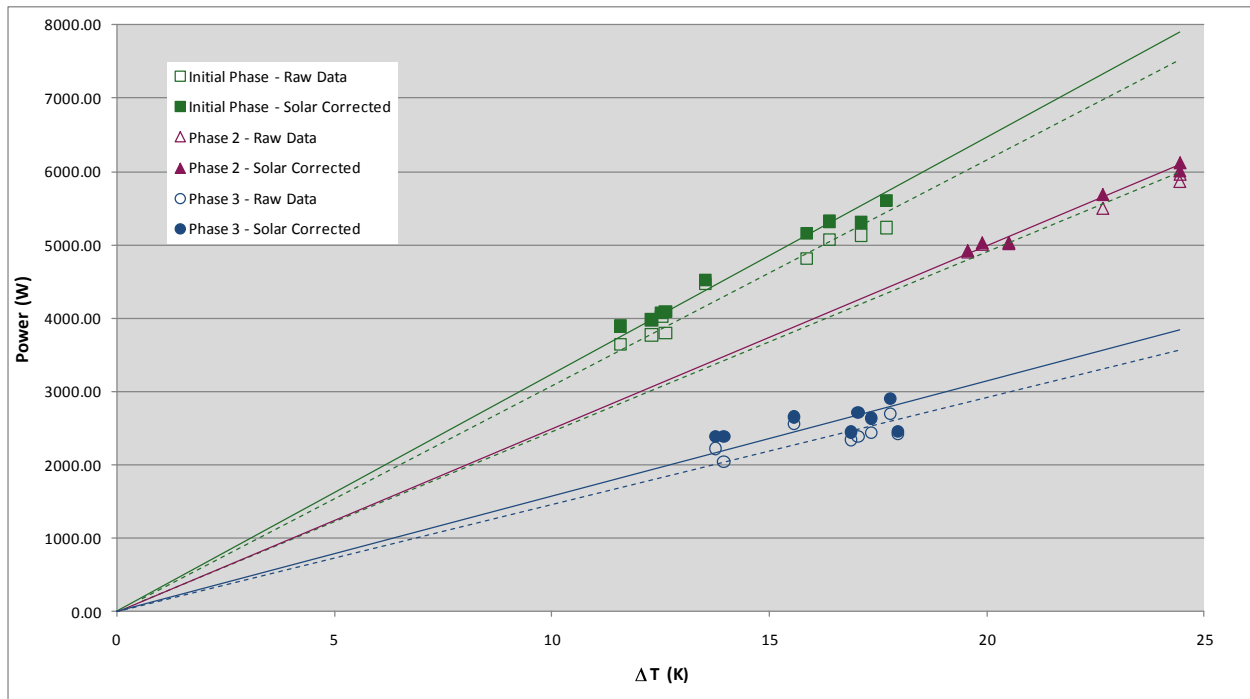
maintain the internal temperatures; the solar gain also needed to be taken into account. The solar-corrected values are also displayed in Figure 53, where it can be seen that the solar insolation experienced for the initial phase and phase 3 coheating tests far exceed those endured in the phase 2 test. This was to be expected given the time of year in which each of the coheating tests was undertaken (Table 2). The values derived for solar gain was added to the measured raw data to help obtain the solar-corrected measured heat loss coefficients, listed in Table 6, of 312.2 W/K for the initial coheating test, 241.8 W/K for the phase 2 test and 147.5 W/K for phase 3. This represents a measured thermal envelope performance 8.5% better than predicted in the initial test, but measured underperformance of 1.3% and 37.6% for the subsequent tests. Measured values for heat-loss parameter and effective mean U-value are also included in Table 6, using the same areas used for the values listed in Table 5.

Figure 53 Raw and solar-corrected data for each phase coheating test.

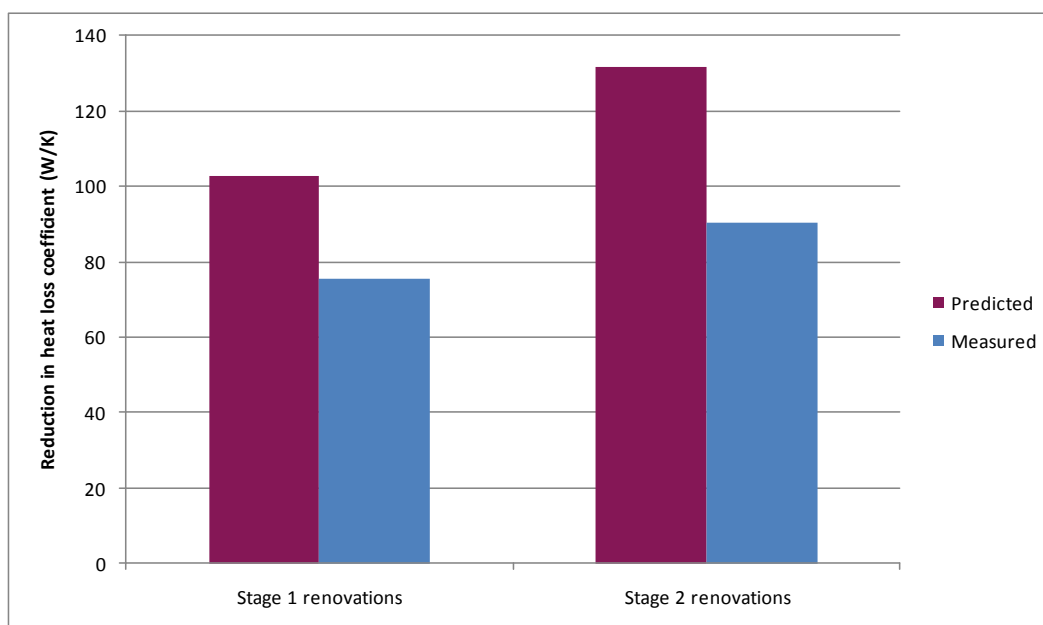
than for the phase 2 test, -37.6% as opposed to -1.3%. Taken at face value this would imply that the measures undertaken in the stage 1 renovation work (the difference between the phase 1 and phase 2 coheating tests) were far more successful than those undertaken in the stage 2 renovation (between phase 2 and phase 3 coheating tests); this was not the case. Figure 54 and Table 7 show the predicted reduction in heat loss as a result of each stage of renovations produced fairly similar rates of underperformance, 31% and 28% respectively. However, when also considering the very dissimilar starting points for each stage of renovations it is difficult to make direct comparisons over the “success” of the measures introduced.

Figure 54 Predicted and measured decreases in heat loss coefficients for each stage of the dwelling renovations.

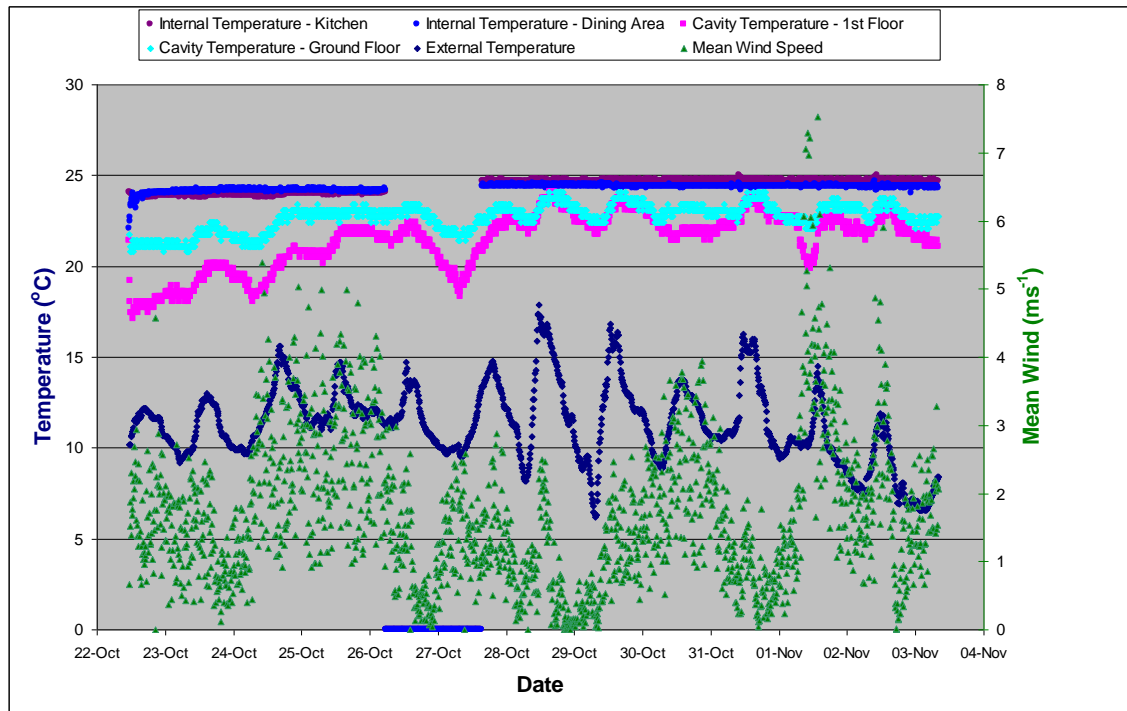
Figure 61 Internal, cavity and external temperatures relating to the rear section of original external wall, now an internal cavity wall.

99 Apart from the brief period on the 26th and 27th October 2009 when an equipment failure prevented the data from being recorded, Figure 61 illustrates how the internal temperatures were relatively constant over the test period, but significant deviation from this was observed in the cavity temperatures recorded. The cavity temperatures appeared to be influenced heavily by the external temperature, and also by the higher wind speeds experienced on both 24th October and 1st November. This clearly shows a bypass in operation and is confirmed by thermal imaging performed in the loft (Figure 62).

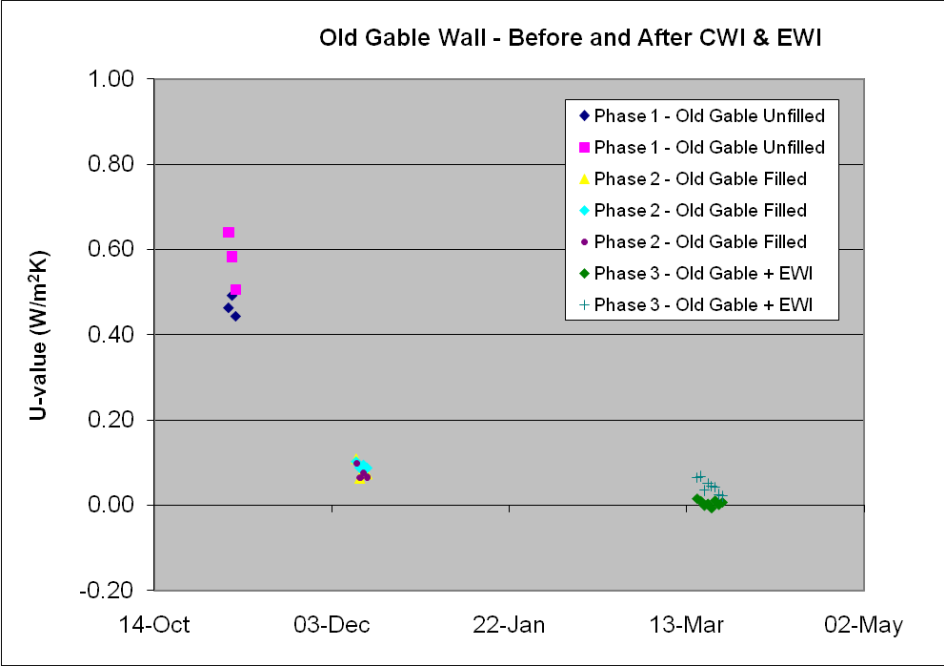
100 Heat flux measurements taken during all 3 coheating phases helped to quantify the effect of the thermal bypassing observed. Figure 63 plots heat flux measurements taken on the hall/stairs wall, which was originally an external gable wall but now backs onto the garage and a 1st floor bedroom. In the dwelling’s original condition the calculated average daily effective U-value was 0.54 W/m²K. With the wall subsequently filled with blown mineral fibre cavity wall insulation (CWI), the external wall cavities also filled and additional loft insulation installed, this value had significantly reduced to 0.08 W/m²K. The application of the external wall insulation (EWI) for the phase 3 coheating test reduced the effective U-value of this wall still further to 0.03 W/m²K. The total elimination of this bypass mechanism was not expected without any suitable edge sealing of the cavity, particularly at

the open top of the cavity in the loft (Figure 62), which could have easily been stopped using proprietary cavity socks prior to the installation of the replacement loft insulation.

Figure 63 Heat flux measurements of the old gable wall recorded during each coheating phase.

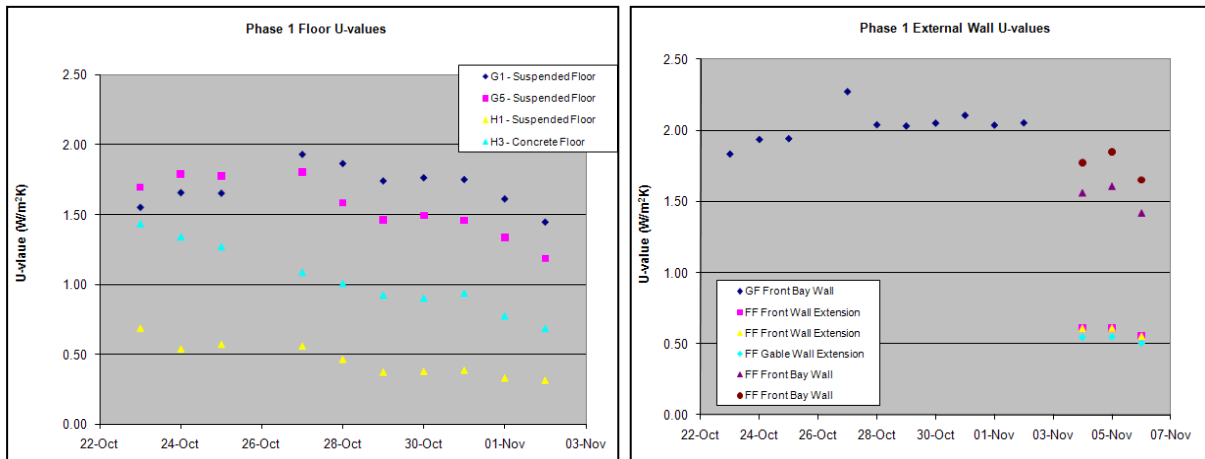
- 102 The floor and wall daily average U-values of the dwelling prior to any renovation show a considerable range in values. Figure 64 illustrates the degree of variation in values depending on the sensor location on both the ground floor and external walls, but none of the measured values corresponded to the assumed values listed in Table 3 of 0.365 W/m²K for the suspended timber floor and 0.881 W/m²K for the solid concrete floor. At the front of the living room measured U-values for the suspended timber floor varied from 1.93 ~ 1.19 W/m²K, compared with 1.44 ~ 0.69 W/m²K in the centre of the property adjacent to the party wall. The much lower U-values of 0.69 ~ 0.31 W/m²K obtained for the solid concrete floor in the dining area may be optimistic, as this area was affected by sunlight through the patio doors in the mid-mornings to early afternoons, but generally showed better performance than the adjacent suspended timber floor. The steady decline in observed values over the course of the test period, particularly at the latter two points, may have been due to increased solar insolation and subsequent thermal mass effects. The variation between assumed and measured U-values for the external walls was much smaller, and although the measured U-values at the ground floor bay wall of 2.27 ~1.83 W/m²K were above the Table 3 value of 1.68 W/m²K, the measured values at the first floor bay of 1.85 ~1.42 W/m²K were in line with the estimate. The measured U-values of 0.61 ~ 0.51 W/m²K for the extension wall indicated a slight improvement over the estimated value of 0.645 W/m²K; however this again may have been affected by early to mid-morning sunlight on the external facades slightly reducing the heat loss through the wall at these points.

Figure 64 Phase 1 floor and external wall calculated U-values from heat flux measurements.

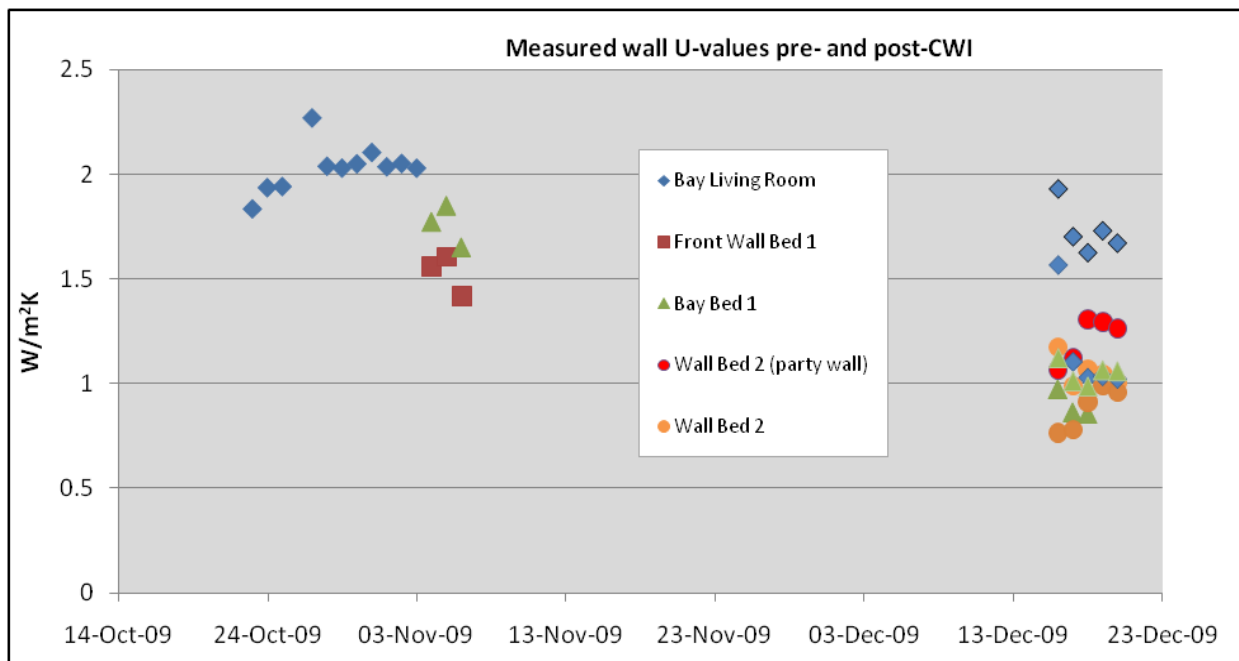
103 Heat flux data was also useful in assessing the benefits of the CWI by comparing the calculated U-values before and after the installation of the CWI. The ground floor bay wall U-value decreased from an average of 2.03 to 1.66 W/m²K (at the same central location) with the addition of the CWI, on the side wall of the bay adjacent to a CWI drill hole this reduced further to an average of 1.01 W/m²K. This appeared to confirm that the filling of the external wall cavities was not uniform.

Figure 65 U-values calculated from heat flux measurements, prior to and following installation of cavity wall insulation.

104 In Figure 65 the ground and first floor bays offer a direct comparison between the thermal performance of these details both before and after the installation of the cavity wall insulation, the front bedroom 1 wall was typical of the original construction and provides a comparator to the rear bedroom 2 wall post-CWI. The reduction in U-value seen at the ground floor bay was far less than that seen for the bay on the 1st floor, in both cases the drill patterns were similar and there were no obvious reasons why the results should differ, even the borescope surveys showed variable fill densities in both bay walls. However, post-CWI improvements in the U-values of the bay walls of the magnitude 0.4 W/m²K to 0.7 W/m²K only brought the wall U-values down to 1.6 W/m²K and 1.0 W/m²K, not even approaching the 0.45 W/m²K assumed in the design and listed in Table 3. The original walls in bedroom 1 and bedroom 2 were originally of brick-brick construction with a nominal 70 mm cavity and a pre-CWI measured U-value of 1.5 W/m²K dropping to between 0.7 and 1.3 W/m²K after the CWI had been installed. The post-CWI data points in Figure 65 shown for the external wall in bedroom 2 are differentiated by their proximity to the party wall (the sensor located

next to the party wall is defined as ‘Wall Bed 2 (party wall)’ and are shown in Figure 9, this was an area that was examined because of the cold area detected during a thermographic survey. In this case the variations in the post-CWI U-values could be explained by extreme variations in the fill densities because the lack of installation of a cavity brush allowed insulation by the party wall to fall down the cavity; but again the design value of 0.45 W/m²K was not achieved.

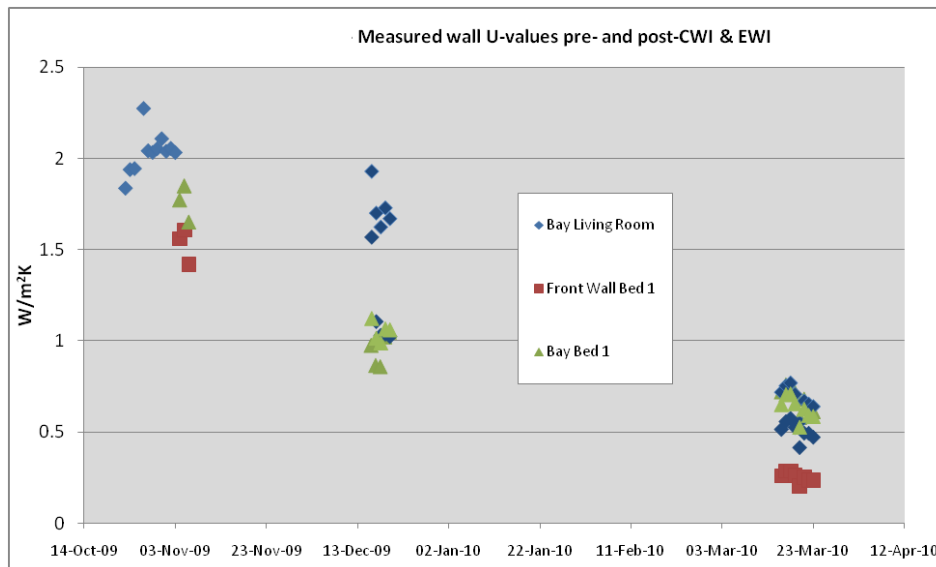
- 105 With the application of the 175 mm thick EWI the U-value of the external wall was designed to fall to 0.15 W/m²K (based on post-CWI U-value of 0.450 – 0.645 W/m²K); however, with the anticipated U-values for the CWI not being achieved, the reductions in thermal transmittance due to the EWI were unlikely to reach such a level. Figure 66 shows the staged improvements in the measured U-values, with the ground floor bay also benefiting from an additional top-up of the CWI performed in January 2010. A marked improvement in the U-values was observed post-EWI in all instances, although the Table 3 predicted U-value of 0.15 W/m²K was not achieved.

Figure 66 U-values calculated from heat flux measurements, prior to and following installation of cavity wall insulation and external wall insulation.

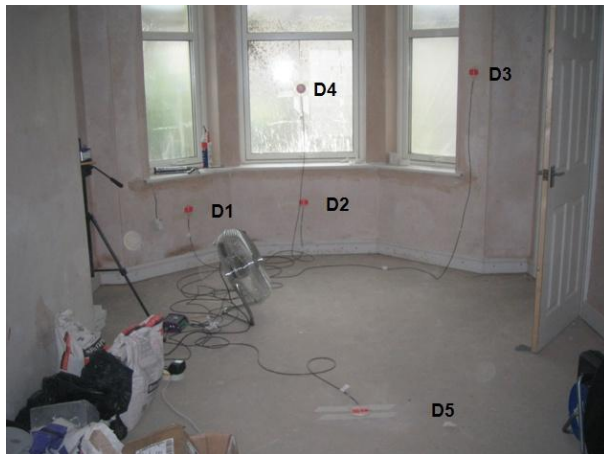
- 106 Some predicted values were achieved, with measurements of the U-values of the new ground floor and triple-glazed windows directly comparable to design values. A single heat flux sensor was placed in the centre of the living room floor to evaluate the floor U-value, resulting in a measured figure of 0.31 W/m²K compared to the designed 0.25 W/m²K (sensor D5 in Figure 67). The centre-pane U-value for the front bay window averaged 0.51 W/m²K (D4 in Figure 67) and is consistent with the manufacturer’s quoted whole window value of 0.83 W/m²K. The wall U-values also shown in Figure 67 were significantly lower than those prior to the stage 2 renovations but did not achieve the design values. Although the close proximity of some of the heat flux sensors to the window openings and junctions will have had some effect on the measured U-values, by incorporating a degree of thermal bridging, it is very unlikely that the differences between designed and achieved values can be explained by this alone and some additional heat-loss mechanism is also in operation. The most likely cause of the additional heat loss is through air movement in the existing cavity, although further investigation would be necessary to confirm this.

Living Room	Location	Average U-value (W/m ² K)
D1	Bay Wall under window - LHS	0.67
D2	Bay Wall under window - Middle	0.51
D3	Bay Mullion - RHS	0.31
D4	Window Glazing - Centre Bay Window	0.51
D5	Ground Floor	0.31

Figure 67 Phase 3 sensor locations and average U-values – Ground floor

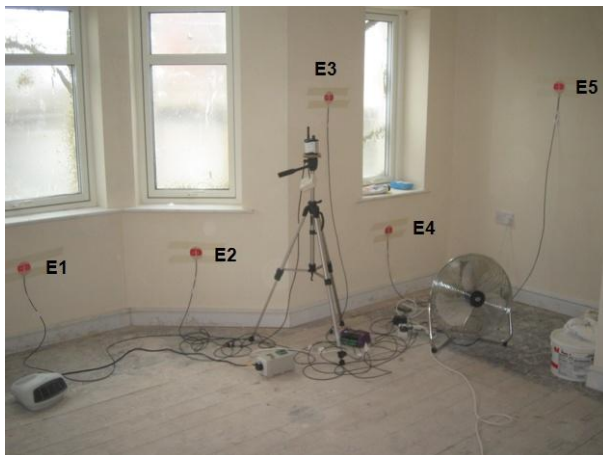
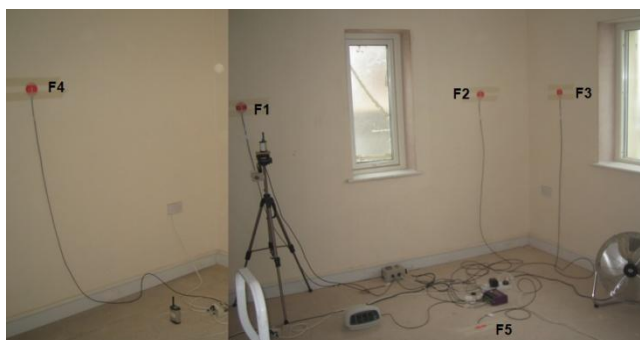
Figure 68 Phase 3 sensor locations and average U-values – 1st floor

107 On the 1st floor, the change in measured U-values following the EWI was considerable, but again did not reduce to the design value of 0.15 W/m²K. Figure 68 shows a range of average measured U-values in the external walls between 0.63 and 0.68 W/m²K for walls under the 1st floor bay window and between 0.23 and 0.34 W/m²K for the external walls elsewhere. The bypass in the original gable wall (now a cavity wall between bedrooms 1 & 3) had been almost eliminated, with measured U-values of 0.01 and 0.04 recorded for the opposing sides. The heat flux sensor placed on the floor of bedroom 3 was positioned between the joists and recorded an average U-value of 0.15 W/m²K, well below the design value of 0.20 W/m²K, although no measurement was made of U-value through the floor directly above the joists to obtain an overall measured floor U-value.

Bedroom 1	Location	Average U-value (W/m ² K)
E1	Bay Wall under window - Middle	0.63
E2	Bay Wall under window - RHS	0.68
E3	Wall between Bay and window	0.25
E4	Wall under window	0.34
E5	Old Gable Wall to Adjacent Bedroom	0.01

Bedroom 3	Logger F	Average U-value (W/m ² K)
F1	Front Wall LHS of window	0.23
F2	Front Wall RHS of window	0.31
F3	Gable Wall LHS of Window	0.26
F4	Old Gable Wall to Adjacent Bedroom	0.04
F5	Floor to Garage	0.15

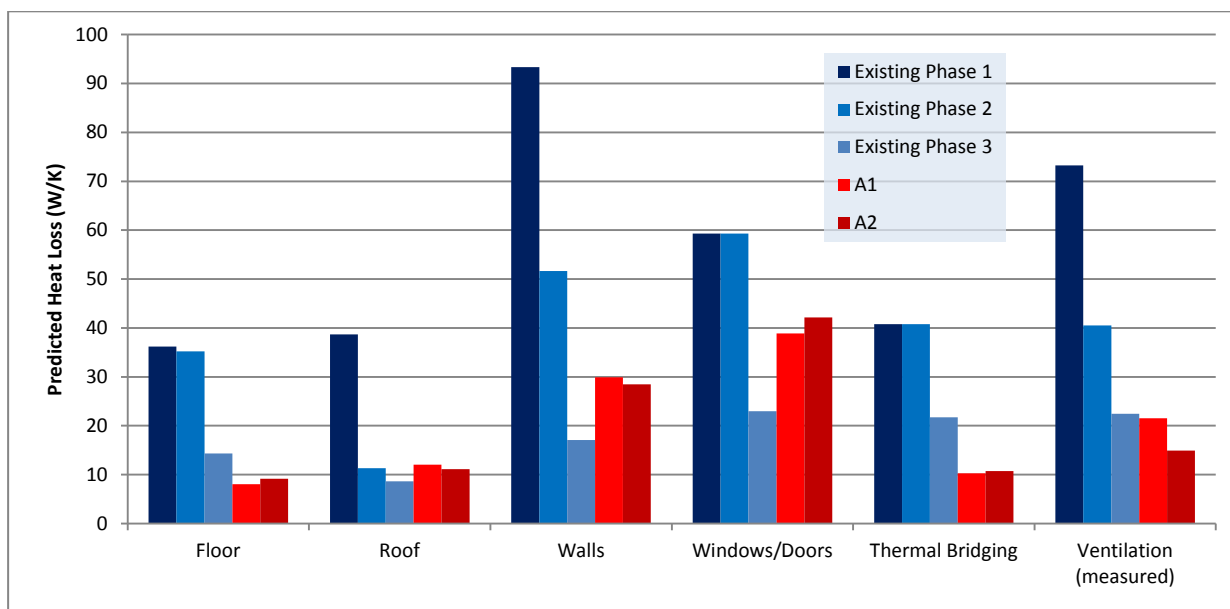
Figure 69 Comparison of predicted elemental heat loss.

A1 Prototype	A2 Prototype	Existing Dwelling
	W/K	W/K	W/K
Design heat-loss coefficient	129.30	120.20	107.18
Measured heat-loss coefficient [†]	149.47	132.86	147.48
	+ 20.17 (15.6%)	+ 12.66 (10.5%)	+ 40.30(37.6%)
	W/m ² K	W/m ² K	W/m ² K
Design heat-loss parameter	0.85	0.78	1.15
Measured heat-loss parameter [†]	0.98	0.86	1.32
	+ 0.13 (15.3%)	+ 0.08 (10.3%)	+ 0.17 (14.8%)
