Condensation Risk – Impact of Improvements to Part L and Robust Details on Part C

Project Reference Number: CI 71/6/1 BD2414

Interim report number 7: Final report on project fieldwork

Malcolm Bell, Melanie Smith & Dominic Miles-Shenton
Buildings and Sustainability Research Group
Leeds Metropolitan University

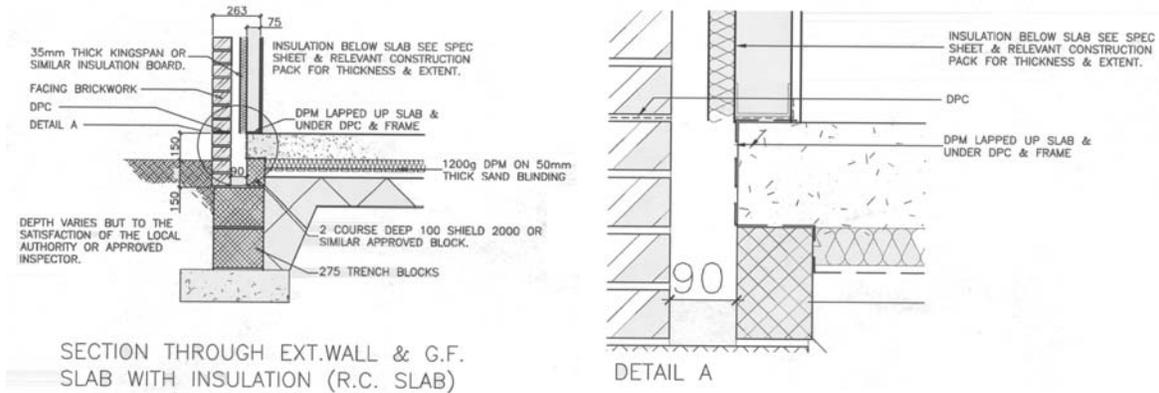
41. An example of this is illustrated on two sites. The drawing information is included in figures 3.01 and 3.02. Here different trades were supplied with a ground floor/foundation/external wall detail. For two trades (Groundworks detail 01 and Bricklayer detail 01) the position of the bottom of the cavity wall insulation was vague, shown positively from dpc/top of slab level, with accompanying text sending the reader to a further design sheet for information as to where to start the cavity wall insulation (figure 3.01). A third trade detail drawing (Joiner detail 01) showed the cavity wall insulation correctly starting at the base of the ground floor slab insulation (figure 3.02). Site observations revealed an inconsistency in construction, with some in accordance with the drawn information on the ground-work and bricklayer detail, resulting in thermal bridging, and some following the more robust joiner version.

Figure 3.01 Extracts from working drawings, showing details for groundworks and bricklayer.

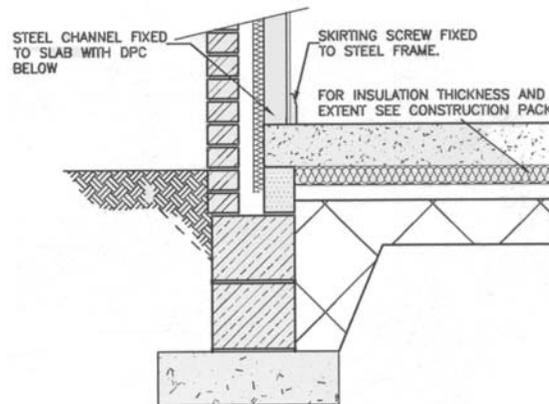
Figure 3.02 Extract from working drawings, showing details for joiner.

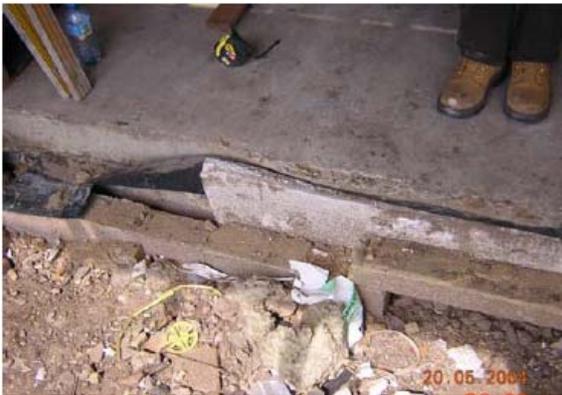
47. In the eight non-standard cases, the placement of edge insulation in the cavity and the use of a suitable lightweight block below the slab are important if thermal bridging is to be minimised. However site observations indicated that in many cases the required edge insulation extending below dpc level was not installed. This is illustrated in figures 3.08 and 3.09 where partial-fill insulation rests on a wall tie at dpc level but no edge insulation exists below this level¹. On some sites, edge insulation was in place, partly to act as a former for casting the slab but then either completely or partially removed, leaving a gap in this edge insulation (see figure 3.10). Similar problems were also evident on sites using pre-cast suspended concrete beam and block floors where edge insulation in the cavity, in addition to insulation at the edges of a floor screed, would be required, as shown in figure 3.11, this was often missing. The omission of edge insulation at level thresholds to patio and entrance doors was another common problem irrespective of construction. Figure 3.12 shows a typical arrangement together with the relevant Robust Detail (RD 8.06). There were examples of well constructed details (see figure 3.13) but these tended to be in the minority.

Figure 3.10 Gap in slab edge insulation in timber frame construction.

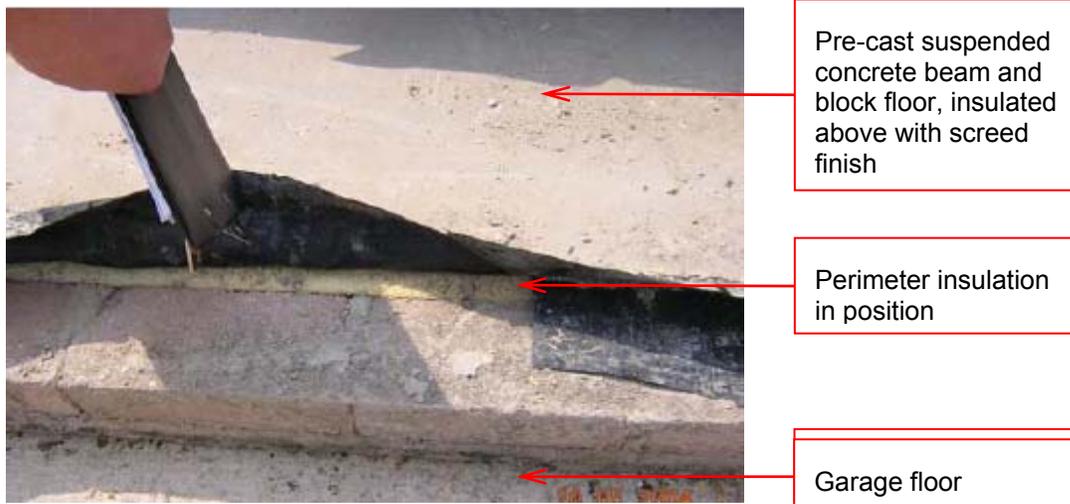
Figure 3.13 Ground floor with perimeter insulation in place.

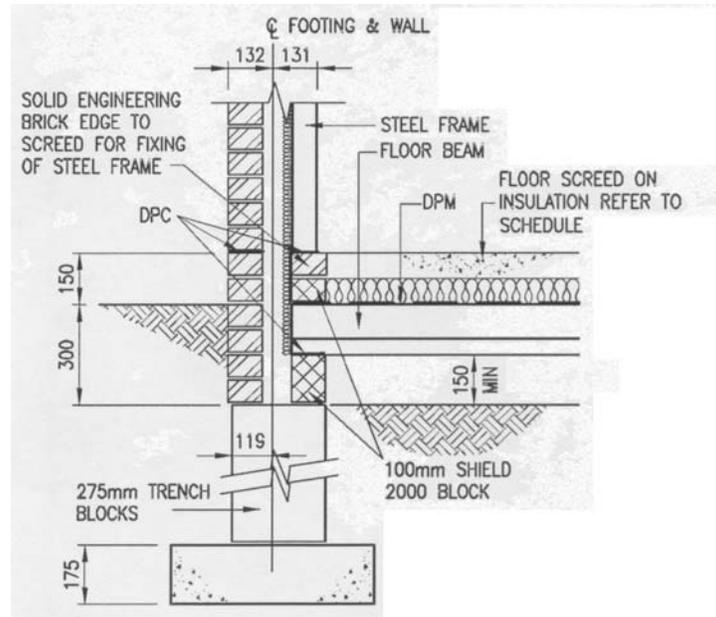
50. All ground floor/wall junction details in the Robust Details document relating to steel frame construction (details 7.07 to 7.11) rely on the continuation of the cavity insulation below floor level and this is the approach used in the designs adopted on the sites studied (see figure 3.17) However, the effectiveness of the insulation is dependant, to some extent on its closeness of fit and the avoidance of discontinuities. In order to achieve a good fit it is important that the frame lines up with the outside edge of the slab or kerb (as indicated in figure 3.17). On one of the steel frame sites visited this was not achieved. Figure 3.18 shows a mismatch between the plan shape of the base and that of the frame. This meant that, on at least one elevation, the base of the frame was not in alignment with the edge of the base resulting in a set back from the edge of around 50mm at one end of a wall section narrowing to almost zero at the other².

Figure 3.17 Ground floor detail in steel frame construction.

51. Whatever the cause of the misalignment (setting out of the base or manufacturing errors in the steel frame) its effect was to make it very difficult to maintain continuity in the external insulation. The practical response to this problem was two-fold; either the wall insulation was stopped at dpc level and a separate piece of insulation placed in the

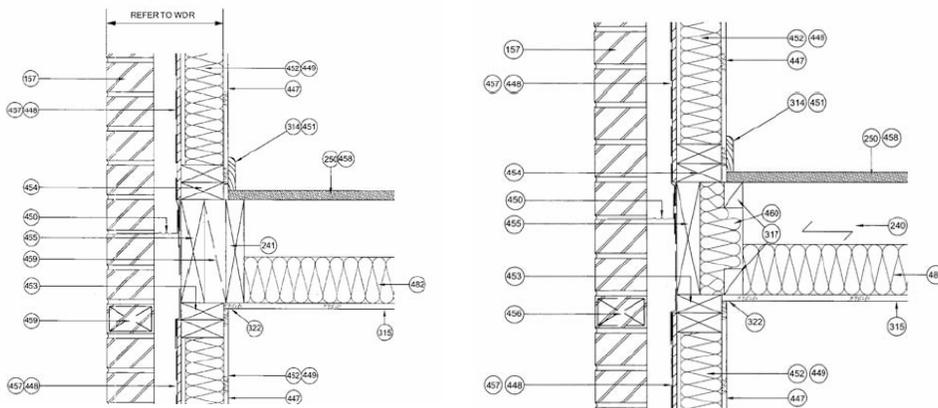
54. The design of intermediate floor – wall junctions in timber frame construction is covered by Robust Detail 6.18, which is illustrated in Figure 3.22. In order to minimise thermal bridging insulation is shown within the perimeter structure. Where large scale design details were available they tended to show the appropriate placement of insulation, as illustrated in figure 3.23. However, in the case of one set of drawings for timber frame flats where floor voids contained some acoustic insulation, the need for full depth perimeter insulation was not always clear (see figure 3.24).

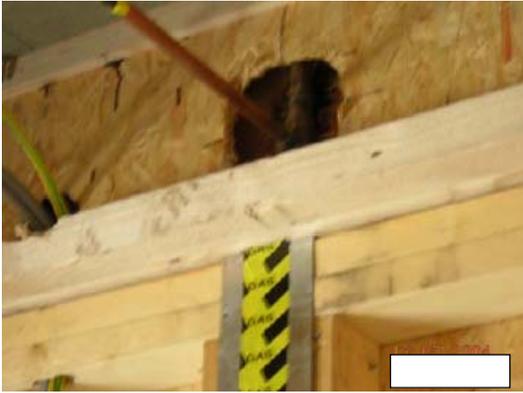
55. Despite the perimeter insulation shown in design drawings, site observations revealed little evidence that it was actually placed. Figure 3.25 shows external walls with wall insulation and vapour control layers in place but no perimeter insulation at intermediate floor level. Although it is possible that insulation would be placed at a later date, this was considered unlikely as it would have required a second visit by the insulation gang. In any case the proliferation of services runs (figure 3.25) would make placement difficult as would the narrow space between the multiple joist and the wall. On some sites there seems to have been an assumption that the timber I-beam floor cassettes would have perimeter insulation fitted at the factory. In one case the site team had an opportunity to check this assumption through a hole in the perimeter space, which was cut for a gas pipe. As shown in figure 3.26 no insulation was evident. Evidence from another timber frame site where access to the floor edge¹ was available provided another example of an uninsulated void (see figure 3.27). The lack of perimeter insulation would seem to be a general problem since in none of the timber frame sites visited was the placement of perimeter insulation observed.

Figure 3.26 Holes made in double I-beams reveal lack of perimeter insulation.

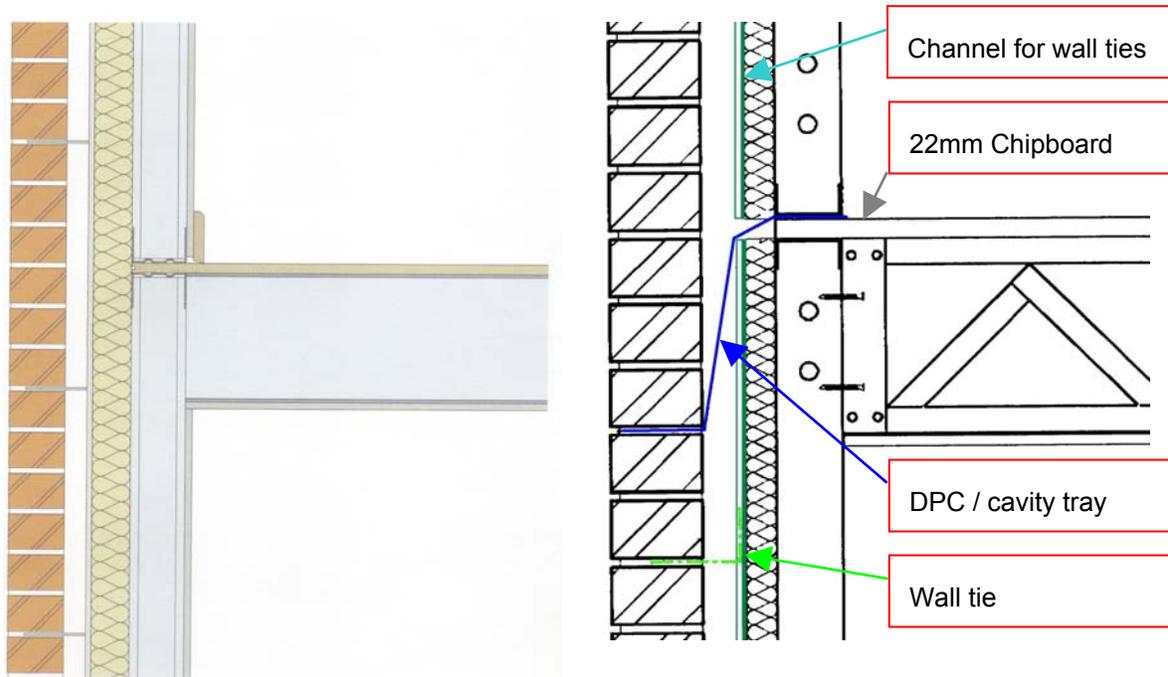
56. As already indicated, warm frame steel frame design relies heavily on the integrity of the external insulation to avoid moisture and thermal degradation problems. In warm steel frame, the primary air barrier is provided by the insulation layer. Thus, gaps in the continuity of this layer will result in coincident air leaks and thermal bridges. Moreover, as our observations establish, there is a tendency for defects in the insulation layer to occur close to framing members – where local thermal conductivities are highest. The coincidence of gaps in insulation, leakage paths and framing members maximises the impact of such defects. In general, on both sites included in the research, the close butting and taping of insulation boards was done with reasonable care. However, as indicated in the ground floor section above, this was not always possible. Figure 3.28 shows the relevant Robust Detail (RD 7.13) for the intermediate floor junction compared with the detail as designed and constructed. The designer thought it necessary to introduce a cavity tray¹, the fitting of which meant that a gap of some 22 mm (the thickness of the floor boarding, which is sandwiched between the upper and lower frame sections) in the insulation layer. Given a perfect fit and a good seal between the frame and the floor covering this may not be particularly significant but site observations indicated that the gap in the insulation could be almost 40 mm and the joint between tray and insulation remained unsealed, providing a potential air leakage path. Air pressure tests carried out on the same site for a related project (see figure 3.29 reproduced from Johnston et al 2004) identified considerable leakage at this junction.

Figure 3.28 Robust Detail 7.13 and typical design detail of an intermediate floor for lightweight steel frame construction.

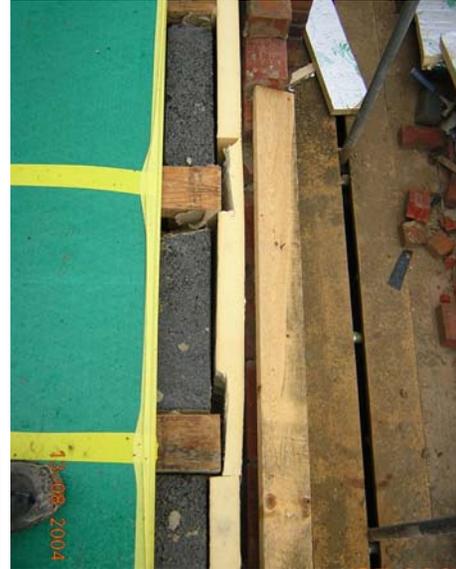
an illustration of the difficulties of insulating across the joist ends. In figure 3.31 the joist ends protrude into the partially filled cavity but instead of trimming the joists to a tight fit the insulation has been cut back, not only reducing the insulation thickness but also leaving room for air flow which bypasses the insulation. This is, perhaps, something of a curio in this project and the problem is not particularly severe but it is conceivable that in extreme cases, even greater thicknesses of insulation could be removed.

Figure 3.31 Partial-fill insulation in masonry construction, cut around joist ends.

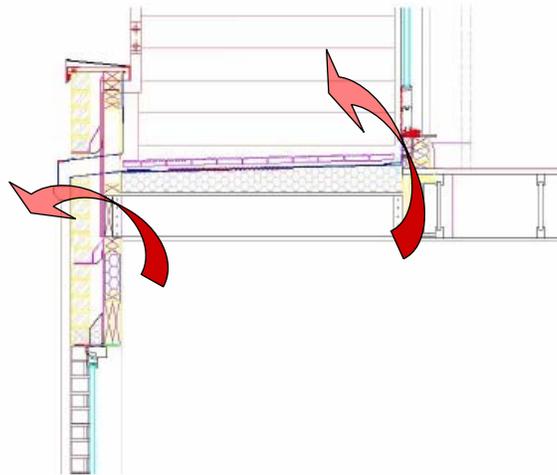
60. Figure 3.32 shows one example of design where the lack of perimeter insulation below the parapet wall results in a thermal bridge through the timber frame. In addition, the area around the steel beam below the balcony door shows a lack of consideration of insulation requirements; RSJs are further also discussed later.

Figure 3.32 Example of balcony drawing detail, with potential thermal bridges indicated (arrows).

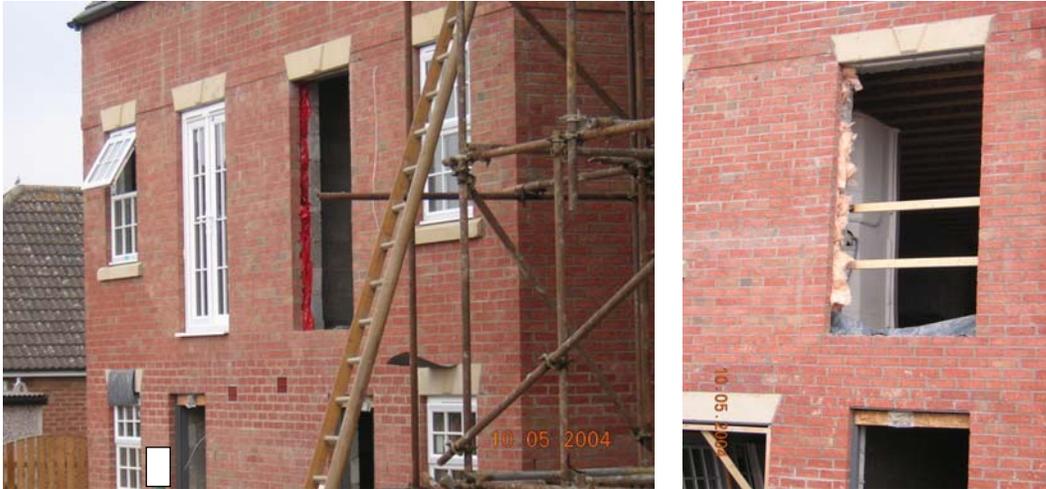
65. Not all sites adopted the propriety closure, some sites using glass or mineral fibre bats wedged into the jamb cavity to be held in place by the window frame as illustrated in figures 3.37 and 3.38 – although from time to time the result was not very pretty. On one site an apparently idiosyncratic mixture of propriety cavity closer and return block was used in the same construction. This is shown in figure 3.39. In this case a well insulated closer was used for the window reveals (a point we discuss below) but in the case of the connected door opening a return block with a rather thin (about 10mm) and ill fitting insulated vertical dpc was used. The impact of the return block is to bypass the partial-fill insulation, resulting in a thermal bridge, the insulated dpc not withstanding.

Figures 3.37 and 3.38 Alternatives to proprietary cavity closers.

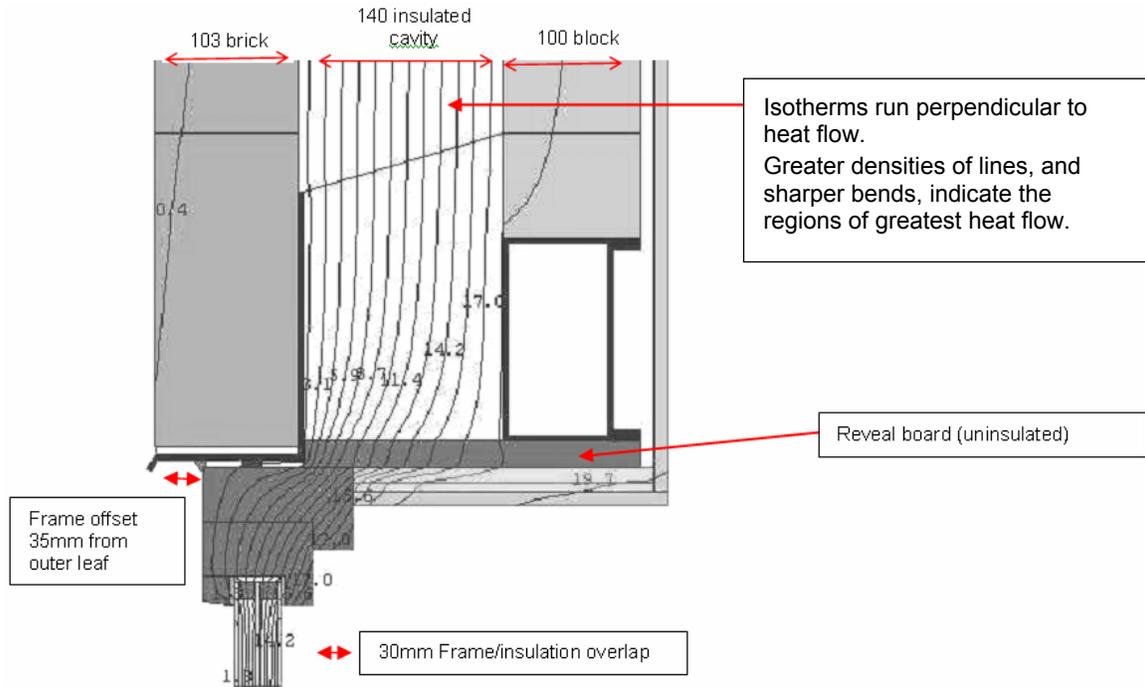
69. The location of the frame with respect to an insulation layer is an important determinant of the extent of thermal bridging, even in otherwise well designed, bridge-minimised, reveals. This point is well illustrated by an analysis of frame location (Roberts, 2004) in the context of a low energy housing scheme (Lowe and Bell, 2002). Figure 3.45 shows the thermal analysis of a head detail produced for one of the house types in the scheme. In its original form the detail adopted the practice advocated by Robust Details (e.g. RD 3.12 figure 3.46) of ensuring a minimum of a 30mm overlap between frame and closer layer. The construction was; 105mm brick – 150mm fully filled (mineral fibre) cavity – 100mm medium density block; separate lintels are used and insulation taken to the back of a liner board so that bridging at the reveal is minimised and the frame set to give a 35mm offset from the front face of the external brick work¹. Given a frame depth of 100mm this resulted in the minimum 30mm overlap required by Robust Details.

Figure 3.45 Head detail with a frame offset of 35mm from the outside surface of the outer leaf – detail drawing 031. (source Roberts, 2004)

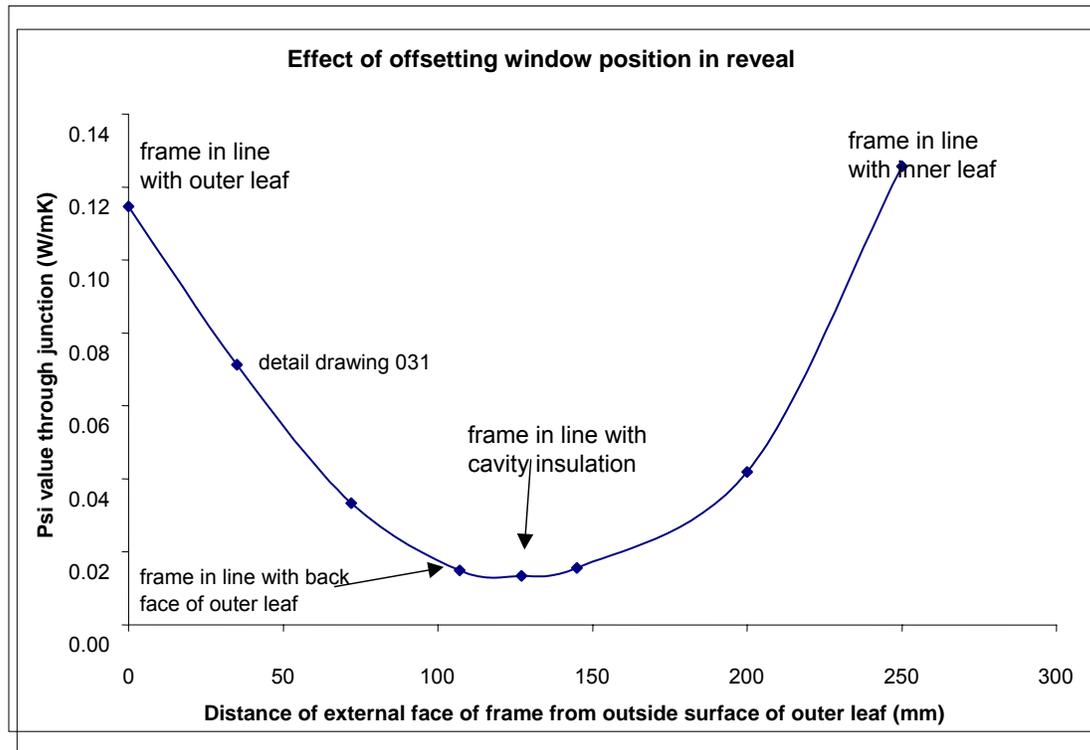
70. Figure 3.47 demonstrates the impact on the linear thermal transmittance (Ψ value¹) of different locations of the frame in this detail. The distinct U shape illustrates clearly the impact of shifting the window into line with the insulation. Increasing the overlap to the full thickness of the frame (100mm) results in a significant fall in the Ψ value of the detail. If applied to all openings in the particular house type analysed, the effect of shifting the

window frame was an improvement in overall wall U value (including thermal bridging) of about 13% (from 0.3 W/m²K to 0.26 W/m²K).

Figure 3.47 Effect of offsetting window position in reveal on Ψ (psi) value of head junction. (source Roberts, 2004)

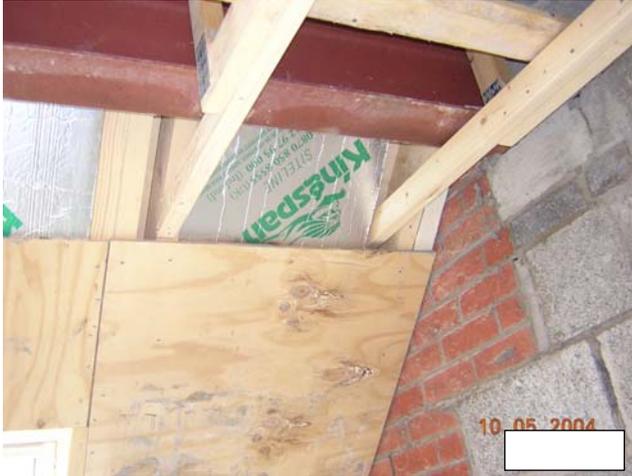
75. The fitting of insulation, particularly when rigid boards were used, was the most common general problem observed, together with the lack of air/vapour control layers in sloping roof sections. Many of the problems were accentuated around roof lights and dormers and the particular difficulties in these areas will be dealt with in those sub sections. The constructions that are most unforgiving if insulation is not tightly fitted tend to be those that adopt a ventilated rafter void with all the insulation fixed between the rafters. Figure 3.51 shows a typical arrangement with 70mm (sometimes as 2 layers of 35mm) polyurethane foam board fixed between rafters, plywood racking board and 12mm plasterboard finish¹. Problems arise with this form of construction where there is no air barrier, or where the air barrier is discontinuous, particularly since gaps around the insulation boards are common, many of which can be large (see figure 3.52).

Figure 3.51 Ventilated rafter void all insulation between rafters.

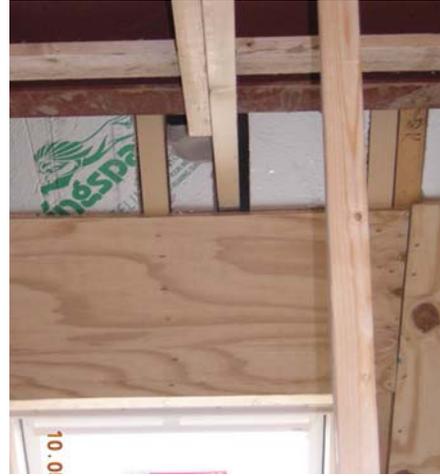
Figure 3.52 Gaps around insulation boards between rafters.

76. From the point of view of condensation the ventilated rafter void reduces the risk considerably, but if insulation gaps are large, particularly if coupled with additional thermal bridging surface condensation risk may be increased. Figure 3.53 illustrates one such area where the gap left between the edge rafter and gable wall not only produced a thermal bridge because of the cavity but also combines with the structural thermal bridge through the brickwork which forms the outer skin of the main house external wall. In addition, the lack of an air barrier exacerbates the problem because it not only reduces the general airtightness of the envelope but also allows air flow around the insulation boards, resulting in reduced thermal performance.

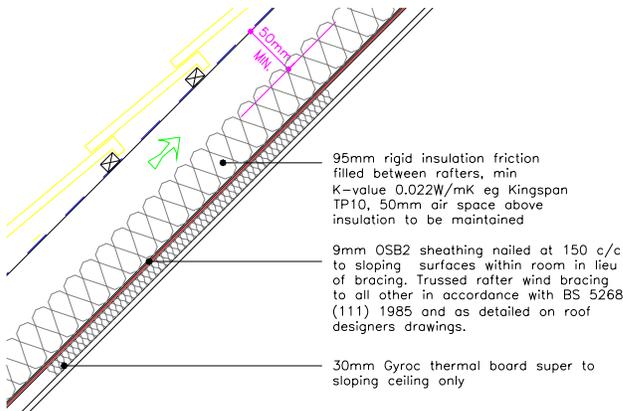
77. An alternative ventilated rafter construction is illustrated in figures 3.54 and 3.55. In this case the construction is a little more forgiving in that the insulated lining will reduce bridging through the timbers and any associated gaps (although on this site the fitting of insulation boards was of very high quality). The lack of an air barrier may remain a problem but with racking ply in place (if used instead of alternative bracing) and taped joints a reasonable air and vapour barrier could be achieved. No taping of joints of roof insulation was observed on any site.

Figure 3.54 Ventilated rafter void with insulation between and under rafters.

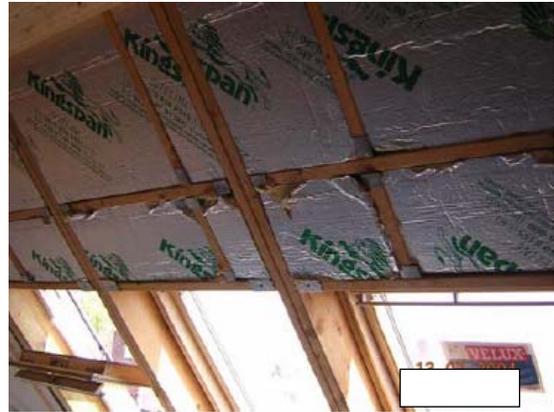
Figure 3.55 Insulation prior to fitting of insulated lining.

79. Maintaining the continuity of insulation at eaves was achieved in a reasonable number of cases where observation was possible. Figure 3.58 is typical of the arrangement in cavity masonry sites and figure 3.55 shows the care taken to fill small gaps at the eaves junction on one of the timber frame sites. However, concerns remain about the level of detailing in relation to airtightness since eaves junctions had little provision for air sealing. The arrangement shown in figure 3.58 is likely to be particularly leaky since the roof wall junction is likely to remain unfinished as the eaves area forms a void useable for loft type storage only. This is not the case in the timber frame example shown in figure 3.55 and as far as can be established this detail follows the recommended robust eaves detail for this type of roof (RD 6.03). However airtightness remains a problem.

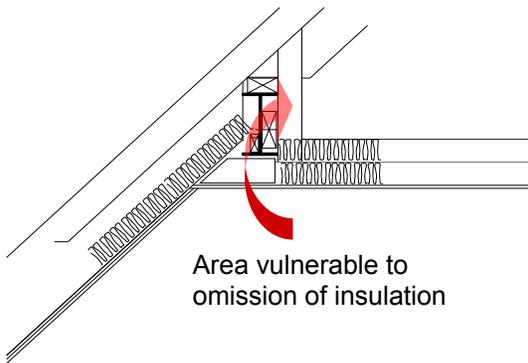
78. In the room-in-the-roof structures encountered, steel purlins were a common feature used as part of a composite type construction with rafters at the lower level and trusses above to complete the roof pitch. Given the high conductivity of steel, insulation detailing around the purlins is critical. This arrangement can be seen in figure 3.51. Figure 3.56 illustrates the key features of the apparent design of the purlin and surrounding construction. In the design illustrated the ceiling level provided the space for the area under the purlin to be reasonably well insulated but if the insulation was installed from above, as would be the case with the main loft, it would be very difficult to place. It could be placed from below, as the plasterboard ceiling is installed, but the general observations during site visits would suggest that such small areas of insulation are often overlooked. Unfortunately no direct observations were made of either ceiling erection or of loft insulating so it is not possible to be certain of the final state in the dwellings surveyed but the detail remains vulnerable. In another case however, it is clear that if constructed as designed (see figure 3.57) a very real condensation risk would exist¹.

Figure 3.56 Steel purlin design - vulnerable to poor insulation placement and potential condensation risk².

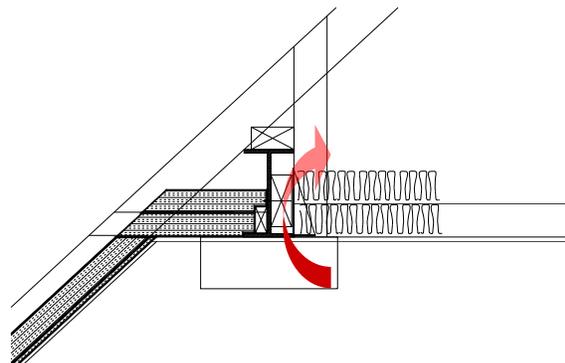
Figure 3.57 Steel purlin design – significant thermal bridge and high condensation risk³.

¹ In passing, this particular thermal bridge appears to be the largest, in terms of contribution to fabric heat loss, to be featured in this report. A rough calculation suggests that the additional heat loss is of a similar order to the heat loss through the fenestration, and effectively doubles the heat loss through the roof.

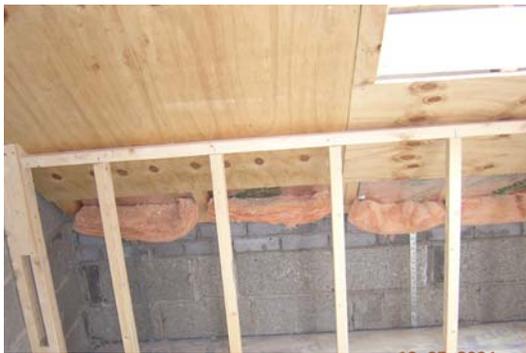
Figure 3.58 Cavity wall – roof junction.

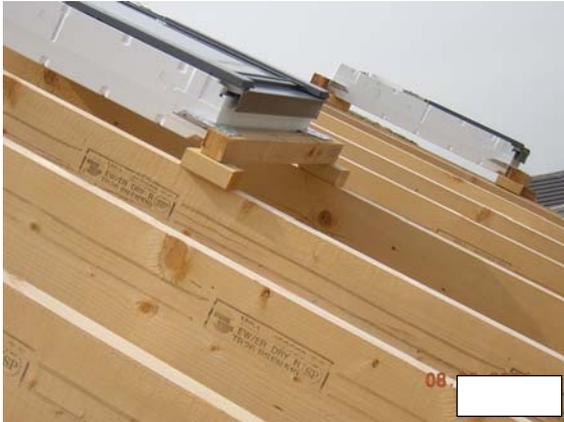
Figure 3.60 Rooflight fixed above external insulation to rafters.

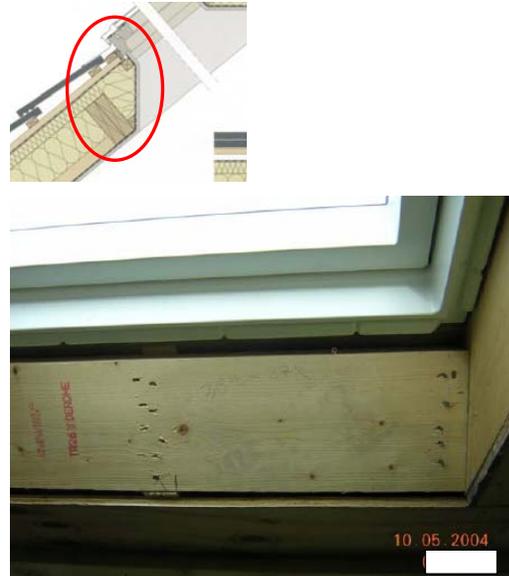
Figure 3.63 Lower lining section, uninsulated

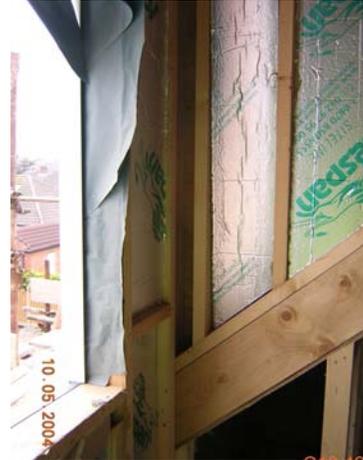
84. As in other cases the main problems related to the fitting of the insulation board. Figures 3.65 and 3.66 illustrate typical fitting problems with gaps around boards and missing insulation in small sections, sections that can be very small indeed requiring considerable attention to detail (see figure 3.64). The missing insulation in the corner section (figure 3.66) is of particular concern since this is one of the most exposed areas of the external envelope.

Figure 3.66 Omission of insulation at small strip in the corner.

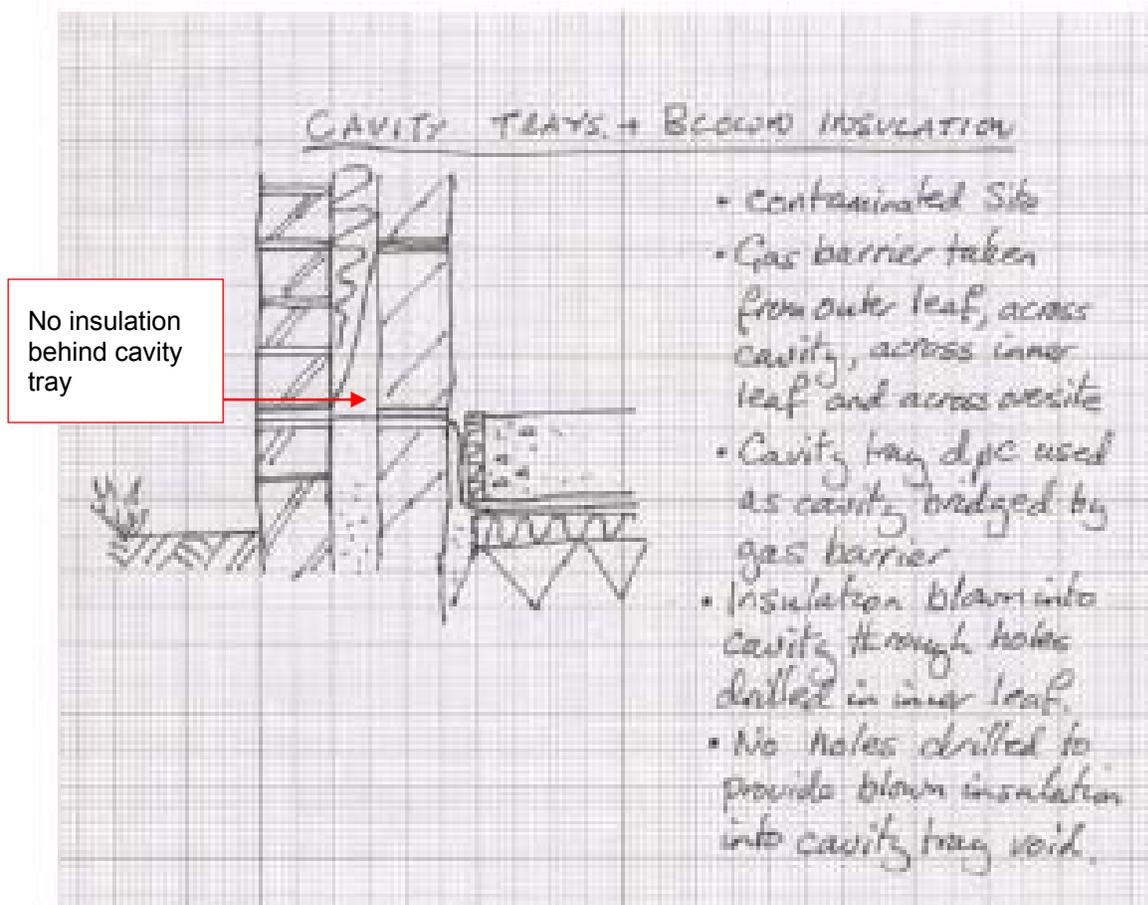
Figure 3.67 Gas barrier and cavity tray at ground floor/external wall junction.

87. The site sketch in Figure 3.67 illustrates the arrangement on one of the full-fill masonry sites. Given that cavity insulation was to be injected from the inside upon completion of the wall, filling this area would be very difficult and, in practice almost certainly omitted. In this case it would be more appropriate to ensure that insulation was placed at the same time as the cavity tray was fitted. Figure 3.68 shows clearly that this was not done, as well as illustrating the age-old problem of keeping the cavity clean. Similar difficulties arise with the placement of partial-fill insulation (see figure 3.69) since if not well fitted below the tray its performance is reduced considerably, almost to the point where it may as well not be placed at all. The effect in both the cases illustrated would be to increase the potential for localised temperature variation, the more so since, as we have discussed above, cavity insulation is often omitted at ground floor slab level. Of course, once the gas barrier is in place the lack of insulation below is hidden from view.

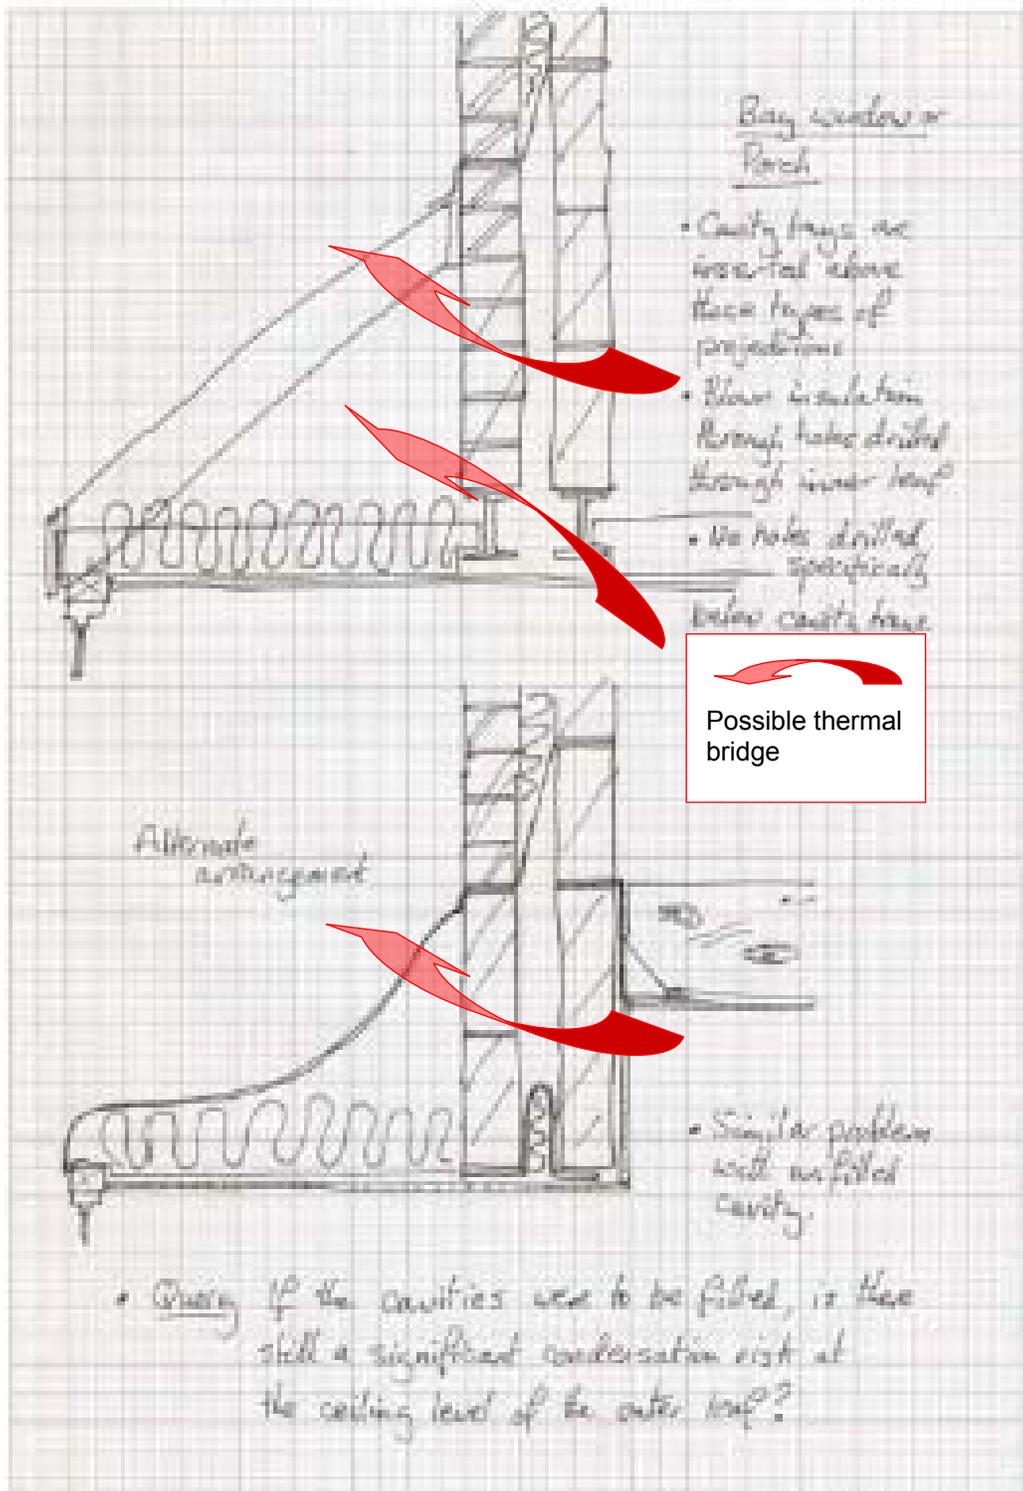
88. The site sketch in figure 3.70 shows a typical arrangement of lintel and cavity tray at bay windows and other projections. In the case of injected full-fill cavity insulation, filling the space below the can be difficult, particularly if there are restrictions such as floor joists. As in the case of cavity trays at gas barriers, placing insulation below the tray as the wall is built would be the only way of reliably avoiding this problem but there was little evidence on full-fill masonry sites that this approach was adopted. Similarly, observations of fill holes indicated that, in a number of cases injection had not taken place below trays. The problem can also manifest itself in partial-fill cavity masonry if access to the space below the tray is restricted; however in this type of construction the problem is more likely to be one of quality of fit rather than omission.

Figure 3.70 Cavity tray arrangements at projections.

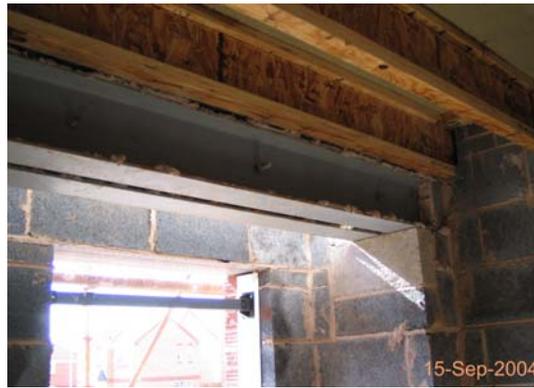
89. Where loads are high, the steel work required is often substantial and insulated lintels are not suitable (top sketch in Figure 3.70). Although there are concerns that insulated combination lintels are either unsuitable or ineffective¹, of greater concern is the detailing around larger steel sections. Some of these concerns were raised in the context of room-in-the-roof constructions. The Robust Details document gives no guidance on detailing around structural steel and the analysis of design and construction would suggest that the design issues are not well understood. Unless additional insulation were provided at ceiling level across the flanges of the steel beams, the arrangement of the steel work in the top sketch in figure 3.70 and the would give rise to increased condensation risk even if cavity insulation was in place. Similarly, detailing around the steel work in the photograph in figure 3.71 presents a considerable detail design challenge².

Figure 3.71 Steel work at large openings.

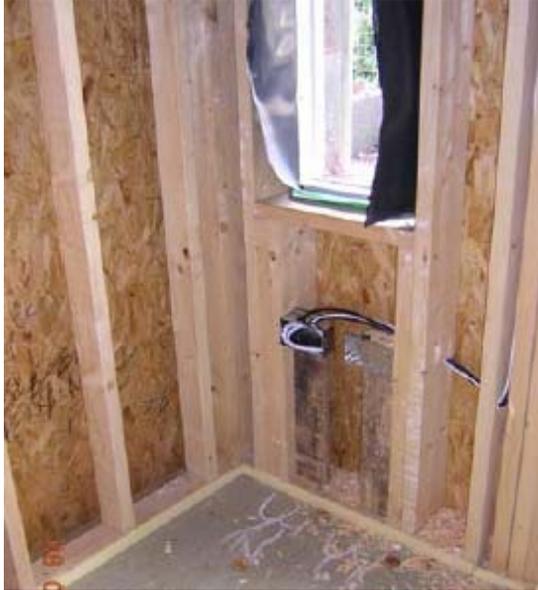
Figure 3.79 Small gap between studs (also, note high timber concentration at corner).

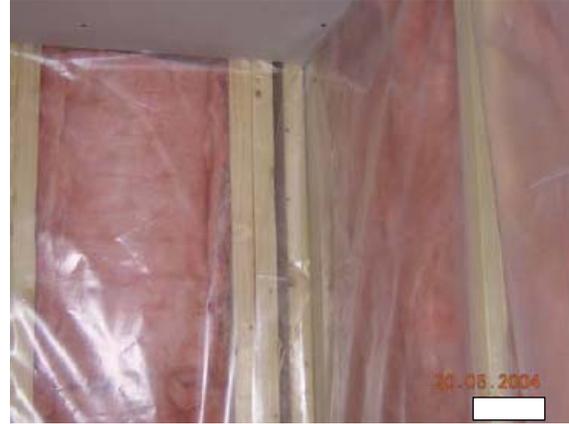
Figure 3.80 Unfilled gap between studs.

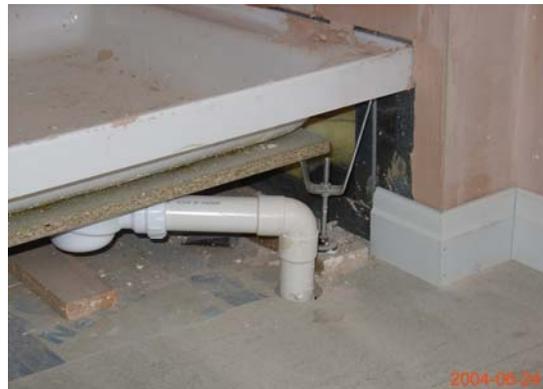
97. The sealing of the junction between wall and floor behind shower trays, baths and kitchen units is rarely done with the same degree of care as in other locations. This can be seen in Figures 3.82 and 3.83 where the internal plasterboard finish is stopped short of the floor (figure 3.82) or cut away to accommodate the fitting (figure 3.83). An air/vapour path is created which can be directly connected to the structural space. In timber frame constructions a polythene membrane is used which is lapped and stapled to the frame but where there is no plasterboard to hold the polythene air barrier tight back to the timber frame, an adequate seal is not achieved at floor level. The fact that these problems occur mainly out of sight behind the fittings in kitchens and bathrooms is of particular concern since these are areas of intermittently high vapour pressure. In warm steel frame construction, it could be argued that air movement, moist or otherwise, in the frame space is of little consequence since the condensation risk is small and a high level of airtightness is maintained as long as the external insulation layer is well fitted and all joints securely taped. This is, of course, a very reasonable position but it places considerable reliance on the integrity of the external layer. Although, on the two steel frame sites, considerable attention was given to insulation and sealing, as indicated in the ground and intermediate floor sections above, this can be compromised at junctions.

Figure 3.83 Plasterboard finish cut away to enable the shower tray to be inset, giving access to the structural space.

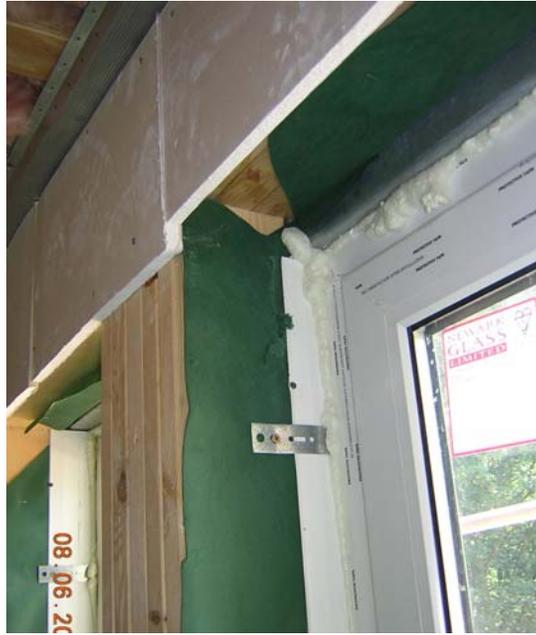
100. Despite the fact that care was taken to ensure that air/vapour control layers in timber frame construction were well sealed there was some apparent uncertainty about parts of the structure that consists of isolated collections of studs or substantial timber lintels. Figure 3.89 presents a typical example, showing 5 studs forming the section between openings and the plaster-boarded window head with no evidence of any air/vapour control. It seems that since there is no adjacent insulation, air and vapour control is thought not to be required.

Figure 3.89 Air/vapour control layer not applied to studs – no evidence of layer across lintels and wrapping into head of opening.

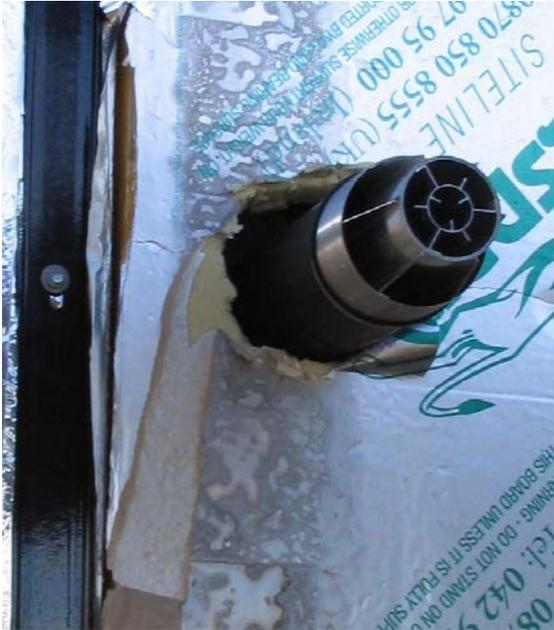
Figure 3.94 Penetration through the insulation/vapour layers in light steel frame construction.
