Interim Report to ODPM Building Regulations Division under the Building Operational Performance Framework

IMPROVING THE FLOOD RESILIENCE OF BUILDINGS THROUGH IMPROVED MATERIALS, METHODS AND DETAILS

Report Number WP2c – Review of Existing Information and Experience (Final Report)

June 2005

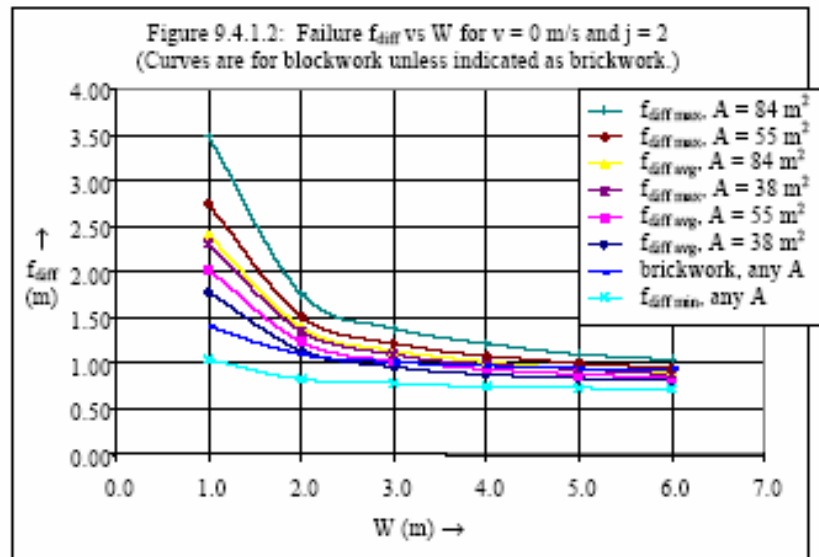
Figure 3 - Predicted Failure Curves for 2-storey Brick/Block Masonry Wall (Kelman 2002)
(F_{diff} = flood height difference outside to inside, W = wall width, A = floor area)

Kelman and Spence (2003b) calculated the required failure loads due to hydrostatic pressure for a range of building elements. For example, the hydrostatic pressure needed for failure of 4mm thick glass double glazed units varied from 15 kPa for a 2 m high and 1 m wide unit to 184 kPa for a 0.25 m by 0.25 m unit. For typical UK masonry walls, they calculated that walls would begin to fail under combined hydrostatic and hydrodynamic loads of between 5 to 10 kPa at the base. A 10 kPa base pressure would equate to a 0.7 m flood at 3.5 m/s velocity. Even very strong masonry walls would fail at around 20 kPa. An example of the predicted failure curves for 2-storey brick/block walls due to hydrostatic forces is illustrated in Figure 3 (Kelman 2002).

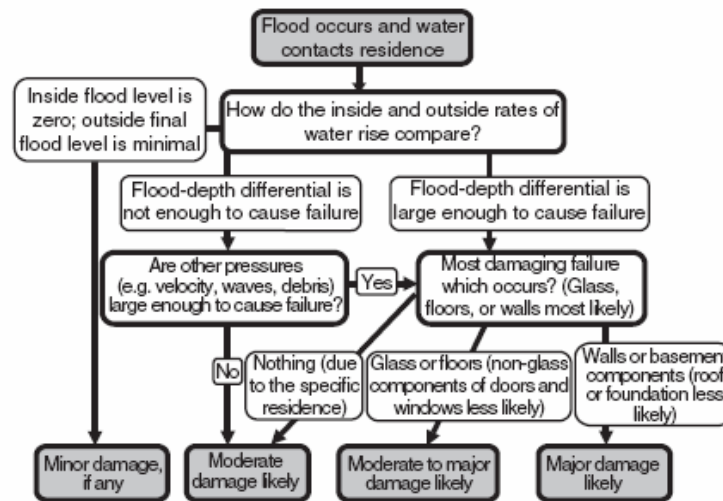
Figure 4 - Flood Failure Flow Chart (Kelman & Spence 2003b)

It is noted by Kelman and Spence (2003b), that the advice given by the DTLR (2002) on the flood resistance of solid floors is somewhat contradictory in that it recommends that solid concrete floors can be an effective seal against flood water seeping in from under the floor but which at the same time states that they should be designed with a gap around the edges to relieve hydrostatic pressures. A flow chart of potential failure mechanisms and likely degree of flood damage was developed as shown in Figure 4.

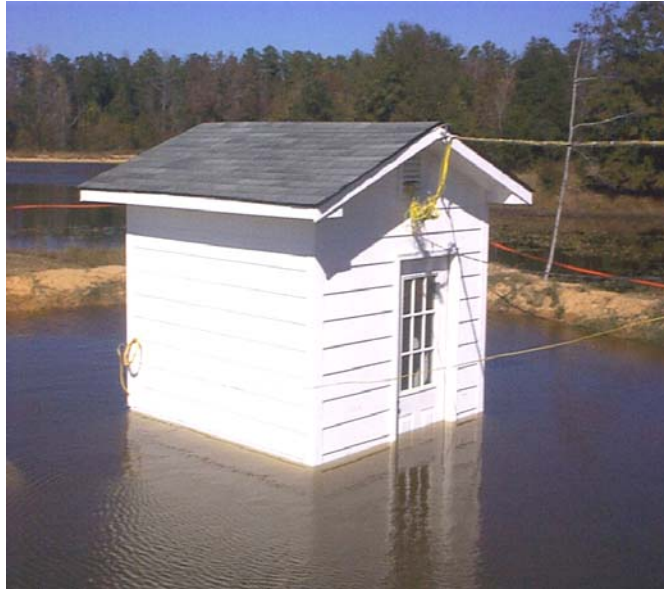
Figure 5 - Typical Module under Test from ORNL/Tuskegee Research Project (ORNL 2005)

Oak Ridge National Laboratories (ORNL) and Tuskegee University in the United States have evaluated a range of building materials and construction systems by testing a series of small prototype structures under simulated flood conditions (ORNL 2005, Wendt & Aglan 2001). The test modules all had a footprint of 8ft x 8ft (2.4m x 2.4m), and were all variations of typical US timber frame constructions on either a concrete slab-on-grade floor or a raised floor. An example of one of the test modules is shown in Figure 5. One of the biggest advantages of this holistic test methodology is that it assesses the flood resilience of typical building element junctions as well as the resilience of the building elements and construction

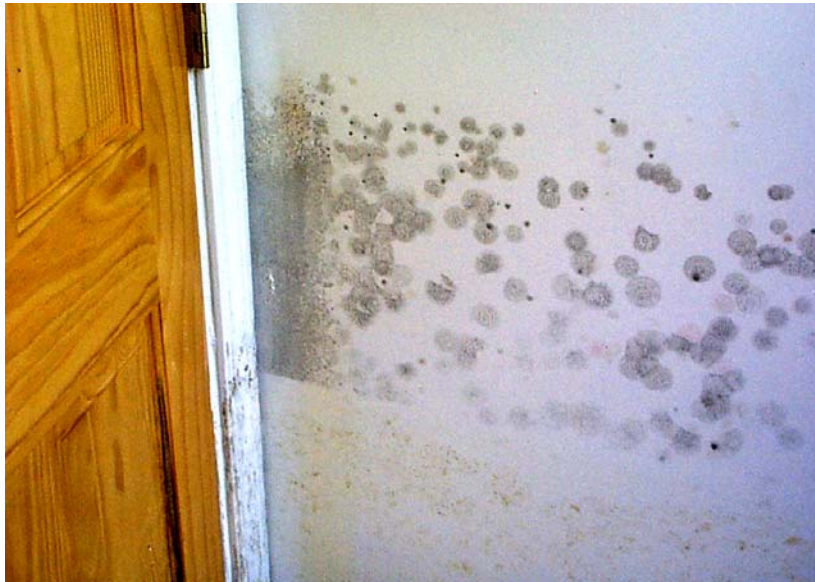
Figure 6 - Interior Plasterboard Showing Surface Mould Growth after a Flood Test (ORNL 2005)

- e) When used with fibreglass insulation, conventional gypsum plasterboard lost 50% of its flexural strength and had high moisture content at the end of the test, whereas a water-resistant fibre-reinforced grade of gypsum board was mostly unaffected. When plasterboard was used with a clear cavity it was found that it was possible to recover the material. Both types of board showed evidence of mould growth on exposed faces, which would be a concern. (see example in Figure 6)

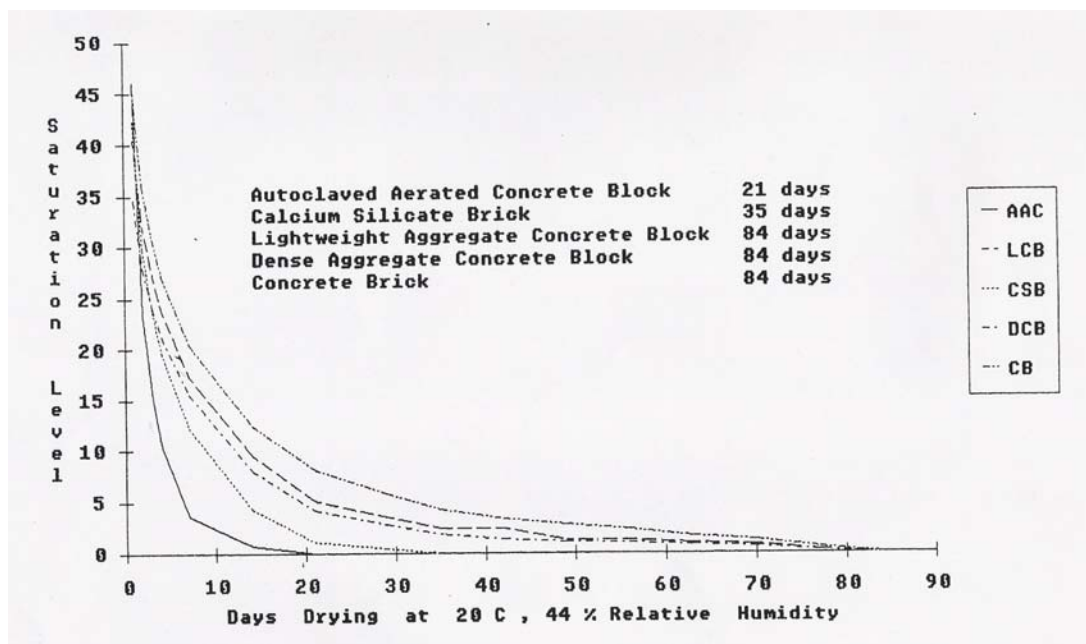
Figure 9 - Graph of Drying Times for Saturated Bricks & Blocks (H&H Celcon 2005)

The drying times for various types of concrete block are shown in Figure 9. These data indicate that autoclaved aerated blocks dry more quickly from a saturated condition than other block types.

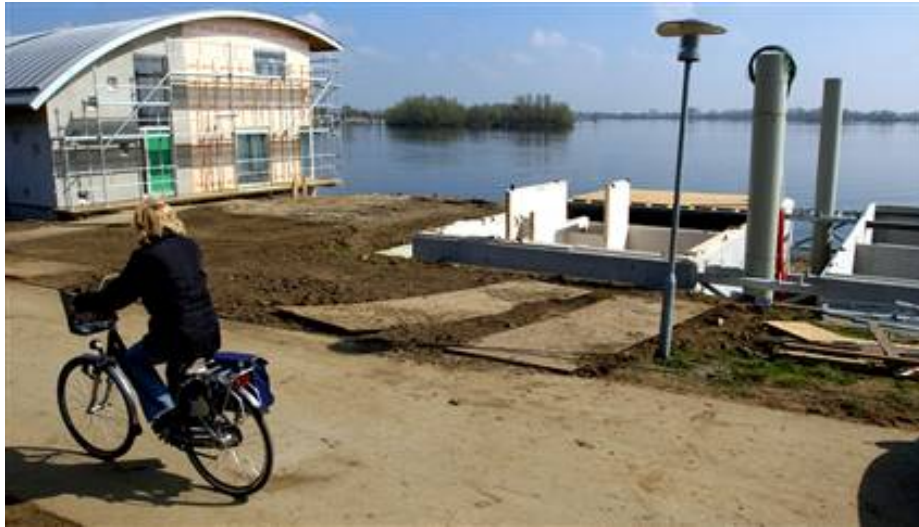
Figure 10 - Floating Homes Being Constructed in the Netherlands (Deutsch 2004)

In the Netherlands, a housing scheme of several dozen floating houses is currently under development by Dura Vermeer (Deutsch 2004). These houses are of mostly timber construction with a hollow concrete base. There are no normal foundations, the building instead resting directly on the prepared ground and connected to 15 foot mooring posts with sliding rings and flexible service connections. In a flood, the dwellings will float. A picture of these dwellings being constructed is shown in Figure 10.
